Taylor Wimpey – Thermal Imaging Project

Site: Hele Park
 Newton Abbot
 TQ12 6JN

Visit Date: 18th December 2017

Plot(s): 294 & 297

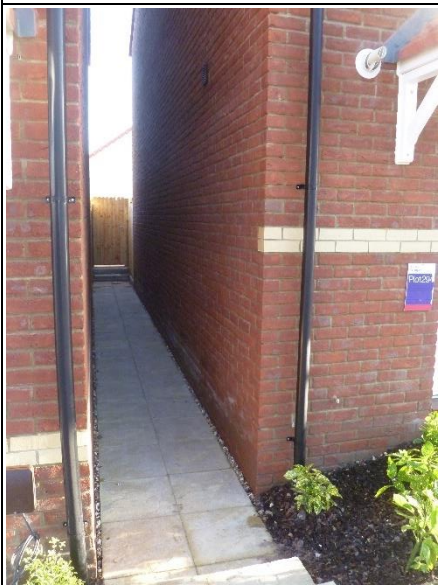
The North West facing gable wall was not exposed to solar, but is reflecting the adjacent heated property's gable wall rather than the clear sky so appears warmer in the thermal image.

Warmer strips are again visible at the ground floor perimeter and also at the intermediate floor level adjacent to the staircase.

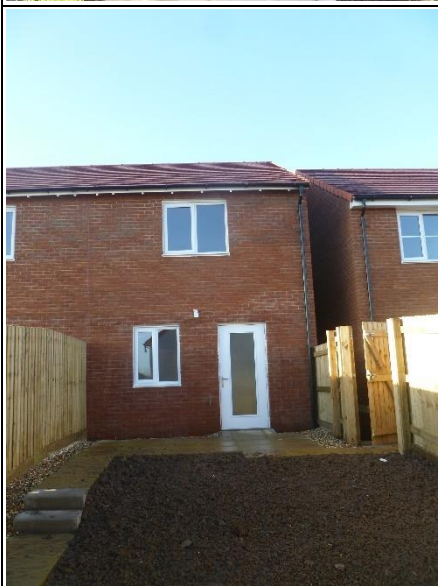
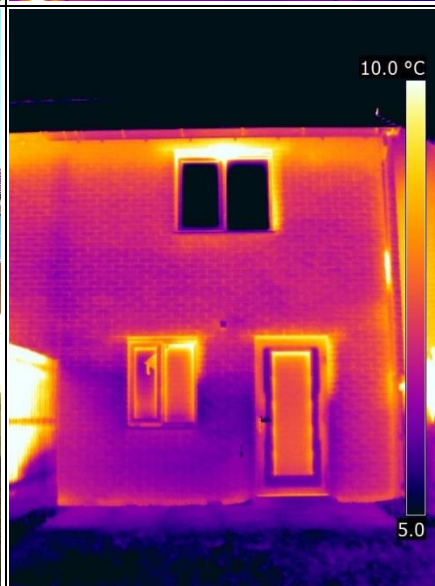
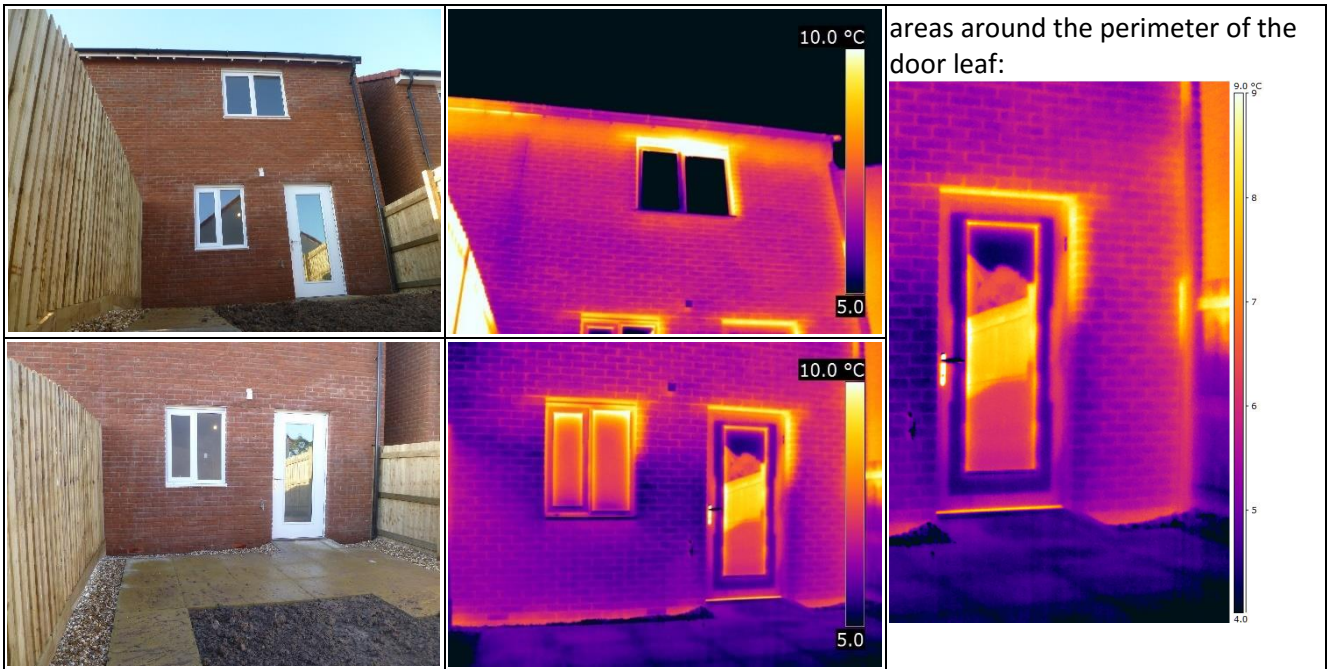
The thermal performance of the rear door and threshold also raised questions. The threshold revealed a significantly warmer strip when viewed from the outside, coinciding with a significantly cooler strip when viewed from the inside; whilst the opaque sections of door varied in temperature by $>2^{\circ}$ from the better performing areas around the glazing panel to worse performing

areas around the perimeter of the door leaf:

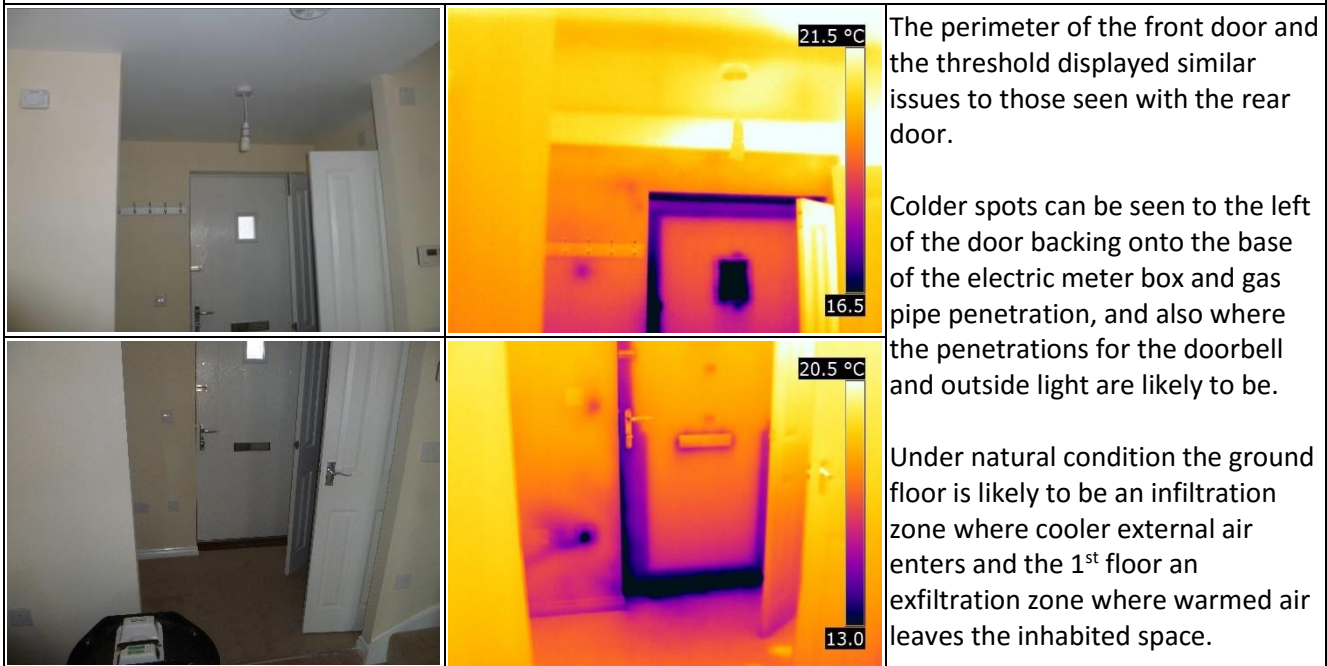
Hall – Under natural conditions

The perimeter of the front door and the threshold displayed similar issues to those seen with the rear door.

Colder spots can be seen to the left of the door backing onto the base of the electric meter box and gas pipe penetration, and also where the penetrations for the doorbell and outside light are likely to be.

Under natural condition the ground floor is likely to be an infiltration zone where cooler external air enters and the 1st floor an exfiltration zone where warmed air leaves the inhabited space.

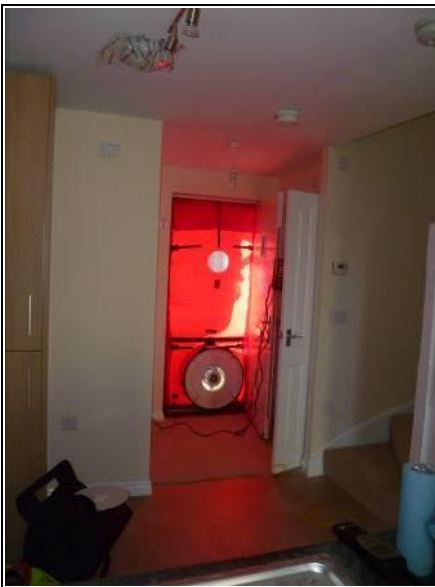
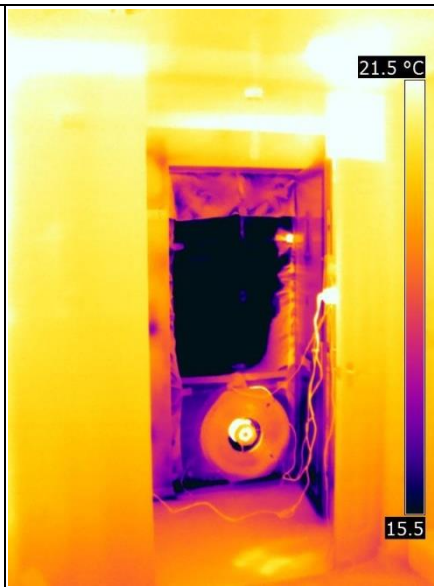
Hall – Under depressurisation

Under depressurisation air is blown out of the property through the blower door fan, allowing cooler air to enter the dwelling through uncontrolled ventilation paths (controlled ventilation such as extract vents and trickle vents are either closed or temporarily sealed for the purposes of this test).

The penetrations through the inner leaf blockwork observed previously are now more obvious as the internal/external pressure difference is held at around -50 Pascal. Cooler air can also be seen moving into the void behind the dry lining plasterboard around the door head and at the base of the door jamb.

Under depressurisation air was also getting beneath the hall carpet and lifting it slightly, although it was not clear where this air was entering it seemed to be from around the door jamb junctions with the threshold.

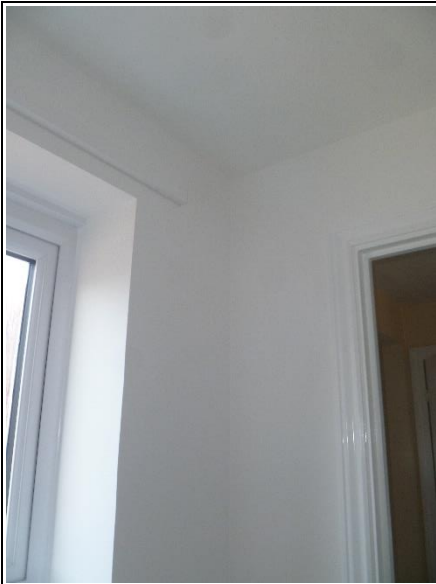
The window reveals varied between jamb and head, with the thermal bridge at the head continuing further than that at the jamb. Possibly there is just plasterboard and no insulation beneath the base plate of the lintel?

The service penetrations for the WC and basin are not obvious under natural conditions.

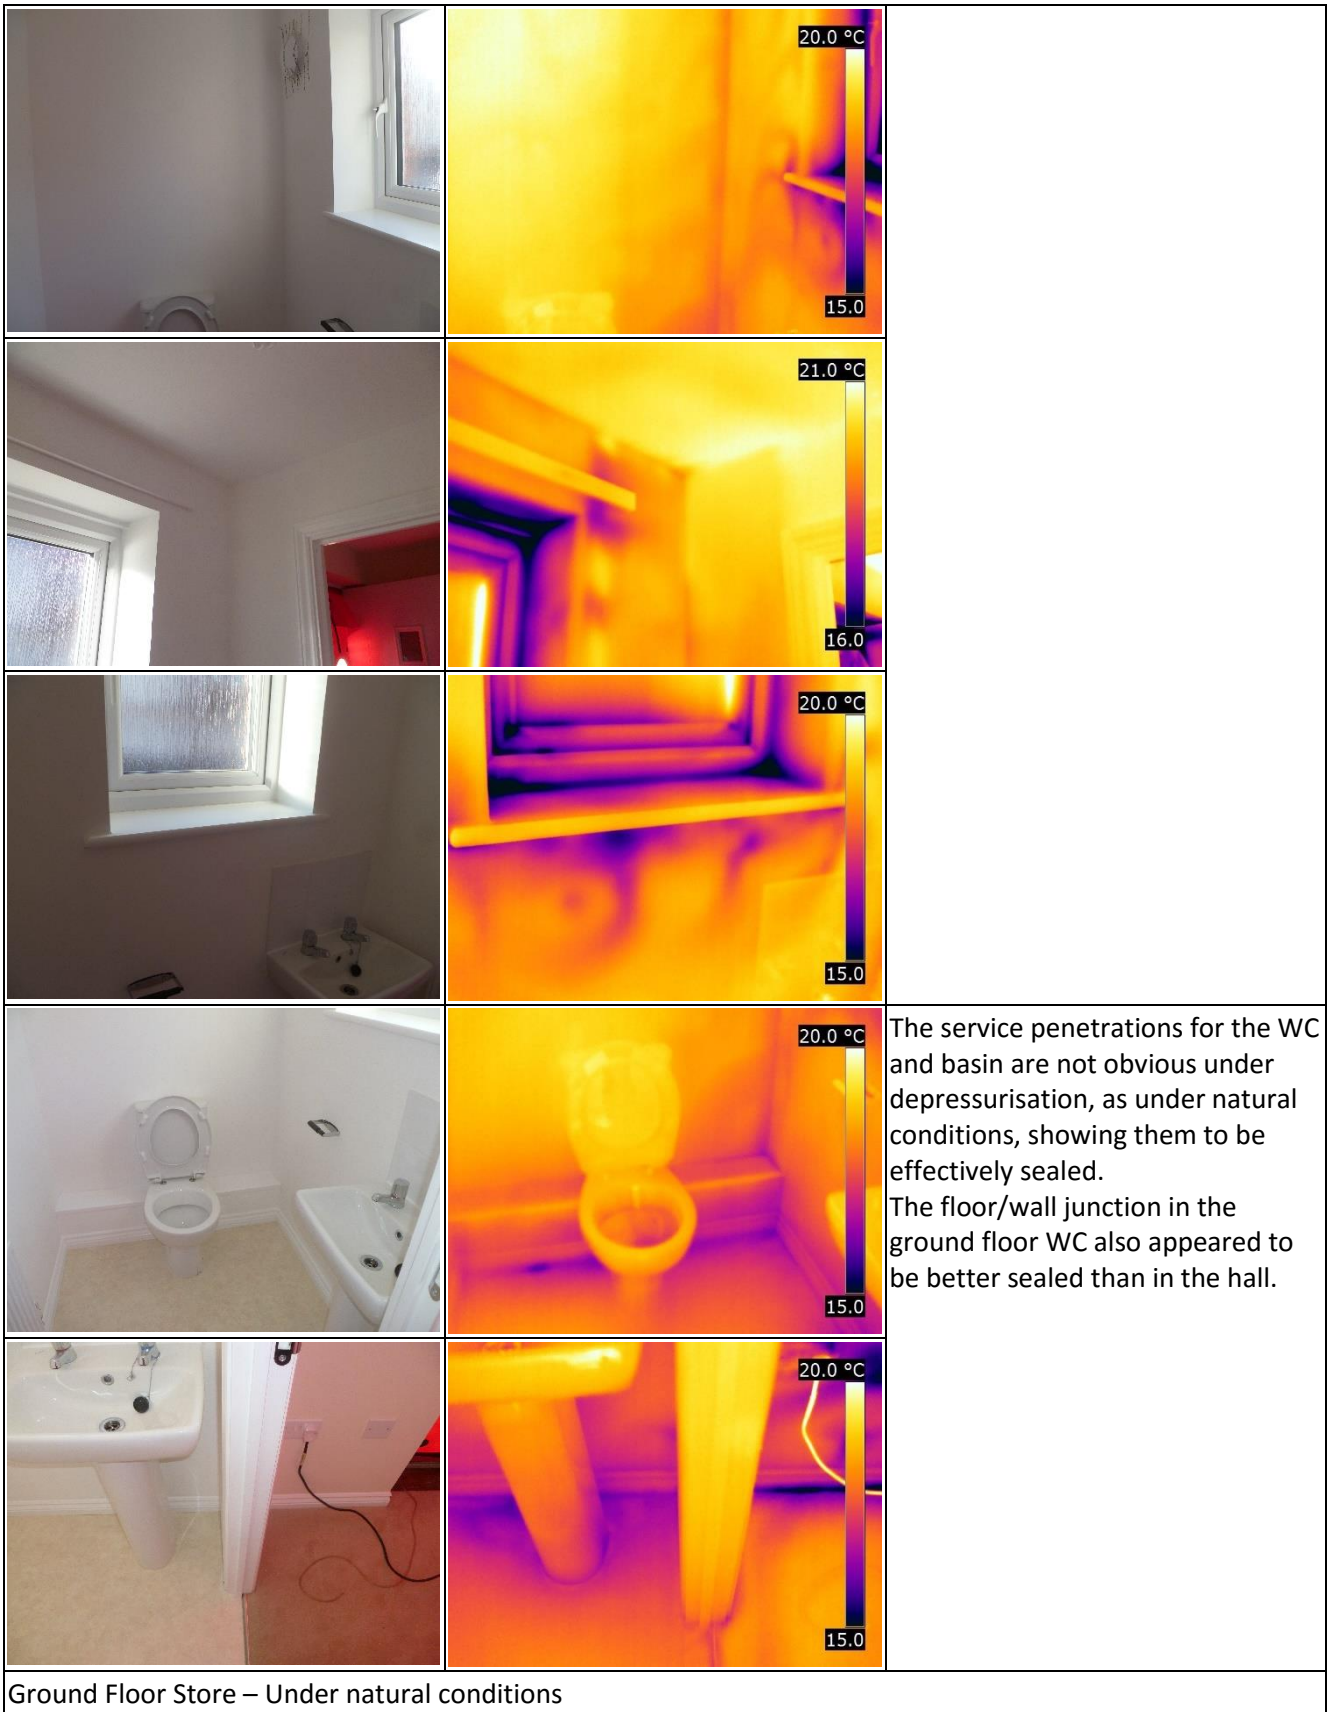
Under depressurisation air can be seen entering the void behind the dry lining and moving around the external wall and into the adjacent void on the party wall. The main points of entry appear to be around the window opening and particularly around the sill board.

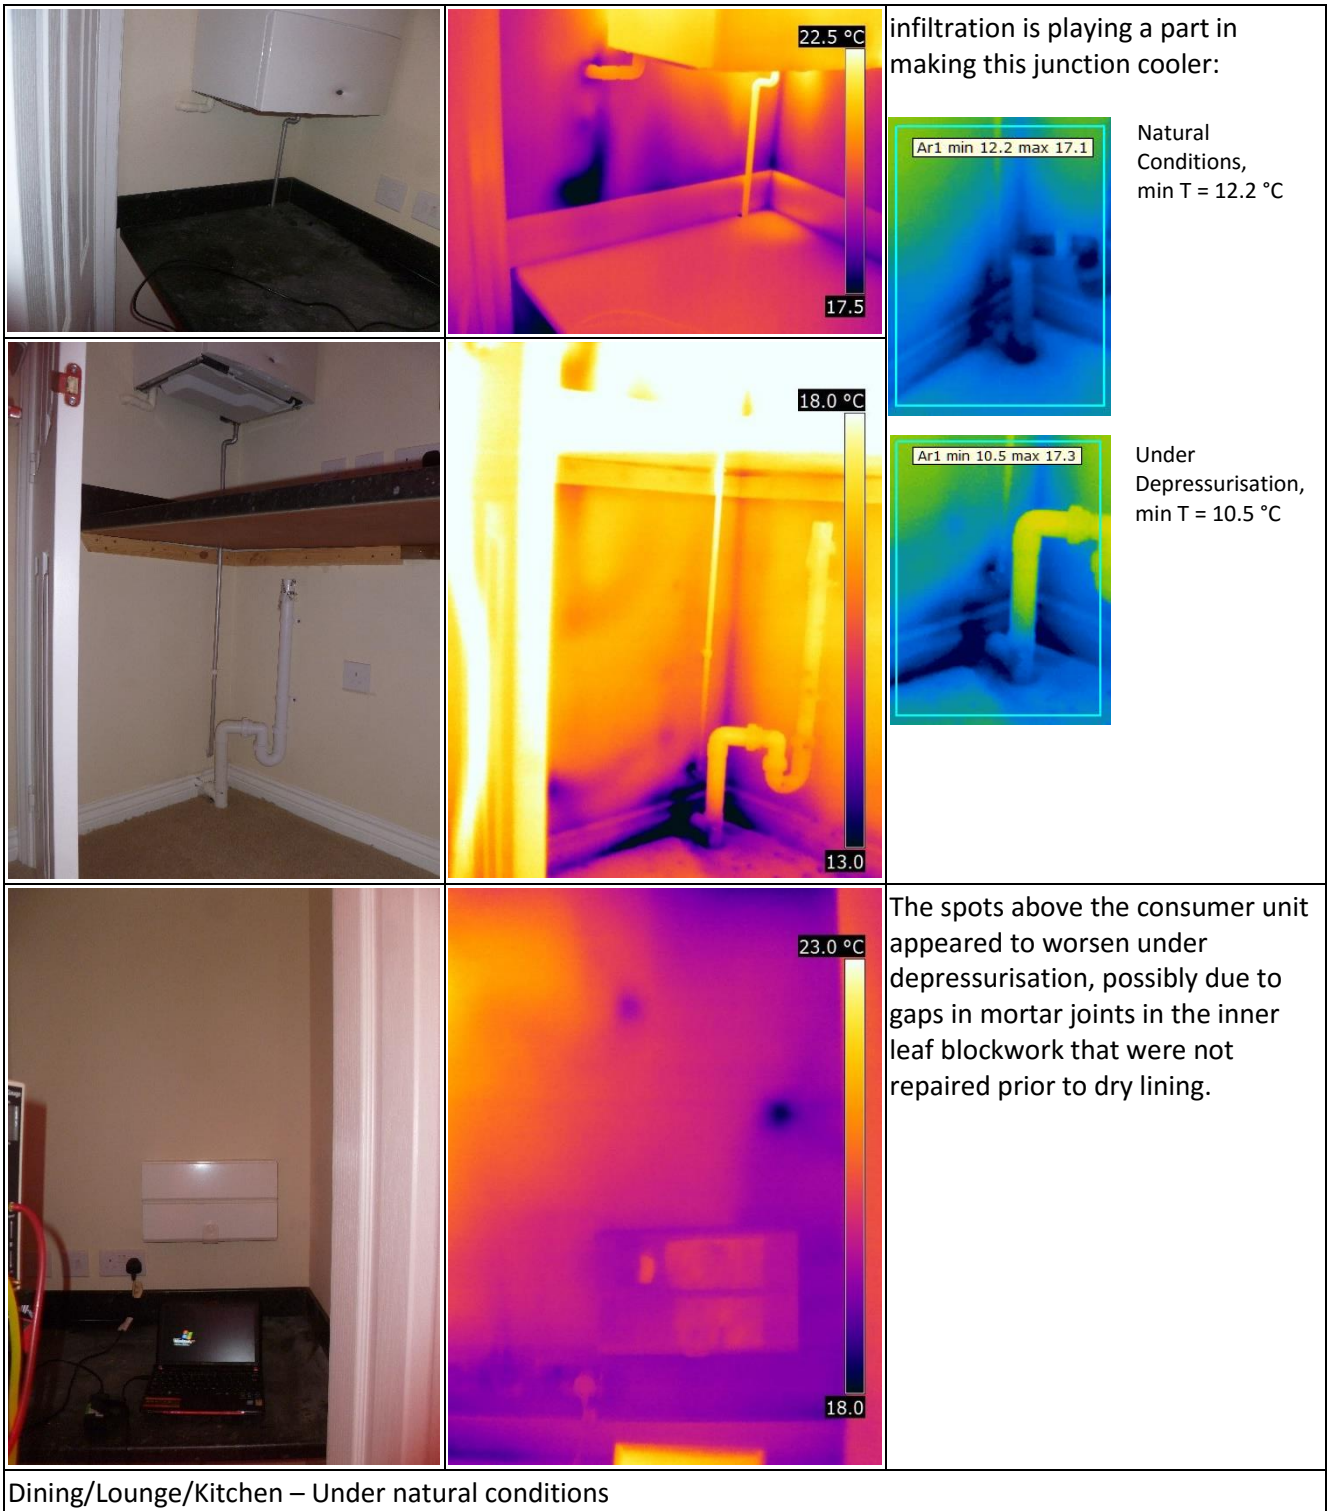
Under depressurisation cold external air could be seen entering around the boiler flue and other external wall penetrations and again moving around through the void behind the dry lining. The cold area in the external corner did drop in temperature under depressurisation, indicating that

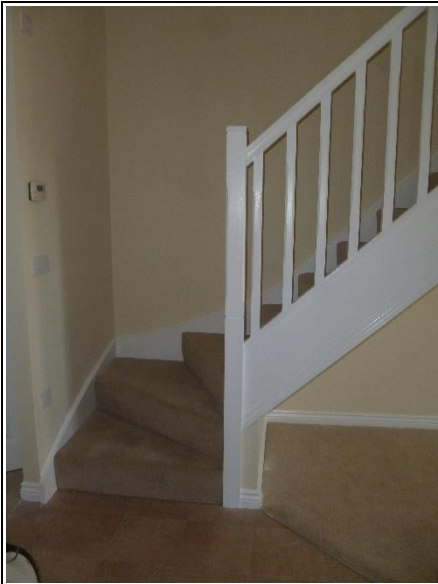
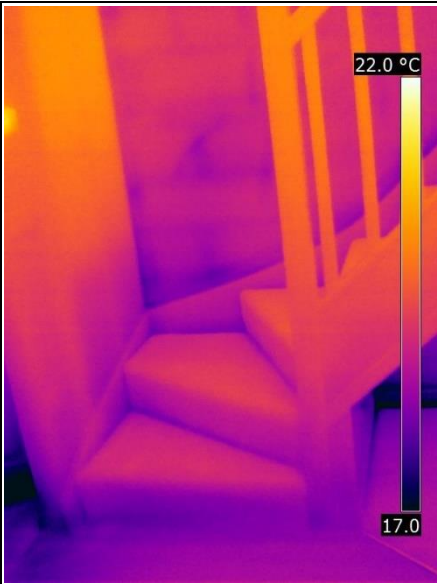
There was a colder strip at the 1st floor ceiling junction with the gable wall, suggesting a lack of insulation

between the gable wall and end trussed rafter.

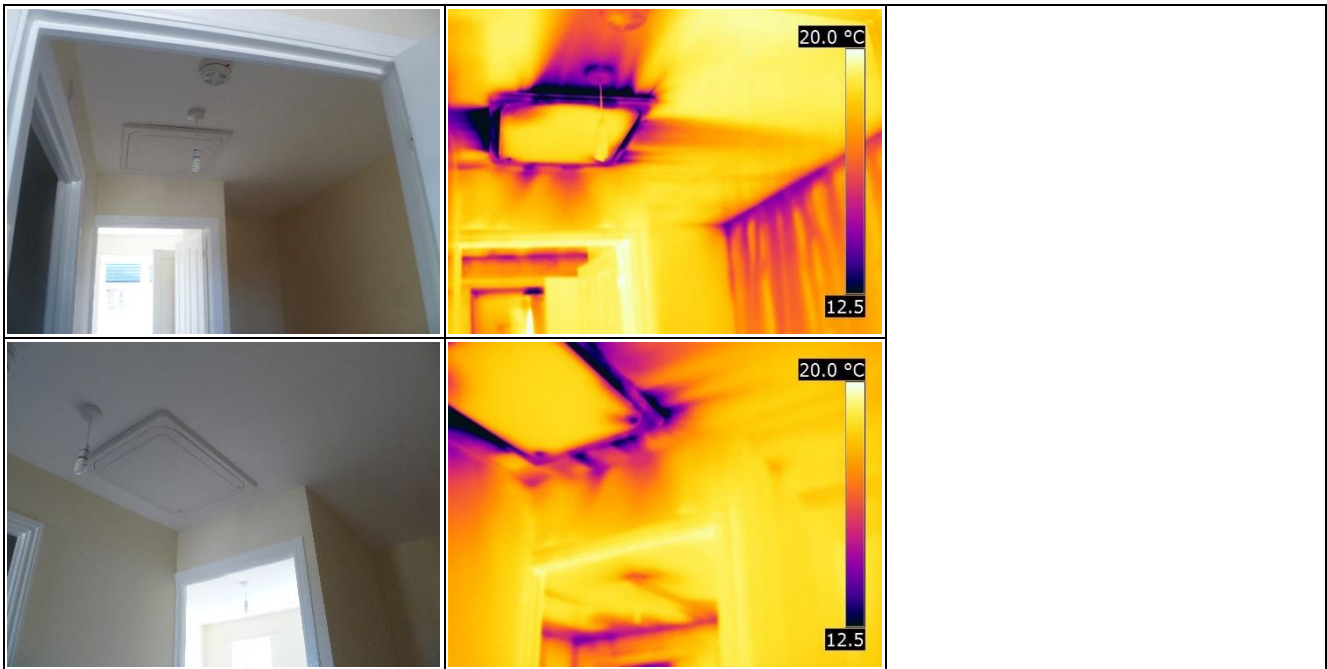
Under depressurisation cold air from the loft was observed being drawn down behind the dry lining on the gable wall, around the plasterboard adhesive dabs. Although nothing appeared to be being drawn down the internal partition voids.

Significant air leakage could now be seen around the loft hatch, both between the door and surround and between the surround and the ceiling.

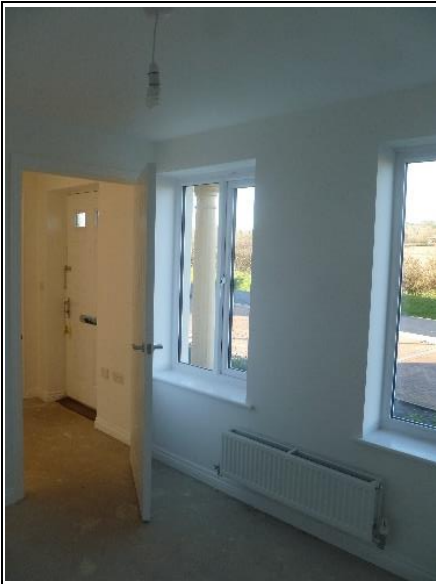
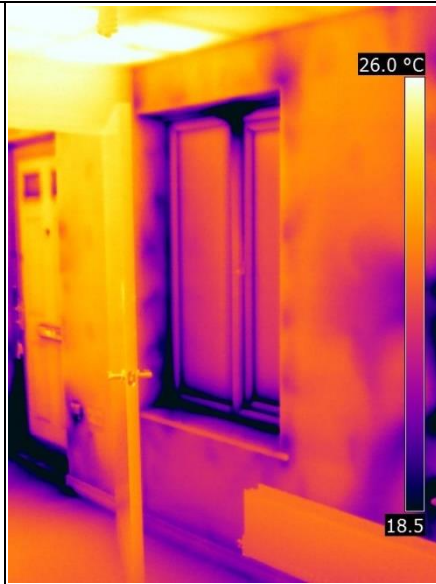
The gable wall was partly covered by the garage and contained the electricity meter box, but neither of these were obvious under natural conditions. The ground floor perimeter was again cooler and the pattern of the blockwork visible through the dry lining.

As in the Lounge, the front-facing windows were on the windward side of the house making it an infiltration zone. There appears to be infiltration below the window adjacent to where the gas meter box is positioned.

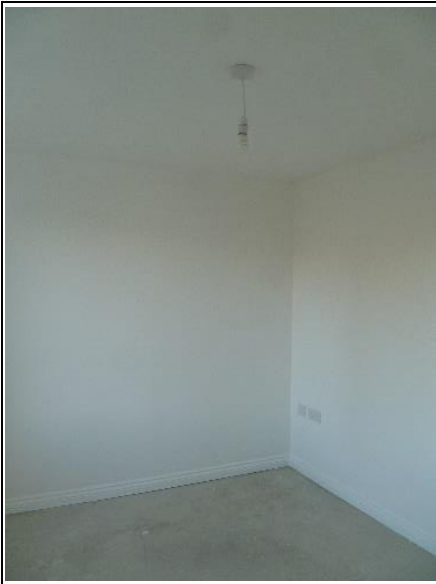
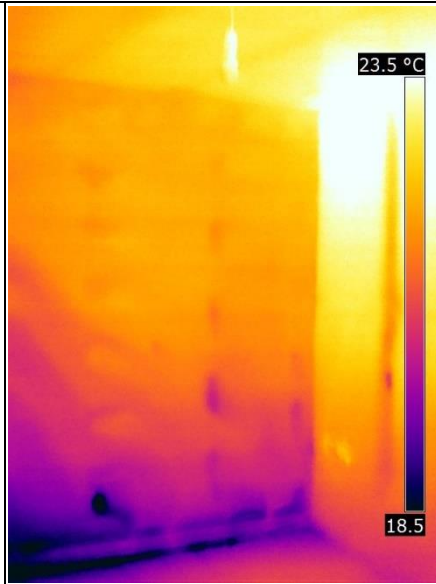
Again, under depressurisation the infiltration paths appear significantly worse, with infiltrating air entering the dry lining void all around the windows.

Adjacent to the gas meter box more air is entering, some of which appears to emerge below the skirting.

On the gable wall there are a couple of spots that again appear to line up with the inner leaf mortar courses. However, the position of the electricity meter box is not visible internally under pressurisation, unlike what was observed with fully filled walls behind meter boxes.

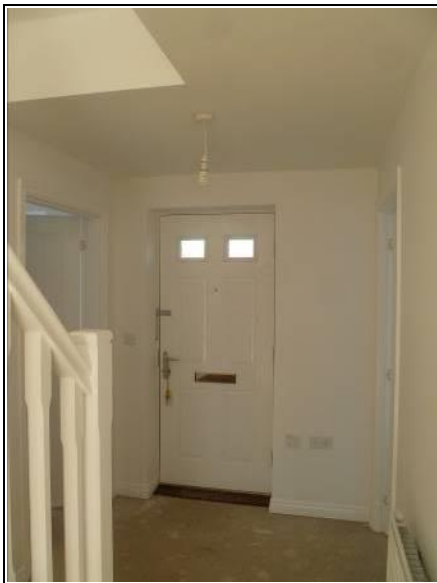
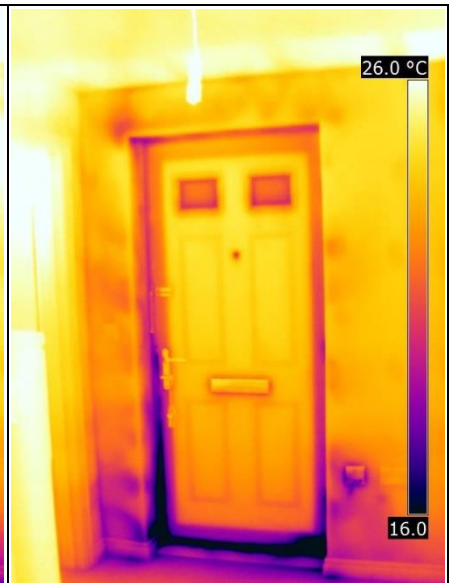
Hall & Stairs – Under natural conditions

The door perimeter is again significantly cooler than the centre of the door, as seen in plot 294.

The threshold is also very cold, although the door having been opened a number of times may have made this look worse.

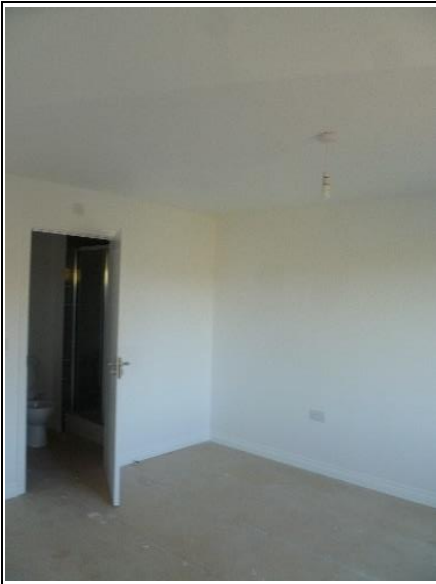
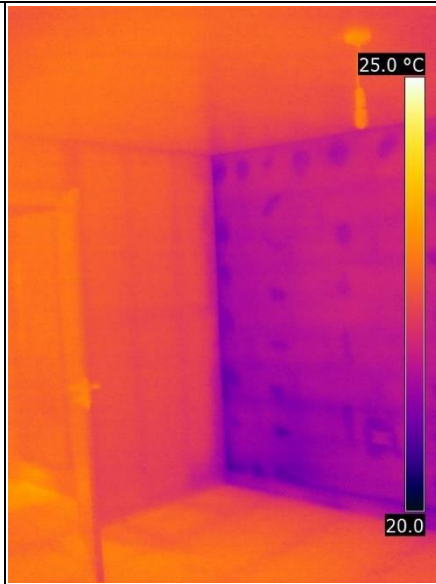
Above the lounge on the 1st floor it no longer appears to be an infiltration zone under natural conditions. The external walls show the blockwork pattern and the adhesive dabs, but no air movement around them or significant thermal anomalies.

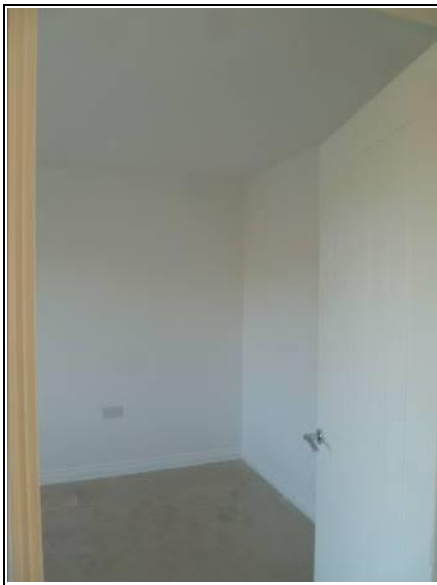
As in bedroom 3 the warm air moving up the wall voids under natural conditions has been replaced by colder air entering from around the window on the front elevation and being drawn down from above on the gable wall.

The cold spots on the wall presumably due to leaky blockwork are more extreme under depressurisation, with some infiltrating air emerging at the floor perimeter.

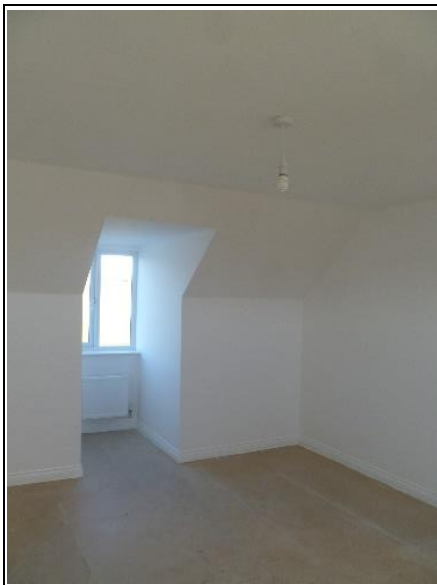
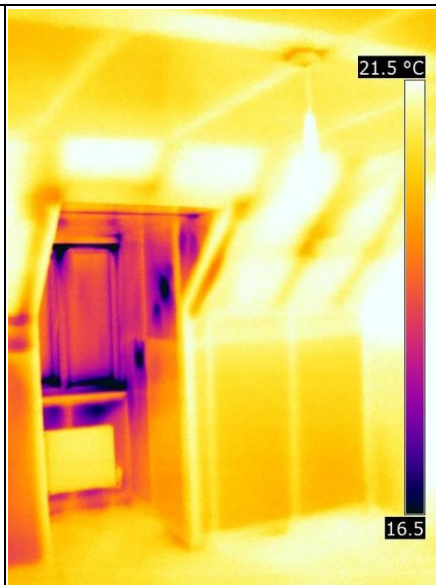
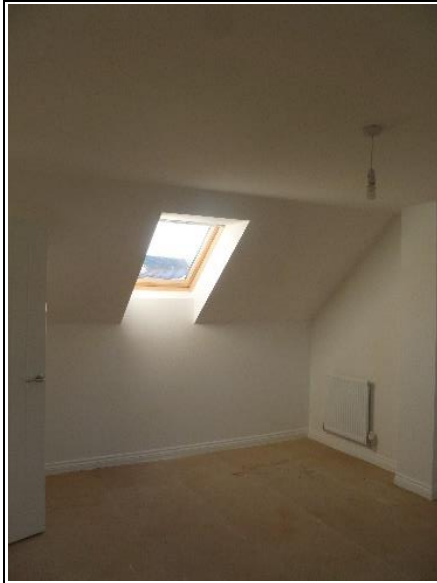
The dormer cheeks appear to be an issue when the direction of air movement is reversed. Cold air appears to be bypassing any insulation in the cheeks.

Air infiltrations around the dormer window appears to still be of

concern; the roof-light however appeared to perform very well.

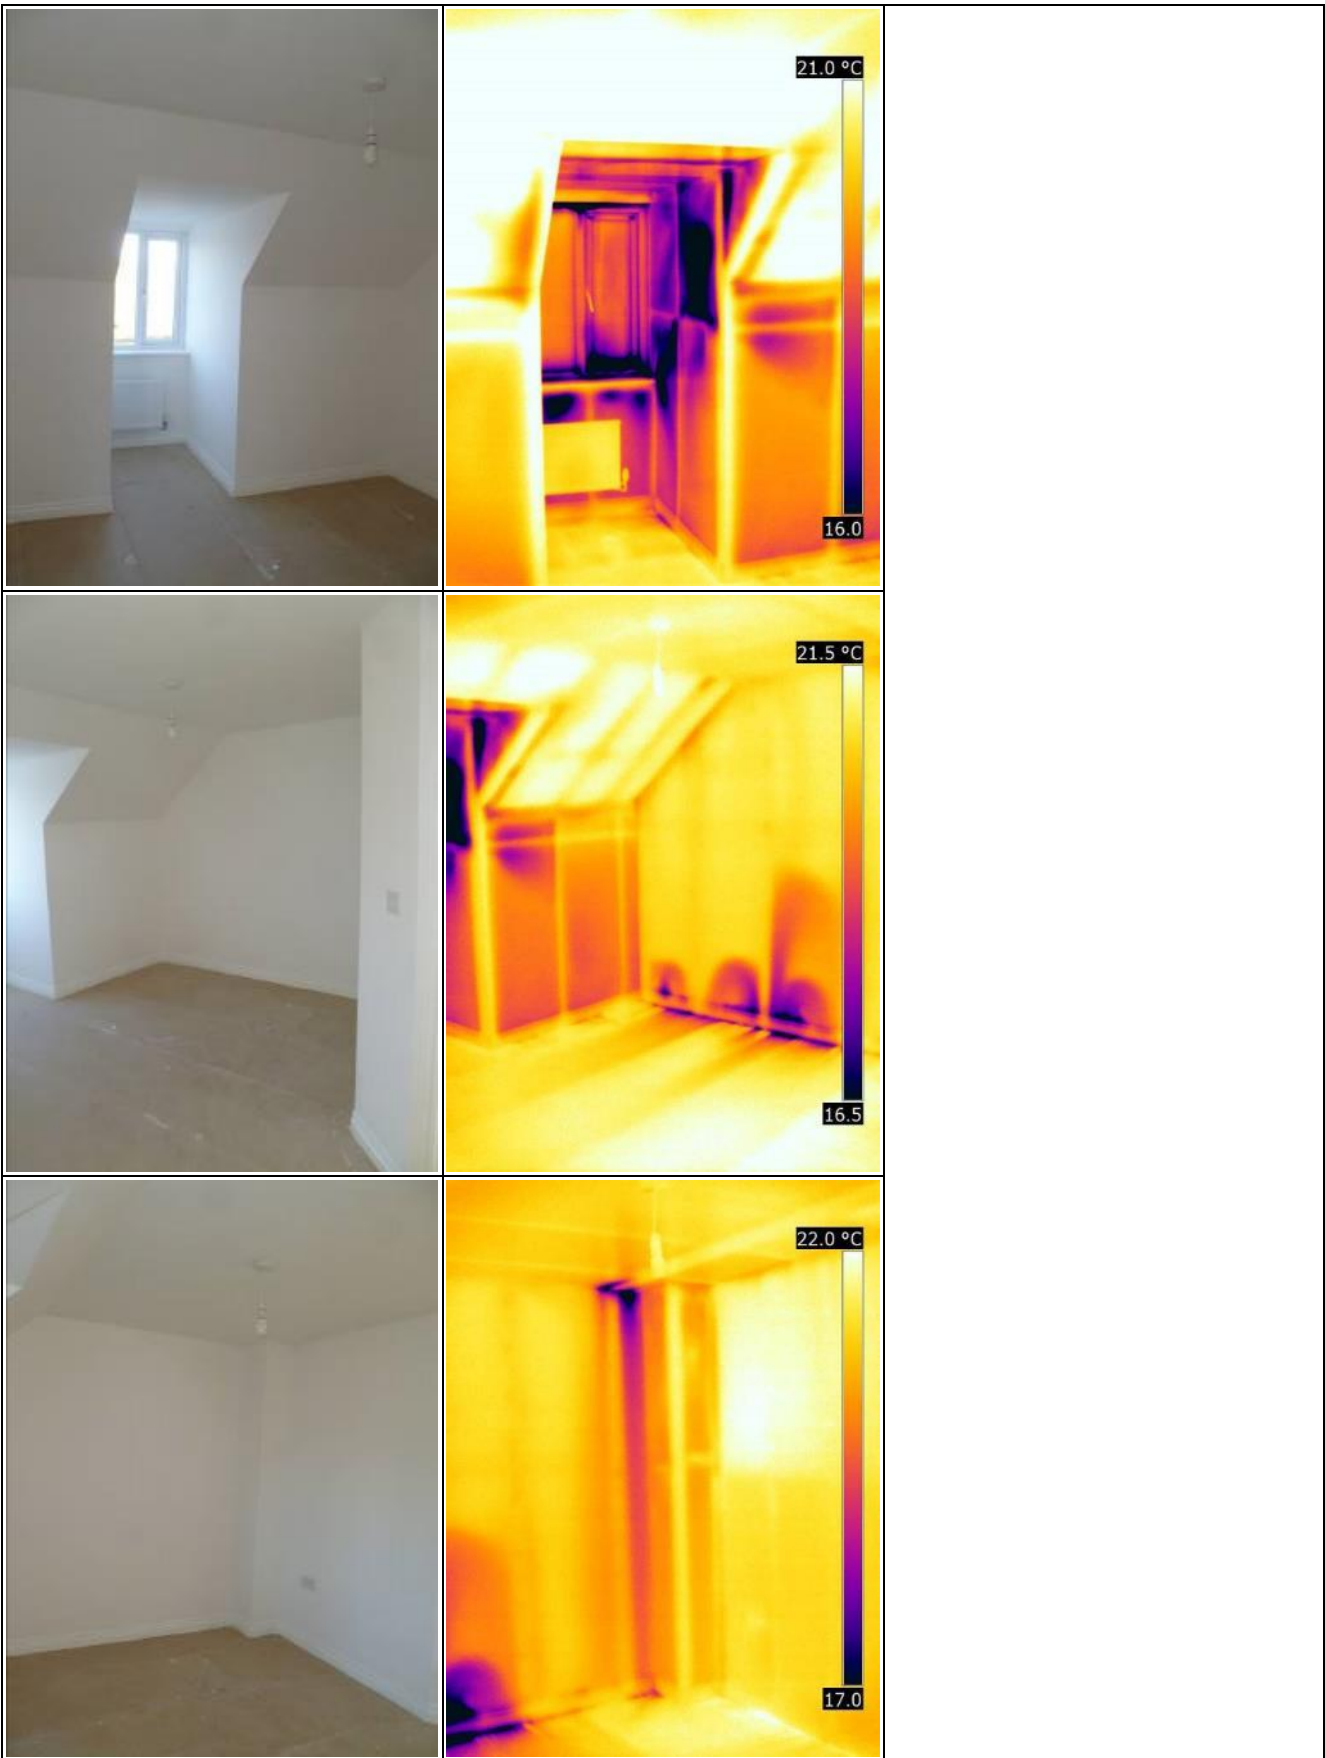
Air leakage was also detected around electrical services into the eaves void, and significant infiltration was observed at the floor wall junction on the gable wall.

Also on the gable wall, the service riser adjacent to the en-suite showed cooler air being drawn down from above.
