X-ray Computed Tomography Study of Kink Bands in Unidirectional Composites

Ying Wang, Timothy L. Burnett, Yuan Chai, Costas Soutis, Paul J. Hogg, Philip J. Withers

An experimental study on the axial compressive failure of cylindrical unidirectional (UD) carbon fibre-epoxy rods has been performed to better understand kink bands and the relevant damage mechanisms in three dimensions (3D). Post-mortem X-ray micro-computed tomography (micro-CT) imaging has shown that fibre kink bands predominantly all lie within the same plane in a cylindrical rod sample uniaxially compressed without lateral constraint. Kink bands at different stages of development are contained in the damage volume and the geometric parameters of fully developed kink bands are consistent through the damage zone, with a kink-band width $w \approx 20\text{-}320 \mu\text{m}$, kink-band angle $\beta \approx 11\text{-}40^\circ$ and fibre rotation angle $\Phi (\varphi + \varphi_o) \approx 18\text{-}52^\circ$. Fibre failure, longitudinal splitting and matrix micro-cracks within the fibre kink zone are identified by scanning electron microscopy (SEM) and X-ray micro-CT observations. The smallest radius of curvature that cor

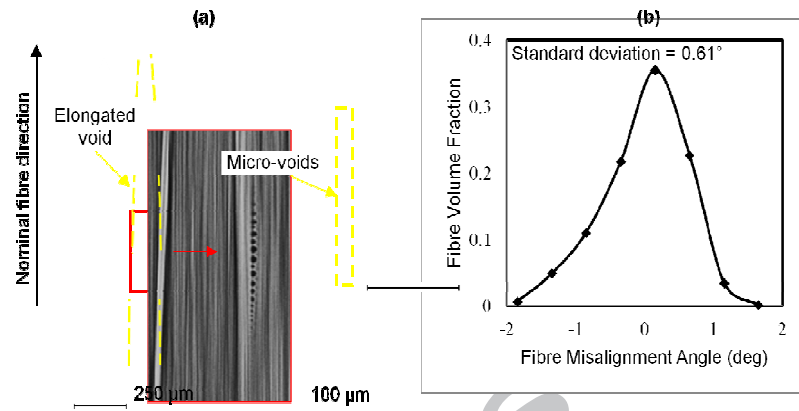
The X-ray micro-CT virtual cross-sections (Fig. 3) show the presence of an elongated void along the fibre direction and localised micro-voids; these probably arise because that it is difficult for air bubbles to be expelled through the closely packed fibres without the aid of flow media. After being cured, the air bubbles remaining in the composite become voids, observed as relatively dark regions in Fig. 3. Micro-voids have been observed both beside and at the tip of such elongated voids. The micro-voids are discontinuously located between the fibres, being separated by resin ligaments. It can also be observed that fibres are more severely misaligned near the voids than at other regions. Generally, the void content is below 1% calculated from segmented void volume in X-ray micro-CT datasets.

Fig. 3. (a) X-ray micro-CT virtual cross-section along the nominal fibre axis of the composite rod, showing an elongated void and micro-voids, and (b) Initial fibre misalignment angle distribution in carbon fibre/epoxy rods made by the SSRI method.

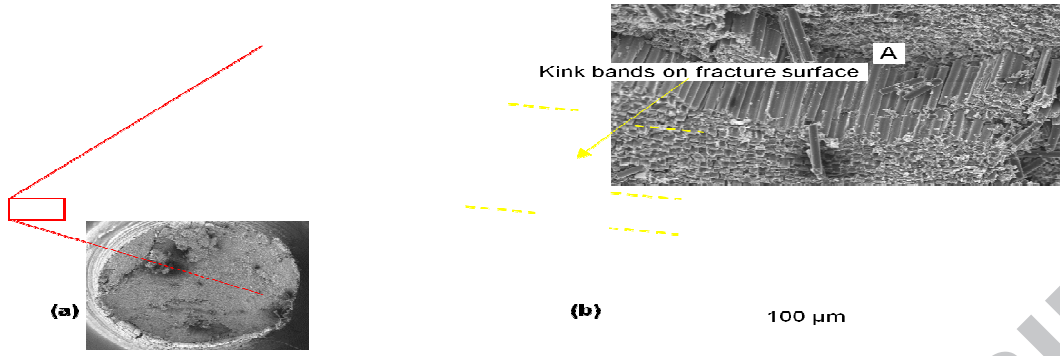
In order to observe damage at the fibre scale, fracture surfaces were examined under SEM (see Fig. 4). The results indicate that kink band formation is the dominant failure mechanism, and the geometrical parameters of the kink bands are similar across different samples.

Generally multiple kink bands were observed, as shown in Fig. 4b. The narrow bands are 25-60 μm wide, while the wider band is 80-90 μm wide. Fibres in the adjacent two narrow bands were aligned along the same direction. However, the fibre rotation angle and kink-band boundary angle could not be measured directly from these SEM images, as the view was inclined with respect to the kink plane.

Fig. 4. (a) Secondary electron SEM image (plan view) of the lower fracture surface of sample A (~1.5 mm gauge diameter), and (b) magnified secondary electron SEM image (oblique view) showing multiple kink bands of variable width (yellow dashed lines indicate kink-band boundaries).

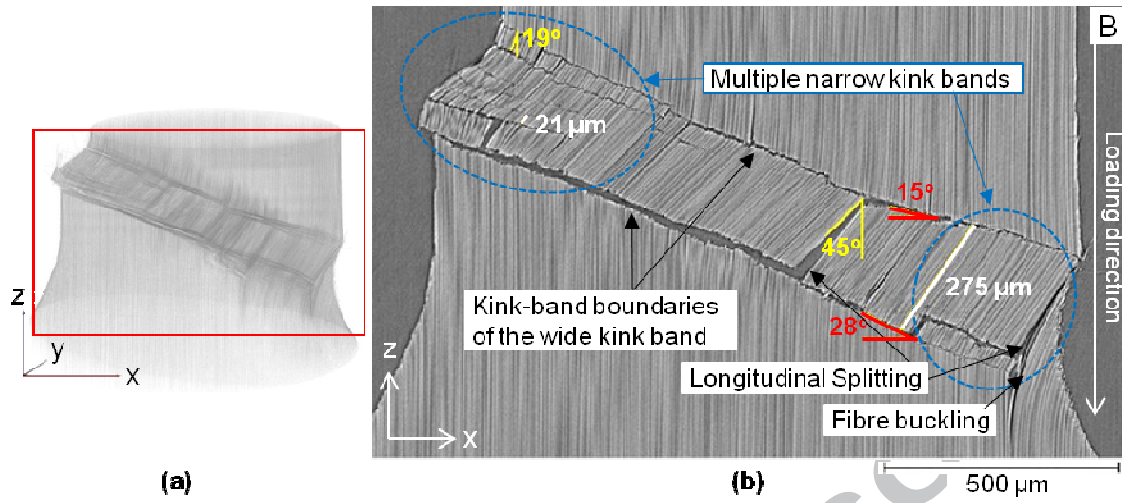
Moreover, damage below the fracture surface cannot be revealed by SEM. By contrast, X-ray micro-CT enables the 3D morphology of the kinking damage zone after failure to be determined and analysed for the partially failed intact sample B (Fig. 5). External examination of the sample reveals evidence of shear failure towards the end of the gauge section possibly due to local stress concentration induced by machining and probably reduced local stiffness due to discontinuous fibres. Fig. 5b exhibits a typical virtual XZ cross-section of the kinked region taken from the X-ray tomogram. Great care was taken to ensure the sample was oriented so as to view the kink band sideways on. To enable this the XY coordinate directions for the X-ray tomogram were selected such that the primary shear causing the kink bands lies within the XZ plane. Thus the geometric parameters can be measured directly from XZ virtual sections. Unlike the angled view in the SEM images, the measurements were made on the virtual longitudinal sections from the tomogram such as that

The geometric parameters of the kink bands are: $\omega \approx 20\text{-}320 \mu\text{m}$, $\beta \approx 11\text{-}40^\circ$ and $\Phi (\varphi + \varphi_o) \approx 18\text{-}52^\circ$ in sample B. The damage zone has almost completely propagated through the whole sample with undamaged regions around the periphery holding the sample together. As many as six individual narrow kink bands can be seen on the inclined left-hand side of the sample, as shown in Fig. 5b. The fibres in the central four bands are aligned at approximately the same angle, while small angular change in fibre direction was observed in the top and bottom narrow bands, in accordance with the observations of Vogler and Kyriakides [13].

Fig. 5. (a) 3D X-ray micro-CT volume rendering of the damage zone of sample B oriented so as to view the kink sideways on. (b) A typical X-ray micro-CT virtual XZ cross-section located in the middle of the sample showing kink bands and associated damage mechanisms. Most of the bands lie in the XZ plane, thus ω (white), β (red) and Φ (yellow) can be measured as indicated.

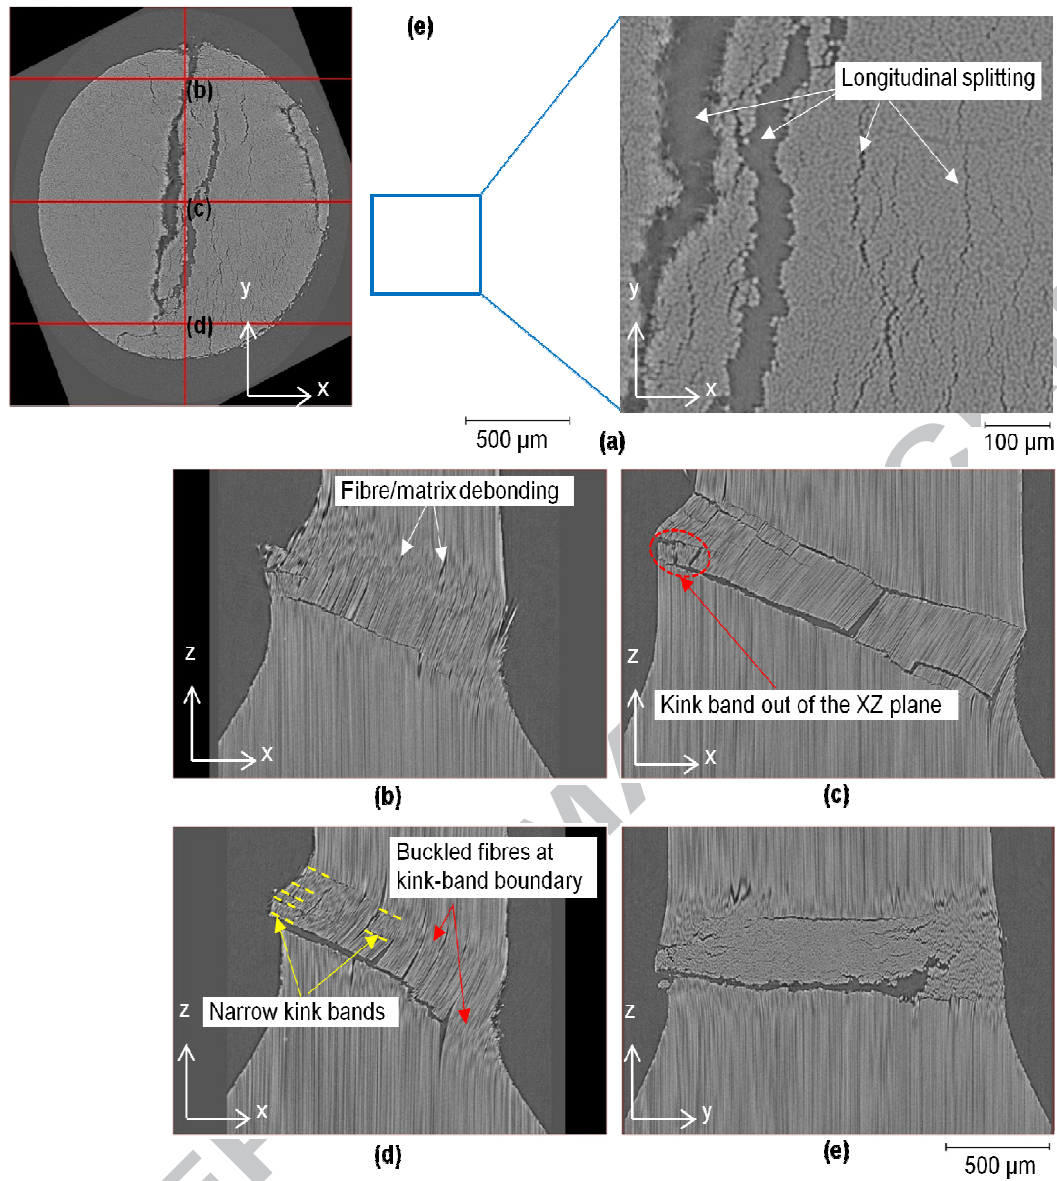
Fig. 6 shows the XY, XZ and YZ virtual cross-sections of the sample across the damage zone. The boundaries of the wide kink band in Fig. 6c were clearly defined by fibre breakage, indicating full development of the kink band. While in Fig. 6b and d some of the fibres at the boundary of the wide kink band had buckled but not fractured. The discontinuous boundaries at the outer layer of the rod indicate that in these regions, the material is at an earlier stage relative to that in the centre of the sample. The geometry of each fully developed kink band was found to be consistent through the specimen along the Y axis. In the compressive failure of high aspect ratio laminates, out-of-plane kink bands are dominant due to the lack of constraint in the through-thickness direction [12]. The specimen tested in the current study is cylindrical, so that the lateral constraint is similar in all directions. Nevertheless the kink bands formed predominantly within the same plane across the sample (defined as the XZ plane) except for a few isolated regions. The YZ cross-sections along X axis show that the boundary planes of the wide kink band are parallel and perpendicular to the loading axis, as can be seen in Fig. 6e.

By observing fibres at various locations in the kinking volume, we can potentially track the status of fibres before failure. As seen in Fig. 6, some of the fibres at the boundary of the wide kink band are heavily buckled but did not fracture. The discontinuous boundaries with both broken and unbroken fibres indicate that curvature of unbroken fibres should be close to the maximum bending curvature that the fibres can undergo prior to fracture. The smallest radius of curvature of the unbroken fibres corresponding to extent of bending at fracture was measured using ImageJ to be $\sim 280 \mu\text{m}$ (40 fibre diameters). Weaver and Williams [29] observed larger radius of curvature ($\sim 530 \mu\text{m}$, 78 fibre diameters) of unbroken fibres in Modmur Type II carbon fibre/epoxy composite rods failed under axial compression with hydrostatic pressure. According to Weaver and Williams, if it is assumed that each fibre was strained in tension and compression equally in reference to its neutral axis ($\varepsilon_t = \varepsilon_c$), the maximum elastic strain at the surface would be $\varepsilon_t = \varepsilon_c = (\text{fibre diameter}) / (2 \times \text{radius of curvature}) = 1.25\%$, which is below the tensile failure strain 2.1% of the T700 carbon fibres as specified in the manufacturer's data sheet. As our values were measured in unloaded specimens, elastic recovery (spring back) will have taken place following unloading the compressive load. Therefore, even larger curvature (higher strains) would have been sustained in the fibre during buckling.

Fig. 6. X-ray micro-CT virtual cross-sections of sample B: (a) XY, (b), (c) and (d) XZ, and (e) YZ, showing different views of kink bands inside the rod (yellow dashed lines indicate kink-band boundaries).

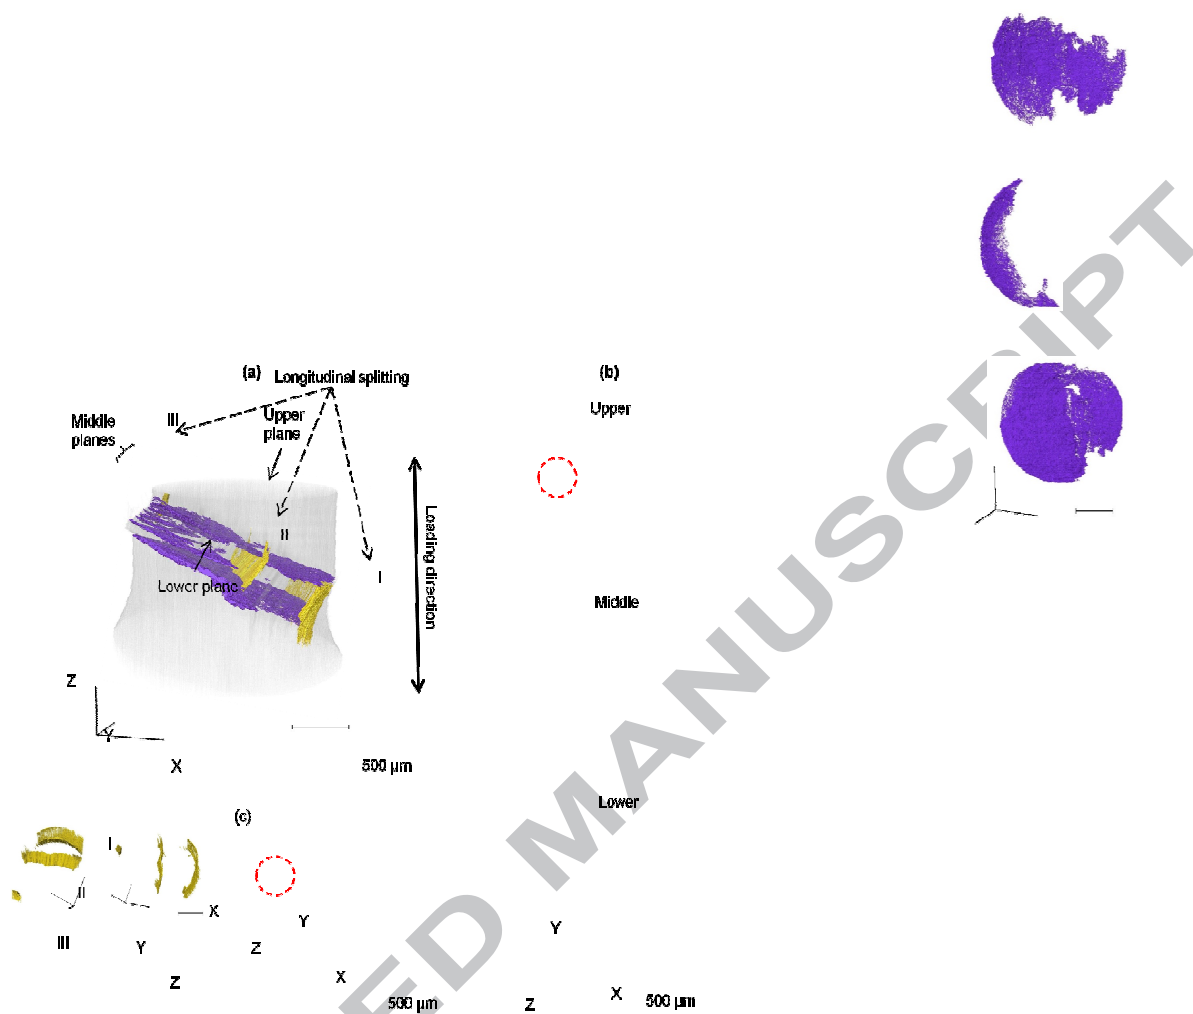
Fully developed kink-band boundaries were defined by fibre breaks. For the wide band, the fibre angle changed abruptly at the boundary, while for the narrow bands, additional fibre rotation was not observed. From the side view in Fig. 7a, all the band-boundary planes were found to be inclined at $\sim 25^\circ$ to the X direction, with slight variation and bending in 3D due to local microstructure and stress state. The middle crack planes formed by fibre breaks were developed with the formation of multiple narrower kink bands and the width of each kink band ranges between 25 μm and 100 μm . As depicted in Fig. 7b, the kink-band boundary planes were shaped differently. The upper and lower boundaries, delineating the wide band, have almost propagated across the entire specimen; while the middle planes, representing the boundaries of narrower bands, are sickle-shaped localised at one side of the circumference. The difference in the planar shape might indicate different triggering and propagating mechanisms of damage.

The longitudinal splitting parallel to the fibre direction in the 2D cross-sections formed 3D curved planes in the kinked volume, as shown in Fig. 7c. The morphology of these planes changes with position along the X direction. Three typical longitudinal splits were segmented near two maximum-bending surfaces and at the centre of the specimen, as shown in Fig. 7a.

Fig. 7c demonstrates that longitudinal splits I and III were curved as the circumference of the specimen; while the waviness of longitudinal split II was because the fibre rotation angle varied through the sample through the Y direction. The morphology of the longitudinal splitting planes suggests that its propagating direction is roughly along the Y axis. It can be seen in Fig. 7a that the formation of longitudinal split I has stopped the propagation of fibre

breakage at the lower kink-band boundary by releasing the stored strain energy. It is also found that longitudinal split III corresponds to the indentation highlighted in Fig. 7b. It is likely that the upper boundary originates from the split, as has been observed by Hapke *et al.* [11].

Fig. 7. Segmented and extracted 3D volume of damage from X-ray micro-CT data: (a) Side view of planes of fibre breakage (purple) normal to, and three splits (yellow) parallel to, the fibre direction. The upper and lower fibre-fracture planes delineate a wide kink band, within which multiple narrow bands that are similarly inclined lie, (b) Top view of kink-band boundaries defined by fibre breakage, categorised in three groups according to their location and morphology: upper, middle and lower, and (c) Angled views of the three splits at different locations in the specimen, numbered I, II and III.

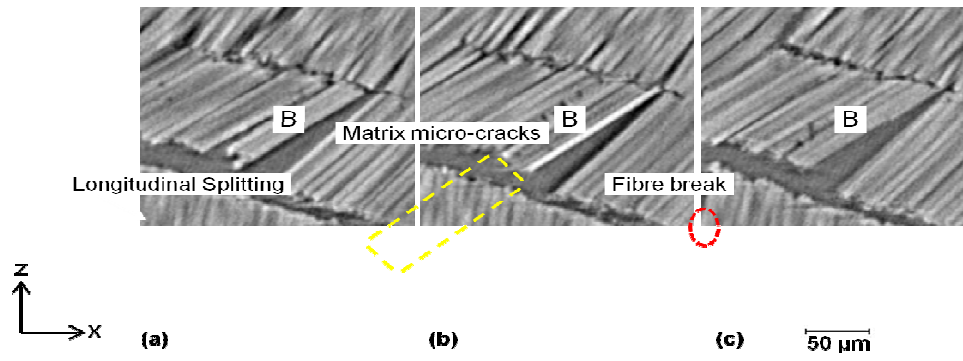
In 3D X-ray micro-CT data, by carefully analysing sequential XZ cross-sections through the sample, the geometric correlation between different damage mechanisms can be identified. Fig. 9 shows close-up views of small region-of-interest in three adjacent XZ planes along the Y axis. The matrix micro-cracks appeared to be localised between a longitudinal split and fibre breakage. The morphology of the micro-cracks is similar to that reported by Gutkin *et al.* [36]. They proposed that the micro-cracks would eventually coalesce into a longitudinal split, which can be validated by the observation here that the longitudinal split and the micro-cracks are connected in sequential images. The fibre fracture plane was inclined at $\sim 45^\circ$ to the fibre axis, indicating the presence of shear stress.

Fig. 9. Adjacent X-ray micro-CT virtual XZ cross-sections of sample B (two sequential images in between were not shown) showing the transition between split (white), micro-cracks (yellow) and fibre breakage (red).
