XIV International Conference on Building Pathology and Constructions Repair – CINPAR 2018

Rehabilitation and seismic upgrading of the masonry arch bridge over the Magra river in Villafranca

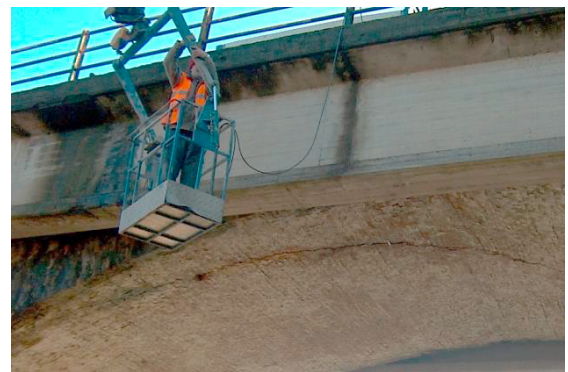
More recently, due to the modification of the river course, scour occurred at the piers on the Mulazzo side, so that in the years 2005-2010 a relevant crack pattern was detected on the last two arches, as illustrated in Figs. 4 and 5.

Fig. 4. Inspection of a damaged arch - monitoring phase (2010)

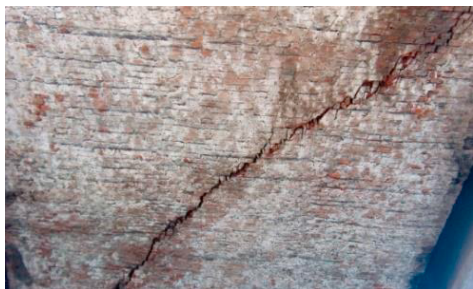
Fig. 5. Main crack on the arch (Mulazzo side 2010)

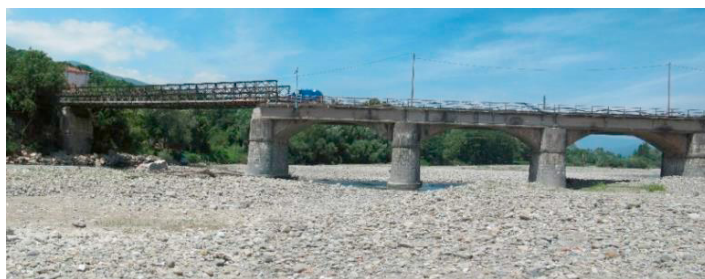
Despite the monitoring program setup to control the structural decay, in 2011, during the Magra flooding, two arches on the Mulazzo side collapsed due to scour of the extreme pier, and a temporary Bailey bridge was placed on the deck to allow at least light car traffic (Fig. 6).

Fig. 6. The temporary Bailey bridge after the collapse of the two arches (2012)

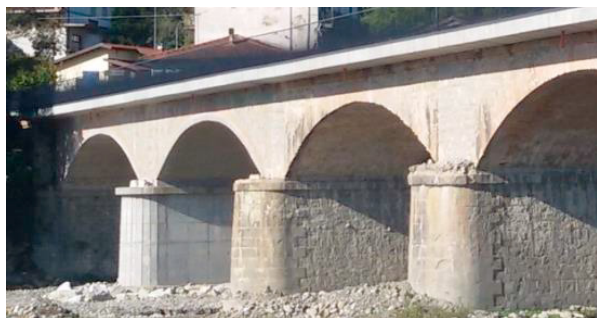
Fig. 7.(a) The new r.c. arches and pier

The intervention involves, *inter alia*, the consolidation of 6 of the 8 arches, the reconstruction of the collapsed pier and of the two arches closest to the right bank and the strengthening of the remaining parts. The two collapsed arches have been rebuilt in reinforced concrete as well as the collapsed pier (see Fig. 7.a), characterized by micro-pile foundation. For casting these new concrete parts, special non-removable lateral formworks have been used, overlaid with bricks and stones looking similar to the original ones, anyhow underlining the modern replacement (Fig. 7.b).

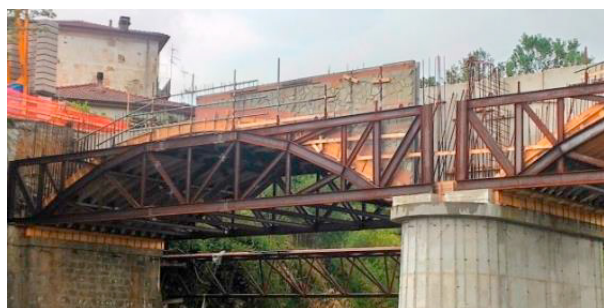
(b) The lateral formworks overlaid with stones and bricks

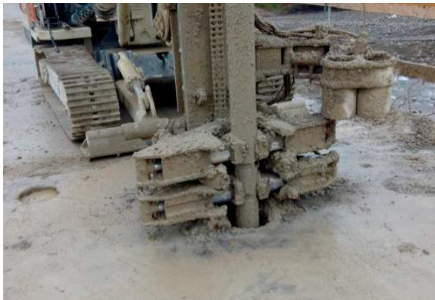
Fig. 9. Execution of micro-pile through the existing piers

The 6 spans subject to rehabilitation were strengthened through a continuous reinforced concrete deck, supported by the existing piers, duly reinforced using tubfix micropiles extending till to the extrados of the existing arch bridge (Figs. 8 and 9), supplemented also by local strengthening interventions on the piers based on $\phi 24$ injected horizontal rebars (Fig. 10). In this way, at the end of the intervention the deck behaves like a new reinforced concrete bridge, of variable thickness, whose scheme is a continuous slab on seven supports, so transferring directly the traffic loads to the existing piers and through their micro-pile reinforcement to the soil, also relieving the existing masonry arch structure, without modifying its behavior (see Fig. 10), contributing to prevent also the scour of the pier. Moreover, to limit the execution time avoiding temporary works in the riverbed, the two r.c. arches were cast on temporary trusses placed above the 200 years flood return period (see Figs. 7.b and 11), so eliminating problems during flooding, that occurred several times during the works (Fig. 12)

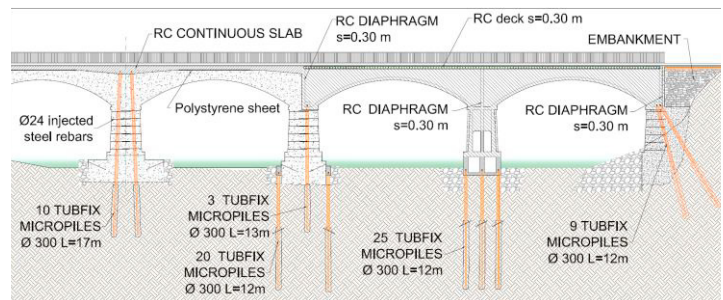
Fig. 10. Detail of the strengthening interventions

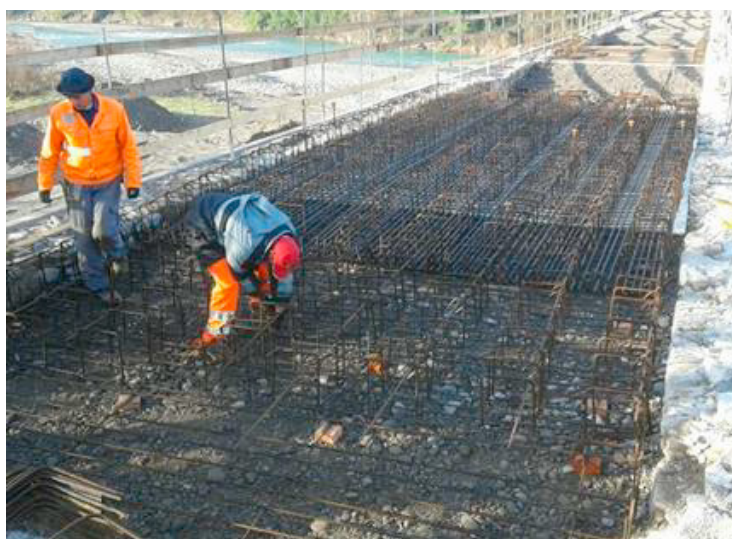
Fig. 14. Preparation of the new r.c. cast in situ deck

As already said, the concrete deck transfers the loads to the existing structure only at the piers; with this aim, the deck was executed casting in situ prefabricated reinforced concrete predalles (Fig. 14), supported by intermediate sheets of soft material, polystyrene, 30 mm thick, already shown in Fig.10, previously placed above the filling of the arches of the bridge, so limiting the interactions between the new concrete deck and the existing arches (see also Fig 15).

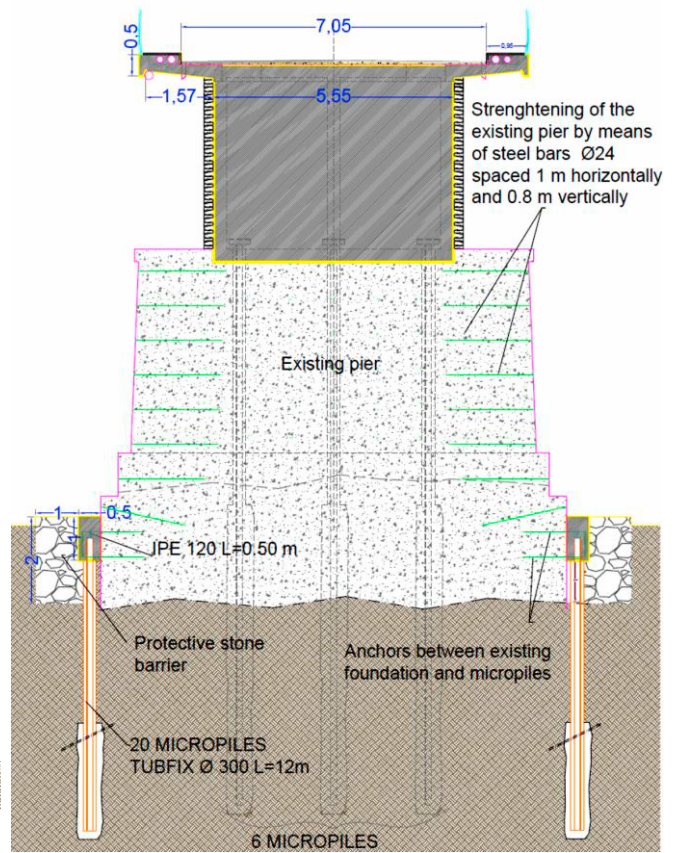
Fig. 16. Strengthening of the existing piers and foundations

- Phase 1: strengthening of the external body of existing piers by means of steel bars $\phi 24$, spaced 0.8 m vertically and 1.0 m horizontally, duly injected, strengthening of the foundations of the existing piers with external micropiles connected to the existing foundations and protected from scour by means of stone barrier (Fig. 16) (in this phase light traffic was permitted);

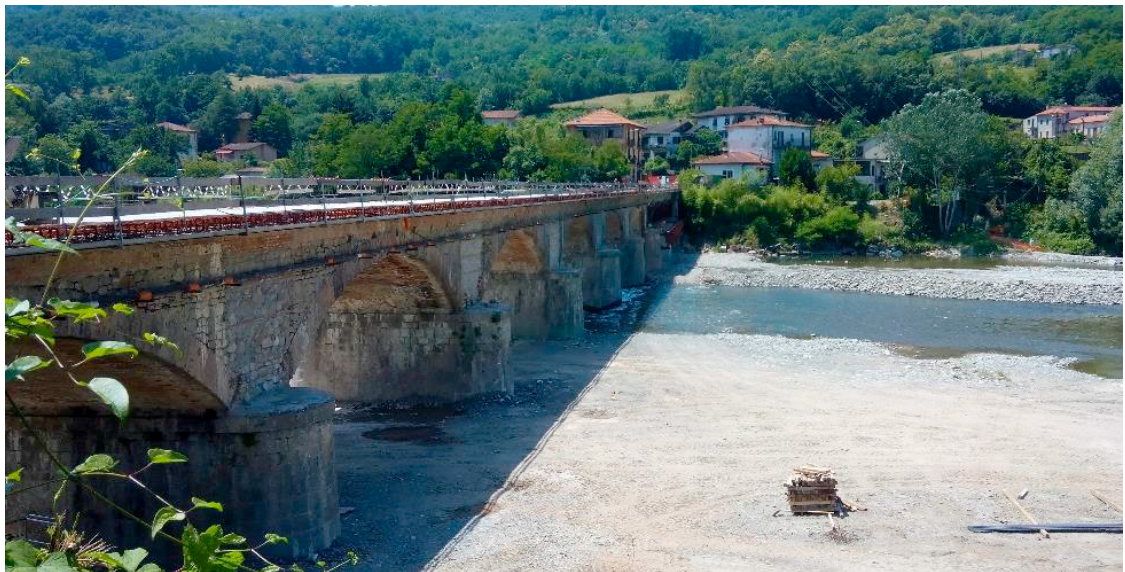
Fig. 17. The bridge after the dismantling of the prefabricated r.c. beams

- Phase 4: dismantling of prefabricated beams in c.a.p. put in place in 1961 to widen the carriageway (fig. 17) and restoration of the external surfaces (Fig. 18);

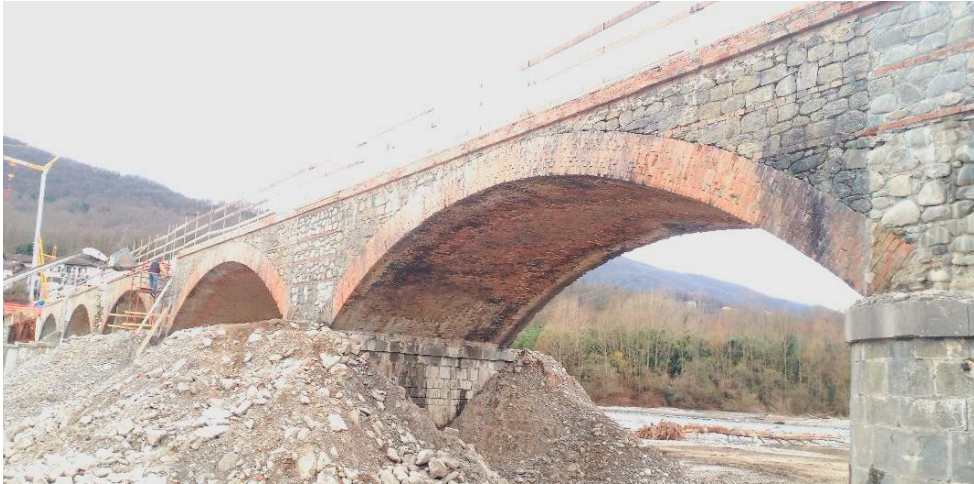
Fig. 18. Restoration of the external surface

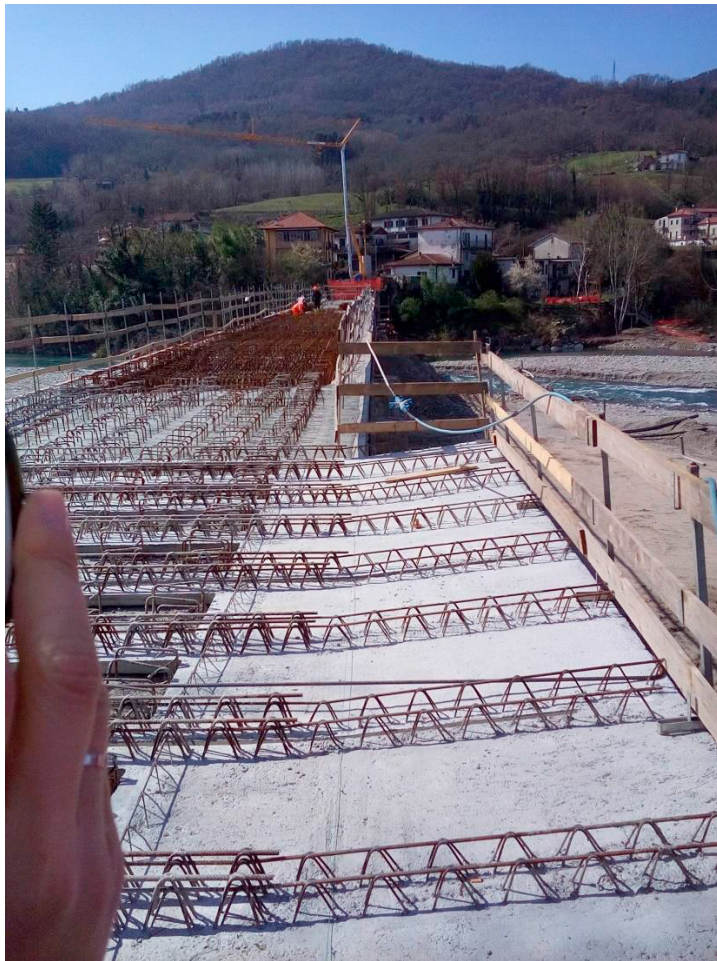
Fig. 19. Preparatory works for execution of the continuous r.c. slab

- Phase 5: disassembly of the Bailey bridge;
- Phase 6: erection of the two new spans in c.a. cast in place (Fig. 19);
- Phase 7: strengthening of the remaining part of the bridge (6 arches);

- Phase 8: erection of the new r.c. concrete deck slab (Fig. 19);
- Phase 9: finishes.
