*Analysis of urban plot of Lorca after the earthquake (2011): the effects
of damages and urbanistic and geotechnical adjustment of the city.*

FINAL BACHELOR DEGREE PROJECT

Alexey Pudovkin Lazchenko

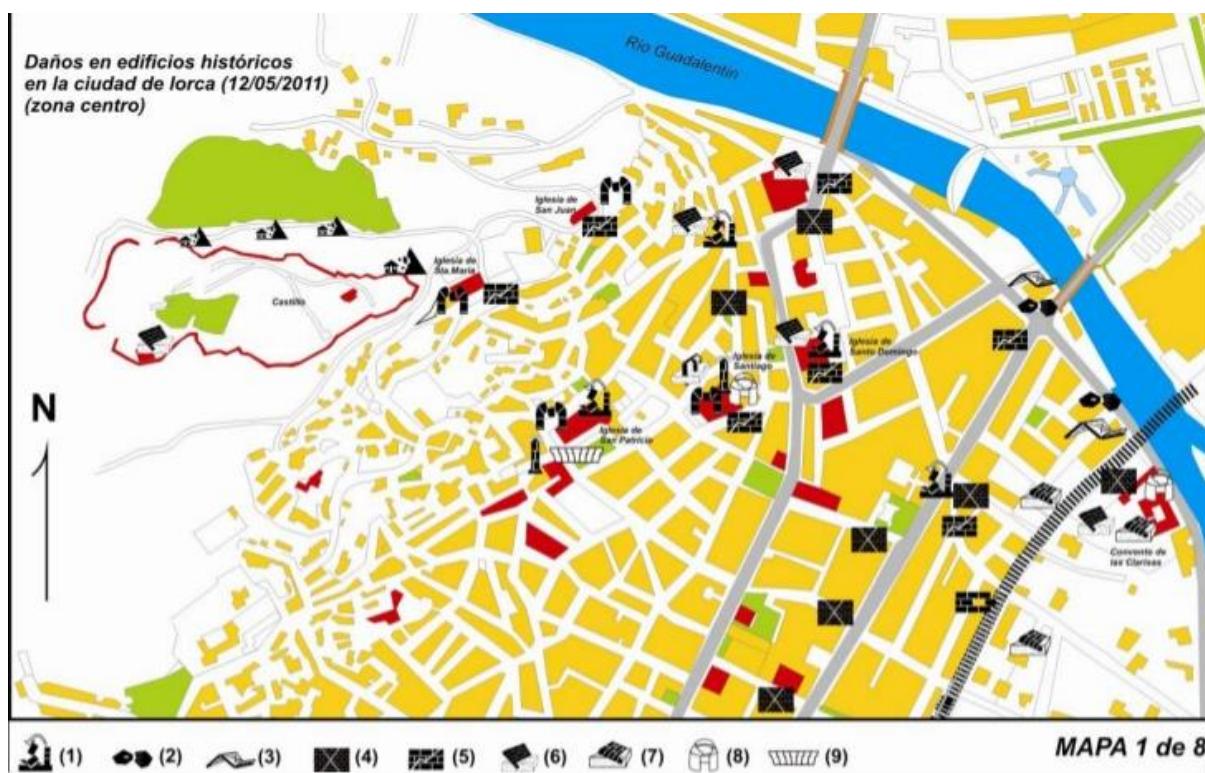
Figure 9.2: Map of downtown of Lorca, with the spatial distribution of the main EAEs classified during the field work after the earthquake. See figure 9.1 for further explanation of the symbols.

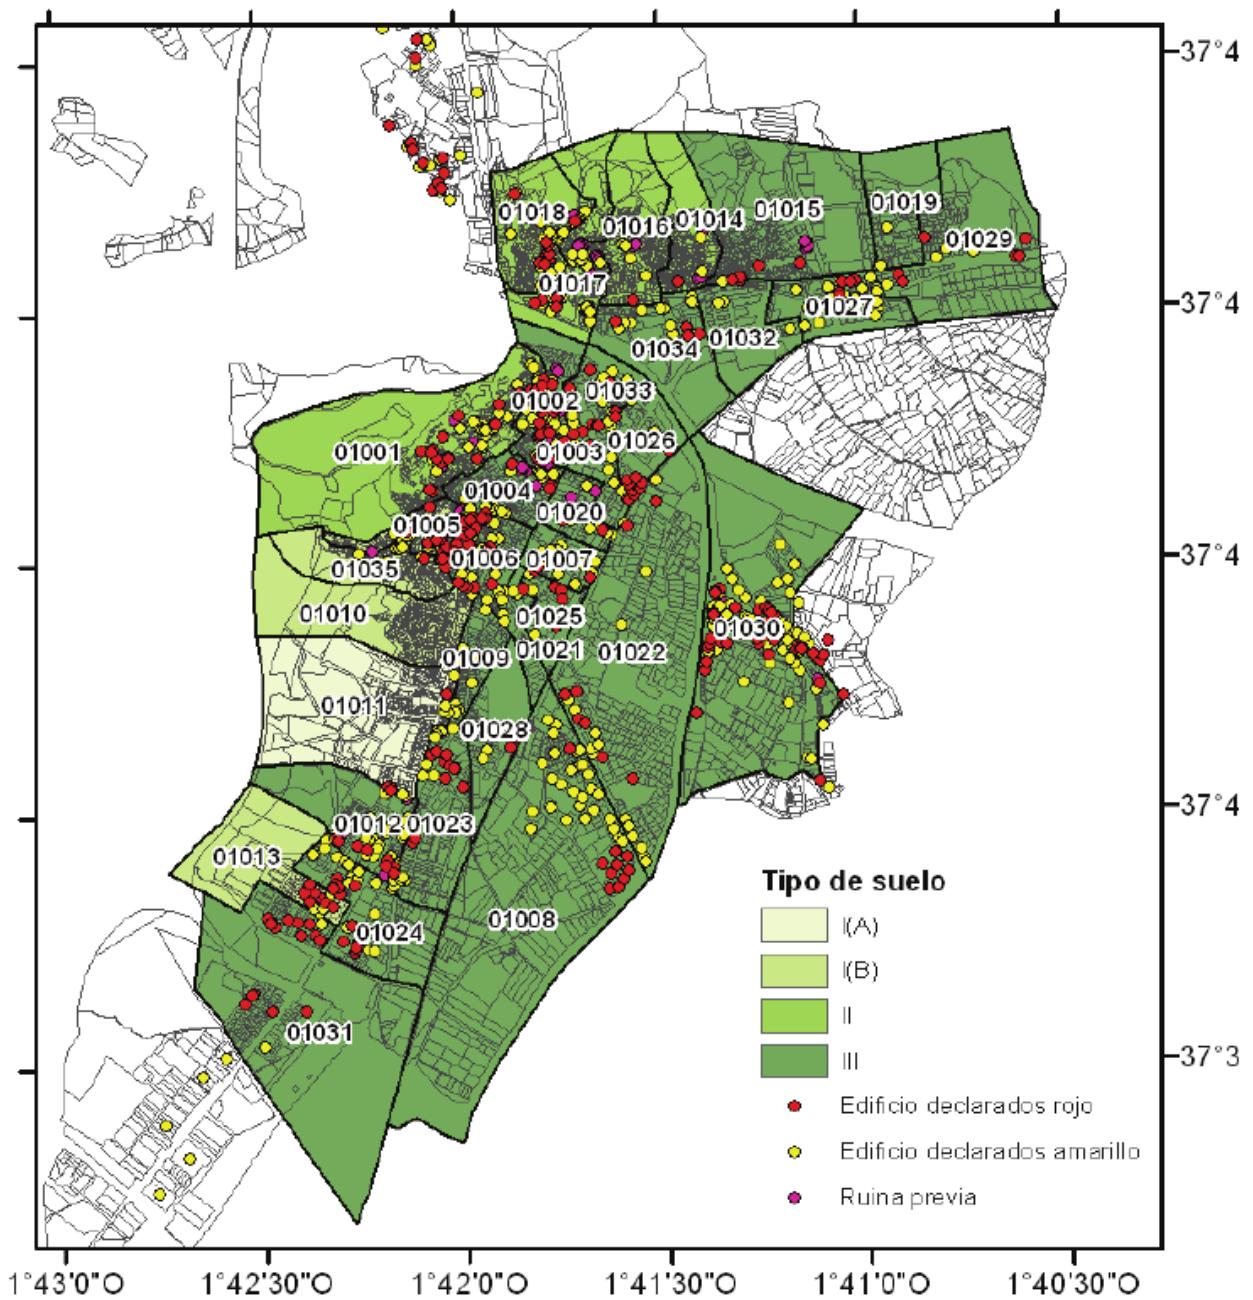
Figure 10: Damages in Lorca indicating buildings declared yellow (moderate damage) and red (serious damage) by census district and type of land with data from May 20. It also indicates those buildings that were already in ruins before the earthquake. The real estate park of the census area studied in this work is 5155 buildings (IGN).

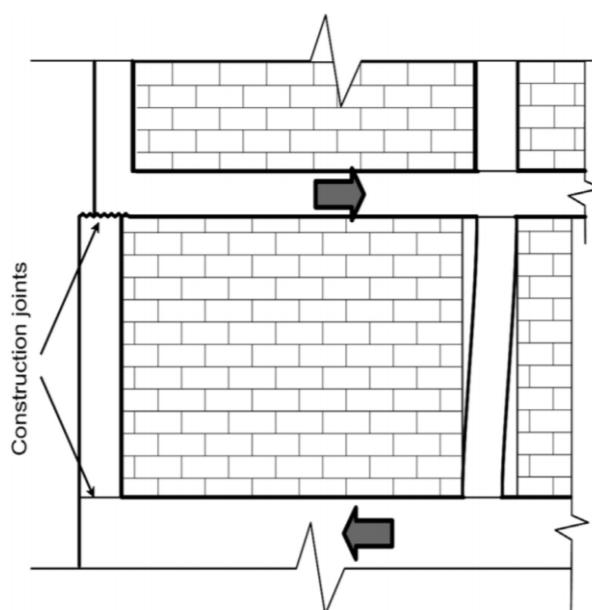
Joints are usually critical points in structures and many efforts have been put into the study of its behaviour. The importance of an adequate design is widely recognized however, quality control during construction is also very important. Construction joints in columns are usually located at the undersides of the slabs and beams as shown in Figure 13.

Figure 13: Failure at the construction joint of beam-column connection.

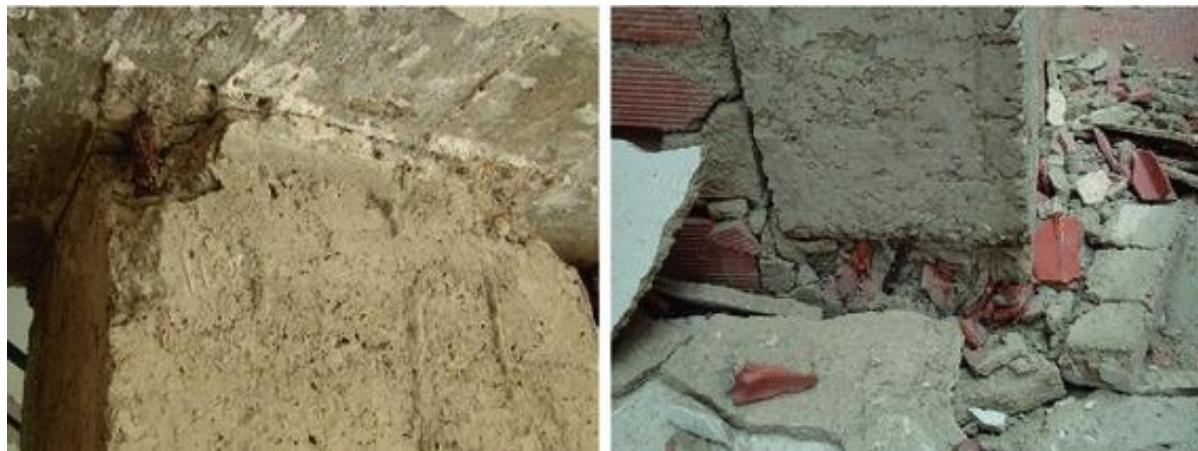
Figure 14. Examples of failure at the construction joint of a beam-column connections.

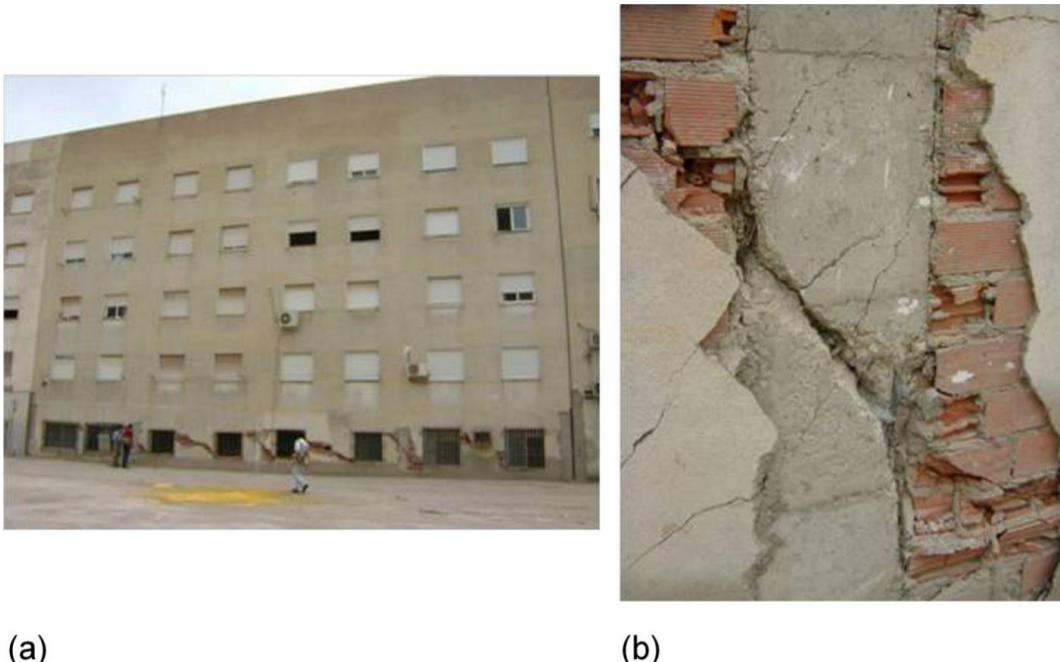
In general crack propagation in the infill panels indicates the position of the traction diagonal that connects two beam-column connections however, in some cases the cracks in the infill panels developed laterally displaced crossing the column at mid height like in Figure 16 b.

Figure 16: Example of cracks crossing a column at mid-floor height. Building (Fig. 16 a) Detail (Fig. 16 b).

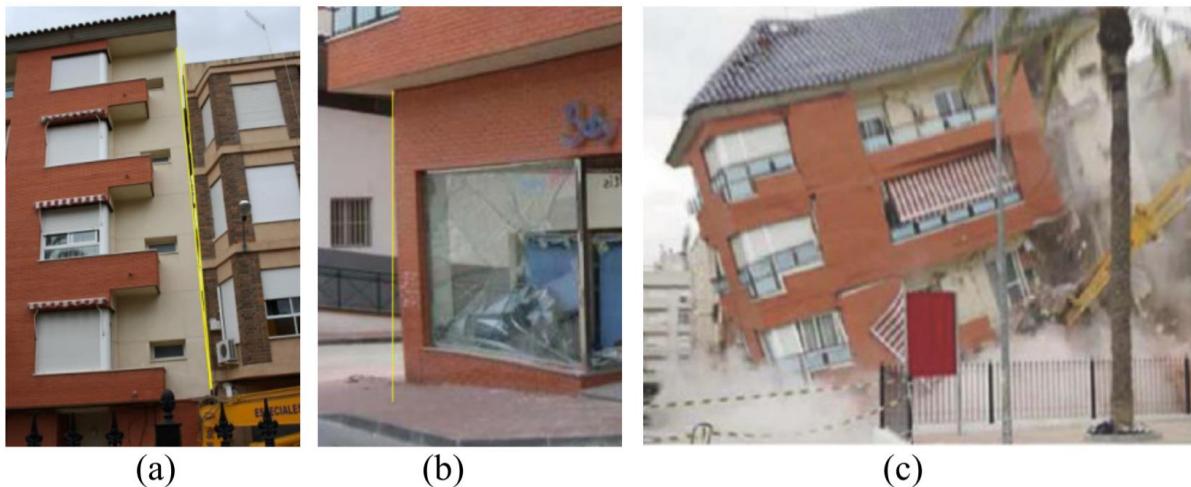
Figure 17: Building in danger of collapse. Evidence of crashes in (a) joint between buildings and (b) corner pillar. (c) Collapse.

According to the proposed form, this building would be a level 4 (very high) estimated risk of loss of global stability and level 2 (moderate) non-structural risk. Therefore, it would be classified as a potential collapse (black colour), as it has at least one level 4 classification (Fig. 18).
