LONG-TERM PERFORMANCE OF WICKING FABRIC TO REDUCE DAMAGE IN
ALASKAN PAVEMENTS

APPLICATION OF WICKING FABRIC TO REDUCE DAMAGE IN ALASKAN
PAVEMENTS

A
THESIS

Presented to the Faculty
of the University of Alaska Fairbanks

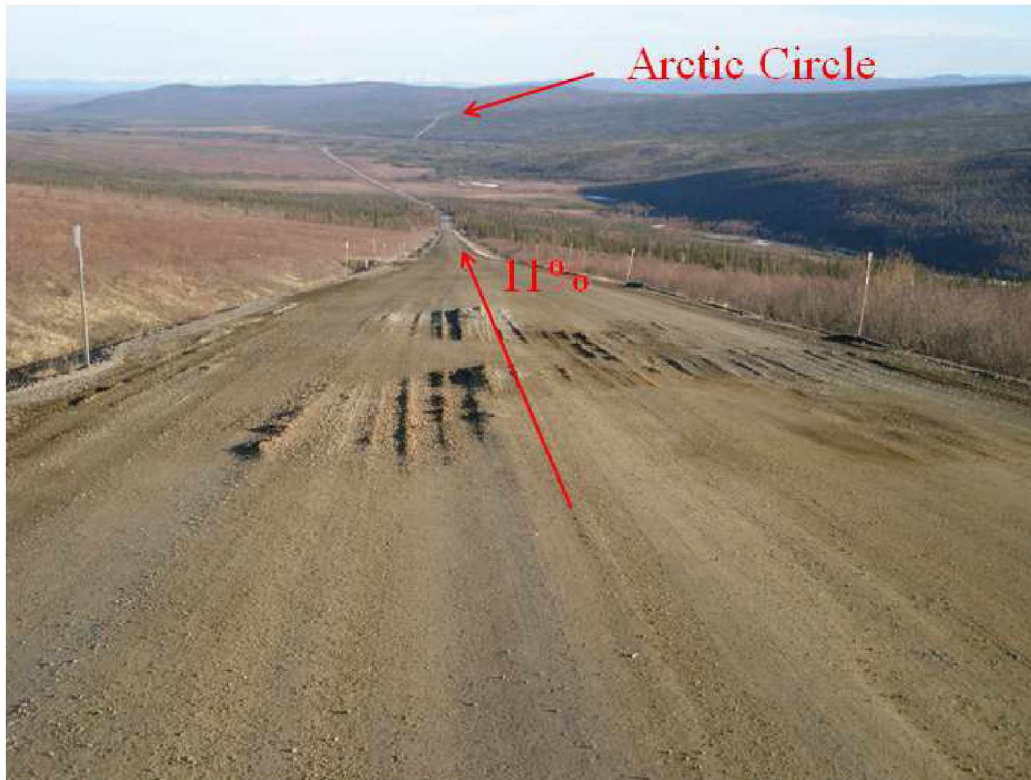
Figure 1.2 Soft Spots at Beaver Slide on May 12, 2010 (Looking North)

Crews from AKDOT&PF have observed soft, loose aggregate at the surface of the road during spring thawing (Figure 1.2). Operators of heavy trucks tend to apply their brake on the downhill slope when encountering the soft spots and make the condition even worse. The soft spots have resulted in extremely unsafe driving conditions and frequent accident occurrences. Alaska Department of Transportation and Public Facilities (AKDOT&PF) maintenance crews

have added material to the road, re-graded the road surface, and have rebuilt the road section in the past to try to alleviate the problem. These conventional methods of repair have not been successful.

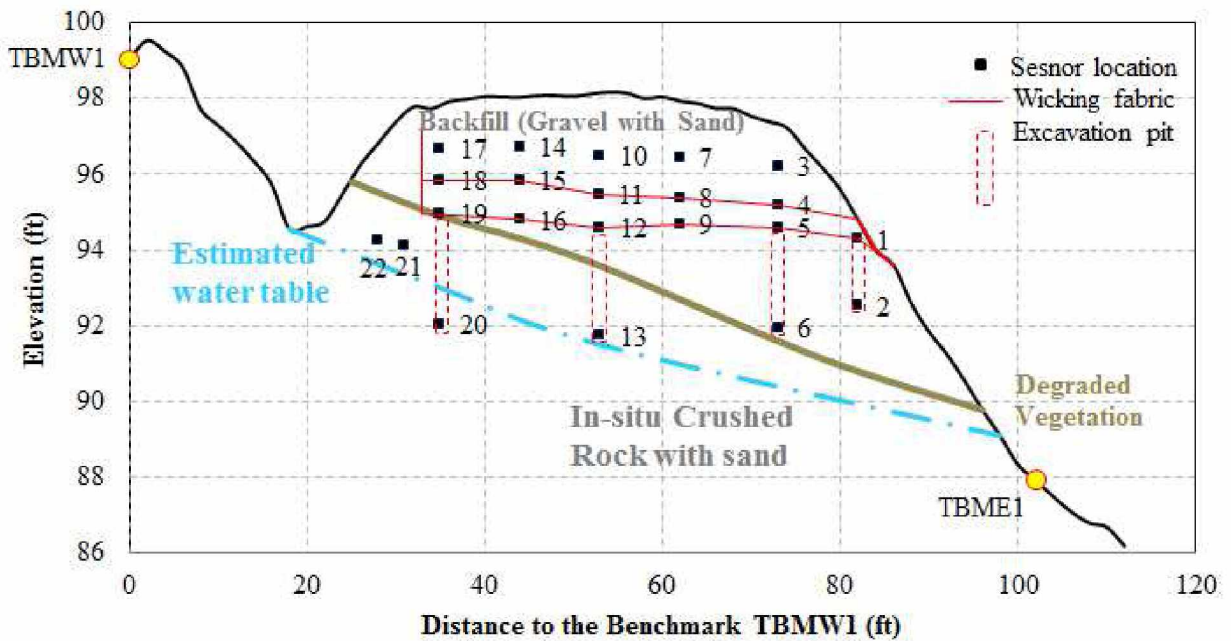
Figure 3.10 Sensor Locations, Groundwater and Soil Stratigraphy

Figure 3.10 shows the soil stratigraphy at the test section location, based upon the observations made during the construction process. It was found that the road section was built directly on the original tundra on the hill, using the degraded granite which was classified as silt with gravel, according to USCS classifications. Sieve analysis of the soils indicated that some soils have fines contents greater than 6%, indicating that some soils at the site may be frost susceptible.

The original tundra was encountered at about 0.91 meters (3.0 feet) below the ground surface at the west edge of the road, and at 1.36 meters (4.5 feet) below the surface at the centerline of the road section. It was about 2.72 meters (9 feet) lower than the road surface where it extended to the tree line at the west shoulder of the road. The buried vegetation encountered was degraded into a dark-yellow layer, which was about 0.05-0.1 meters (1-2 inches) thick. *In situ* crushed rocks with sand were encountered below the vegetation. Ground water was observed 0.15 meters (6 inches) below the tundra surface, once the tundra was removed. Additionally,

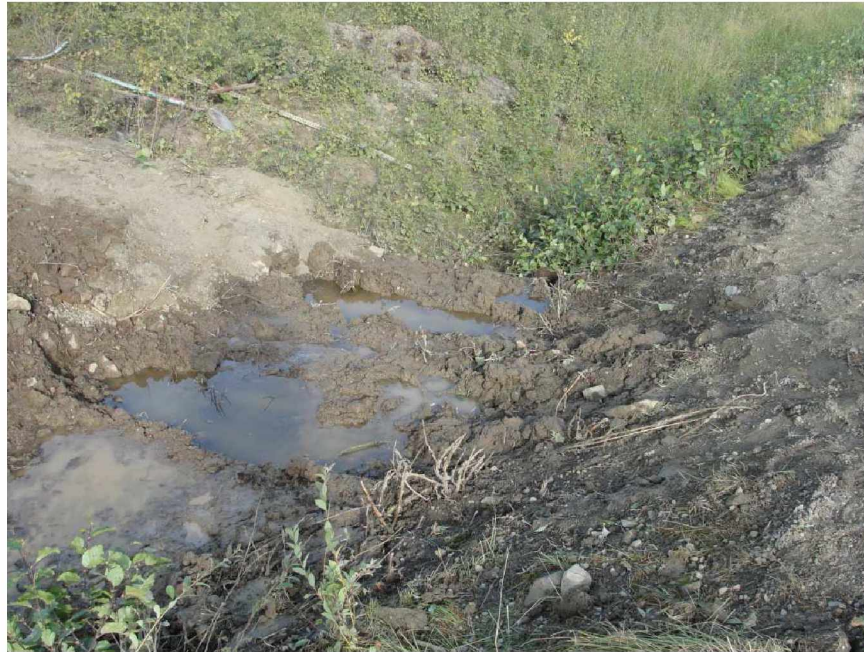
Figure 3.12 Water in Existing Ditch on East Side of Road on August 5, 2010

standing water was observed during the construction process in the existing drainage ditch along the west side of the road. On the east side of the road, water was sporadically present along the tree line.
