## Building Performance Evaluation – A design approach for refurbishment of a small traditional building in Scotland

J. A. Foster<sup>1</sup>, A. Poston<sup>1</sup> and S. A. Foster<sup>2</sup>.

This paper introduces a case study building, the Land Sea and Islands Centre (LSIC) located in Arisaig, Highland Scotland, where BPE was undertaken to provide information on the current building condition. This information allowed the architect to develop an evidence based refurbishment design approach for this building. A second BPE process post refurbishment evaluated the building performance and provided verification of the design process.

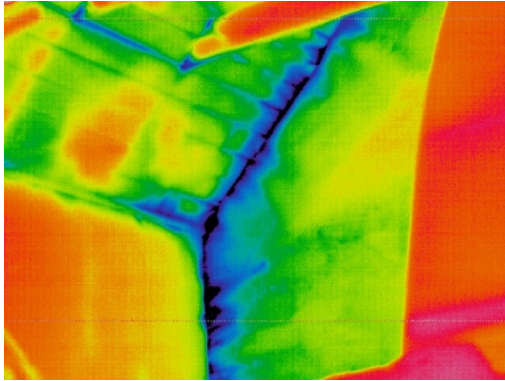
The air permeability was tested in order to identify the areas of air leakage, insulation installation and areas where thermal bridges occurred and were therefore at risk of condensation and mould growth. The results for PERIOD 1 revealed the building to have excessive infiltration levels of 16.76 m<sup>3</sup>/h.m<sup>2</sup> @ 50Pa (Table 1), which had caused significant discomfort for the occupants through draughts. Tracing the air leakage pathways, using smoke pencil and infrared thermography highlighted locations in the building where air leakage was the most severe. These were most notably where the three extensions and

replacement roof (added in 1999) connected to the existing stone building (Figure 4). The most significant air entry points were at all joist ends, mains electricity incoming cable and the soil vent pipe adjacent to the WC. In addition, the infrared thermography identified areas of incomplete insulation, where a consequence of this was localised cooling and an increased risk of condensation.

*Figure 4. Thermogram of the uninsulated north gable junction with the insulated west wall and ceiling. This indicates significant air leakage at joist ends, cool spots behind timber ceiling and air ingress at the corner.*

The architect had previously developed an airtightness strategy for the building, however, the extent of air leakage pathways identified were unexpected. There were significant infiltration pathways at the vertical junctions associated with the later building additions, as well as at both ends of the exposed roof trusses, also added in 1999. These weak points in the building fabric provided a means for unheated outside air to infiltrate the building, move freely behind the plasterboard and timber lined ceilings, entering the building at joist ends, sockets outlets and light switches which were detected in the building as draughts. In response to this the architect developed a sealing method for these using flexible vapour open building materials and added these to the drawings which identified a need for one single person from the contracting team to be an airtightness champion.

During the refurbishment pre-start meeting the architect communicated the evidence based airtightness strategy and indicated areas where particular attention was required. The infrared thermography undertaken with the air permeability test indicated that there was missing or poorly fitted insulation behind plasterboard surfaces. The removal of finished surfaces on internal walls was included as part of the refurbishment strategy to improve the quality of fitting of the existing insulation. The PERIOD 2 monitoring indicated that an overall air permeability improvement of 85% was made. Thermograms taken during the PERIOD 2 test revealed a vast reduction in thermal bridges that were a result of the architects detailing strategy, combined with good quality workmanship. While the staff did not know what this meant they all noticed a lack of draughts in the refurbished building, and commented on how warm the building was.

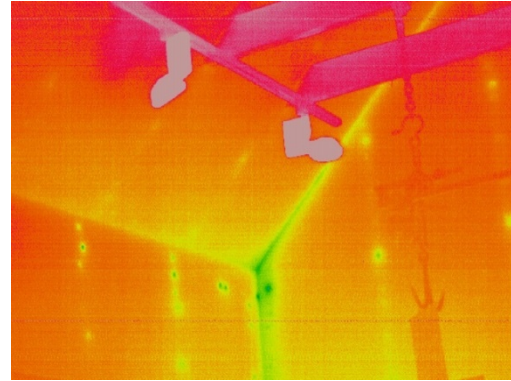
The PERIOD 2 air permeability test result of  $2.7 \text{ m}^3/\text{h}\cdot\text{m}^2$  @ 50Pa (Table 1) was extremely low and is now lower than the Building (Scotland) Standards current regulations for new buildings of  $7.5 \text{ m}^3/\text{h}\cdot\text{m}^2$  @ 50Pa [9]. Moreover when compared with the results from PERIOD 1, the thermal improvements and attention to the design detail by the contractor have reduced uncontrolled infiltration by 85%. The testing provided confirmation of the architects' refurbishment approach, however, air leakage in the shop area was found to be higher than other areas in the building. Aligning with the refurbishment strategy, where minor refurbishment was made in the shop, with demolition and a replacement extension planned for the future.

*Figure 5. Thermogram of where the newly insulated and lined north gable junction with re-insulated west wall and ceiling. This indicates no cooler areas at joist ends, and a slightly cooler area at the corner.*
