**Materiales de construcción incompatibles dentro de las esculturas
estereotómicas de Avalos en el Valle de Caídos (Madrid, España)**

**Incompatible building materials within the stereotomic
Avalos sculptures of the Valley of Fallen (Madrid, Spain)**

J. García-Guinea^{a,*}; G. Almendros^a; D. Benavente^b; V. Correcher^c; A. Pérez-García^d;
L. Recio-Vázquez^a and S. Sánchez-Moral^a

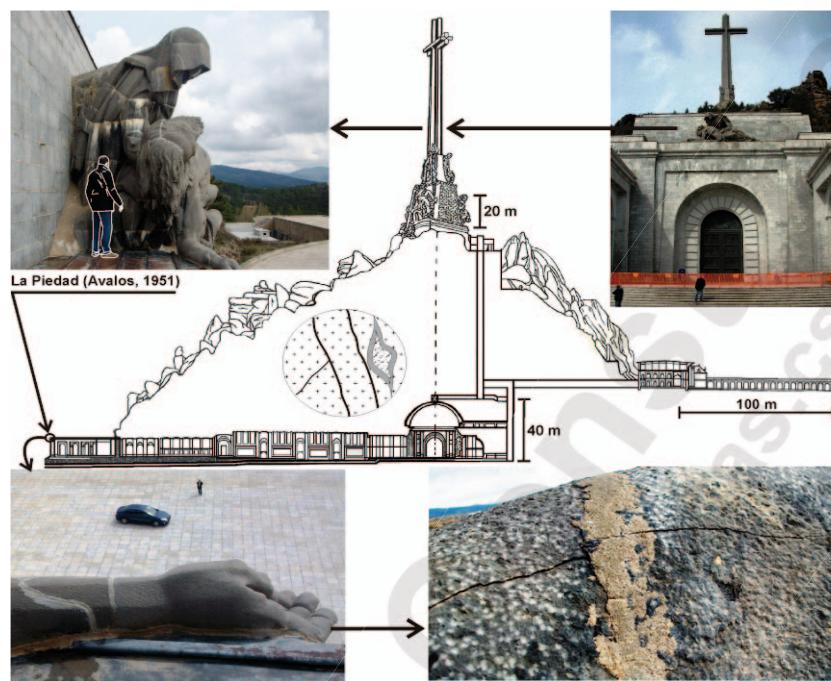
Figura 1/Figure 1

The near revision of the La Piety sculpture (Figure 1) let us to identify a strong white efflorescence formed by CaCO₃ speleothems together with open fissures affecting other previous sealed fissures with epoxy-quartz mixtures and placed in a dangerous over-hanged position of part of the Piety sculpture just on the top of the Basilica main gate. The restoration action performed on La Piety sculpture (Figure 2) let us to collect very dissimilar specimens (Figure 3) from the different sections, as follows: (i) external calcium carbonate efflorescence, (ii) external cover formed by BLC, (iii) intermediate join of gypsum and (iv) internal concrete core made of cement and leuco-adamellite granite aggregates with sodium feldspars. The analysis of these powdered samples by X-ray diffraction shows as the Piety sculpture inner contains hydrous phases in both concrete and joins. Figure 3 Table-1 also display a table of the percentages distribution of mineralogical phases for each sample performed by semi-quantitative XRD analyses using Spanish Xpowder software. Phases were identified performing background subtraction, K α 2 stripping and chemical elements restraining to the major elements previously determined by ESEM-EDS, i.e., Na, Mg, Al, Si, P, S, K, Ca, Ti, Fe. These features improve the Boolean search-matching on the ICDD-PDF2 and RRUFF databases suggesting PDF2 card files, as follows:

Figura 1/**Figure 1.** Detalles de la escultura de La Piedad, como eflorescencias, posición extraplomada de un brazo de Jesús sobre la entrada de la Basílica, caliza Calatorao fisurada a pesar de una consolidación previa con epoxy. La Piedad se erosiona soltando peligrosos fragmentos de roca. / Details of La Piety Sculpture such as efflorescence, overhanging position of a Jesus arm, Basilica inside and main gate and fissured BLC in despite of the former epoxy consolidation. La Piety sculpture drops dangerous flakes and fragments of weathered stone.

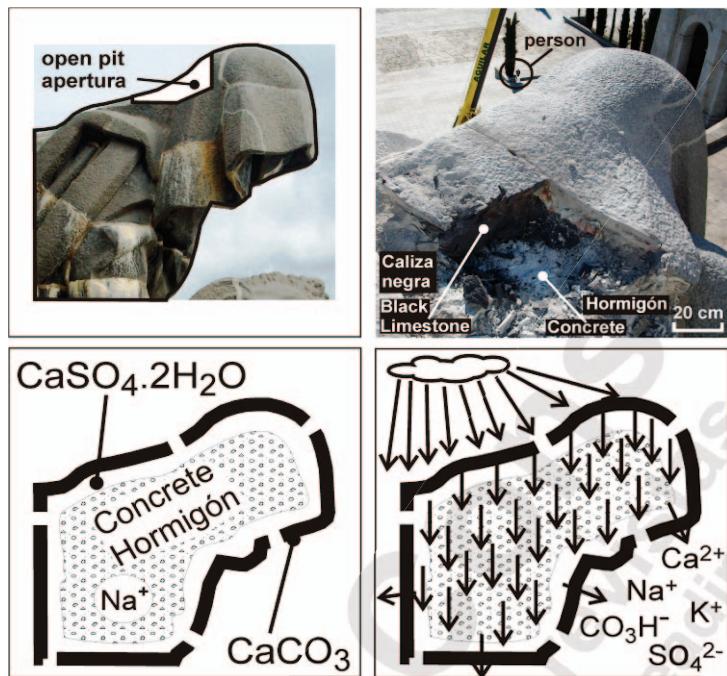
Figura 2/Figure 2

The examination of the recently open hole in La Piety sculpture shows BLC slabs of 20 cm and a white adhesive with moisture water. The stereotomic structures have open way to raining waters from the initial building time. La Piety sculpture core shows weathered concrete and joining blends composed by hydrous phase's portlandite, mirabilite, ettringite and gypsum. The anhydrous counterpart phases are totally absent of the concrete specimens analyzed. The extra gypsum used to join the BLC slabs and the rain waters keeps inside large amounts of ettringite. The concrete alteration associated to ettringite reduces its adhesive properties mainly to the

Figura 2/**Figure 2.** Detalles del agujero realizado sobre la cabeza de la escultura de la Piedad, materiales internos y resumen de los procesos de meteorización del sistema./Details of the open pit in La Piety Sculpture, internal geomaterials and weathering processes summary.

crystallisation pressures. A theoretical restoration of the Avalos Sculptures removing the external incompatible building materials, i.e., sulphates, will be to remove the BLC blocks, to clean the sulphates, to scratch the weathered concrete outer, putting back again the blocks. Alternative soft proposals sealing the sculptures with organic polymers keeping inside large amounts of sulfates only will cause its degradation under the UV sunlight, new entrance of raining waters and further enhanced destruction of sculptures as bigger blocks. The strong difficult of the sculptures restoration stem from the wrong decision taken by Juan de Avalos to use internal gypsum and granite aggregates with sodium feldspars together with the huge size of the stereotomic structures.

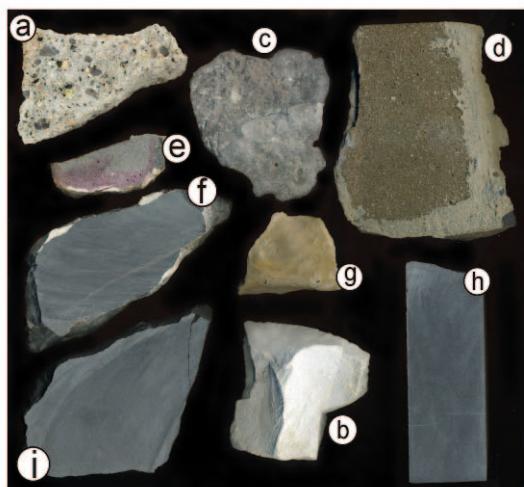
Figura 3a/**Figure 3a**

Figura 3/**Figure 3.** (a) Nueve muestras recogidas en el interior de la escultura de La Piedad analizadas por difracción de rayos X. Se trata de calizas de Calatorao, hormigón meteorizado, sulfatos y carbonatos hidratados y fragmentos de mezclas de unión epoxy-cuarzo. La tabla 1 muestra los respectivos porcentajes de minerales de cada muestra. (b) Difractograma de la muestra de mortero-b con asignaciones y porcentajes de fases determinadas mediante software español Xpowder.// (a) Nine stones collected in the La Piety inside analyzed by semi-quantitative X-ray diffraction. They are Calatorao limestone, weathered concrete, hydrous sulphates and carbonates of the sulfate join blend and epoxy-quartz fragments. Table 1 displays mineral percentages by each sample. (b) XRD pattern of a mortar-b sample including the phase assignations and percentages determined using the Spanish software Xpowder.

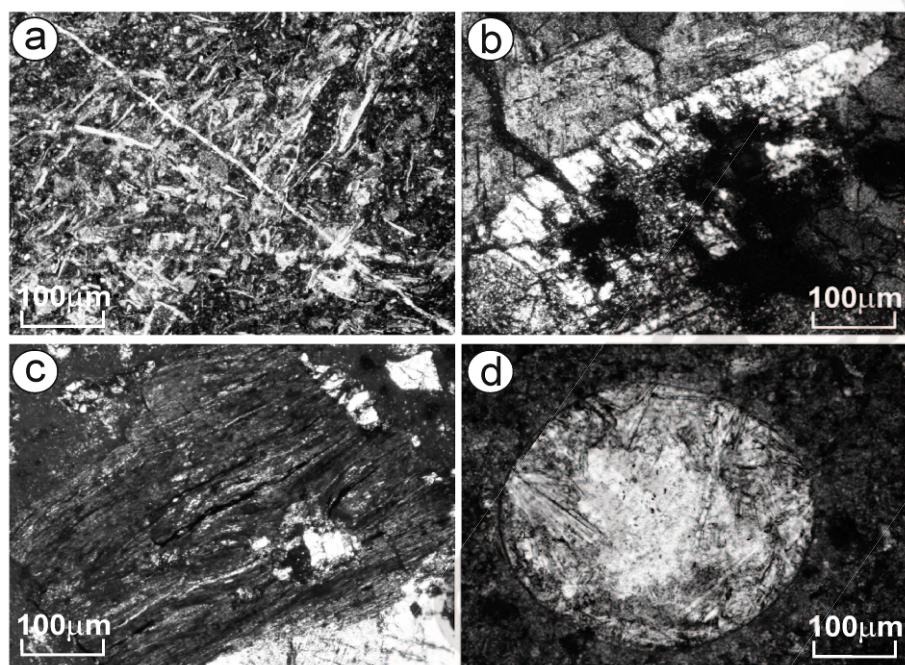
Figura 4/Figure 4

Figura 4/**Figure 4.** Secciones de 35 µm de las muestras bajo el microscopio de polarización: (a) Caliza negra Calatorao compuesta por fragmentos de conchas y materia orgánica oscura. (b) Feldespato alterado de áridos del núcleo de hormigón. (c) Biotita de los áridos de granito. (d) Espacio de una antigua vacuola ahora rellena de fibras de etringita./Slices of 50 µm of the collected specimens under the polarizing microscope: (a) Calatorao limestone mainly composed by calcite shells and black

kerogen. (b) Weathered alkali feldspar of the concrete nucleus. (c) Biotite of the granite aggregates of the concrete. (d) Empty space of a former bubble nowadays stuffed with fibrous ettringite.

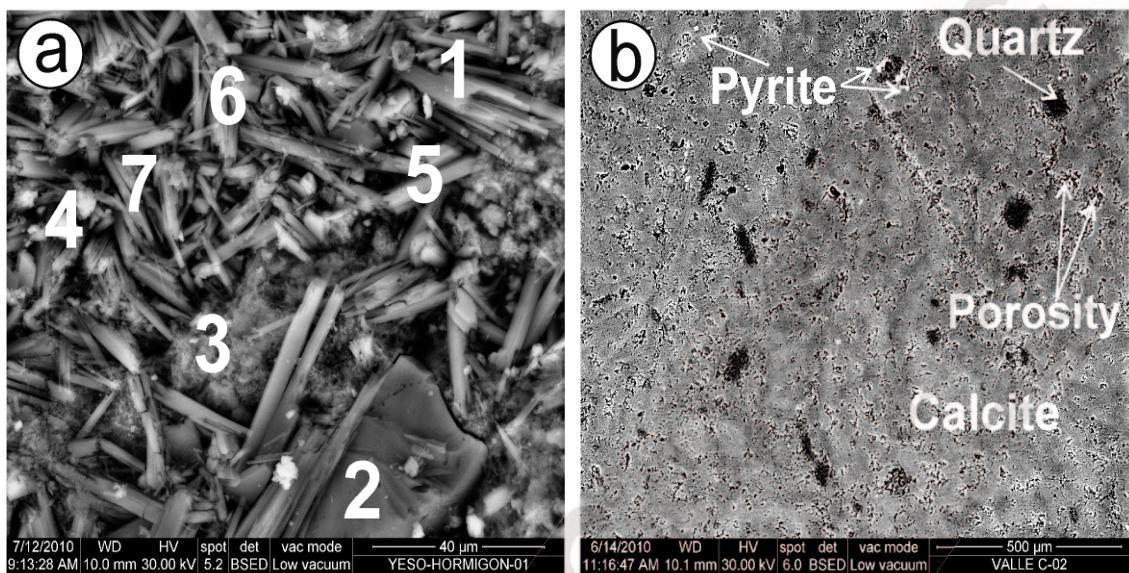
Figura 5/Figure 5

and trona, all of them neo-formed hydrous phases. The ESEM images of these mixtures of the white mortar sample showed two different types of needles masses (Figure 5a), as follows: (i) crystals groups sized from circa 10 to 40 μm and (ii) micro-crystals sized under the micron forming homogeneous masses. The EDS-ESEM analyses of these masses of spiked crystals displayed important amounts of Al_2O_3 , SO_3 and CaO and minor impurities of quartz grains and native copper, lead and tin metals (Figure 6 Table 2). The comparative Al_2O_3 – SO_3 – CaO ternary plot (Figure 6 right) allow to separate different micro-sample spot analyses of quartz, inferred thaumasite, gypsum and ettringite together with a central group of different mixtures ettringite-thaumasite-portlandite. The simple conclusion is that both, the sulfated joint and the concrete inner contain important amounts of hydrous phases such as gypsum, portlandite, trona, ettringite and normative thaumasite (inferred from the chemical analysis) being totally destroyed in the concrete section sampled. Moreover, it is important to note that the semi-quantitative XRD analyses of the concrete sample show 37% of alkali feldspar (Figure 3-a). This important amount of alkali feldspar in matrix and concrete aggregates is an important source of leachable sodium and potassium. These alkaline elements combined with the observed sulfates in the glued sculpture joints provide dangerous salts for the architectural heritage preservation.

Figura 5/Figure 5. Imágenes de microscopía electrónica de barrido ambiental: (a) Aluminosilicatos hidratados y sulfatos aluminosos hidratados de diferentes composiciones, fundamentalmente taumasita y etringita. (d) Detalles de los granos de cuarzo, piritas oxidadas y porosidad de la caliza negra de Calatorao./Environmental Scanning Electron Microscope images: (a) Hydrous silicates-aluminates-sulfates of different compositions, mainly thaumasite and ettringite. (d) Details of the quartz grains, pyrites and porosity of the black-limestone.

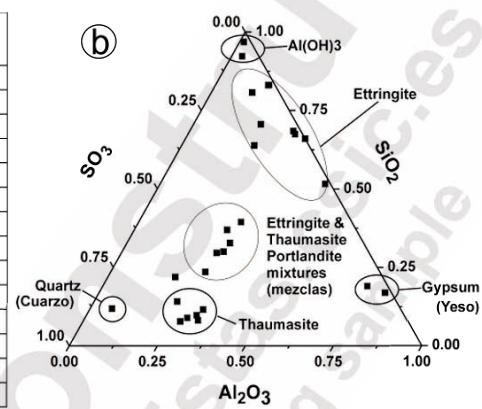
Figura 6/Figure 6

Figura 6/Figure 6. Distribuciones composicionales SO_3 — SiO_2 — Al_2O_3 de los análisis químicos EDS tomados sobre diferentes puntos de un mortero sulfatado, mostrando ettringita y taumasita normativas (inferidas a partir análisis químicos). Tabla 2.- Análisis EDS de masas de cristales aciculares mostrando importantes cantidades de Al_2O_3 , SO_3 and CaO con algunas impurezas de cobre, plomo y estaño procedentes de los soportes metálicos cercanos de la escultura./Compositional plot SO_3 — SiO_2 — Al_2O_3 with ESEM-EDS chemical analyses taken in a sulfated mortar exhibiting normative compositions of ettringite and normative thaumasite inferred from the chemical analysis. Table 2.- EDS-ESEM analyses of the masses of spiked crystals displaying important amounts of Al_2O_3 , SO_3 and CaO and small impurities of copper, lead and tin metals from the sculpture metallic supports and neighboring roofs.
