CIVIL ENGINEERING STUDIES
Illinois Center for Transportation Series No. 11-083
UILU-ENG-2011-2009
ISSN: 0197-9191

EVALUATION OF SENSYS WIRELESS DETECTION SYSTEM: YEAR-AFTER EVALUATION AND OFF-CENTER SENSORS

Research Report ICT-11-083

A report of the findings of
ICT-R27-58
**Evaluation of Wireless Detection Systems at
RR Crossings & Signalized Intersections**

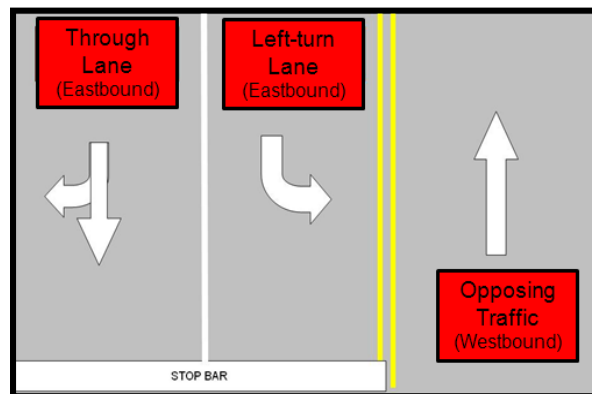
Figure 1. Railroad grade crossing at Chandler Road and U.S. Route 45.

The main difference between errors in the two sensors was the close proximity to vehicles traveling in the opposite direction. As can be observed in Figure 1-B, there was no median and the left-turn lane was immediately adjacent to the westbound lane. Traffic in the opposite direction created more than 30% of the calls in the left-turn sensor, as observed in columns *h* through *k* in Table 10. This source of error was almost non-existent for the right-thru sensor and accounted for only 0.3% of the number of activations.

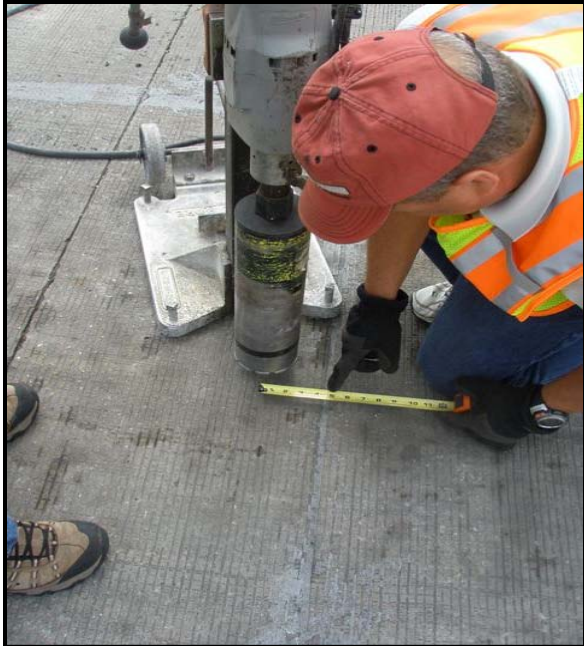
A – Sensys representative indicates the location where sensors should be installed (about 5 inches from the leading edge of loop).

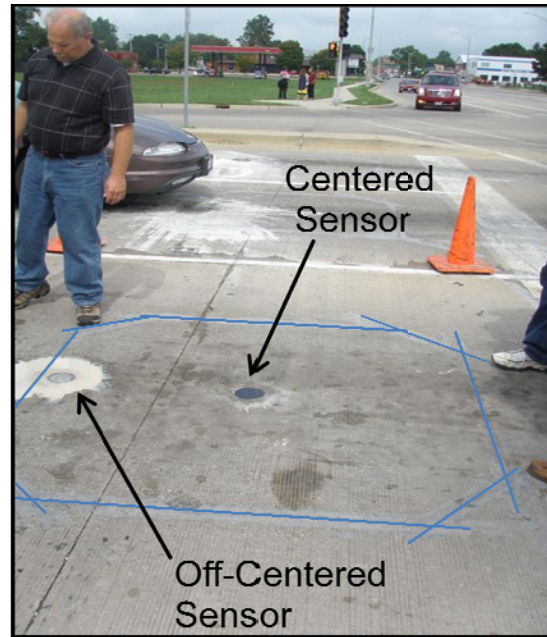
D – Detail of location of centered and off-centered sensors in relation to loop detector and stop bar.
