Analysis of building damage caused by earthquakes in Eastern Turkey

Professional paper

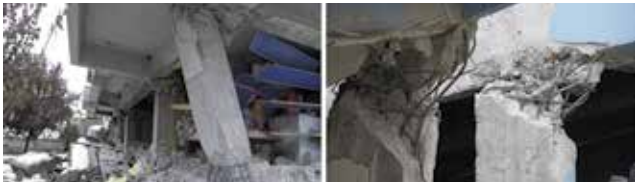
Structural elements are designed to withstand static and dynamic forces under various circumstances such as excessive gravity loads and earthquakes. It would be desirable for permanent damage to occur at the end of the beams, while the columns should remain elastically intact. In this way, the total collapse of the buildings would be prevented and people inside the building could be evacuated without any loss. However, the observations regarding earthquakes that hit the city of Van and the town of Erciř have revealed that most of the heavily damaged buildings have the RC beams which are stronger than the columns, contrary to the above mentioned principle. This proves that acceptable structural behaviour has not been provided for in the design and construction of buildings in this area.

Figure 9. Examples of plastic rotations at the end of columns instead of beams in Erciş

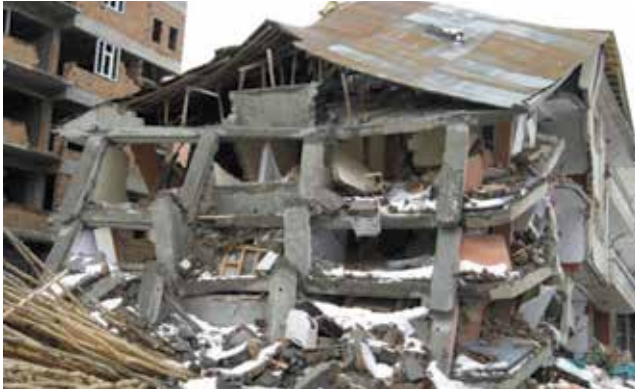
Figure 10. Total collapse of a building in Erciş due to sway mechanism after plastic rotation at the end of each column of individual storeys

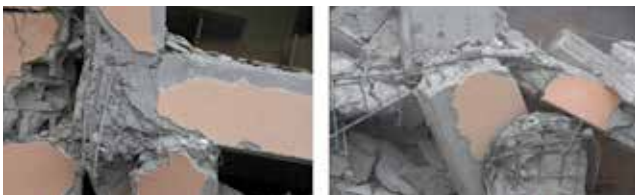
The beam-column joints are the most vulnerable parts of the structural system when the latter is subjected to lateral loading actions, such as those occurring during earthquakes. To provide for an adequate rotation and shear capacity, the detailing of the reinforcement is of highest significance. In particular, the lateral reinforcement of longitudinal rebars of the columns must be continued throughout the height of the joint. However, this reinforcement was not done in almost every damaged building, Figure 11.

Figure 11. Typical failure at the joints of a multistorey building in Erciş

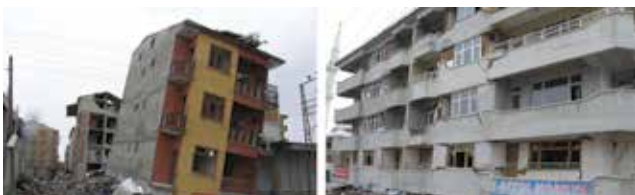
Figure 12. Collapse of two buildings due to soft storey effect at the ground floor level in Erciş

Buildings adjacent to streets are usually used for both commercial and residential purposes. To provide enough space at the ground floor, the storey height is generally higher than that of the upper floors and also, there are no infill walls at the street side of the ground floor, because of the need to provide for better visibility of the commercial area. However, this fact causes a soft storey effect in case of multi-storey buildings. Due to the lack of lateral stability at the ground floor level, the building sways up to the limit of the lateral deformation capacity of the columns at the ground floor, resulting in collapse of the entire soft storey, Figure 12.

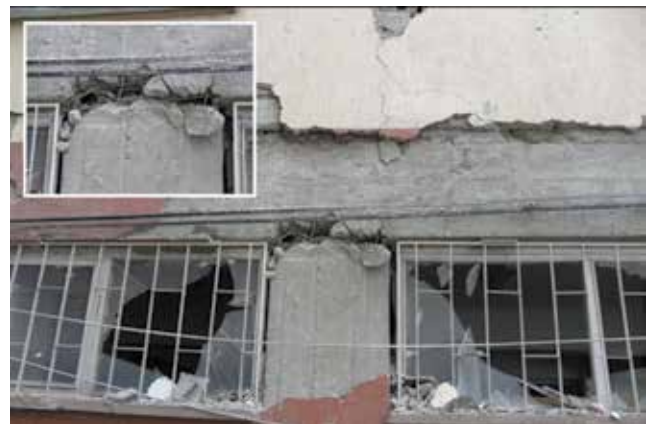
Modern seismic design codes prevent shear failure of columns by prescribing a certain amount of confinement around longitudinal rebars. However, if the shear span of flexural elements is shortened for some construction related reasons, the structural element is prone to excessive shear forces rather than flexural forces. As a result, during the quakes, the diagonal shear cracks occur along the free height of the flexural element, Figure 13. Such damage could create undesirable mechanisms at the building's floors.

Figure 13. Shear failure at the top of the column due to short shear span in Van

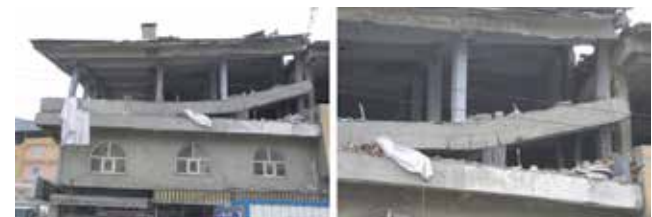
The buildings constructed in the downtown of Van and Erciş are row house style buildings situated along both sides of the streets. Unfortunately, the lack of regulations on the height of buildings creates a practical problem of having different story heights, as shown in Figure 14. Hence, during ground shaking, the rigid floor of one building may hammer at the middle of the columns of the adjacent building. Such lateral forces acting on the columns lead to disastrous drop of the column stability and, accordingly, to the collapse of the entire slab above.

Figure 14. Partial collapse of the slab due to pounding in Erciş

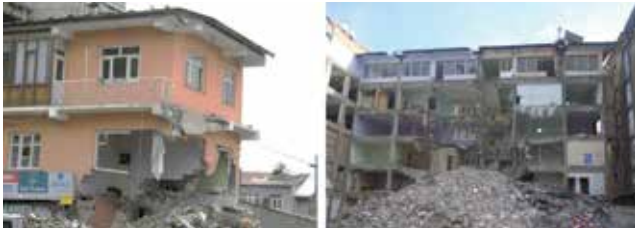
In medium to high density housing areas of Van and Erciř, many more buildings are affected by the impact of collapsing buildings, Figure 15. Buildings of low construction quality or buildings built contrary to relevant regulations are subjected to heavy damage during a strong ground shaking activity. In case of partial or total collapse of such buildings, it is quite possible that they will fall on neighbouring buildings that may have survived the quake. Unfortunately, no precautions can be taken to prevent such an event, except for effective inspections during the design and construction of buildings.

Figure 15. Damage due to the impact of the collapsed building on the neighbouring building in Erciř and Van

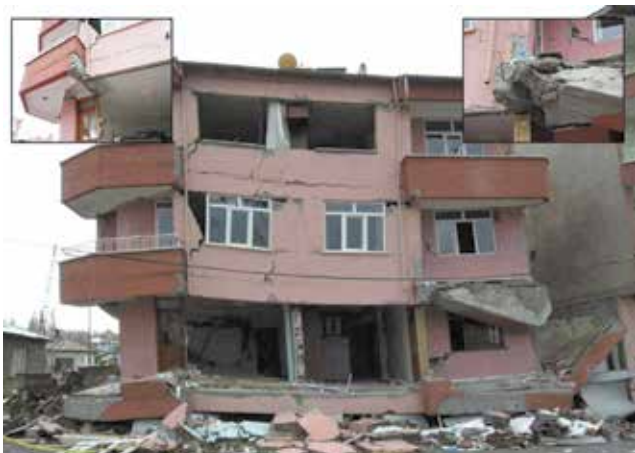
Selection of the structural system and elements is a crucial engineering decision in earthquake prone areas. Therefore, the practicing engineer must have experience in the earthquake resistant design of structures. Even if service loads do not inflict any damage on a poorly designed building, the earthquake load may exceed the bearing capacity of the element, and ultimately lead to catastrophic results, Figure 16.

Figure 16. Damage due to selection of an improper structural system in Erciř

- In areas where considerable seismic activities are likely to occur, mixed load bearing systems (shear wall and frame) must be preferred to frame structures.

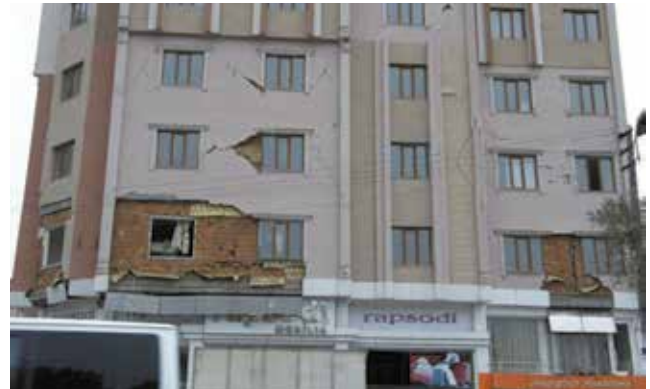
Figure 17. Although structural systems of buildings were not damaged during the first earthquake in the city of Van, almost every building had diagonal cracks and out of plane deformations on outer walls, which is due to the total lack of mechanical bond between the double brick layers.

Figure 17. Diagonal damage patterns occurred at the infill sandwich walls in city of Van

- External infill walls should preferably not be made of two-layer brick walls. If such layered walls are used, they must be mechanically connected with ties.

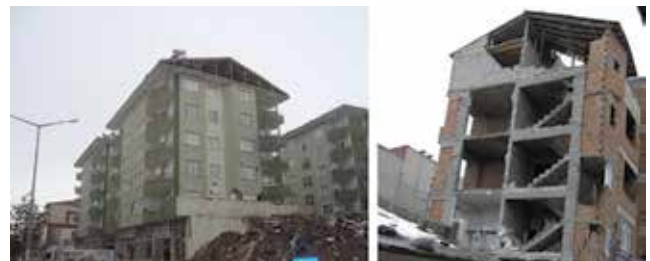
Due to the severe winter conditions, or in order to enable the use of attic space, the roofs are significantly elevated and inclined. Therefore, the walls under gable roofs are accordingly high, which causes out-of-plane stability problems. In addition to that, the lack of tie beams at the top of gable walls is yet another reason for an insufficient stability, Figure 18. Such construction defects have been observed at almost every building in Van and Erciř.

Figure 18. Out-of-plane deformation damage of the gable walls

- Gable walls under high roofs must be framed with tie beams to achieve required stability.

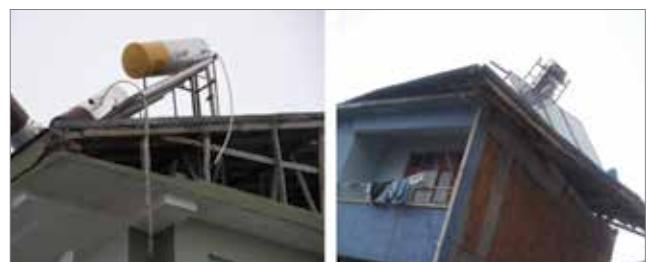
Structural systems supporting the roof do not usually provide an appropriate lateral stiffness. This situation has additionally deteriorated when water tanks (each about 10 kN) with solar panels were installed on the top of the roof consequently causing additional seismic mass on the roof structural system. During the earthquakes, the majority of the roofs swayed or fall down from the top of the buildings, Figure 19.

Figure 19. Swayed roofs due to low stiffness and additional seismic masses in Erciř

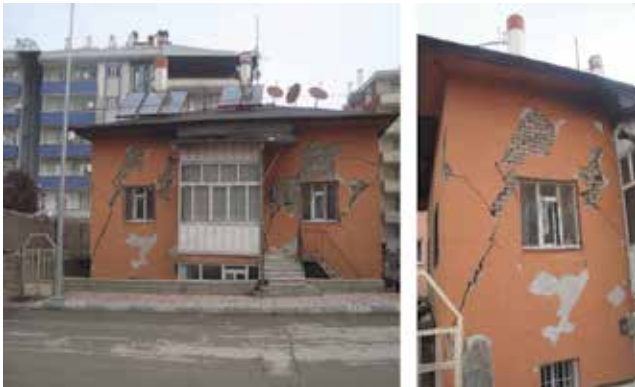
In masonry buildings, the lateral stiffness is provided by strong adobe walls and slabs on the walls. In case one of them is insufficiently constructed, a severe damage to masonry buildings during a strong ground motion is unavoidable. The typical damage observed in masonry buildings are diagonal shear cracks and openings on walls, Figure 20.

Figure 20. Typical shear damage observed on structural walls of a masonry building in Van

- Adobe buildings are prone to shear deformations unless beams are provided. Thus, horizontal and vertical tie-beams and reinforcement should be provided to masonry walls in high seismic areas.

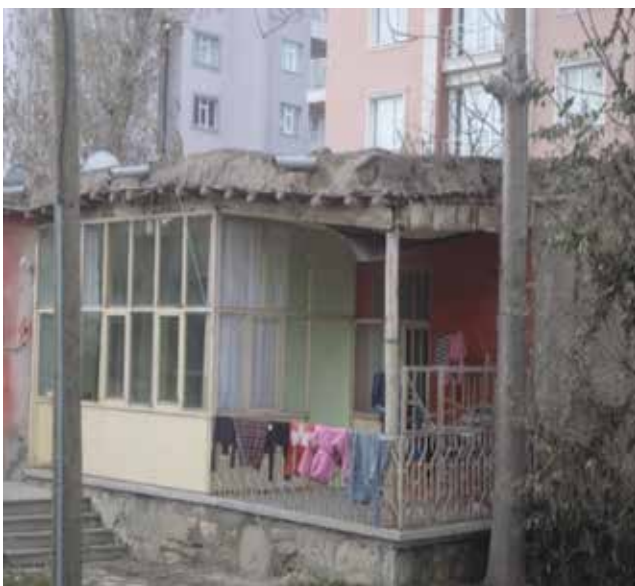
Slabs resting on masonry walls are usually made of earth material filling on wooden beams. The higher the earth material filled, the more lateral force is exerted on the walls, which causes shear openings. This phenomenon was observed at most of the old masonry houses in Van and Erciş. The thickness of the earth fill on the roof reaches up to 40 cm, Figure 21.

Figure 21. Excessive earthfill on the roof of a masonry building.

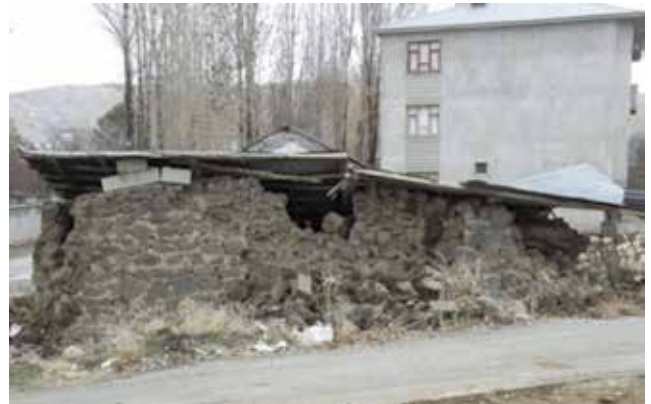
The lack of an appropriate connection detail between intersecting walls and roof-wall intersections, and the absence of mortar, lead to an out-of-plane instability of masonry buildings made of natural stones, Figure 22.

Figure 22. Collapsed masonry building due to the lack of connection and mortar on the walls and roof in Erciş

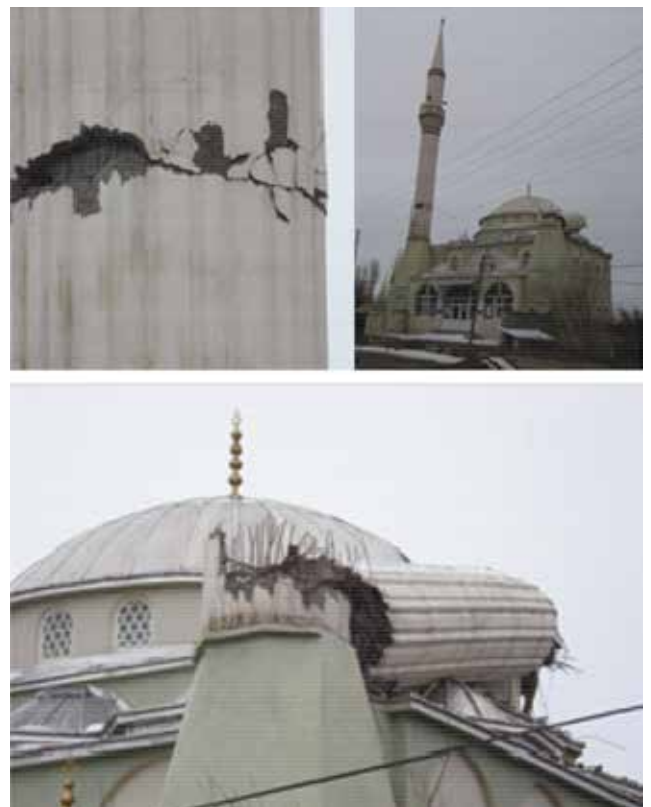
Minarets built near mosques are exceptionally slender structures. They are made of either block stones or reinforced concrete (RC). The inspection of minaret damage has revealed that the block stone minarets of poor mortar quality lost their stiffness and stability, and totally collapsed. On the other hand, the RC minarets have suffered damage at the parts where there is a change in section geometry or material property, Figures 23 and 24.

Figure 23. Local damage and two totally collapsed minarets of a mosque in Erciş

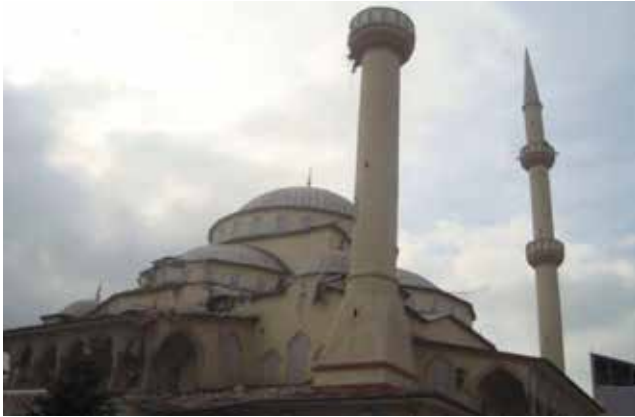
Figure 24. Intact and damaged minarets of a mosque in Van

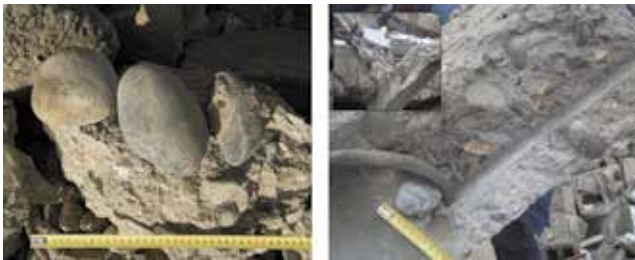
The concrete at the damaged or collapsed buildings displayed a poor quality of the concrete mixture. Aggregates used in the mixture are far from acceptable diameters as stated in Turkish Standards [12], Figure 25. It is obvious that the aggregates were derived from river beds instead of stone pits. In addition, the cohesion of the cement with the aggregate is almost nonexistent, Figure 26.

Figure 25. Inappropriate aggregates used in Reinforced concrete buildings

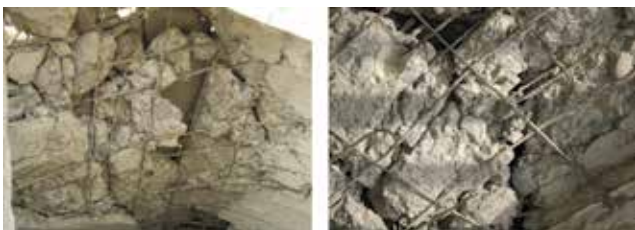
Figure 26. Poor cohesion between cement and aggregate

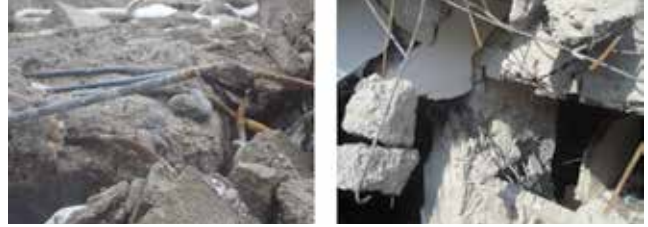
The study of the damaged or collapsed buildings has revealed that both the longitudinal and lateral reinforcement details at structural elements are not consistent with the code based regulations. For example, the Turkish Earthquake Code (TEC2007) strictly forbids the use of plain rebars as longitudinal reinforcement in earthquake-prone areas. However, most of the multistorey RC buildings that collapsed in Van and Erciş suffered from the poor-bonding problem, Figure 27.

Figure 27. The use of plain reinforcement as longitudinal rebars in RC beams and columns

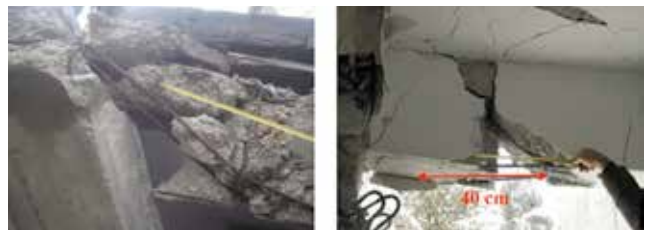
In case of reversed cyclic deformations, the confinement of the RC beams and columns is very crucial for maintaining adequate resistance of longitudinal rebars to shear forces. Therefore, lateral reinforcement intervals along RC elements are limited to 10-20 cm and 15 cm for the columns and beams, respectively, [10], Figure 28. In the majority of the damaged or collapsed buildings, structural elements did not have a sufficient quantity of lateral reinforcement. In addition, the hooks at the end of the rebars were also either missing or were not arranged at 135 degrees as required by the codes, Figure 29.

Figure 28. Inadequate lateral reinforcement intervals

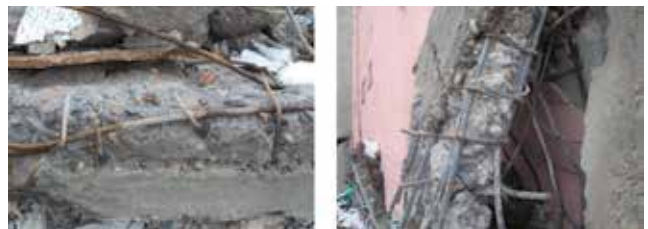
Figure 29. Poor hook arrangements at the end of lateral confinement bars

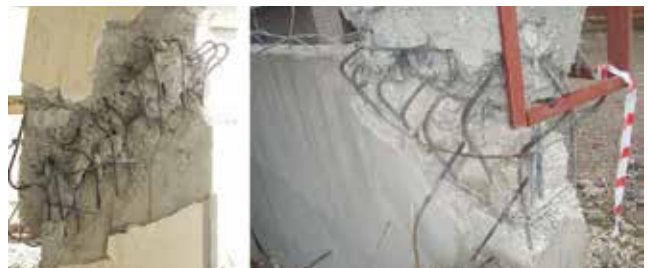
In case of structural elements with insufficient lateral rebar intervals, the buckling of longitudinal rebars may occur when such elements are subjected to severe shear forces, Figure 30.

Figure 30. Shear damage and buckling of longitudinal reinforcement due to insufficient lateral rebar interval
