Underground Water Problem at Chadron, Nebraska: Causes and Solution

UNDERGROUND WATER PROBLEM AT CHADRON, NEBRASKA: CAUSES AND SOLUTION

Arthur W. Struempfer

Chemistry Department
Chadron State College
Chadron, Nebraska 69337

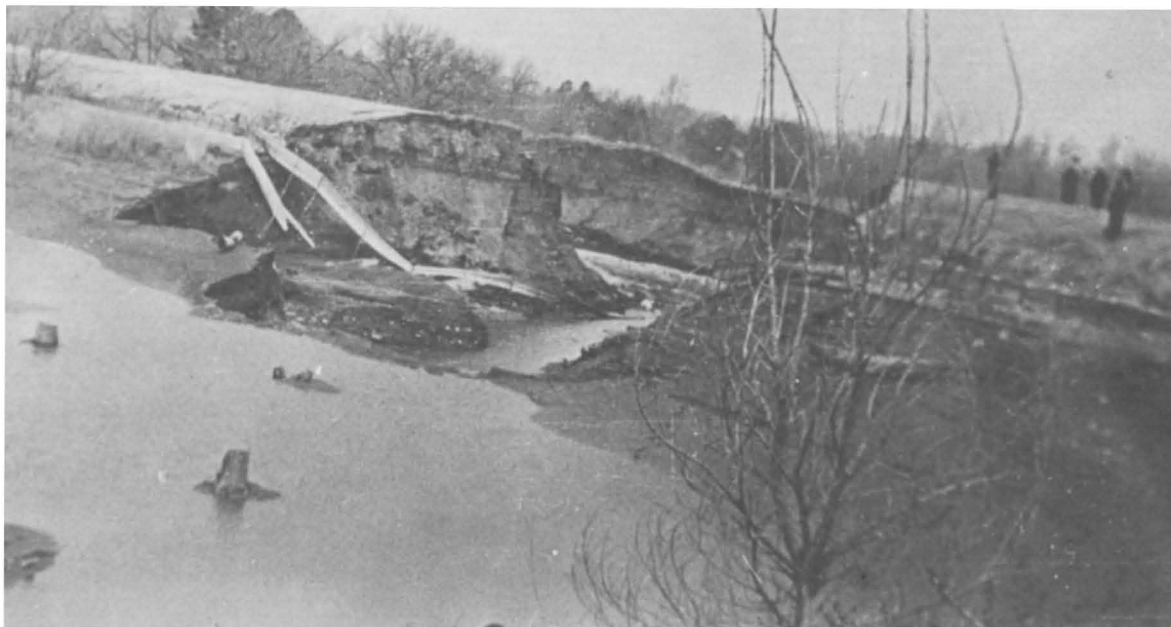
In 1930, the dam was once again destroyed by a flood (Fig. 1), and was again rebuilt. In 1960, another storage reservoir was constructed on Chadron Creek, doubling the water storage capacity. Bids later were let for a one-million-gallon steel reservoir, which was placed on C-Hill south of the College campus.

FIGURE 1. Destroyed Chadron reservoir dam on Chadron Creek, April 1930. (Photo by Billy J. Smith)

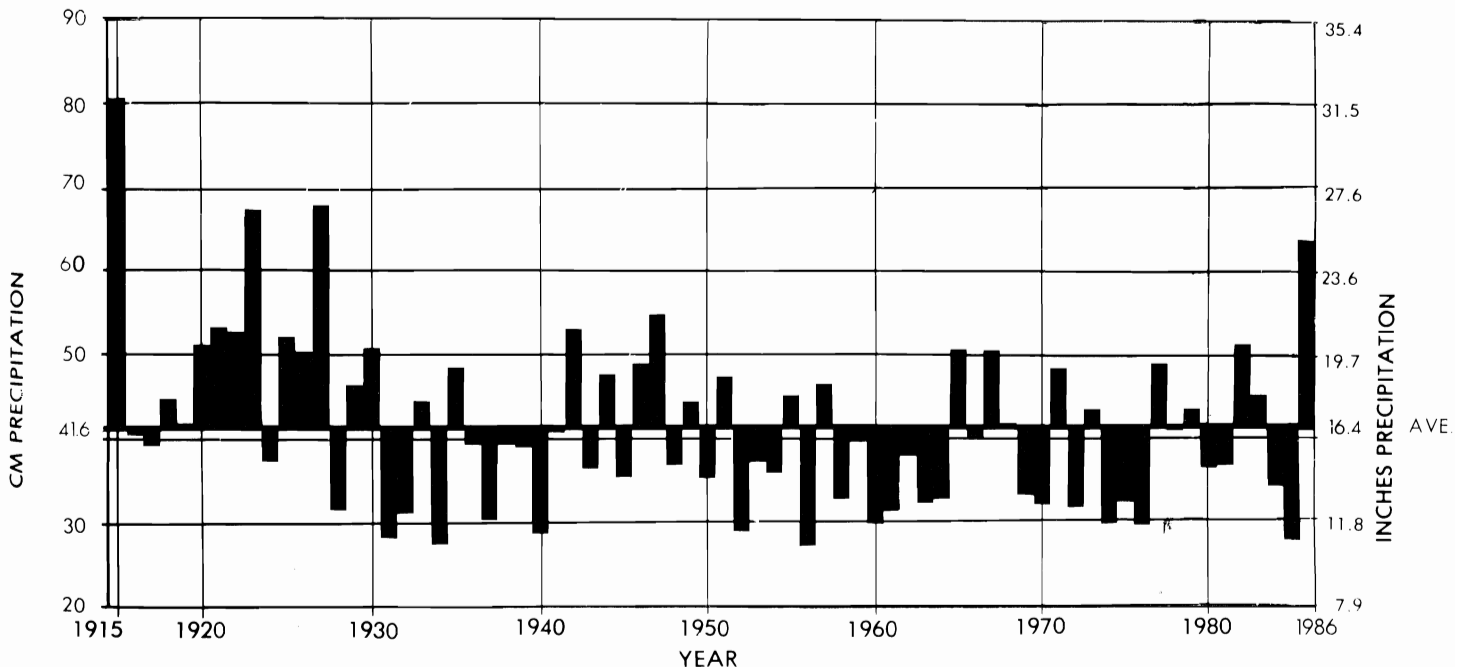
FIGURE 2. Annual precipitation at Chadron, Nebraska. Black areas indicate amounts of precipitation above or below the average of 41.6 cm (16.4 in) for the 72 year period.

The annual arithmetic mean for the 1915–1986 period is 41.57 cm (16.37 in). Greatest annual precipitation of 80.64 cm (31.75 in) was recorded in 1915; least precipitation was 27.02 cm (10.64 in) in 1956. A very small amount of 27.28 cm (10.74 in) was also reported in 1934. In 1985, Chadron and surrounding areas experienced a drought with the third lowest precipitation recorded in 72 years; only 27.66 cm (10.89 in) of precipitation was received. Of this total, only 15.75 cm (6.20 in) fell the first eight months of the 1985 season.

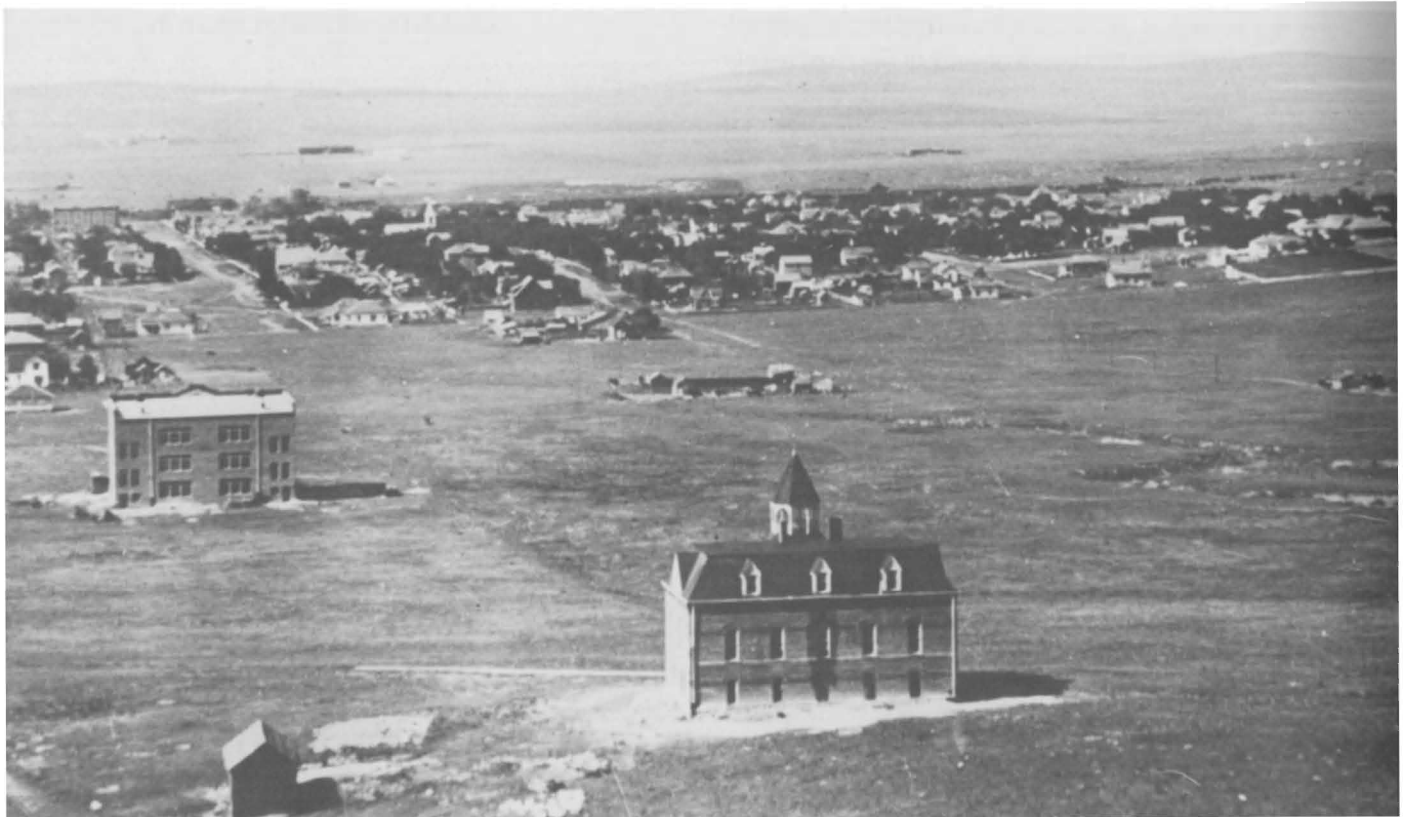
An early photograph of Chadron (Figure 3) provides a clue of the surface drainage patterns. This photograph, taken about 1912 from C-Hill, and viewing north-northeast, shows the Chadron Congregational Academy in the foreground and the middle portion of the Administration Building, built in 1910–1911, behind it. A drainage pattern is shown in the middle-right of the photo and is assumed to be the drainage area near the present Armstrong Gymnasium.

FIGURE 3. Looking north-northeast, about 1912, from C-Hill. The Chadron Congregational Academy is in the foreground and the middle section of the Administration Building in the left foreground. (Con Marshall photo)

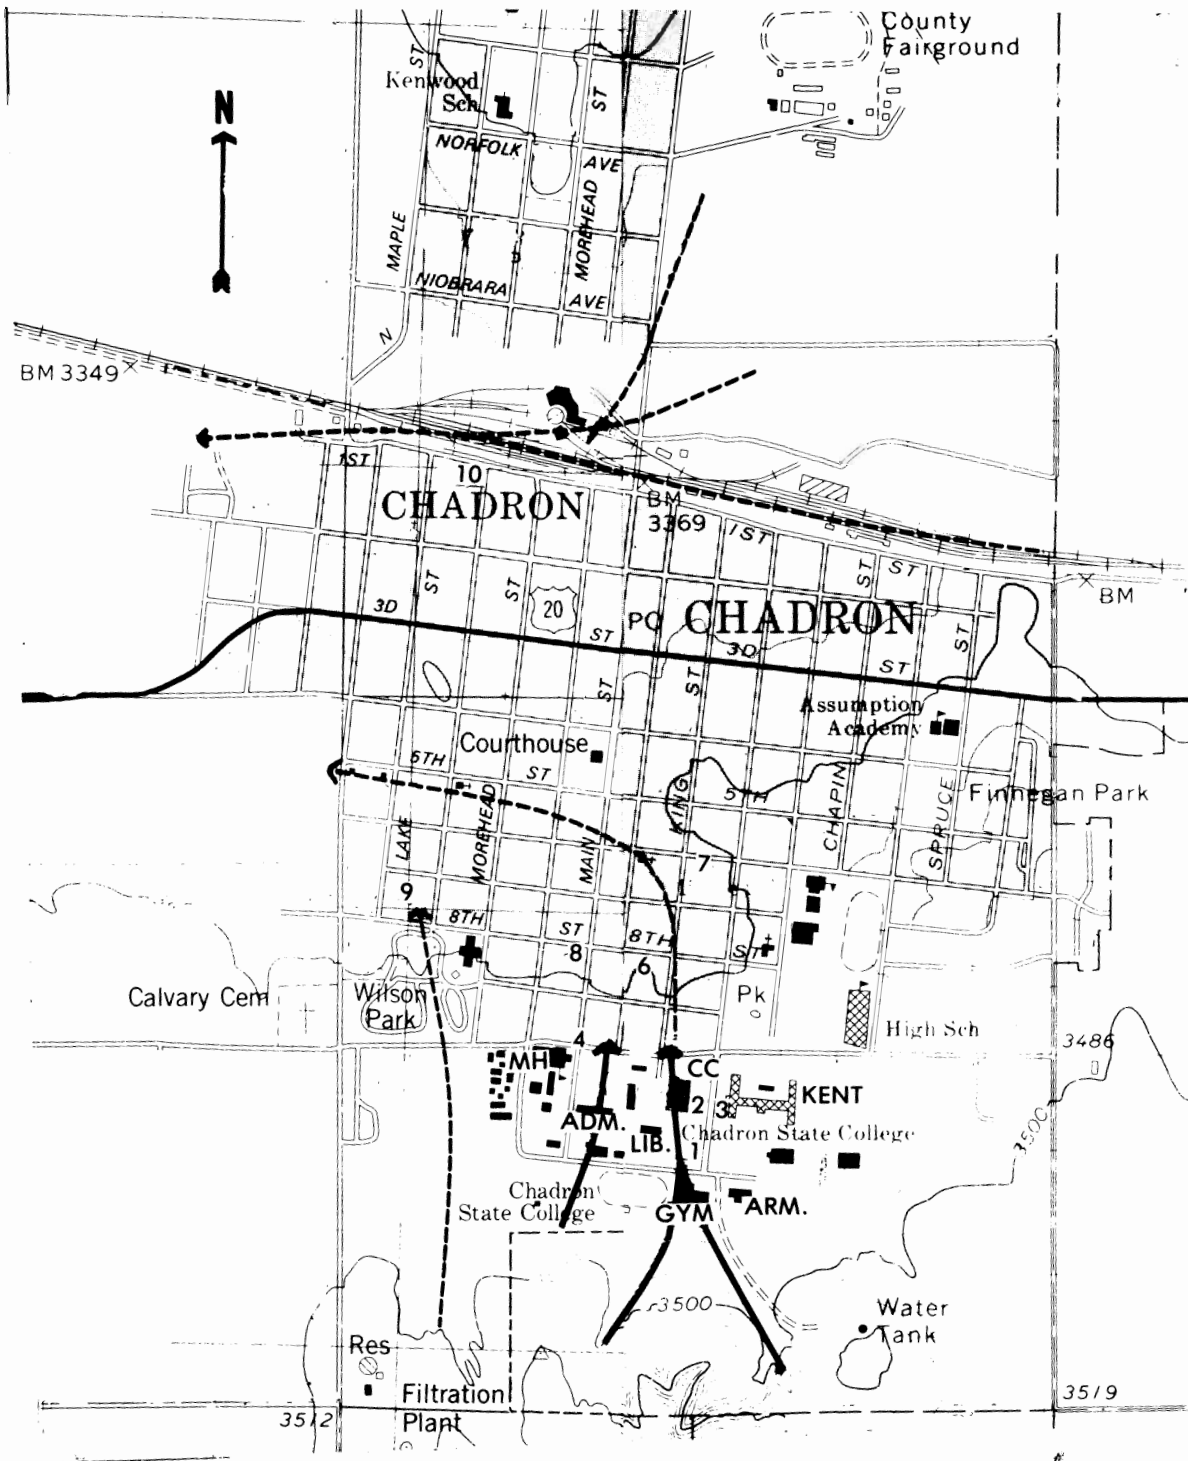
FIGURE 4. Modified U.S.G.S. topographic map of Dawes County, 7.5 series, of Chadron East (1970) and Chadron West (1967). Solid lines indicate the buried drainageways based on test borings. The slashed lines indicate surface drainage patterns. Caption: CC = Campus Center, ARM = Armory; GYM = Gymnasium; LIB = Library; ADM = Administrative Building; MH = Memorial Hall; KENT = Kent Hall.

lines in Figure 4 indicate the surface drainage patterns. These drainage areas are reasonably certain and are mostly based on topographical maps. The solid lines show the buried drainageways as determined by photographs and test borings on the Chadron State College campus. Again, the locations of these lines are reasonably certain (engineering report prepared for Chadron State College by Francis-Meador-Gallhaus, Inc., 1823 West Main, Rapid City, South Dakota, 57701, November, 1980).

Also, in recent years street deterioration and structural damage in homes are increasingly evident in an area north and northwest and down gradient from the campus. Damage appears to be most pronounced in an area down King Street following the assumed drainage area (slashed line) shown in Figure 4, then veering northwest and west along Sixth Street. Waste wells and pumps have or are being installed in many basements and outside locations to alleviate the rising water problems in basements.

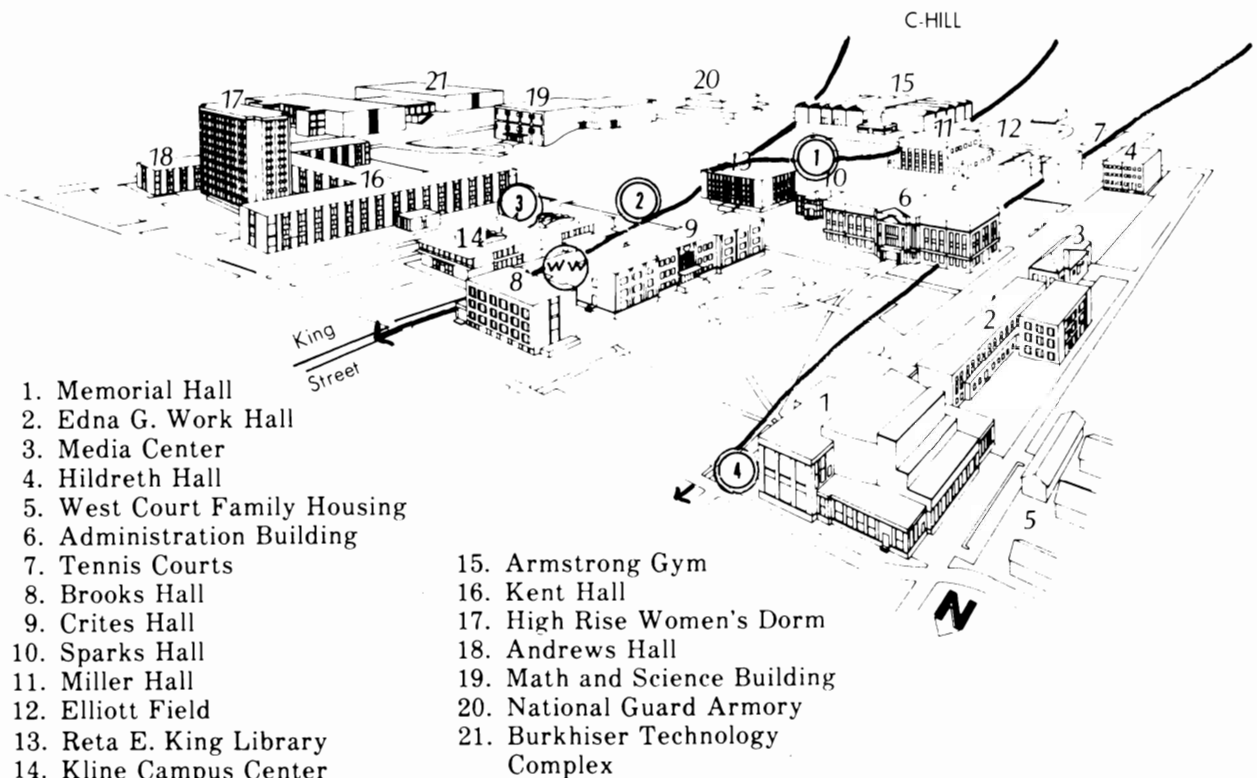
Figure 5 shows a more detailed map of the assumed drainageways through the campus in relationship of the College's buildings. It also shows the locations of the four test wells and the waste (desaturation) well.

FIGURE 5. Location of wastewater (desaturation) well (WW) and test wells 1-4. Solid lines indicate underground drainageways.

Older buildings not located near the old drainageway, and recently showing settlement problems, include Crites Hall located about 30 m (100 ft) west off the Campus Center (Fig. 5); the Administration Building located about 60 m (200 ft) southwest of the Campus Center; and the east part of Brooks Hall.

In the spring of 1986, a wastewater well was installed between the west side of the Campus Center and the southeast corner of Brooks Hall (Fig. 5), and the wastewater is discharged in the storm sewer. It has pumped continuously since its installation at the rate of 22 gallons per minute. As shown in

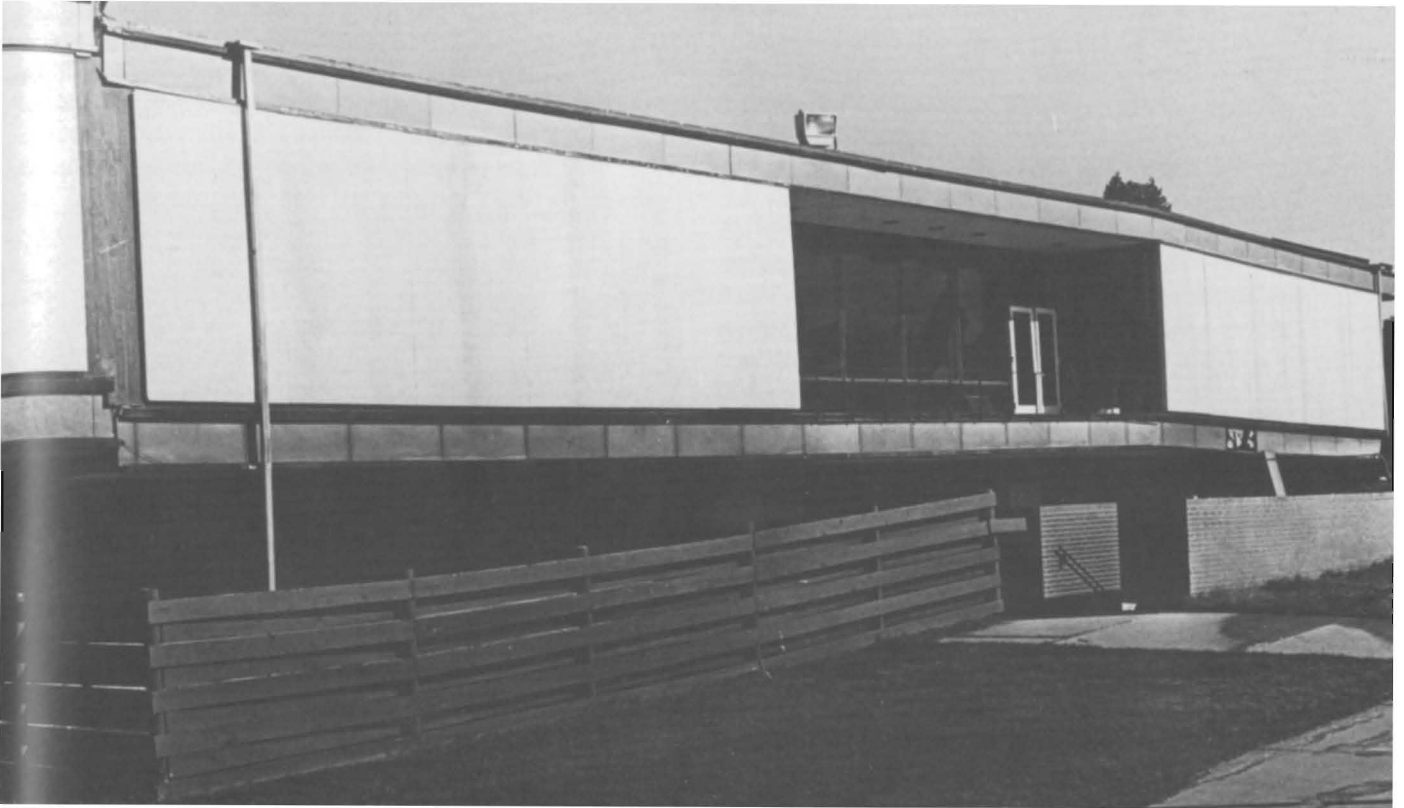
Settling problems of buildings on the Chadron State College campus were identified as early as 1964 (letter to F. Clark Elkins, President of Chadron State College, from E. Albin Larson, Secretary of the Board, regarding settling problems of the Kline Campus Center, dated December 22, 1964) and also in an engineering report for the College; the latter reported groundwater at 13.2 m (43.5 ft) below ground surface at the southwest side of the Campus Center (letter to Clark & Enersen, Olsson, Burroughs & Thomsen from Western Laboratory, Inc., 1630 Q Street, Lincoln, Nebraska, February 18, 1965). The settling problems now appear to be most pronounced on buildings constructed since 1960 on spread-footing foundations, and located on or near the assumed underground drainageway running down gradient (north) of the Armstrong Gymnasium. These include: (1) the north half of the Campus Center, constructed in 1967 and built on pier-type foundations, the main floor now showing settlement problems possibly related to the rising underground water levels, wetting, and compressibility of the soil; (2) Armstrong Gymnasium; (3) National Guard Armory; and (4) the south half of the Kline Campus Center, built in 1961, and condemned in 1979 because of structural differential sinking of 5 to 30 cm (2 to 12 in) (Fig. 6). Since 1971, many thousands of dollars have been spent on remedial repair of

FIGURE 6. Differential cleavage of 10 inches between the north half of the campus center constructed on pier-type foundations (extreme left) and the south half of the campus center built on spread-type footings. (Photo by Con Marshall)

buildings (Agenbrood, 1979). At the time of this writing (September, 1987) the south half of the Campus Center is soon to be demolished at a cost of nearly \$400,000.00.

On the basis of the foregoing considerations, I suggest: (1) the College install a limited number of strategically located wastewater wells to further prevent structural damages to existing campus buildings; removal of campus underground water would also prevent its downward flow into the residential areas of the City; (2) concurrent with pumping, water levels be monitored for changing underground water levels; (3) the College and High School manage irrigation water so that the earth is not saturated below plant root depth.

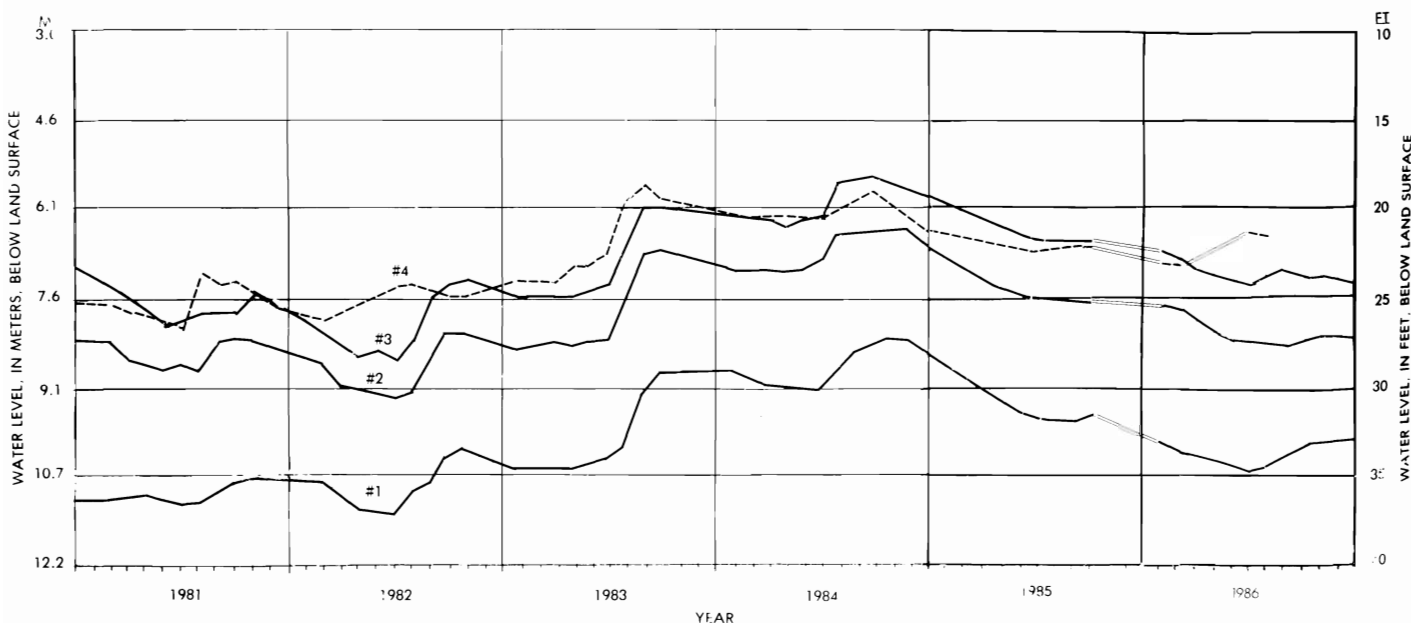
(Fig. 4). Well 1 is located north of the Armstrong Gymnasium, well 2 is south of the Campus Center, and well 3 is adjacent to the southwest corner of Kent Hall (east of the Campus Center). These three wells are in line with the old assumed drainageway. The underground water levels for wells 1–4 for years 1981–1986 are shown in Figure 7. Note the synchronous seasonal cyclic patterns of the wells for the 1981–1984 period. In each case, a buildup of water occurs in late summer, followed by a slight decrease in the spring months. The overall trend, however, is up. The rate of increase (slope) for wells 1, 2, and 3 is approximately 67 cm (2.2 ft) per year. These three wells are subject to upgradient supplemental campus lawn watering.

Figure 7, a notable decrease in groundwater levels is noted during the 1985–1986 period, especially for wells 1, 2, and 3. The double lines between the November 1985–February 1986 time period represent extrapolated data because the wells were not measured due to snow cover. Well 4 caved in during the summer of 1986 and its data are terminated at that point. The decline in groundwater during the 1985 season is probably due to the drought experienced in Chadron during the year (27.66 cm or 10.89 in). The continued decline during 1986 appears to be linked to the pumping influences of the wastewater well since 1986 was a wet year (63.65 cm or 25.06 in). Although not shown in Figure 7, this decline in water levels has continued into 1987 at the time of this writing (September, 1987), again probably linked to the discharge of saturated water into the storm sewer.

FIGURE 7. Depth in meters and feet to underground water on the campus.

One aspect is obvious from this study, namely, that groundwater levels on parts of the campus have been rising at the rate of approximately two feet per year for the years 1981, 1982, 1983, and 1984. During this time period, no wastewater well was in operation.

In 1985, however, campus underground water levels started to decline at the rate of approximately two feet per year. This decline is probably linked to the drought and the decreased use of lawn-irrigation water. In 1986, a desaturation well was installed and this rate of decline continued.

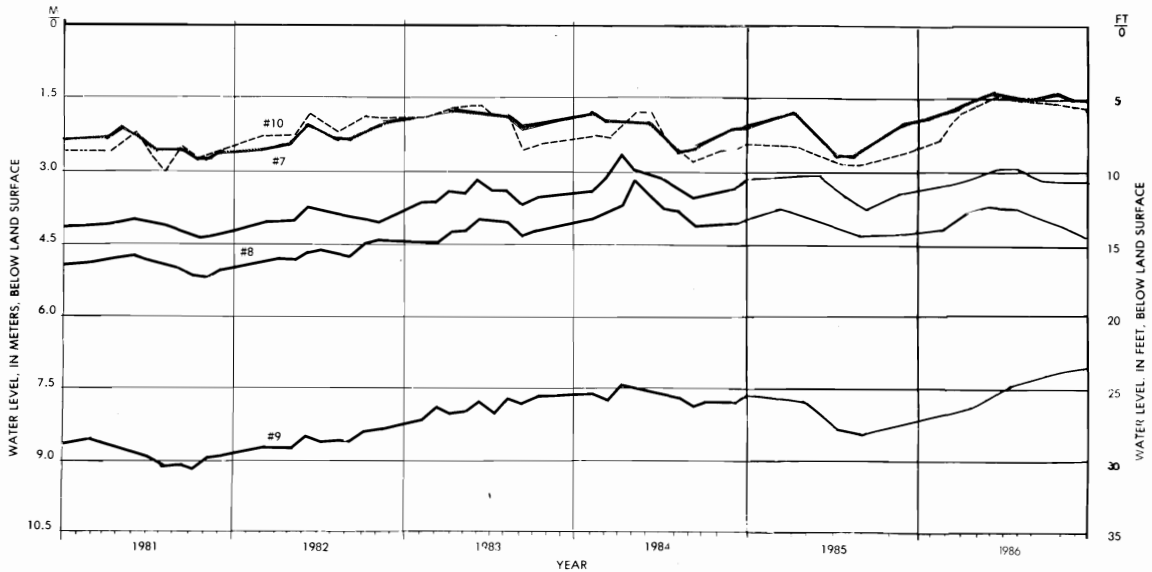
For the 1981–1984 period the underground water levels from all wells 6–10 follow the same seasonal synchronous and phase patterns (Fig. 8). During this period water levels tend to fall during the summer months and tend to increase slightly during the winter months, resulting in a slight net gain until 1984. In 1984, the water levels tended to remain static. The lowering of groundwater levels during the summer months appears to be related to the use of these wells for irrigation purposes. In 1985, a decline in groundwater levels is noted in

all the wells, probably related to the drought and the need of increased pumping for lawn-irrigation purposes. The increase in water levels during 1986 may be related to the abundant rainfall during 1986.

FIGURE 8. Depth in meters and feet to underground water in the city.

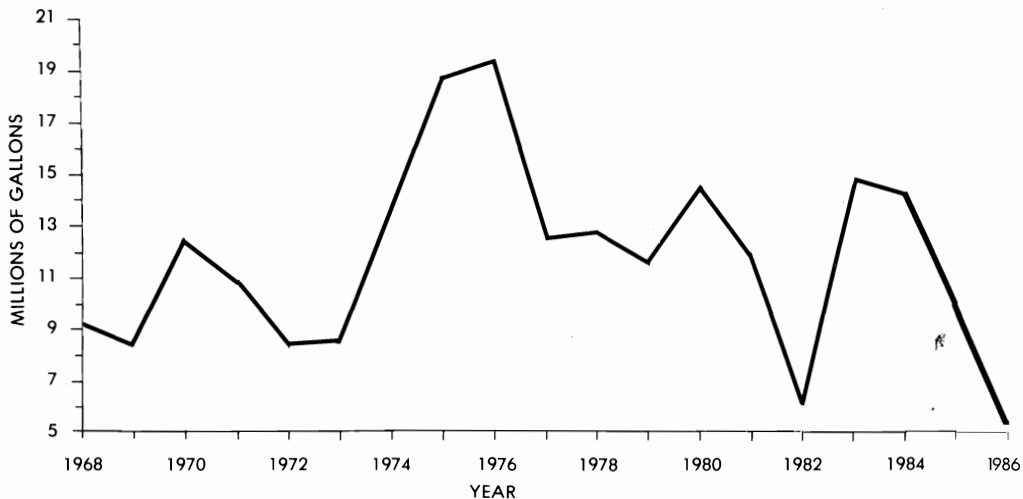
Chadron State College is the largest single user of water within the City. A view of the College's use of water for irrigation purposes on the campus is shown in Figure 9. Only taps serving irrigation purposes are used in the data. Two exceptions, however, are made: (1) water usage from the baseball field has been deleted because the field has not been used in recent years and is located away from the area of study; (2) water usage has been estimated for the area between the Gymnasium and Campus Center based on an equivalent area usage of the football field; this area is not on a tap supplying irrigation water only, yet it has been an important consumer of irrigation water. Unfortunately, complete data of campus usage could not be obtained for years before 1969, which would have added to a broader data base prior to the deep-well system. The data, however, indicate that on the average, for the last 18 years, approximately 12,300,000 gallons of water have been used by the College annually for lawn purposes from taps used exclu-

sively for irrigation for an estimated area of 5.5 ha (13.6 acres). Generally, water consumption is inversely related to precipitation patterns; the exception is the 1985 season. It is noteworthy that a wastewater discharge of 22 gallons per minute equates to eleven million gallons of water in one year, or about the same volume applied for lawn purposes each year.

Poor water management has also been suggested as a source of rising underground water. In several investigations concerning building deteriorations, recommendations have been made to better utilize irrigation water and reduce groundwater levels (letter to Edwin C. Nelson, President of Chadron State College from Don T. Pyle, representing Ketchum, Konkel, Barrett, Nickel, and Austin, Consulting Engineers, 730 Kalamath Street, Denver, Colorado 80204, May 20, 1971). Another investigator noted a lawn sprinkler setting of 18.5 hours applying 20.3 to 21.6 cm (8.0 to 8.5 in) of water in one setting (letter to Edwin C. Nelson, President, from Vincent H. Dreeszen, Conservation and Survey Division, University of Nebraska, Lincoln, Nebraska, July 30, 1971). Since that time, lawn water-usage has not decreased except for 1982, and 1986, both wet seasons. This practice appears to have contributed to the rising underground levels.

FIGURE 9. Water usage for lawn beautification at Chadron State College.

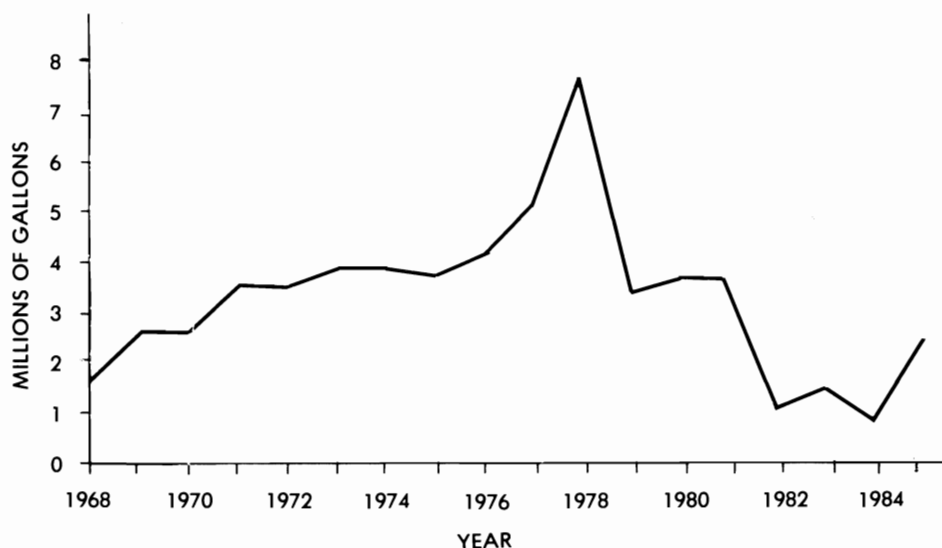
Seepage from the swimming pool has been suggested as a possible source of rising underground water. Figure 10 shows the usage of water from the Armstrong Gymnasium, where the pool is located, for a 18-year period. The data indicate increased water usage in 1976, 1977, and 1978, suggesting leakage. Perhaps as many as four million gallons of water may have leaked from the pool and entered the old drainage pattern. It was repaired in 1978, and water consumption in the Gymnasium has now been reduced.

FIGURE 10. Water usage for Armstrong Gymnasium.
