Hydrogeologic Relationships to Structural Failure Chadron State College, Nebraska

HYDROGEOLOGIC RELATIONSHIPS TO STRUCTURAL FAILURE

CHADRON STATE COLLEGE, NEBRASKA

LARRY D. AGENBROAD

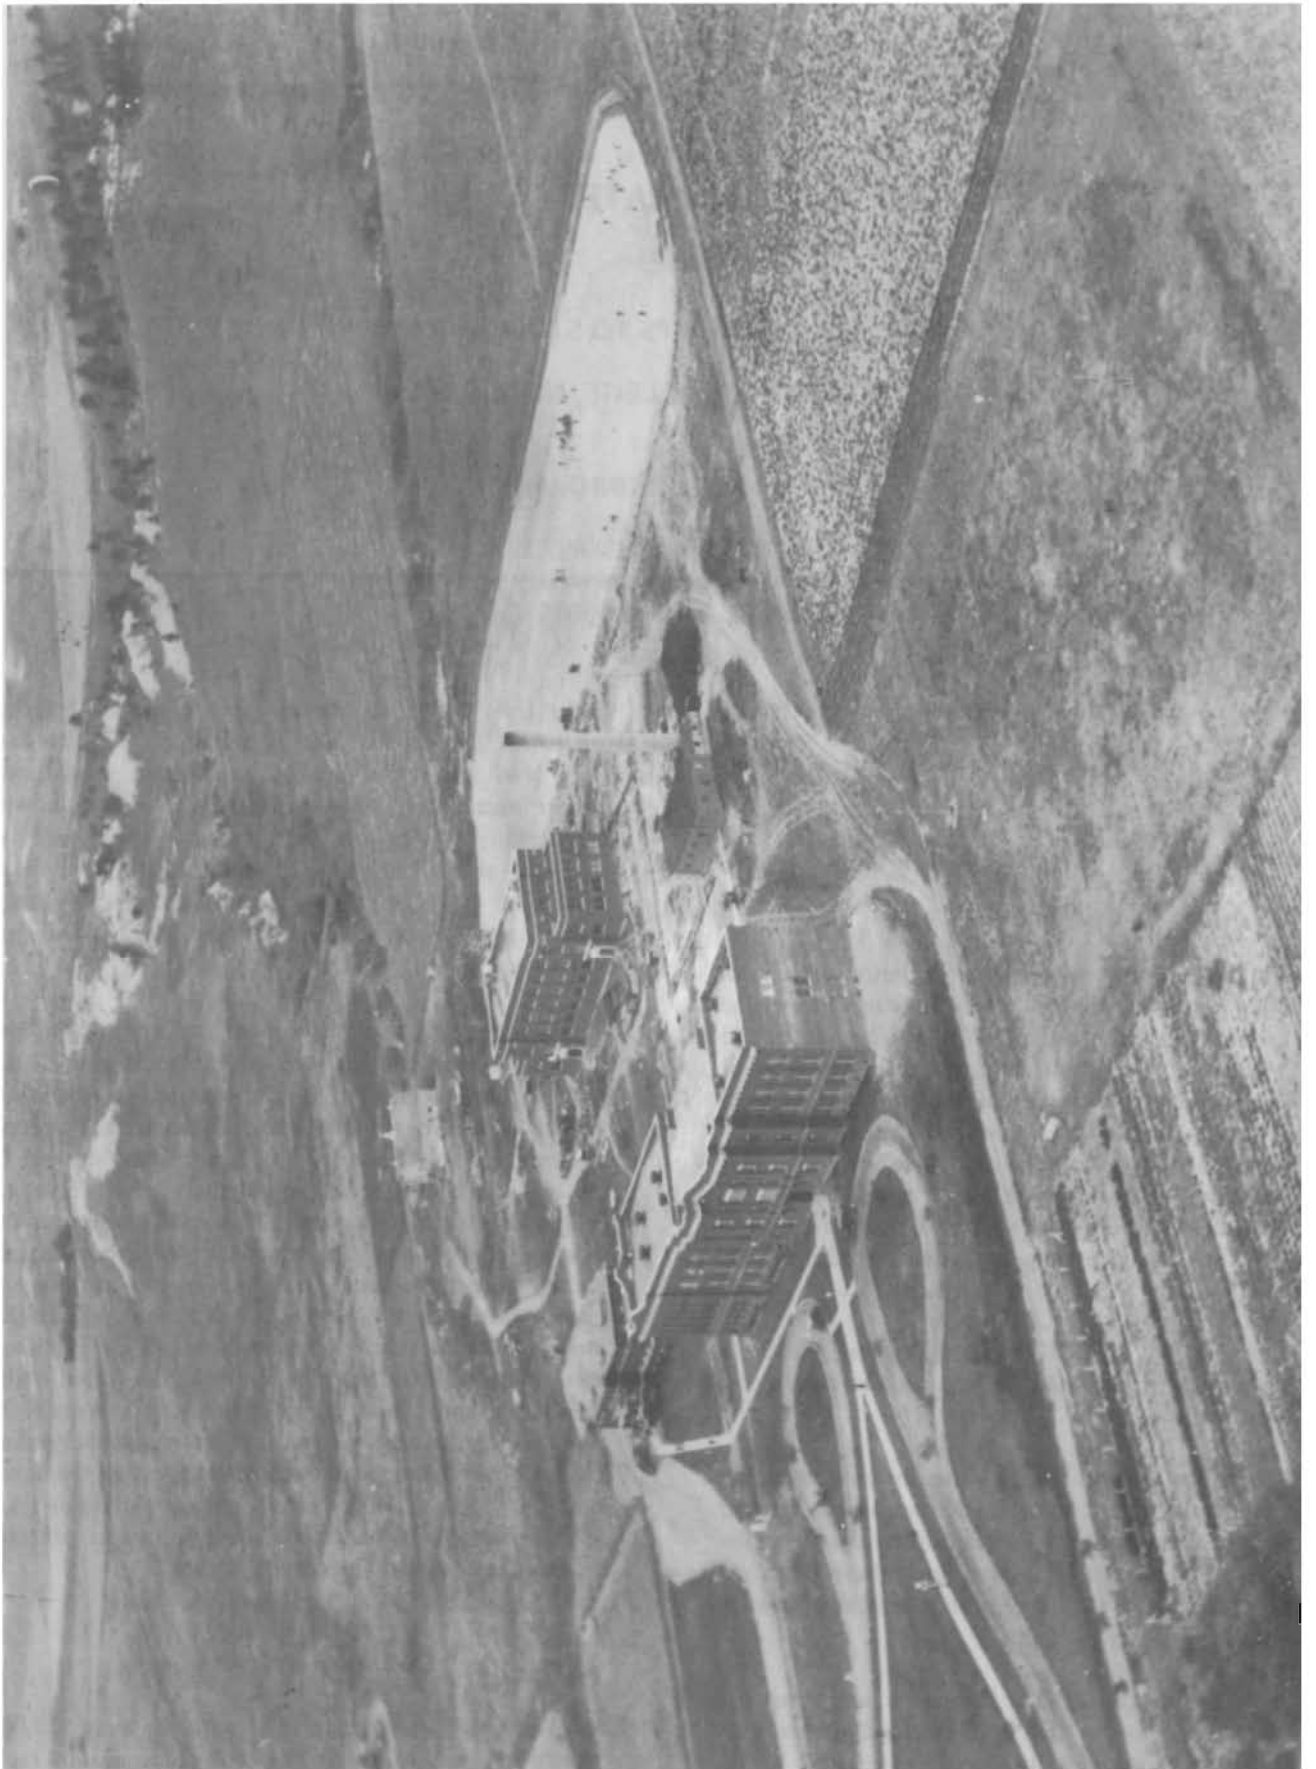
An air photo (Fig. 1) taken in 1920 by Dr. G. E. Condra, State Geologist, shows the confluence of two washes at or near the location of the Armstrong Physical Education Building. A vertical air photo (Fig. 2), taken about 1965, shows that these washes had been filled by simple (noncompacted) procedures and that the football stadium and practice field, the college library, and the north half of the Campus Center were under construction. The Physical Education Building and the National Guard Armory had been completed before 1965.

Projection of the wash alignments into the fill areas indicates the location of the gym is on the west wash alignment at or close to the juncture with the east wash. Similar analysis suggests the Armory is on the east wash alignment. The southwest part of the Campus Center extends onto the fill of the wash alignment, down gradient from the juncture of the east and west wash.

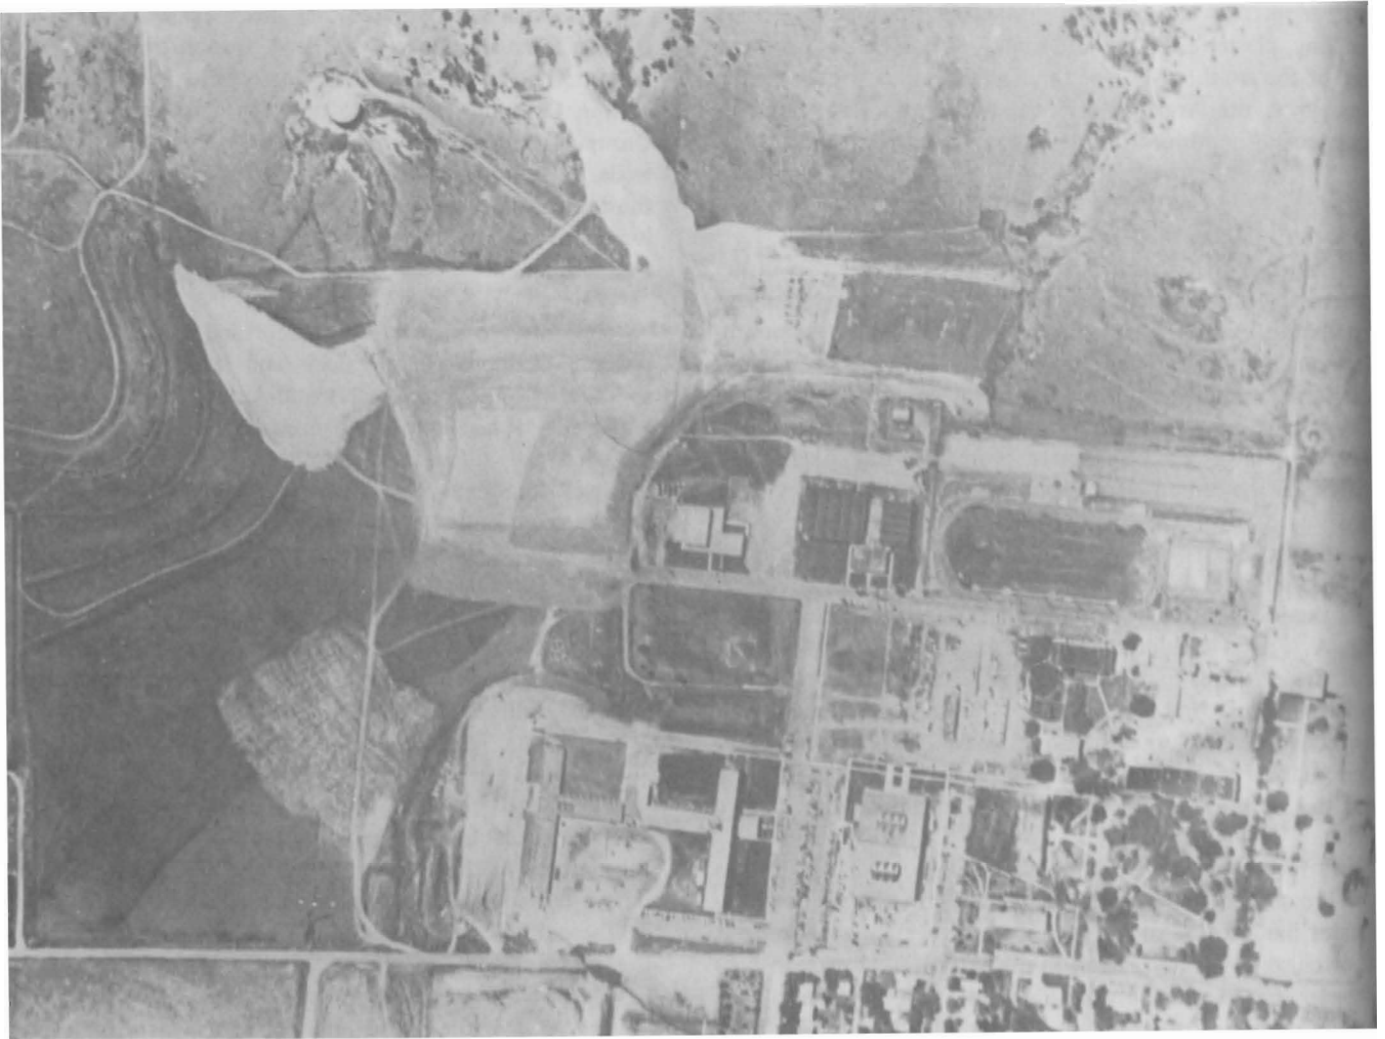
Figure 2. Vertical air photo (ca. 1965) of the Chadron State College Campus. Washes have been obliterated. The Armstrong Physical Education Building, the south half of the Kline Campus Center, and the National Guard Armory had been completed. The library and north half of the Kline Campus Center were under construction. (Photo courtesy of Linda Rector.)

1. Dewater the fill material in the vicinity of the damaged building by pumping from a series of shallow, low-cost wells. The water removed could be used to irrigate campus lawns and thereby save potable water for human consumption. Dewatering would reduce the instability of the foundation material for the damaged

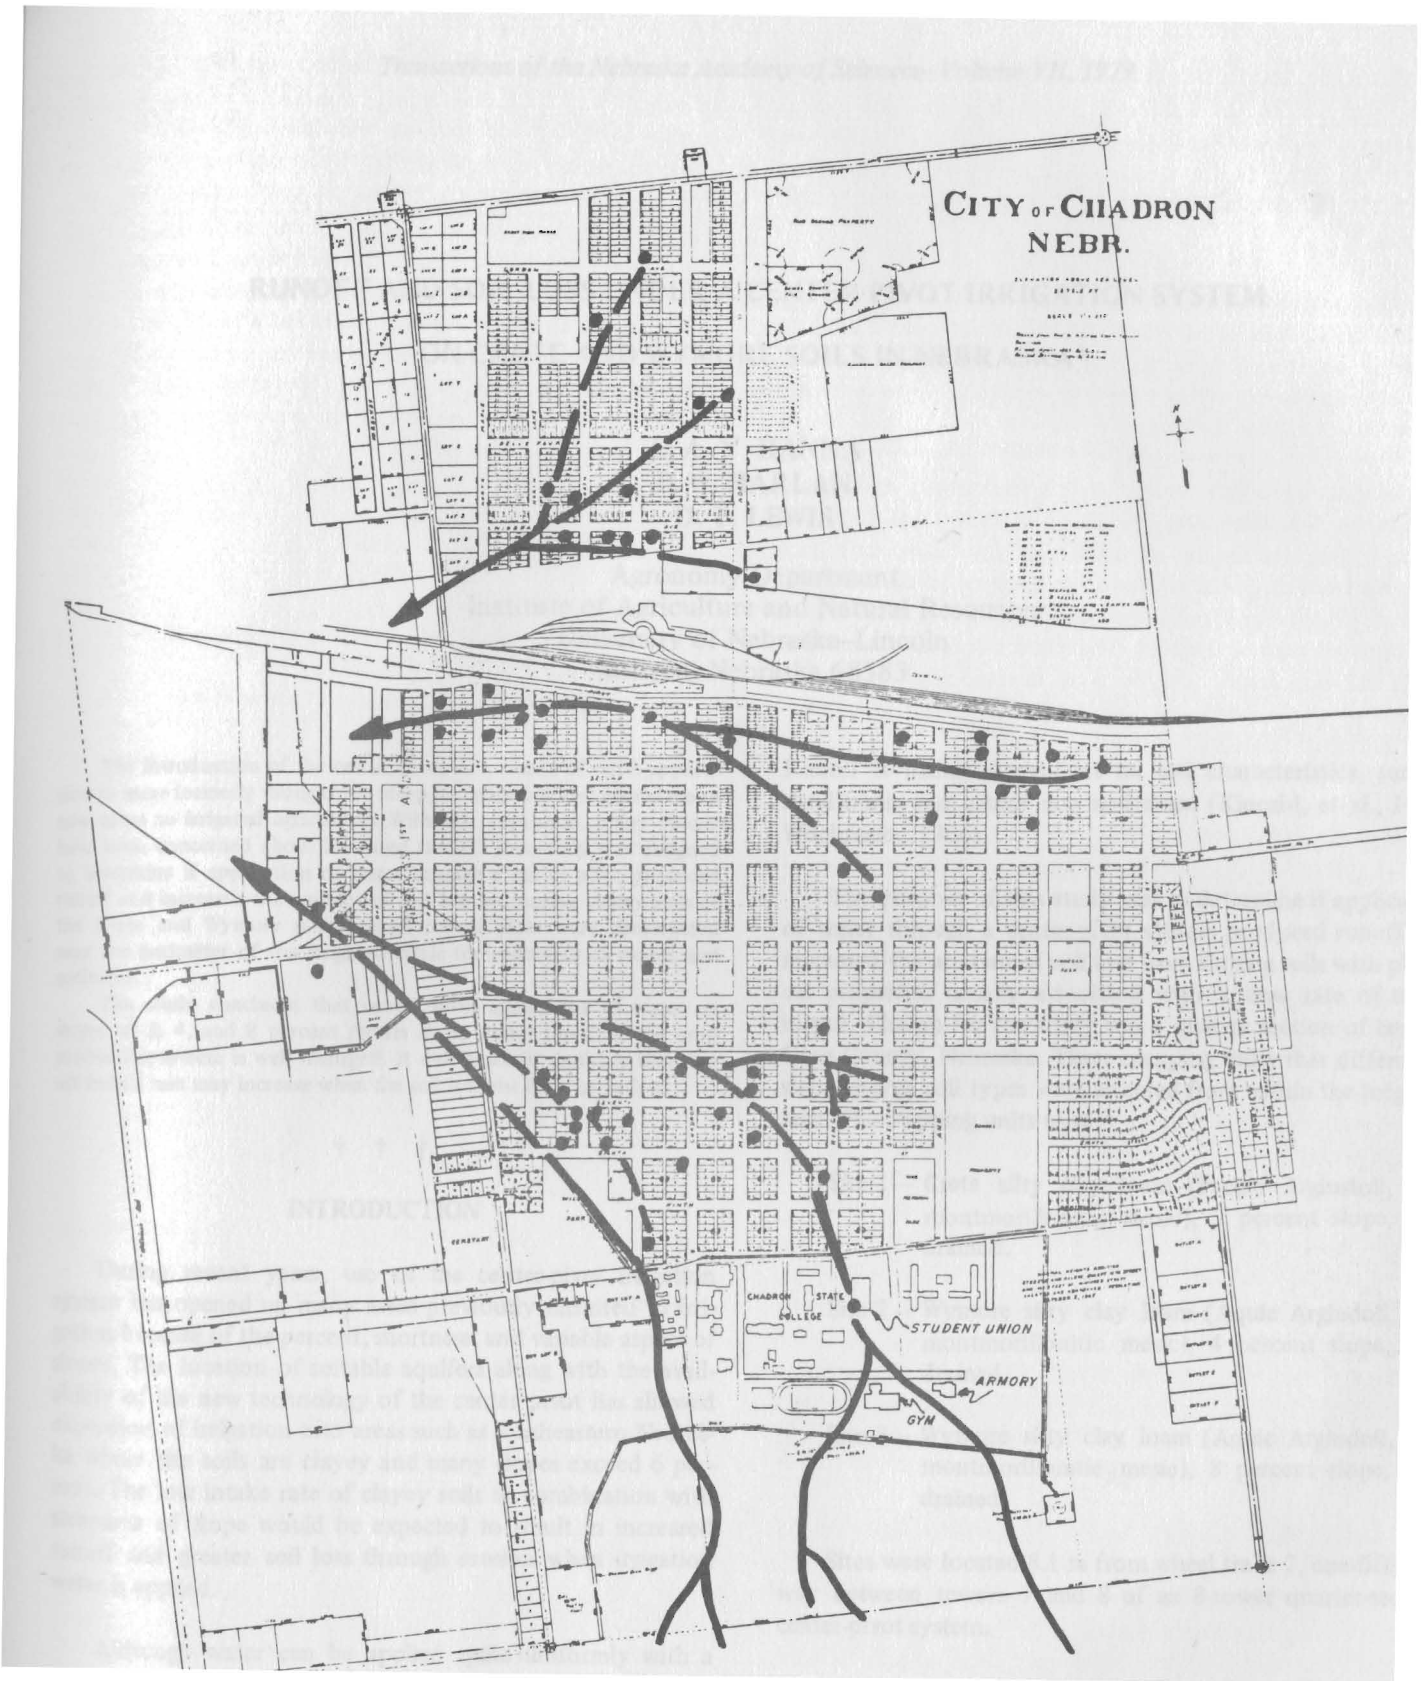
A plot of the domestic wells in the city is shown in Figure 3. Most of the well locations are coincident with the approximate alignments of the pre-construction (urban) drainage features. The data from Condra's photo allow connection of the unmodified portions of the washes, south of the campus, with the well concentrations and topographic lows, defining the original drainage pattern, and is coincident with the damaged structures.

It should also be noted that successful wells are in topographic lows along the postulated pre-construction drainage pattern. The low porosity and permeability of the sandy silts of the Chadron Formation and the Tertiary White River Group of sediment are not generally conducive to successful wells. The alluvium along the drainage pattern established by the pre-construction washes would be of much better hydrologic character, allowing flow of ground water and successful well drilling.

Figure 3. A map of the city of Chadron showing the location of known shallow wells. Projected topographic alignments of former drainage patterns are coincident with the well locations. Dashed lines indicate a lesser degree of certainty of position. (Photo courtesy of Linda Rector.)
