High Temperature Creep and Hydrogen Embrittlement Failure of a Steam Trap Bypass Tube

Abstract. A coal fired power plant with its normal operation temperature of 540°C in which its steam trap bypass tube in that power plant was totally fractured. The aim of this study is to explore the evidence related to the steam trap bypass tube failure and to determine the failure mechanism and the root cause of the failure and to give an appropriate recommendation. From the evidence with considering the contribution factors such as temperature, pressure and environment, a fault analysis was made and it can be concluded that the cause of failure to the steam trap bypass is due to multi causes which consists of creep failure and hydrogen damage.

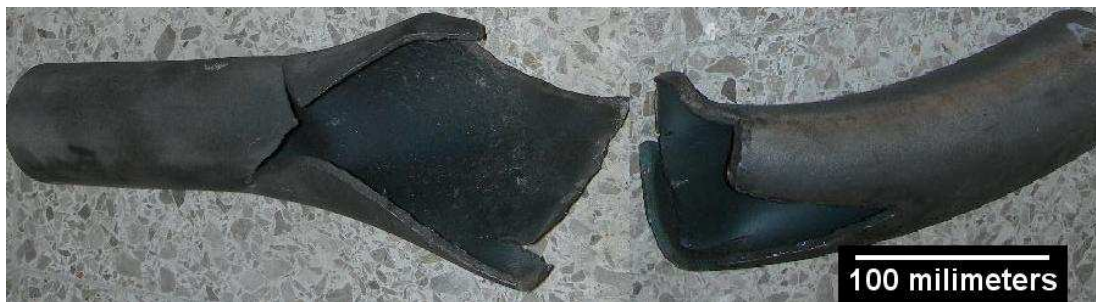
The tube had catastrophically fractured with a fishmouth appearance as shown in Figure 2. Visual inspection on fractured surface of the fractured surface exhibited bright and granular features. It has thick edge as shown as red mark in Fig. 2. With thick edge and fishmouth crack appearance, it is an indication of high temperature creep or long term overheating failures as reported by R.W Bryers [2]. Longitudinal cracks and oxide scale were found inside the tube surface. The oxide scale of 3.5mm thickness was measured on the inside tube surface.

Fig 2 : Digital camera image of fishmouth appearance that catastrophically fractured apart due to high pressure.

It can be estimated that the metal temperature adjacent to the oxide scale would be around 580°C, however the maximum temperature permitted for the tube steel is 649°C with the initial creep temperature of 537.8°C [2]. The working estimated temperature of tube had not exceeded the maximum permitted temperature but was higher than the initial creep temperature which was an evidence of creep occurred.

From the results, it can be concluded that the steam trap bypass tube had fractured due to high temperature creep and hydrogen embrittlement (multi causes). To avoid further failure recurrence, corrective actions have to be taken which includes replacement of the fractured tube with higher Cr-Mo tube material content for higher creep resistance and continuous steam trap operation monitoring to eliminate condensate.

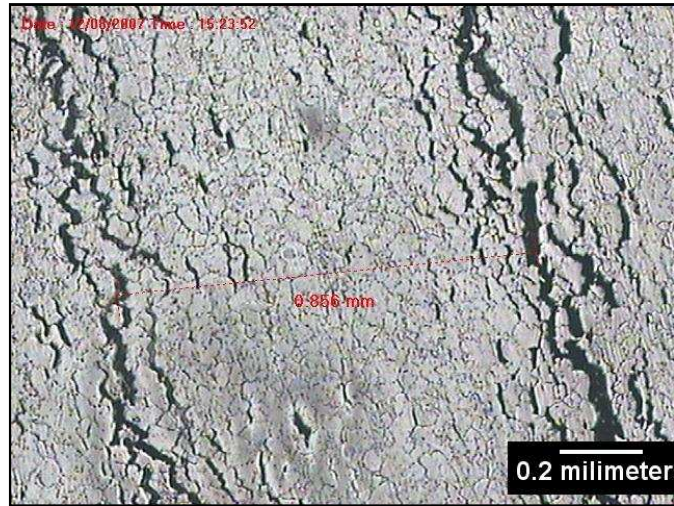
Fig. 3 : Optical metallograph of inside tube surface.

Intergranular microcracks had formed under the oxide scale with ferrite and pearlite grains (Fig 3). The grain growth rate near the inside tube edge was almost two times greater than that of the grains far from the inside tube edge which had reduced the strength and toughness of the tube. Graphitized microstructure, microvoids, pores and microcracks were also observed. These microstructural changes usually occurs in carbon or low alloy steels that are subjected to moderate temperatures for long period of time [2].

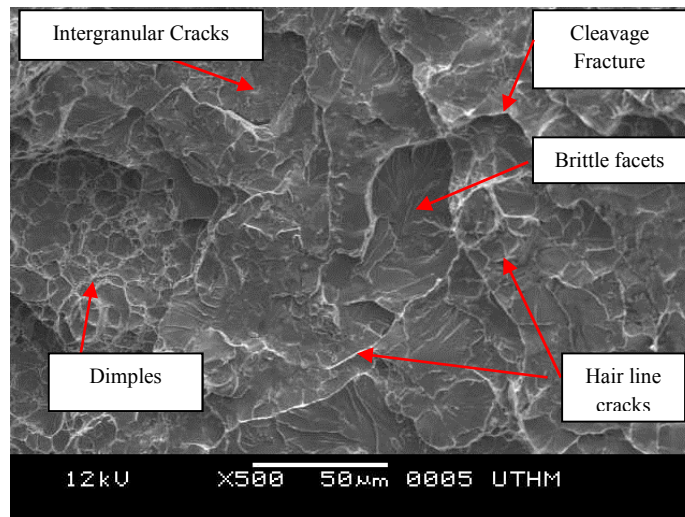
The fracture surface clearly revealed dimpled structures associated with brittle facets, cleavage fracture, ductile hairline cracks and micropores as shown in Figure 4. The fracture surface also indicates typical characteristics of hydrogen embrittlement [3] which in the form of a partially intercrystalline fracture with ductile markings on the grain boundaries (crow's feet). The indication of hydrogen embrittlement showed that hydrogen embrittlement had also occurred which was a result of chemical reactions between tube material and condensate.

Fig. 4 : SEM micrograph of heterogenous structure including dimples, brittle facets, cleavage fracture and hairline crack.
