TRAFFIC SAFETY STUDY

OTTUMWA, IOWA

SEPTEMBER, 1980

Prepared by
**HENNINGSON, DURHAM & RICHARDSON
OMAHA, NEBRASKA**

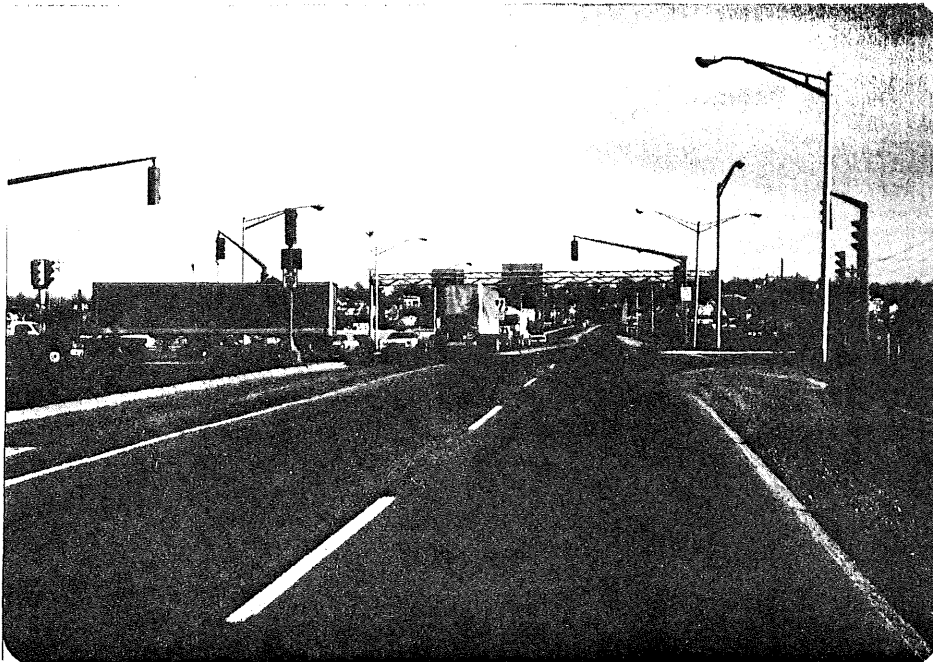
Looking northeast on Wapello - an additional signal head and backplates are recommended.

- Install a longer mast-arm on the Wapello approach and relocate the existing pole-mounted left turn signal to the mast-arm.*
- Install an additional overhead signal head for each approach.*
- Replace the left turn signals with optically programmed signal heads.*
- Replace the existing airport signs on the east and west approaches with MUTCD recommended airport symbol signs.*

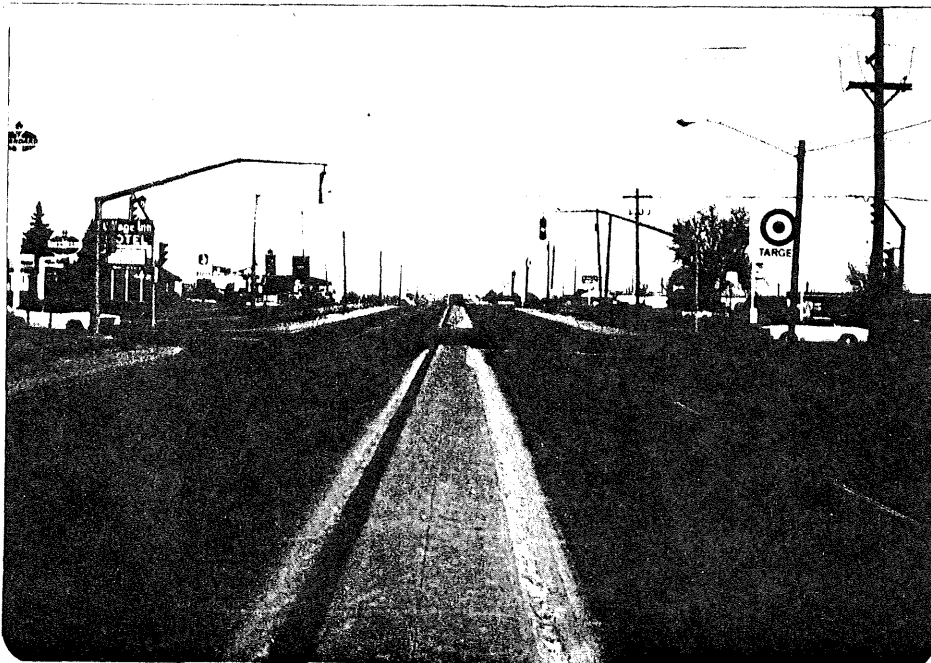
A view of the north U.S. 63 approach showing the absence of left turn bays.

- Construct left turn bays on U.S. 63.*
- Install an additional luminaire on the northeast and southwest corners.*

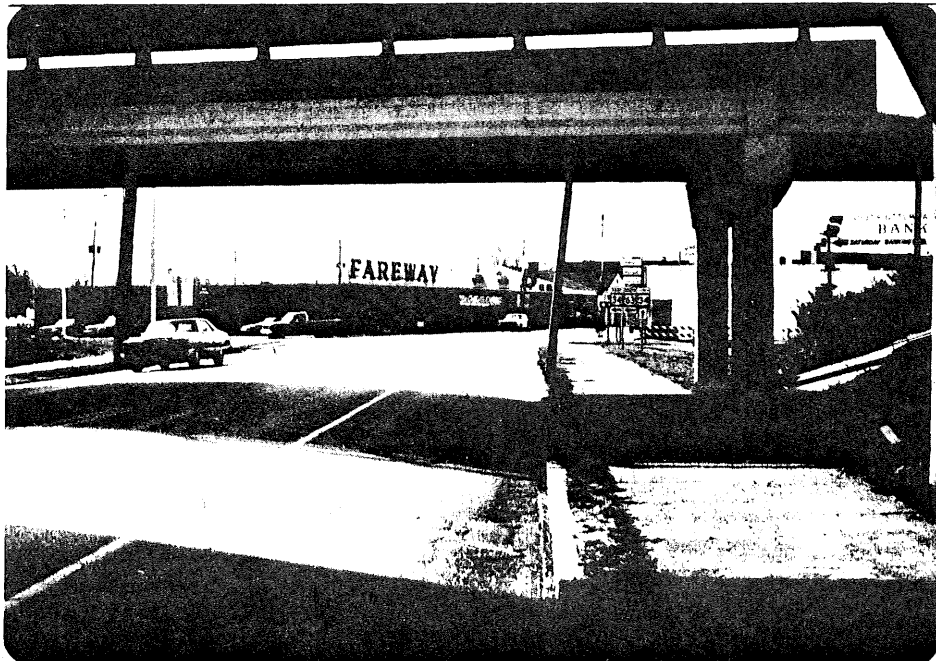
Looking south along Church Street.

- Redesign the northwest corner radius to flatten the bend in Church Street.
- * Responsibility of the Iowa D.O.T.

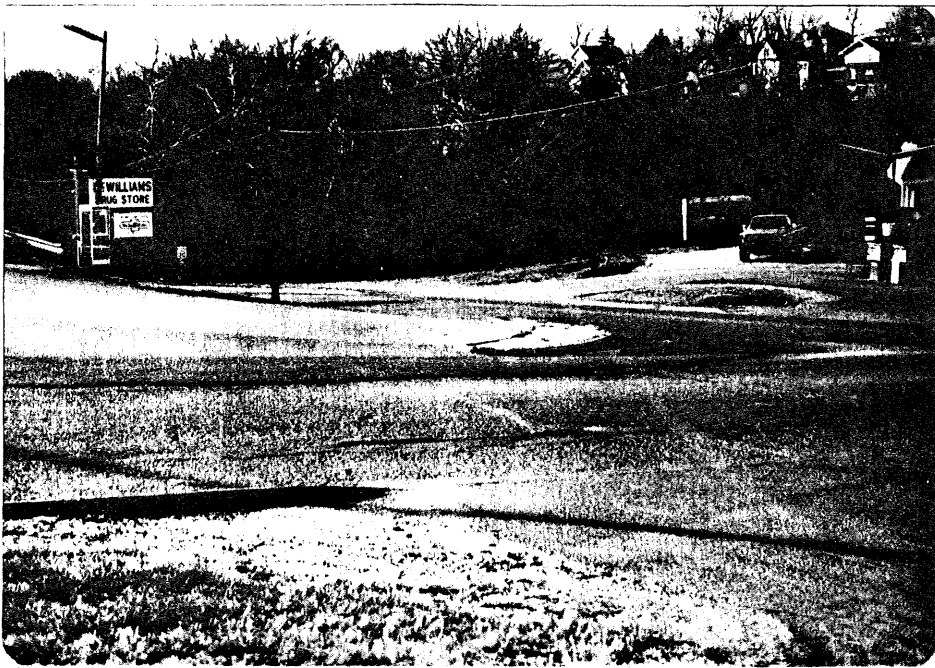
The southeast corner of Pennsylvania and Jefferson
as seen from Pennsylvania Avenue.

- Redesign the southeast corner curb radius and enlarge the corner island.

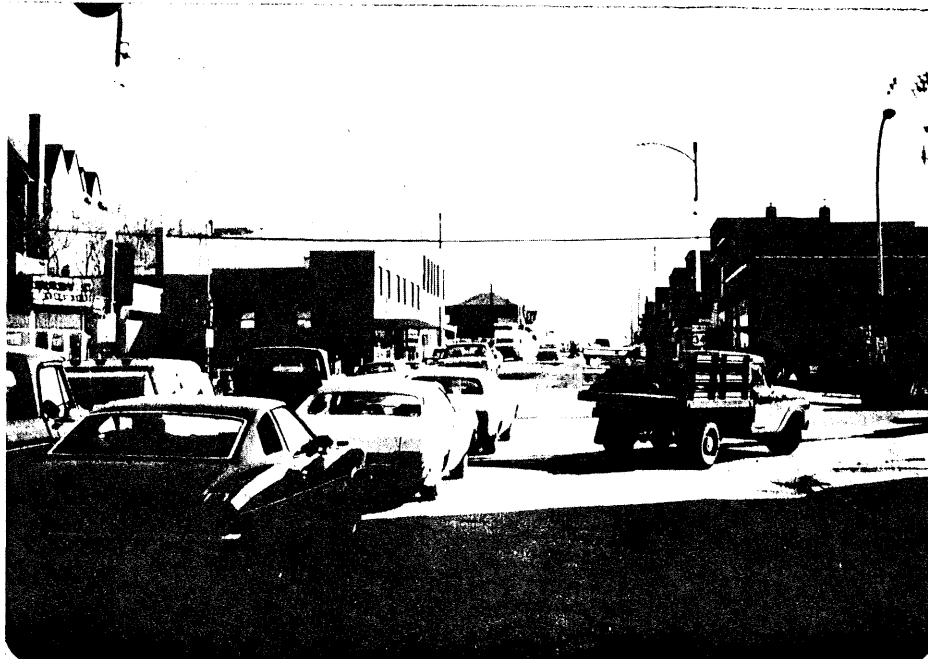
Looking east at the nonconforming
Main Street signals.

- Install a new pretimed signal controller.
- Install mast-arms with 12 inch signal heads.

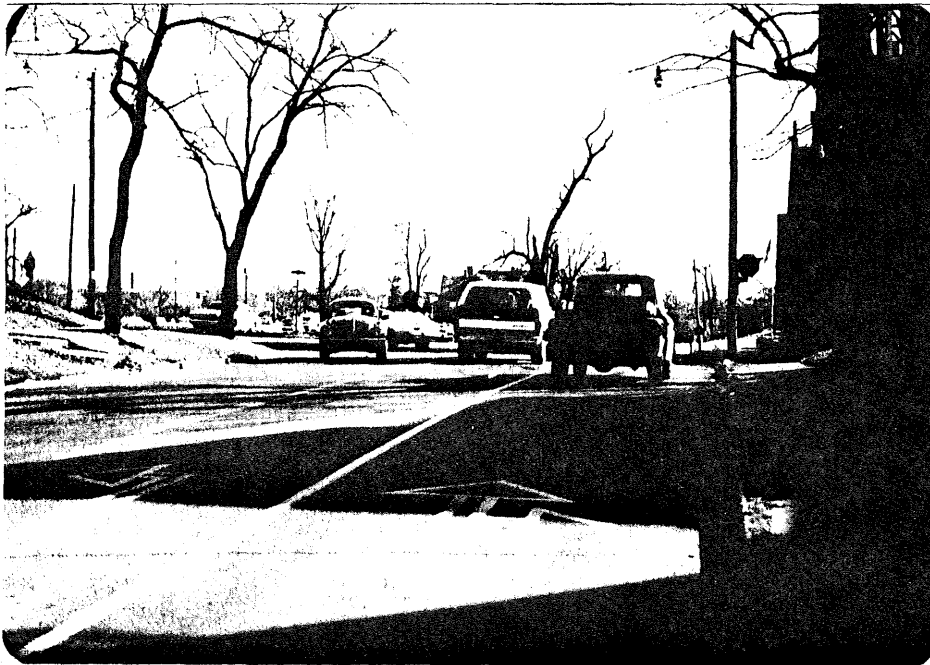
Nonconforming pavement arrows at
Fourth and Jefferson

- Restripe the Jefferson Street approaches to provide 10 foot lane widths and replace the existing south approach center line with a solid double line.

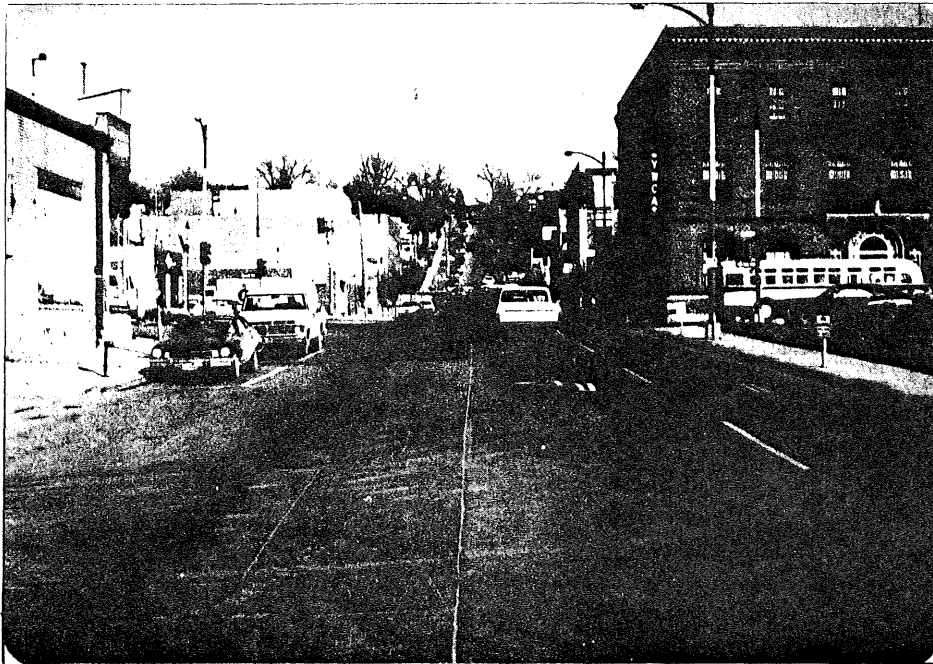
A view of Washington and Second showing poor visibility of the traffic signals.

- Install a new pretimed signal controller.
- Install mast-arms with 12 inch signal heads and pedestrian signals.

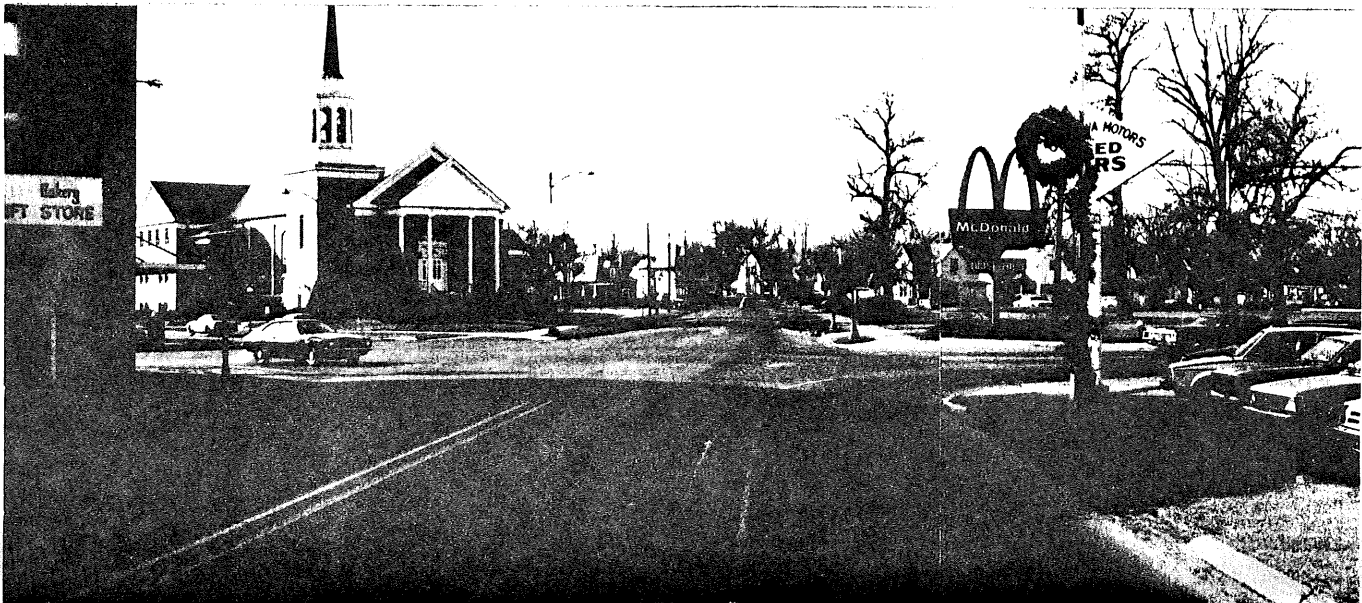
Church and Richmond looking
south on Church Street.

- Install vehicle detectors on the Vine Street and Willard Street approaches.
- Install a new 4-phase controller with two actuated modules.
- Install mast-arms with 12 inch signal heads.
- Install overhead lane use signs on signal mast-arms (Richmond Avenue and Church Street Approaches).

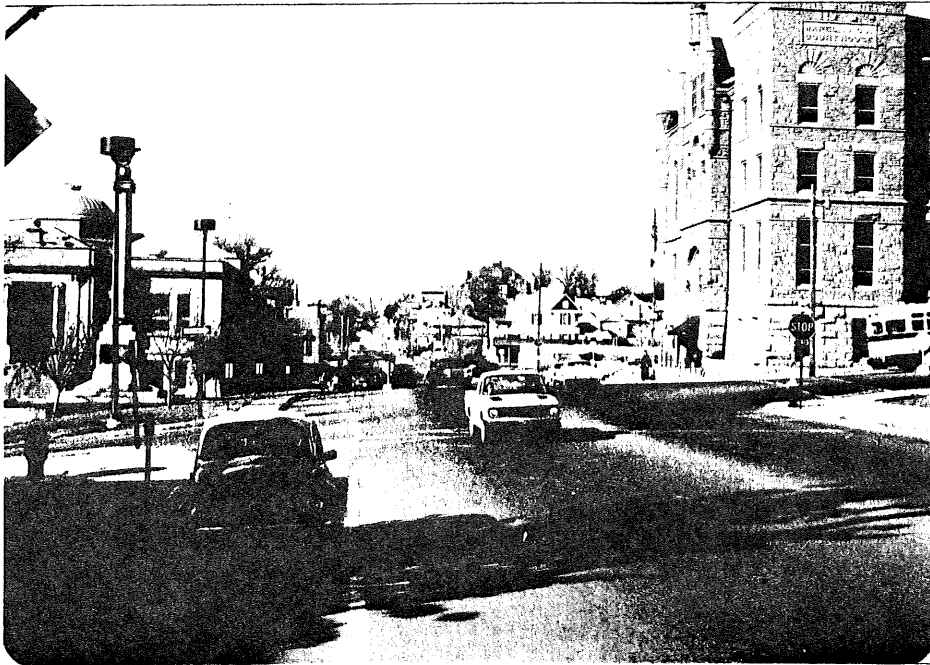
Fourth and Court - Looking northwest

- Close the park entrance and exit roads.
- Relocate the crosswalks on Fourth Street as shown on the improvement diagram.
- Remove the Stop signs on Fourth Street.
- Install center line striping on the Fourth Street approaches.
- Install Pedestrian Crossing signs (W11a-2) on Fourth Street in advance of the crosswalks.
- Install pavement arrows on the Court Street approach.
- Relocate the library drop box as shown on the improvement diagram.

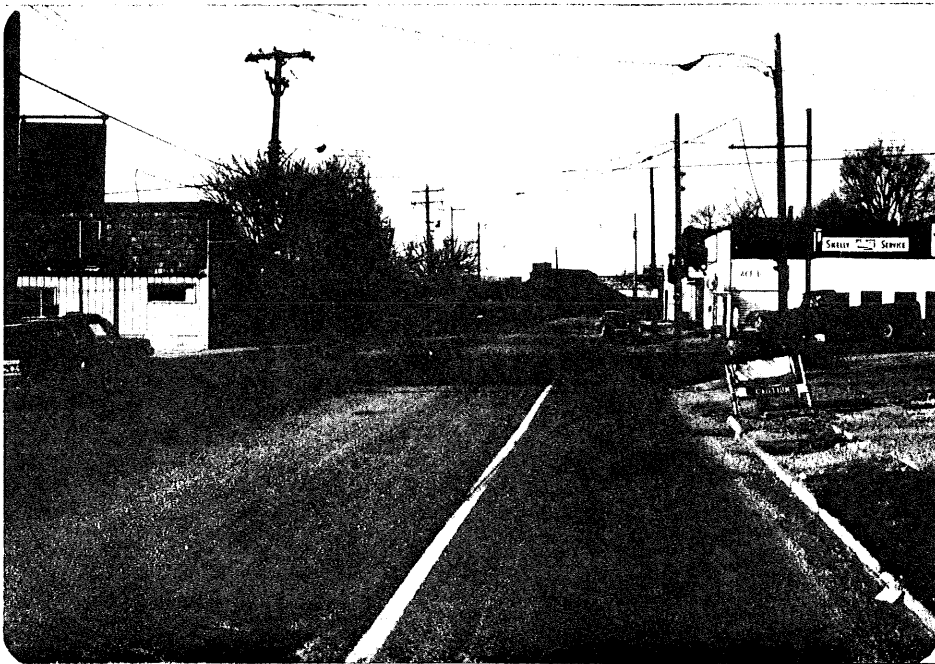
A view of Main and Iowa showing the poor visibility of traffic signals.

- Install a new pretimed signal controller.
