Investigation and Rehabilitation of Lining Imperfections and cracks in an Operating Railway Tunnel

Investigation and Rehabilitation of Lining imperfections and cracks in an Operating Railway Tunnel

The X.Z.Y. tunnel is a curved tunnel with single-rail track for the railway in southwest China. The construction was started in April 2003 and completed in August 2004. The tunnel crosses a hills area where the excavation was in a stratum of mudstone mixed with sand stone. The stratum was formed horizontally with developed joints. The tunnel was constructed using the conventional tunnelling method with an integral lining system.

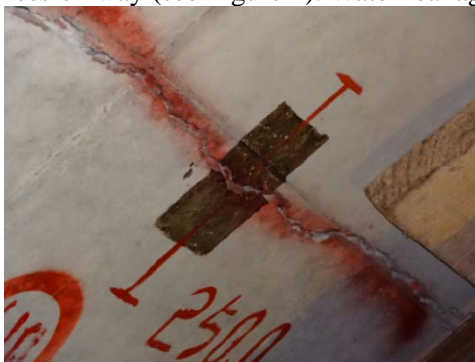
(a) mileage DK168+340 right side

In March 2014, a vision inspection shows that the X.Z.Y. tunnel lining was found severe damaged and cracked in some sections, as shown in Figure 3 and Figure 4. Cracks have a maximum width 10 mm; maximum detective depth 15 cm; maximum longitudinal spread of crack 40 m. In typical damaged section, the tunnel lining was cracked symmetrically at the intrados of tunnel arch shoulder due to bulge (see Figure 3) and crushed at the crown in a compression way (see Figure 4). Water leakage occurred at some positions on the lining surface.

Figure 3 longitudinal tensile crack at intrados of tunnel arch shoulder

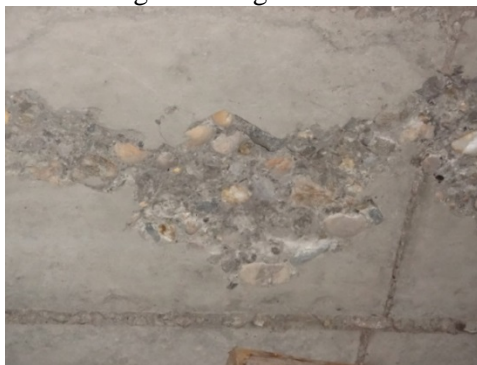
(a) mileage DIK68+325 crown

Figure 4 crushing at crown due to local compression (flaking and falling)

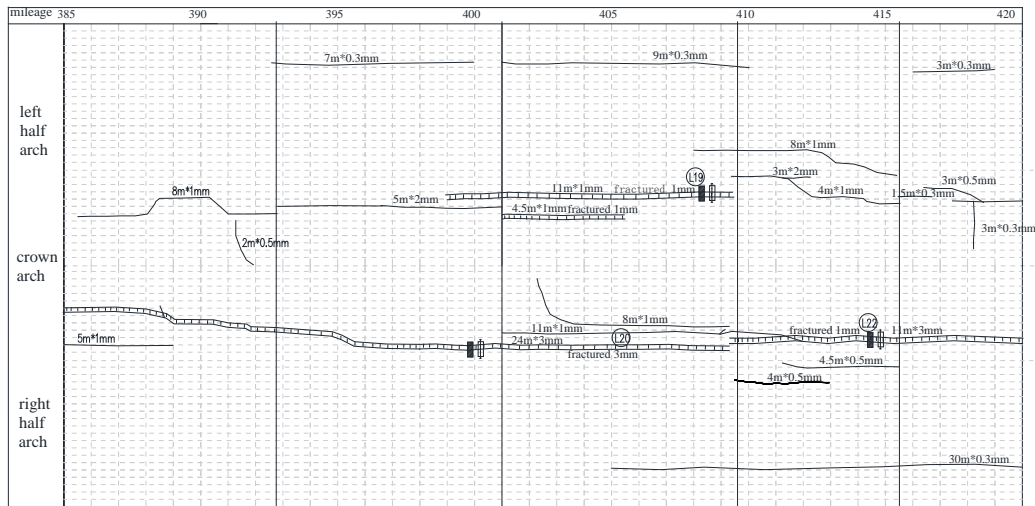
Figure 5 The distribution of imperfections and damages on tunnel lining at DIK68+385-420 (cracks are majorly longitudinal found at the intrados of tunnel arch shoulder)

very easy to cause a tensile crack due to the low tensile strength of the lining concrete. This results highly coincides with observed result in Figure 3 and Figure 5.

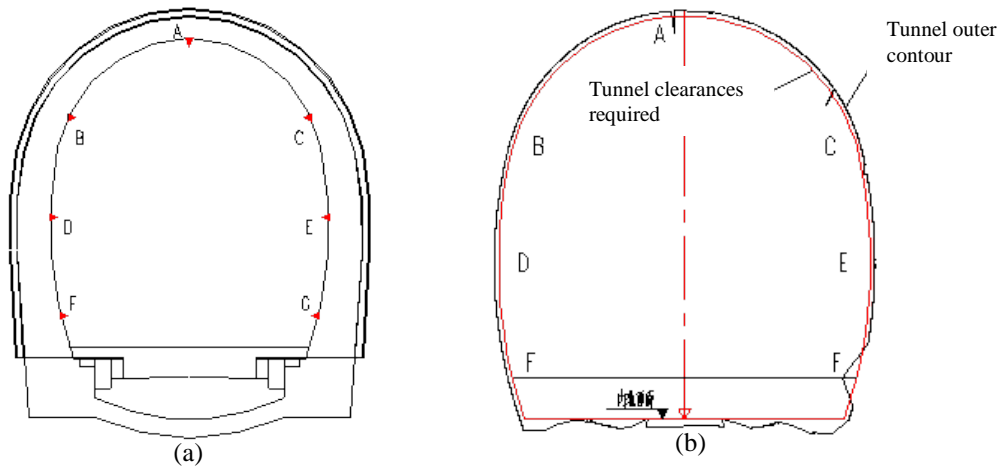
Figure 6 shows the monitoring of the tunnel clearance. Seven points at each transverse cross section was measured to obtain the tunnel lining inner profile, as shown in Figure 6 (a). The measured results of a typical section was shown in Figure 6 (b). It was found most of points

along the tunnel contour have sufficient surplus space compared with the required clearance while only individual points intrude in the required railway clearances. It is suggested that rehabilitation measures could be take place at the surplus tunnel space outside the clearances. However, attention should be also paid to those individual points already inside the clearance profile.

Figure 6 Monitoring of the lining clearance; (a) distribution of monitoring result; (b) measured lining profile

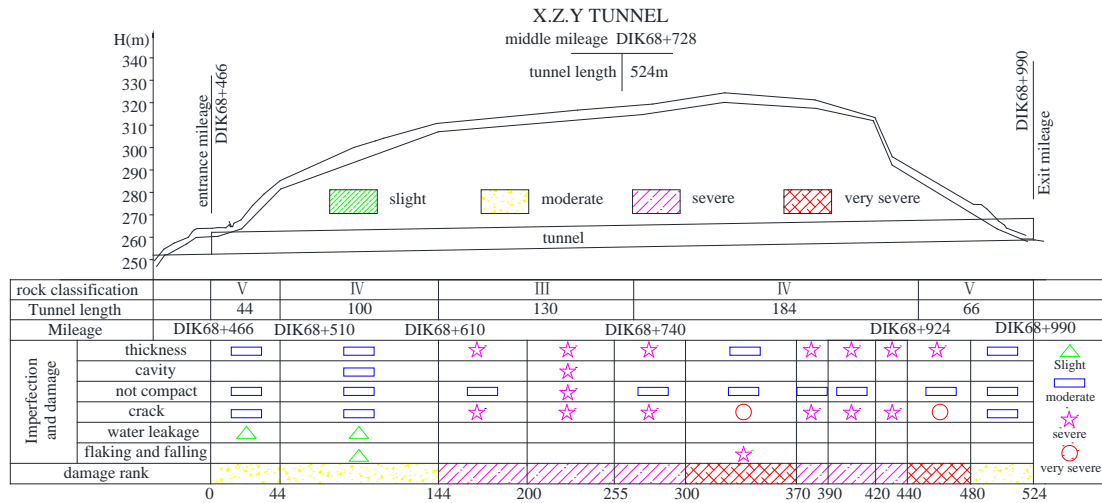
Based on the distribution of lining imperfections and damages, surrounding rock grade, ground water condition and safety for operation, the lining damages can be divided into five categories: intact (A1), slight (A2), moderate (A3), severe (A4), very severe (A5). The evaluated tunnel damage categories at each element blocks were presented in Figure 8. It is clear that most of the tunnel lining has undergo a severe damage. Table 3 summarized the overall damage categories of X.Z.Y tunnel into very severe. There two block sections abot 110 m was assessed into the very severe damage category which is 38.4% of the total length. More than half of the tunnel overall length was categorized into severe damage. Hence, concrete rehabilitative measures should be took to reinforce the tunnel lining.

Figure 8 Damage categories along X.Z.Y tunnel longitudinal section

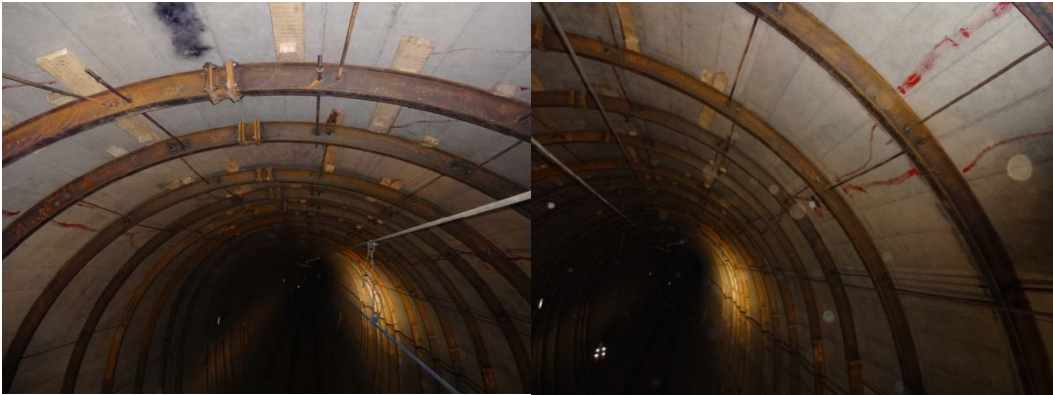
Figure 11 Temporary steel-rib arch for supporting vert severe damaged lining section

Two stages of measures were carried out to rehabilitate the tunnel lining imperfections and damages. In the first stage, the running speed of the railway was reduced to 80km/h ; and then temporary steel-rib archs were placed for supporting tunnel lining where were evaluated as very severe damaged (mileage of DIK68+324-370 and 440-480). Figure 11 shows the photos of the steel-rib archs taken on site. This temporary support ensures the safety of railway operation during day time and the rehabilitation work in the night time.
