ADVANCED MASTERS IN STRUCTURAL ANALYSIS  
OF MONUMENTS AND HISTORICAL CONSTRUCTIONS

# Master's Thesis

**Investigation of damage and repair  
of masonry piers affected by fire in  
the church of Santa Maria del Mar  
in Barcelona**

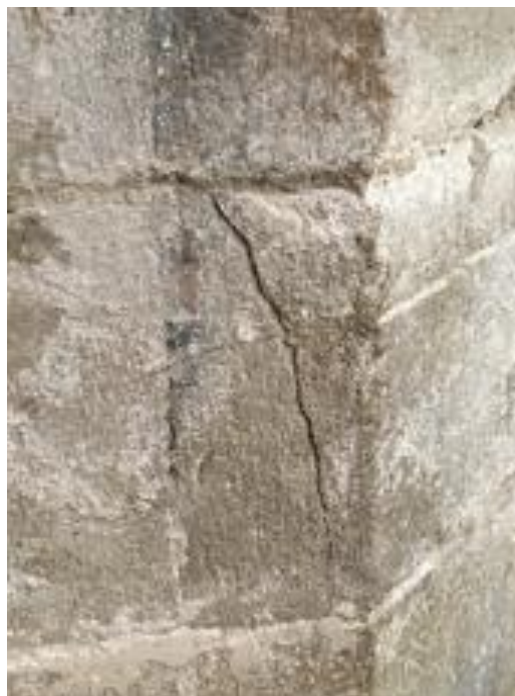
One type of damage observed in the pillars of Santa Maria del Mar is vertical cracks that are contained in a single masonry block. Some of these cracks have a slight diagonal inclination as shown in Figure 8. This particular crack is located near the edge of the face. The single unit vertical cracks tend to be located near the edge or in line with the mortar joint of the stones above and below. It should be noted that the vertical cracks contained in one unit were far less common than the vertical cracks that crossed many units.

Figure 8: Single block crack

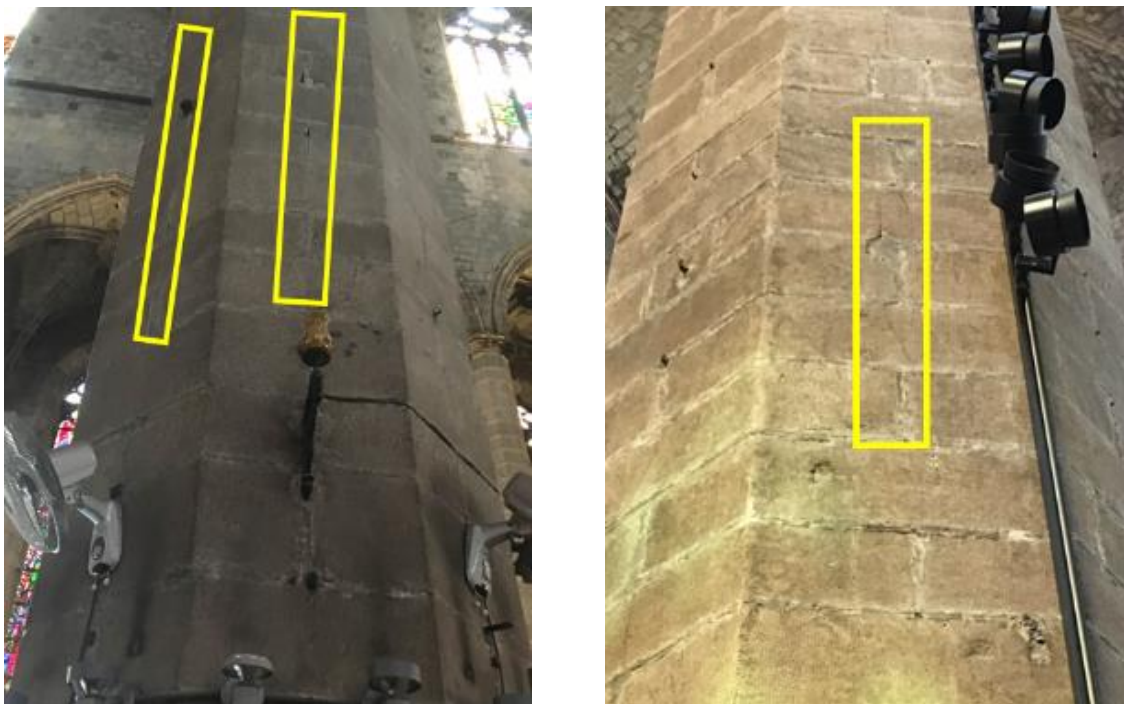
One of the most prominent damages observed is the presence of vertical cracks that extend through multiple masonry blocks. These cracks are consistently located around the mid-height of the pier and extend often through five or more masonry units. This type of crack is found in the center of the pillar face and aligns with the mortar joints that occur on the center of the face in alternating units. These vertical cracks are often found at the same height on successive faces of the same pier. They are a common phenomenon, occurring on four of the eight piers of the main nave. It is important to note that the cracks occur at approximately the same height on each pier.

Figure 9: Multi-block vertical cracks (left) shows successive faces

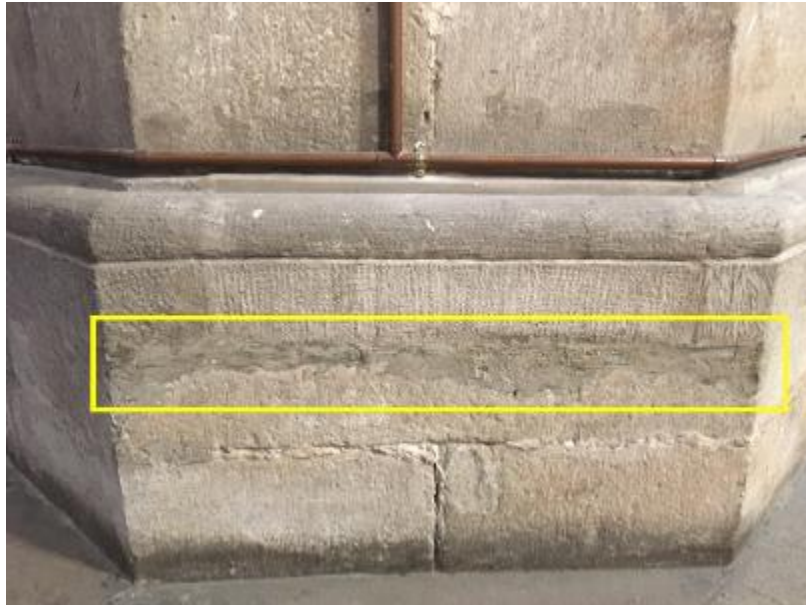
Horizontal cracks were observed in the base stones of two piers, 3 and 5. They occur around the mid-height of the stone, and in the case of pier 3 are found on multiple successive faces.

Figure 10: Horizontal base crack in Pier 3

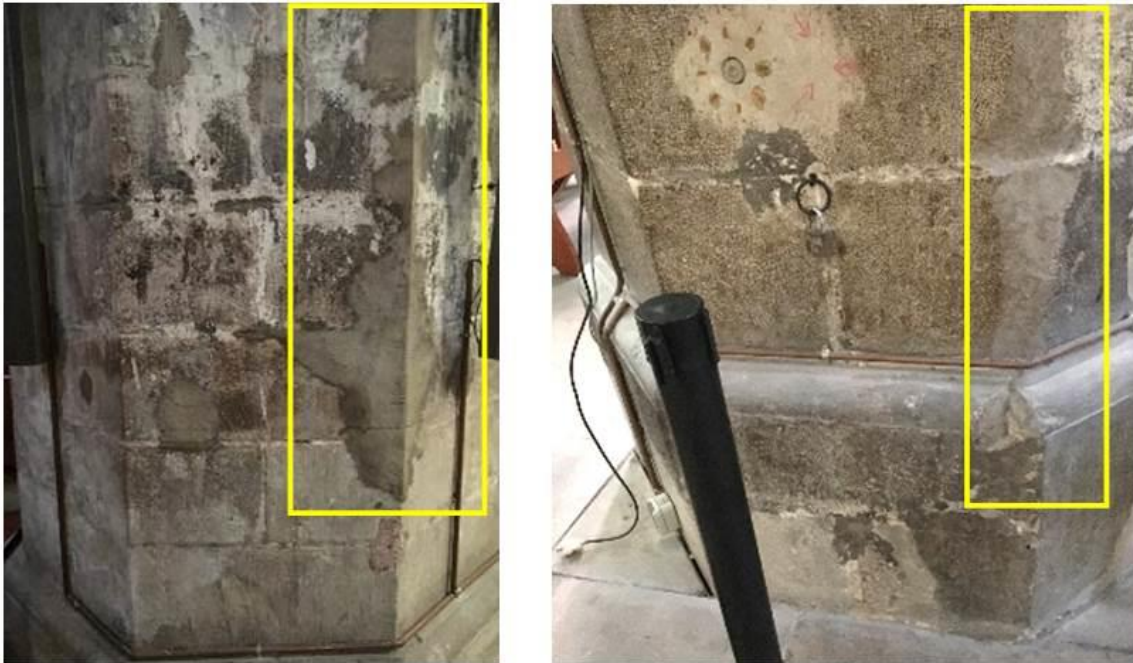
Another widespread damage typology found on the pillars is spalling of the masonry at the corners of the faces. Often the spalls extend through many units. While spalls also occur on the pier faces, they are most prominent on the corners - the least confined area of the pier. In most cases, the spalls are patched with a Portland Cement repair as shown Figure 11 (left), however some are also still exposed as shown in Figure 11 (right). In some cases, the Portland cement repairs have also spalled from the pier due to inadequate bonding between the repair material and the sandstone. Sometimes, corroded iron connecting elements are left exposed after the repair material has spalled. Spalling is one of the most common damages and is found on every pier with varying severity.

Figure 11: Spalling (left) patched, (right) unpatched

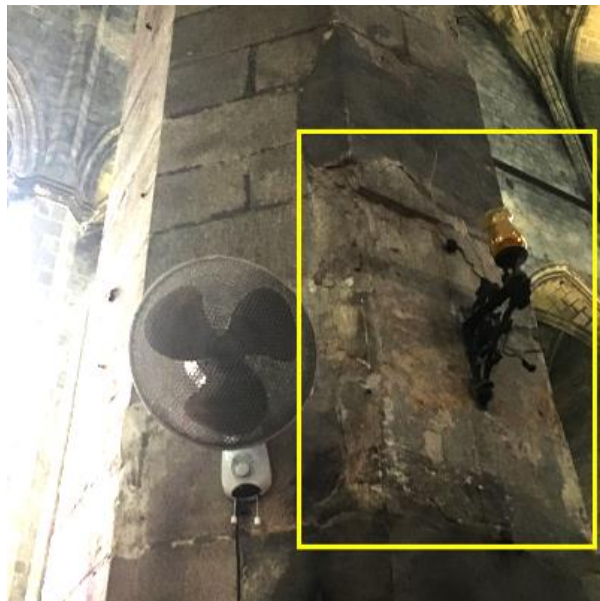
Sheeting, also known as scaling, is the spalling or loss of material in even sheets or planes. This occurs both on the faces of the piers and at the edges. Most of the sheeting observed extends across the surface of multiple blocks. The depth of the material loss is between 2 and 6 cm. Often areas of sheeting are adjoined to areas of more uneven spalling.

Figure 12: Sheeting damage on Pier 2

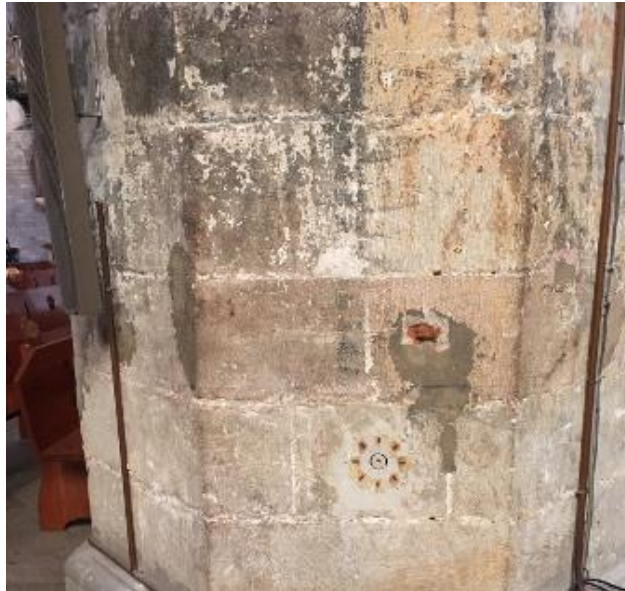
Color change of the stone was visible on most of the piers, but was most significant on Pier 3. Colors observed were pinks, yellows, and darkening such as greys and browns. Black soot coating was also observed but will be addressed separately. As shown in Figure 13 multiple color changes could be observed in a single area such as the one shown in Pier 3.

Figure 13: Color change on Pier 3 (note reds, yellows, and darkening)

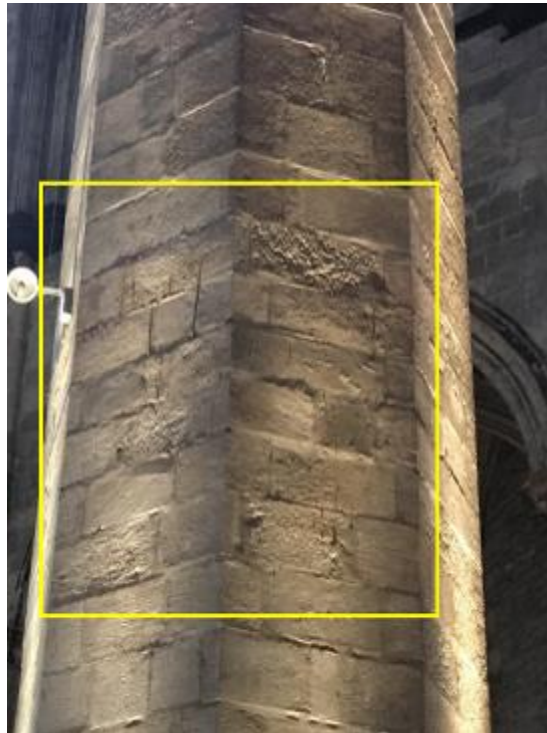
A pitted texture on the surface of some stones was observed on many of the piers in the choir and in Piers 4 and 5. As can be seen in Figure 14 this damage tends to be confined to a single stone, but occurs on the surface of multiple stones in the same area.

Figure 14: Pitted texture on choir pier

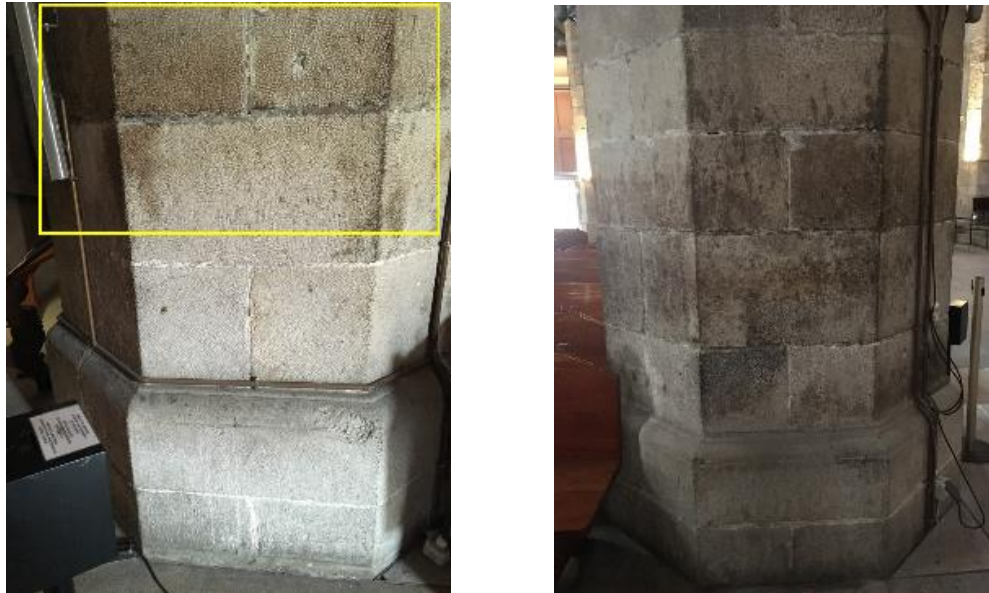
Often dark staining is found on the piers in speckled pattern. It is more frequently observed on the lower portion of the piers. It is most likely a residue on top of the stone and not a color change of the stone itself.

Figure 15: Speckled staining (left) Pier 1, (right) Pier 8

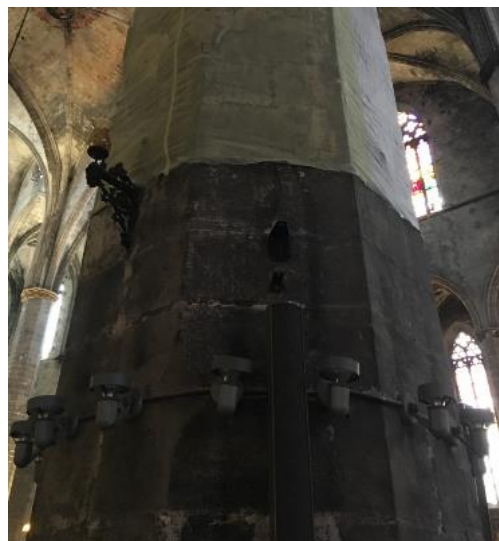
Dark black soot accumulation is found on many piers. It usually covers large areas across many stones, however small patches of soot are present too. In many cases, the soot layer is partially spalled from the pier. It is likely that the soot coverage was more widespread immediately after the fire, but some has been cleaned or spalled from the surface.

Figure 16: Soot accumulation on Pier 7

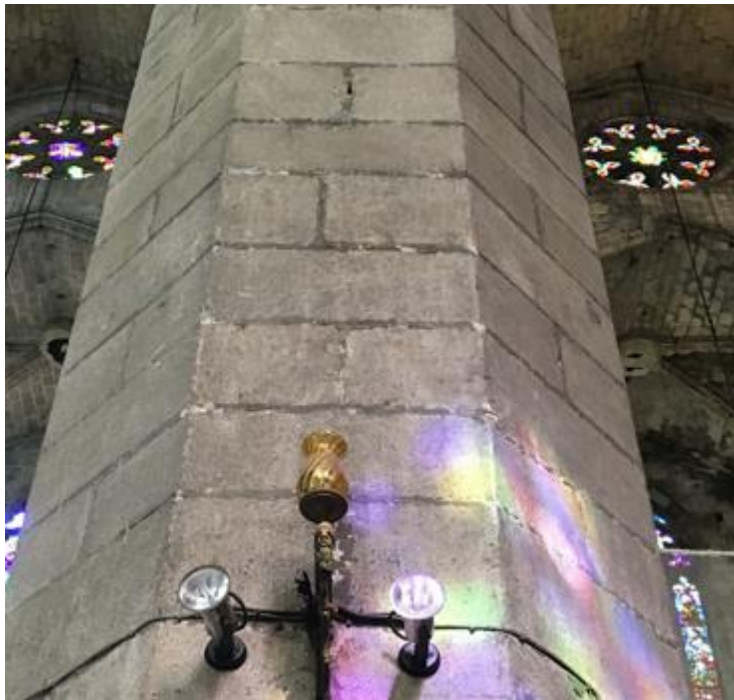
Joint repointing is found on all of the piers and ranges from isolated areas in some to almost the entire pier in others. It has a darker color than the original mortar and is often found bulging outside of the joints.

Figure 17: Joints repointed with Portland cement mortar (note darker color)

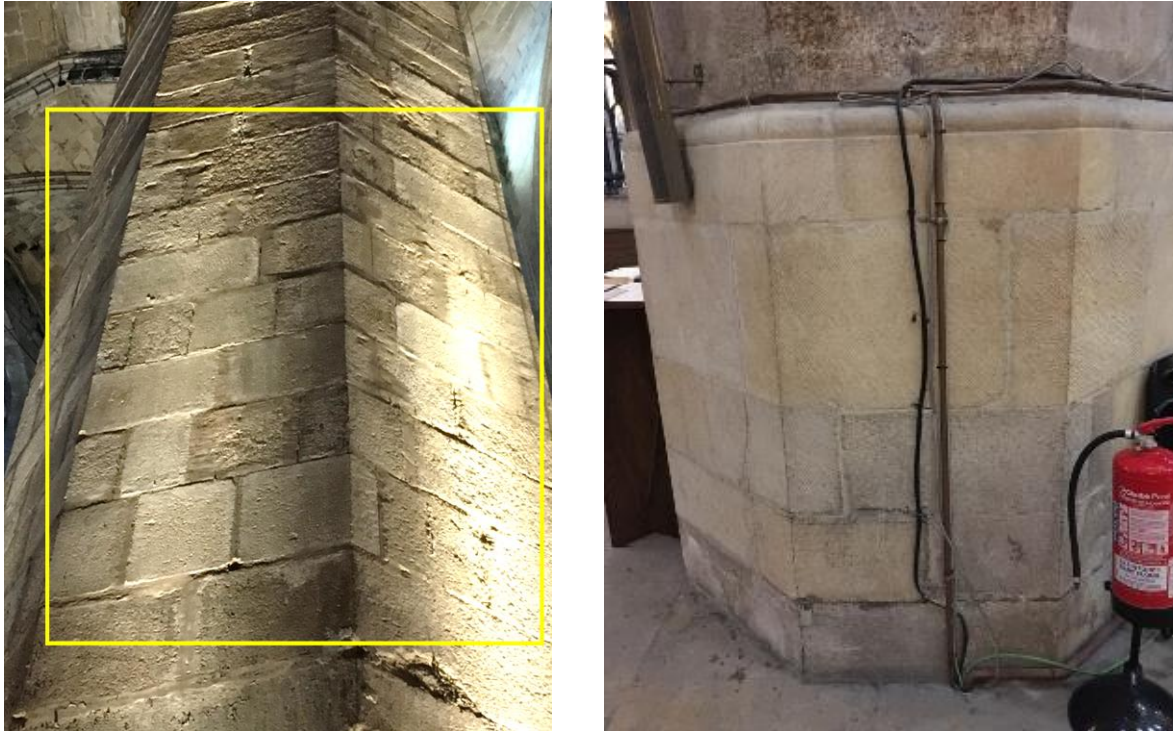
Stone replacement is observed on some of the piers, especially at the bases and around the mid-height of the piers, usually around the corners. It is visible as a break in the typical masonry pattern of the pillars. Stone replacement is especially common on the piers of the choir. The depth of the

replacement and bonding to the original material are not known. These repairs can also be hiding significant damage.

Figure 18: Stone replacements in choir (left) mid-height, (right) base

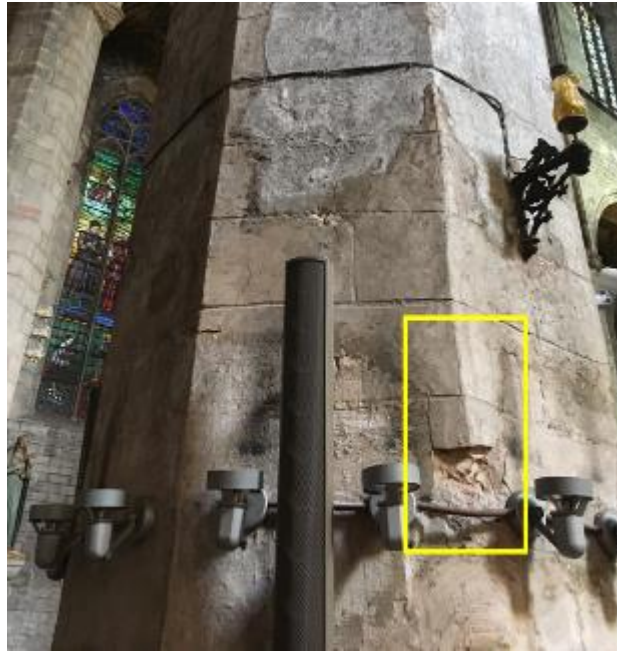
Cracking is noticed in most of the repaired sections. Many of these cracks are likely shrinkage cracks and are only superficial, however some of the larger cracks could indicate structural problems or weaknesses.

Figure 19: Cracks and spalls in Portland cement repair

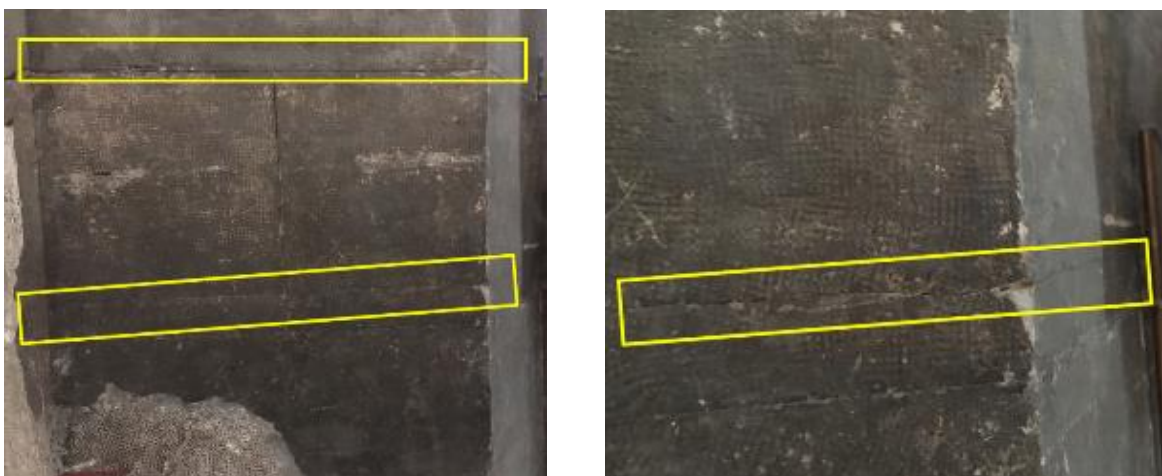
One specific cracking pattern in the Portland cement repairs is long horizontal cracks occurring near the base of successive stones in large areas of repair. This trend is noticed on Pier 2.

Figure 20: Horizontal cracks in Portland cement repair Pier 2

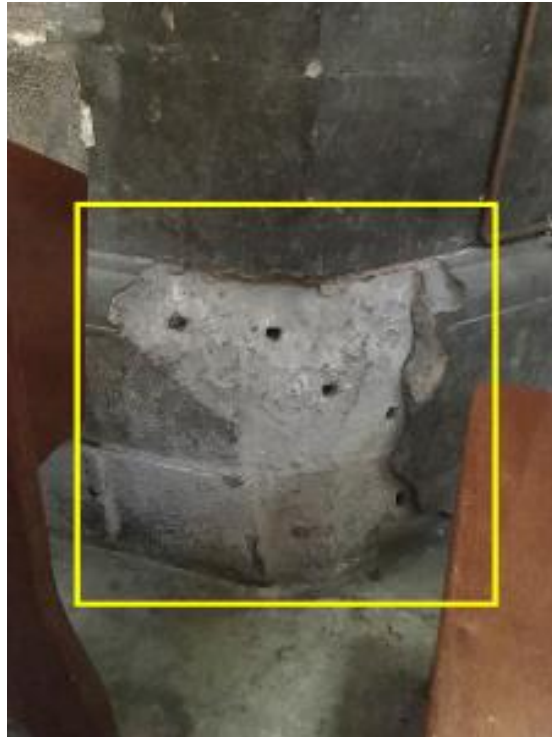
Crusting, or the spalling of a “sheet” or layer, of the repair material is a common phenomenon. This is especially true at the bases of the piers, which are in more direct contact with human activity and are more likely to be touched, bumped, come in contact with the pews etc.

Figure 21: Crusting of repair at base

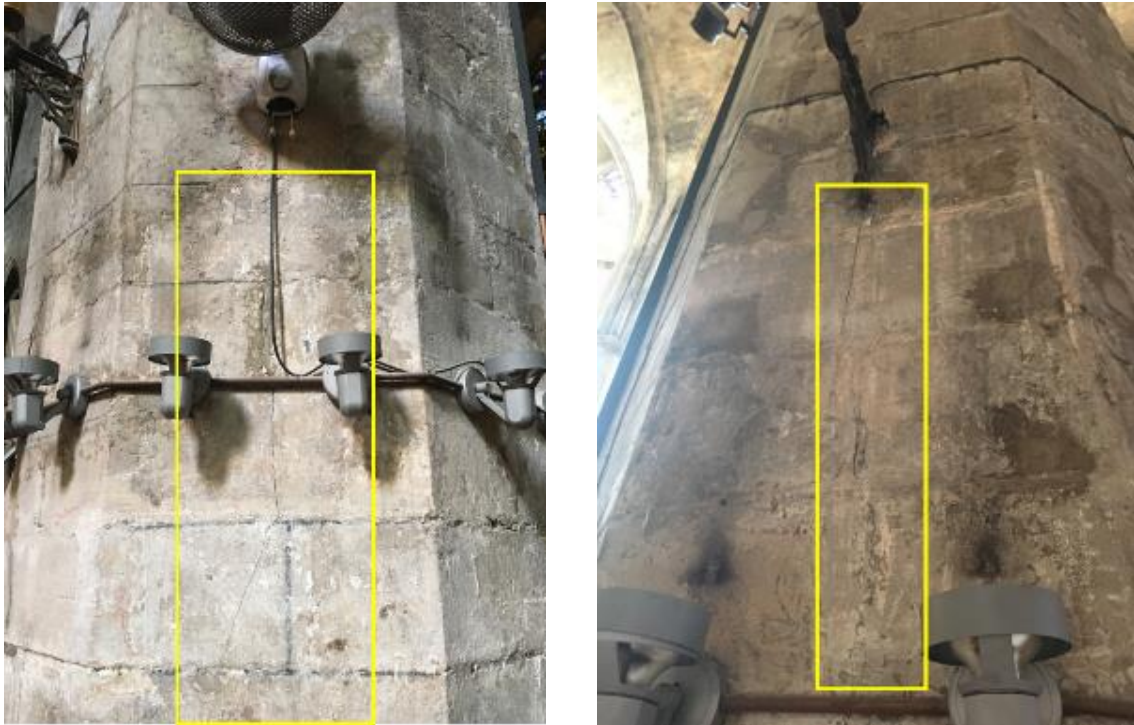
Another type of multi-block vertical cracks is identified to occur below fixtures mounted in the pillars such as lights and fans. The depth and severity are not known. While the candle holders could have been present during the fire, the fans and electrical installations were not, so the cracks occurring due to these are post-fire damages.

Figure 22: Cracks below fixtures

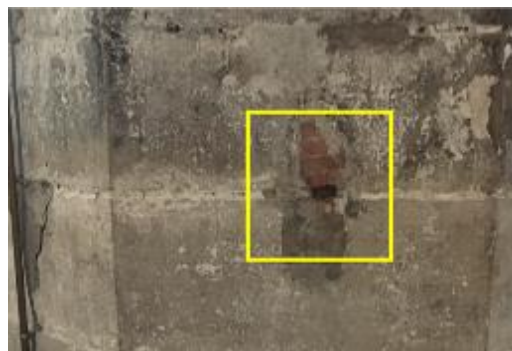
Brick additions with iron connection elements are found on many piers, they were likely an intervention to allow mounting an object to the pier. Today, the iron elements are corroding.

Figure 23: Brick mount with corroded iron

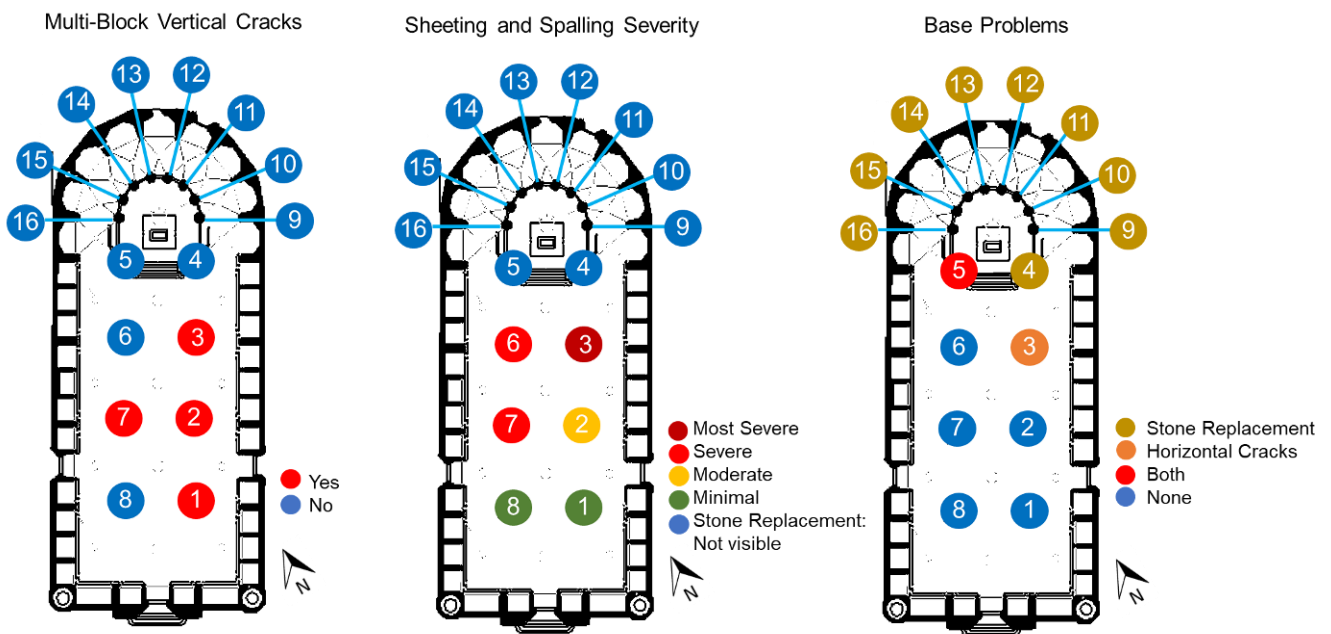
After the documentation of the damages and the damage mapping and classification, they were analysed to understand what conclusions could be drawn about the fire and the distribution of the destruction in the church. Figure 25 presents in plan view the distribution of three types of damage phenomena that could be the most consequential: the multi-block vertical cracks, sheeting and spalling, and problem in the base which include significant cracking, material loss, and replacement stones. It can be seen from the sheeting and spalling map that the most severe damage occurs in piers 3, 6, and 7. It is also likely that piers 4, 5 and the piers of the choir suffered a large amount of

spalling and material loss, as these piers have a high concentration of replacement stones suggesting previous damage. This indicates that the greatest amount of damage occurred in the choir and the piers closest to the choir, suggesting that as the center of the actual fire event. The map of the columns with problems in the base also indicates this pattern. It should be noted that the bases of the choir piers were all rebuilt likely due to their damaged condition. When looking at the map of the multi-block vertical cracks, it can be seen that this damage does not follow the same location pattern. In fact, this damage was not observed in any of the piers of the choir or the closest piers of the nave, the locations where fire damage has been the worst. Also, these cracks were observed in Pier 1, which suffered almost no other damages due to the fire. Considering their distribution away from the majority of the fire damage, and their height on the piers, above most of the damage and direct contact with flames; this further analysis suggests that perhaps the multi-block vertical cracks are not due to fire. Their true cause will be further explored in Chapter 10.

Figure 26: Damage type and location summary

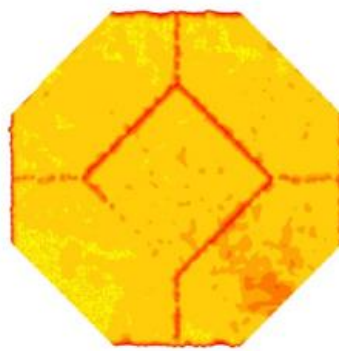
damage. Some superficial deterioration was identified, possibly caused by the fire of 1936. (Roca et al., 2008)

Figure 27: Seismic tomography image showing internal composition of piers
