INLET FOGGING AND OVERSPRAY IMPACT ON INDUSTRIAL GAS TURBINE LIFE AND PERFORMANCE

Klaus Brun, Ph.D.
Manager
Southwest Research Institute®
San Antonio, Texas, USA

Rainer Kurz, Ph.D.
Manager
Solar Turbines, Inc.
San Diego, California, USA

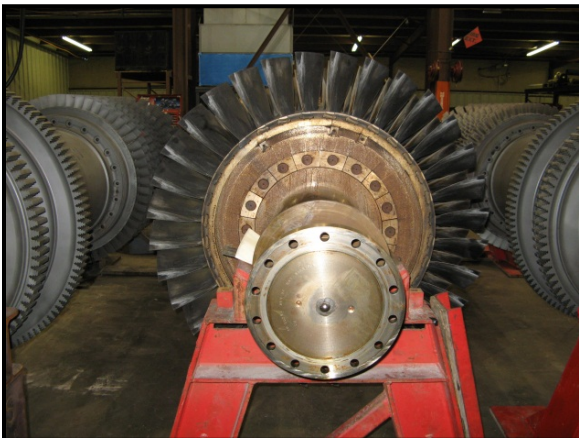
Figure 2. Rotor of GE 5002 Gas Turbine Prior to Overhaul

The above information (along with a previously performed water chemistry analysis) allowed for the analysis and determination of sources of deposits and corrosive agents inside the gas turbine (i.e., sources of undesired constituents that cause damage and degradation to the gas turbine during fogging, washing, and normal operation). Results from this investigation can then be further utilized in thermodynamic performance, life, and degradation studies. The results of the visual inspection and material analysis of the fouling deposit for different rows of one of the GE 5002 rotor are discussed below. Figure 2 shows a picture of the assembled rotor that was analyzed.

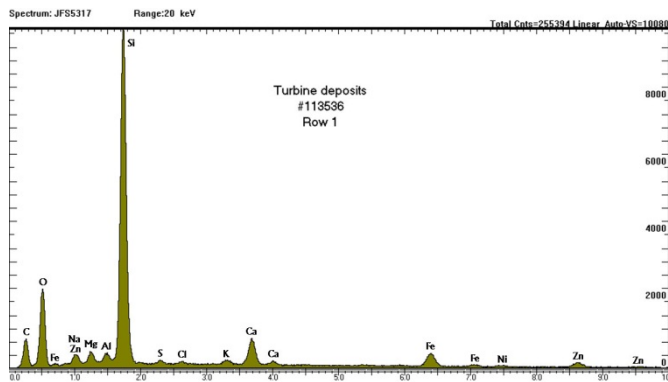
Figure 3. Compressor Deposits in Row #1

Deposits collected for each stage of the rotor were chemically analyzed for their constituents using Spectrum Analysis. Example results for blades from rows 1, 4, 11, and 16 are presented in Figure 3 through Figure 6. Figure 3 shows the composition of the deposits analyzed at the compressor row 1. A very high concentration of silicon is observed and low chloride (salt) quantities are seen. This is an indication of dirt deposits and, thus, for incomplete or inefficient inlet air filtration or inlet duct leaks. Filter saturation (discussed below)

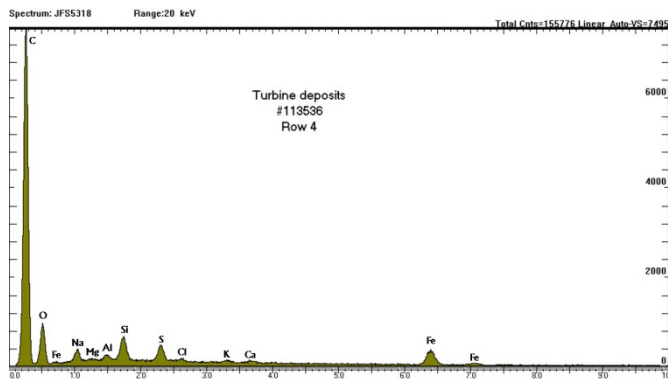
Figure 4. Compressor Deposits in Row #4

Deposits on blades in row 4 showed a high concentration of carbon deposits as shown in Figure 4. The chemical analysis performed for this study cannot distinguish whether this carbon is an indication of oils and waxes or pure carbon deposits. However, based on the visual examination, it is apparent that these are pure and hardened carbon deposits and not oils. These carbons are usually due to the ingestion of exhaust fumes from another combustion turbine or other internal combustion engines. Although these are hard to remove (once fully hardened onto the blade), they do not generally cause any significant performance degradation impact. Hardened carbon deposits in the first couple of compressor stages are also an indication that the compressor on-line and off-line water washing program is not effective.

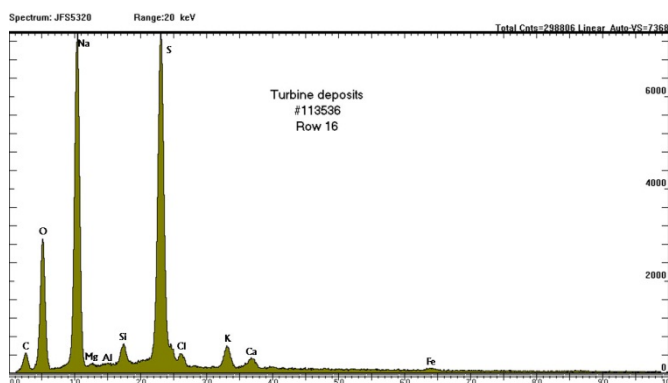
Figure 6. Compressor Deposits in Row #16

Figure 6 shows the blade sample composition found on the row 16 blades. Both sodium and sulfur are present in high amounts. The salt is likely due to redepositing of upstream salts during on-line water wash, but the origin of the sulfur is not clear. Typically, sulfur deposits in gas turbine axial compressors are found when the unit operates in an industrial area with high ppm sulfur content in the air. However, in the case of subject site, the sulfur (in combination with the carbon deposits) is an indication that the gas turbine inlet is subjected to exhaust gases from itself or from other gas turbines that operate with a sulfur-containing fuel gas (as is the case here). Sulfur, in combination with moisture, leads to aggressive sulfurization corrosion. In the combustor and hot turbine section, sulfur compounds can cause hot corrosion.

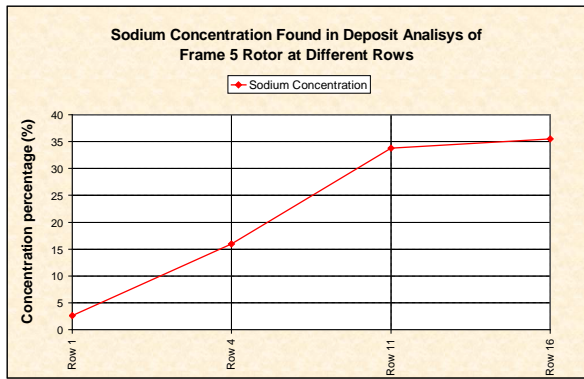
Figure 7. Concentration of Sodium in Different Compressor Rows

Blade surface erosion pitting is seen throughout the rotor, but the most severe is evident on compressor stages 10-15. This is consistent with the chemical analysis that shows highest salt deposits in the downstream stages. Figure 7 shows the concentration of sodium deposit as a function of blade number. A clearly increasing trend is observed.

Generally, all salts should be avoided in a gas turbine, and usually most salt deposits are found in the first stages of a compressor. In the subject case, the highest salt concentration is downstream in blades where even off-line washing is ineffective. The likely mechanism of these formations is as follows:

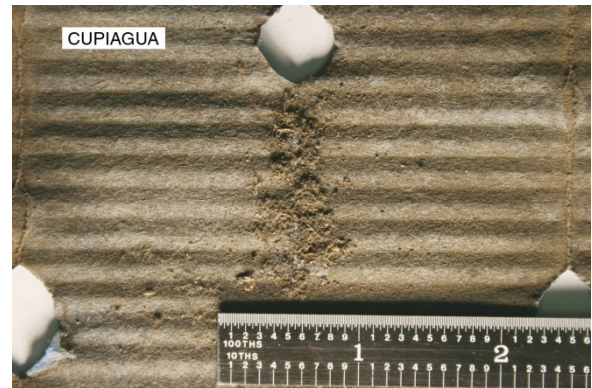
Figure 8. Inlet Filter Sample

differential pressure exceeds the original-clean differential by 1.0 to 1.5 inches of water. In tropical environments, as is the case at the site investigated, there is a significant potential for filter media saturation. This is caused by (frequent, heavy) tropical rain wetting the dirty filter media which then allows the smaller dirt particles to be carried through the inlet filter pores with the moisture. The increased pressure differential across the filter caused by the sealing effect of the moisture enhances this process. Eventually, dirt will be present on both sides of the porous media filter and will be released into the gas turbine inlet with every subsequent rain event. The problem can be mitigated by improving the weather protection of the inlet filter housing using vanes, covers, or hoods.

- Inlet filter samples analyzed show dirt saturation and dirt carryover. This is likely caused by insufficient filter weather protection, cleaning, or replacement of the filter cartridges. Blade deposit samples of the first couple of compressor rows showed sand (silicon oxide) constituents, which is consistent with this observation.

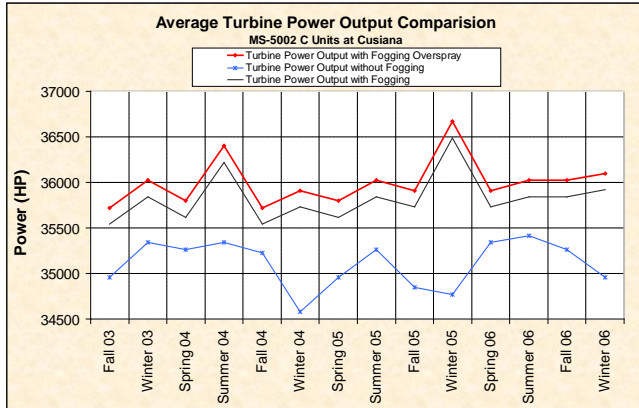
Figure 9. Average Turbine Power Output Comparison with Fogging and Overspray

Figure 9 shows an example of the predicted maximum power output of the 5002C gas turbine without fogging, with dry-fogging (99.5 percent saturation) and overspray fogging (102 percent saturation) operation. An increase of power between 1.5 percent and 5.1 percent (depending on ambient

conditions) is achievable with dry fogging versus no fogging. However, the overspray fogging is seen to only provide a marginal benefit of less than 0.8 percent additional output power over dry fogging. Figure 10 shows the gas turbine's efficiency increase of fogging versus no-fogging. A very marginal (less than 0.5 percent) power increase is seen. Namely, fogging and overspray do provide a power boost but do not significantly improve efficiency. Also, the small relative benefit of overspray versus dry fogging operation should be evaluated in light of the significant amount of blade corrosion and, thus, performance degradation, the overspray is causing.

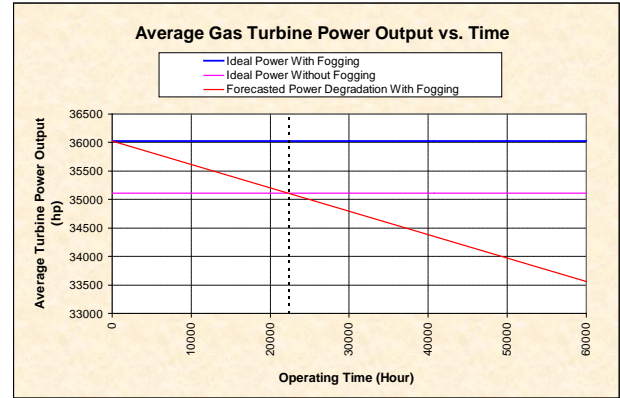
Figure 11. Average Gas Turbine Power Output vs. Time

Results of this study, shown in Figure 11, demonstrate that after approximately 22,000 hours of operation with full overspray, the gained power has been negated by blade degradation. Thus, over a typical rotor life of 60,000 to 70,000 hours, the net cumulative power due to overspray is a negative. One should note that this statement applies to overspray and

clearly not to dry fogging. As long as all water is evaporated prior to entering the compressor inlet (i.e., no droplets), blade erosion due to water should be minimal.

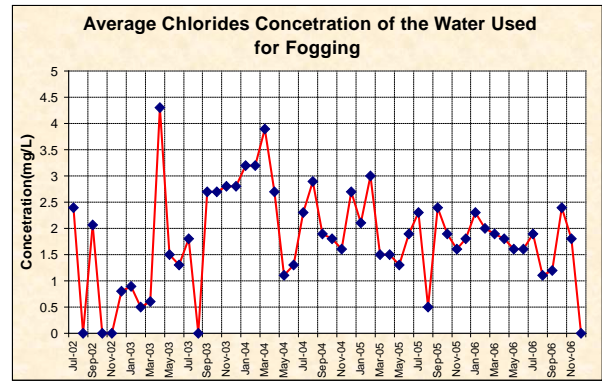
Figure 12. Average Chlorides Concentration of the Water Used for Fogging

Figure 12 shows a graph of the chloride concentration in the water utilized for fogging (from the site water analysis). Typical values range in the below 4.5 mg/L range.

Given the water spray rate during normal fogging/overspray operation and assuming typical deposit efficiency, the total accumulated deposits over extended periods can be determined. Results show that each gas turbine ingests about 1,000 g of chlorides per month and about 200 to 400 g of these form deposits. Significant amounts of salts are, thus, seen to enter and possibly deposit inside the compressor. Some of these salts will form deposit layers that can subsequently break off in larger pieces and can cause downstream damage and degradation in the hot section turbine (including the potential for cooling passage plugging). These chloride deposits lead directly to blade surface fouling, corrosion pitting, and even rotor unbalance. Thus, the combination of continuous fogging, overspraying, and the use of not completely clean water are significant contributors towards performance degradation of the gas turbine.
