Unstable Reading of Accelerometers in Cryogenic Service

RasGas

Project Engineer
Ebara International Corp
Cryodynamics Division

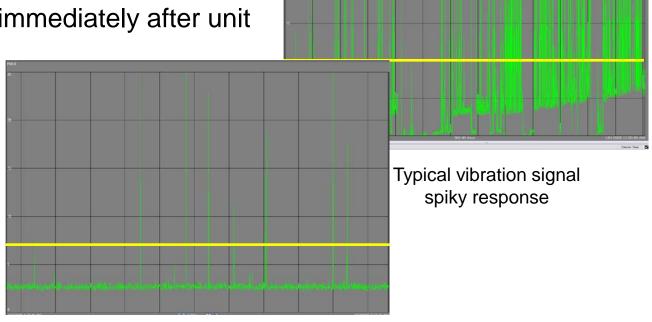
Time zoomed signal

- Three modes of sensor response were identified during operation:
 - Spiky signal response without sensor failure after time in service

Spikey signal response with sensor failure.

Sensor failure immediately after unit put in service

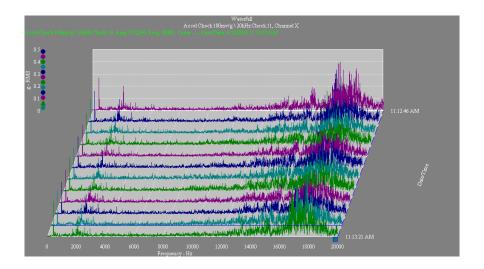
Old accelerometer with high frequency 18KHz excitation

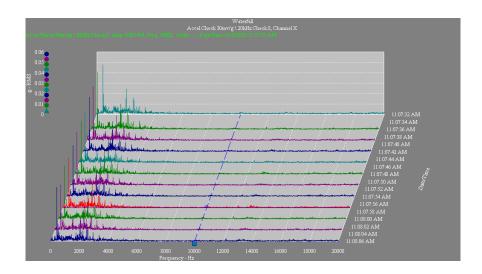
New accelerometer without high frequency excitation

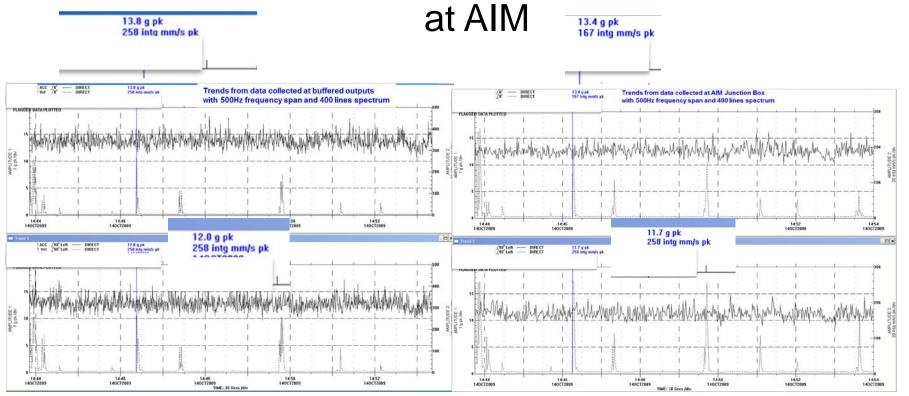
Time base and spectrum of vibration excursion

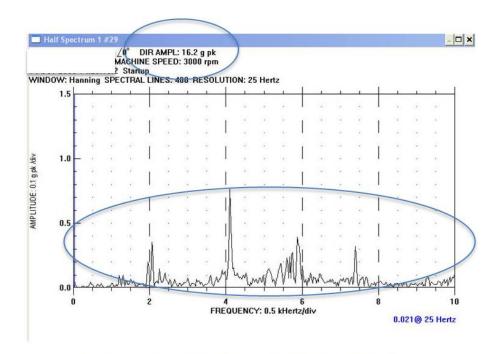
Spectrum from data collected at AIM Junction Box with 10000Hz frequency span and 400 lines spectrum

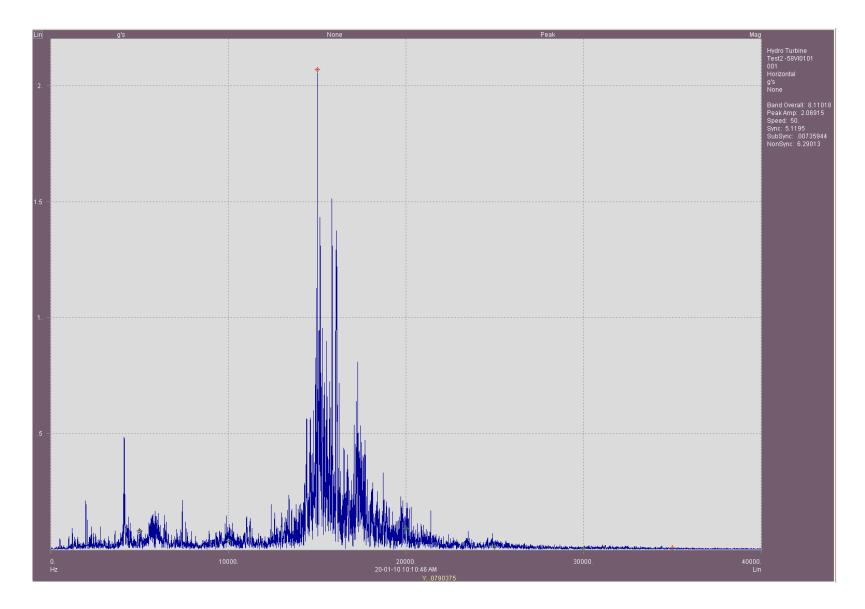
- Data collected with a 10 KHz frequency span (FS) shows that most of the energy its generated at higher frequencies.
- New set of data was collected, using a 40 KHz FS, confirmed that most of the vibration energy is being generated around 15KHz. This frequency is very close to the specified accelerometer mounting frequency (≥12KHz).
- The vibration excursion is caused by the system being overloaded when the natural frequency of the accelerometer is being excited
- With this information a prototype accelerometer was developed between OEMS and RasGas.

Spectrum from data collected at AIM (field) with a FS of 40KHz
