# RESOLVING STRUCTURAL VIBRATION ISSUES ON A WATER FLOOD PUMP

Nicolas Péton, Sergey Drygin,  
Dmitry Leonov

This case study is designed to outline how the high vibration issue of two Water flood modules was successfully diagnosed, the root cause for the high vibration and finally how it was mitigated using some structural analysis techniques.

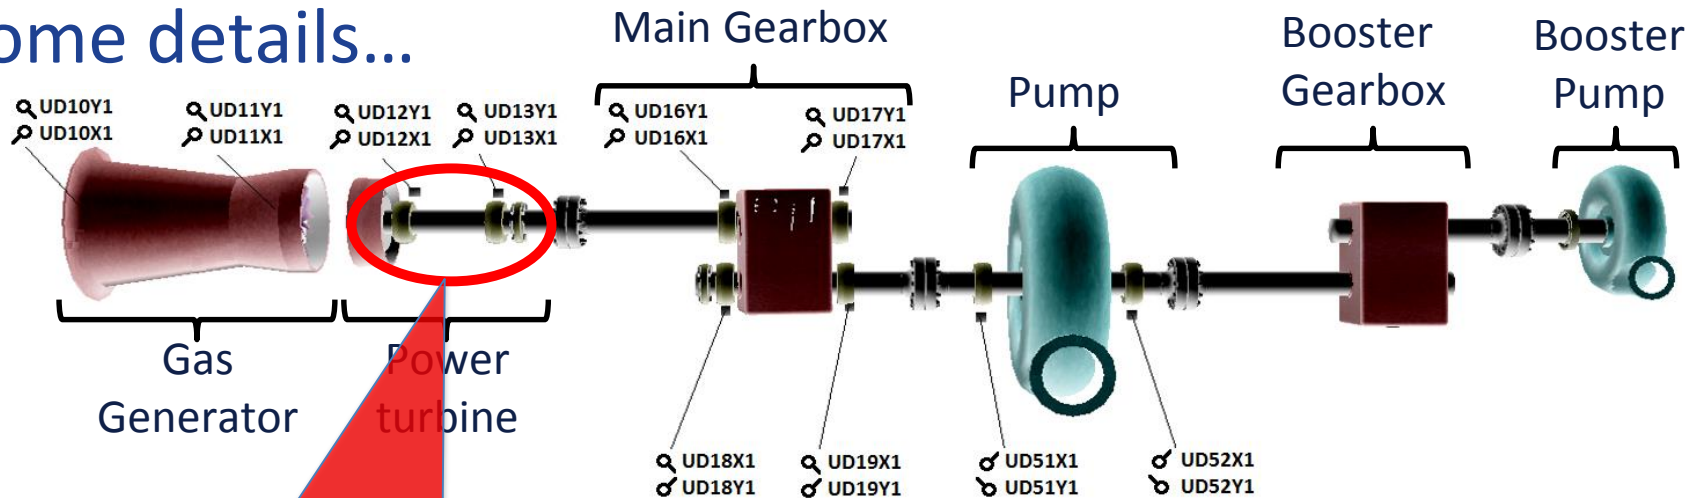
**Power Turbine**  
 High level of Shaft  
 relative vibration  
 > 90 um pp (3,5 mils)

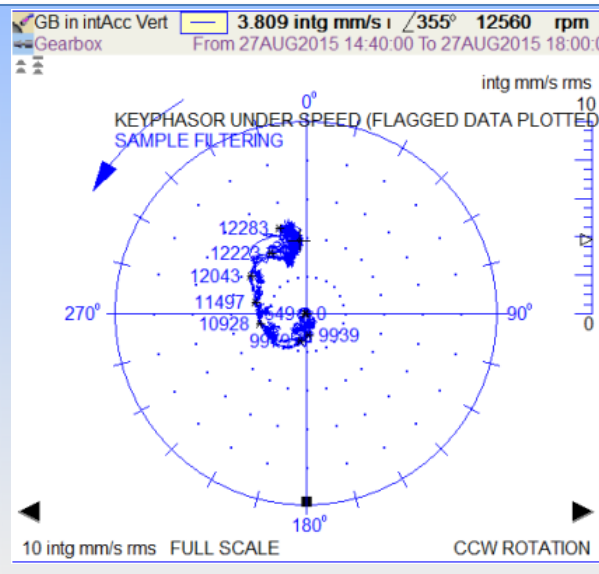
Over 160° phase shift – well above resonance

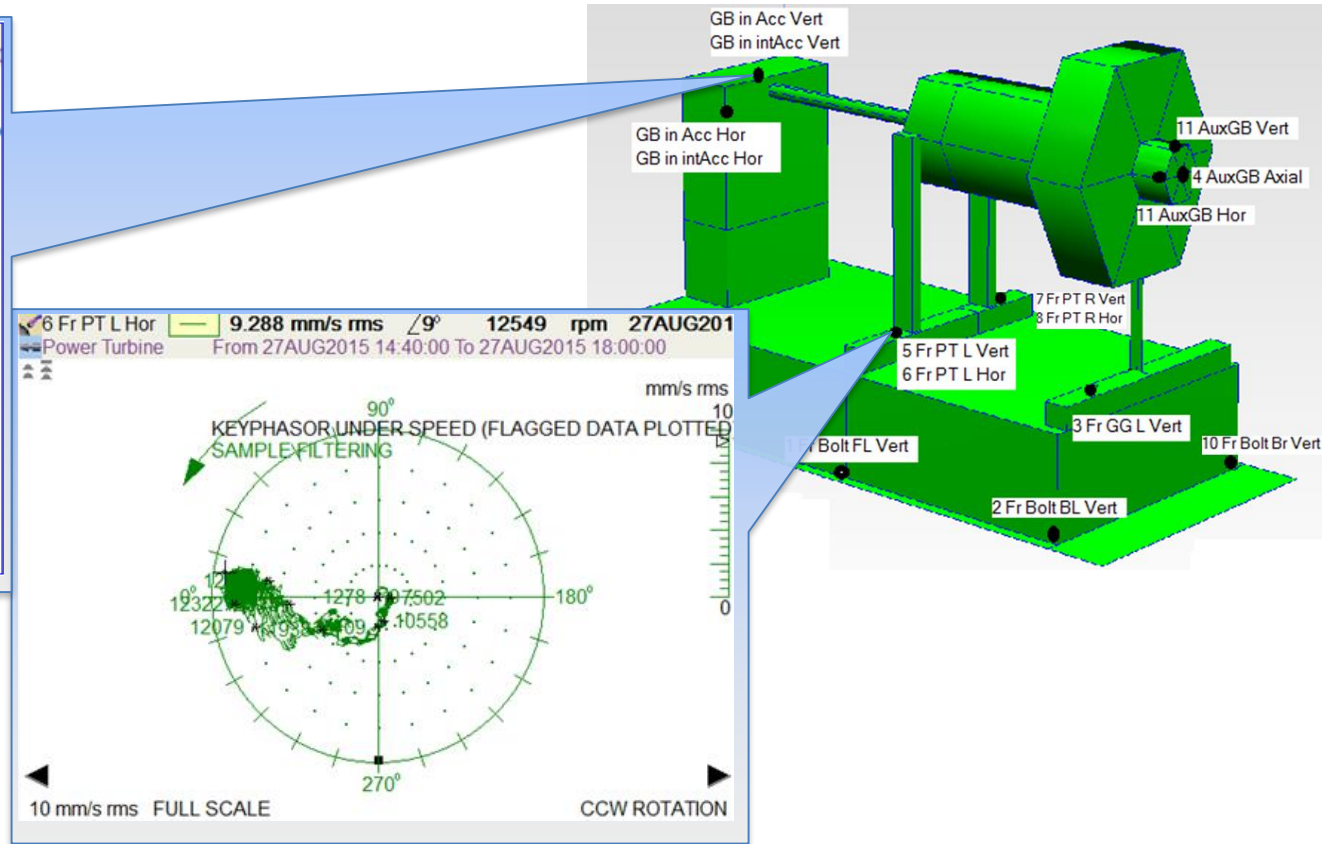
Close to 90° phase shift – on resonance

- the dominating frequency component for the Main Gearbox Shaft relative and casing vibration was the 1X rotational speed of low speed shaft,
- the Power Turbine Support Casing vibration Polar plots shows vibration amplitude grows, starting at speed 12000 rpm and approx. 90° phase shift from low speed to 12500 rpm,
- this indicates rotor is operating on or close to the Power Turbine supporting system resonance frequency.

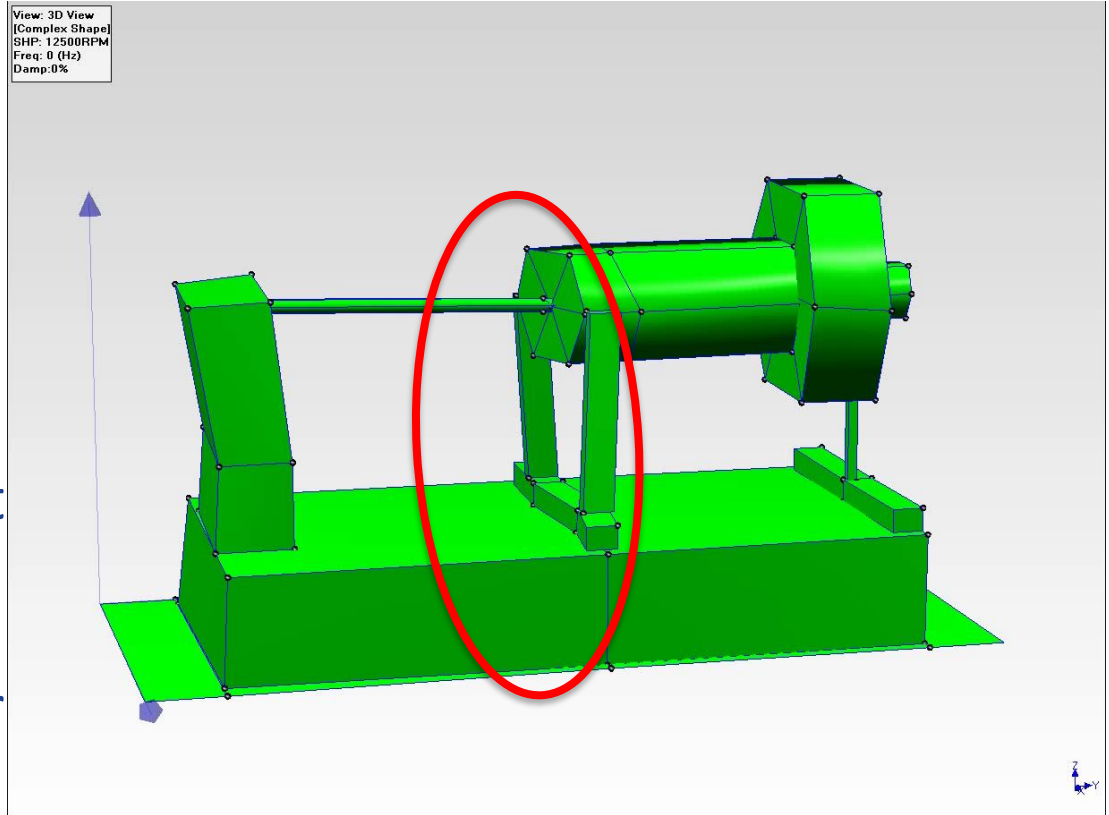
12500 RPM mode shows clear picture of Power turbine Drive end side supporting system resonance.

This PT Drive end side supporting system movement can be the result of supporting system stiffness degradation, or lack of supporting system or frame design.
