ASIA TURBOMACHINERY & PUMP SYMPOSIUM  
MARCH 2018 | SUNTEC SINGAPORE

# Resolving High Vibration On a Vertical Pump

Baker Hughes, a GE Company

Saudi International Petrochemical Company

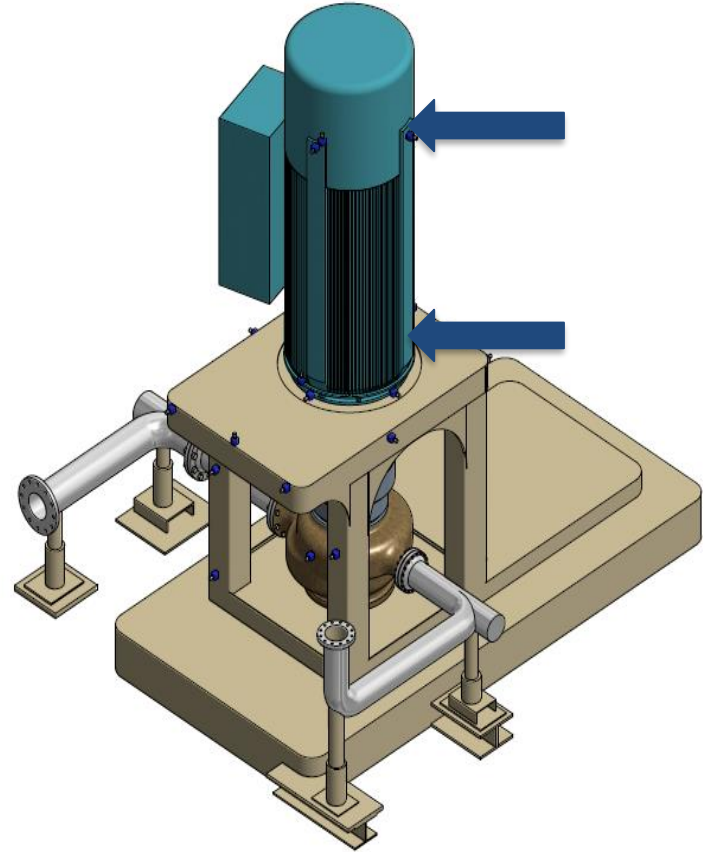
- High overall vibration levels with 1X motor dominant frequency
- Transient Start-Up / Shut-Down data showed that the unit is running well above the 2nd critical speed
- **The highest amplitude while passing the 2<sup>nd</sup> critical frequency (70 mm/sec Peak)**

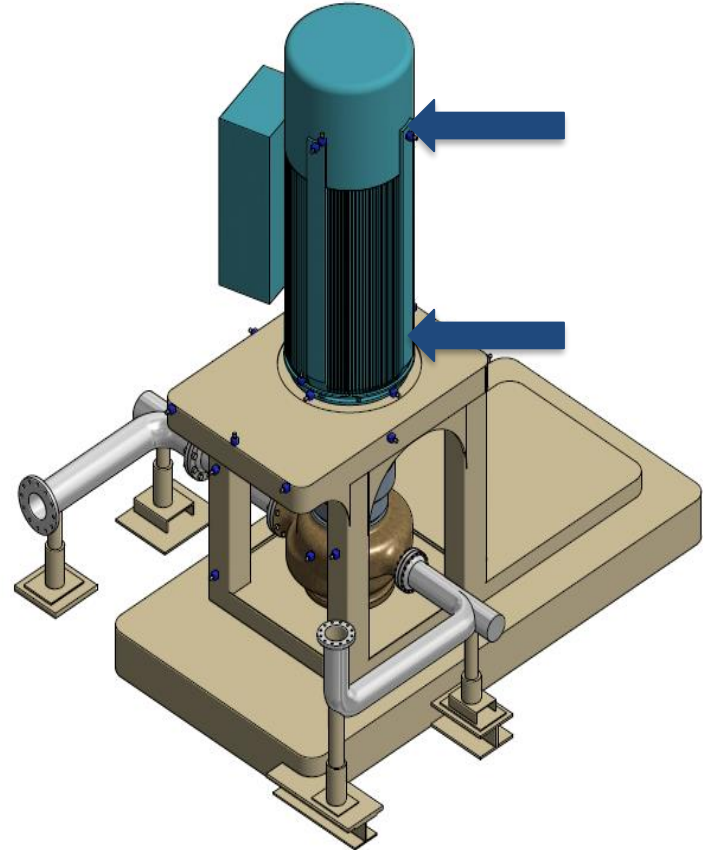
- High vibration at same locations as in coupled run
- **High residual unbalance response on the motor while passing 2<sup>nd</sup> critical frequency**
- **Bode & polar plots confirmed the residual unbalance response**

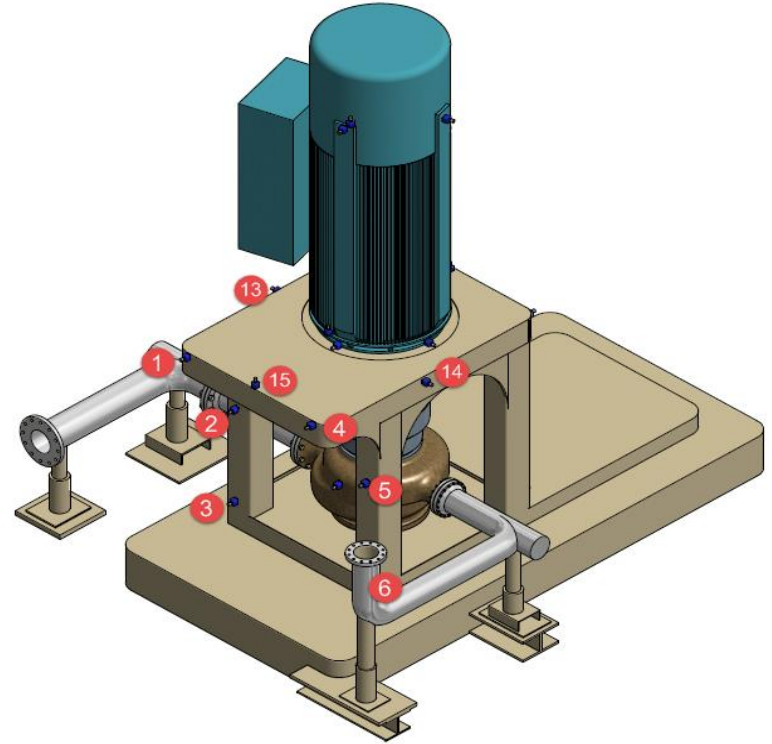
mm/sec Peak	Coupled Run		Solo Run	
	Overall	1X <sub>motor</sub>	Overall	1X <sub>motor</sub>
Str#1	12.9	11.2	11.5	11.2
Str#2	8.5	6.2	6.7	6.2
Str#3	1.3	0.2	0.4	0.2
Str#4	12.5	11.2	11.6	11.2
Str#5	9.1	6.7	7.3	6.7
Str#6	1.7	0.5	0.7	0.5
Str#14	11.2	10.5	10	9.9
Str#15	3.1	0.9	1.5	0.9

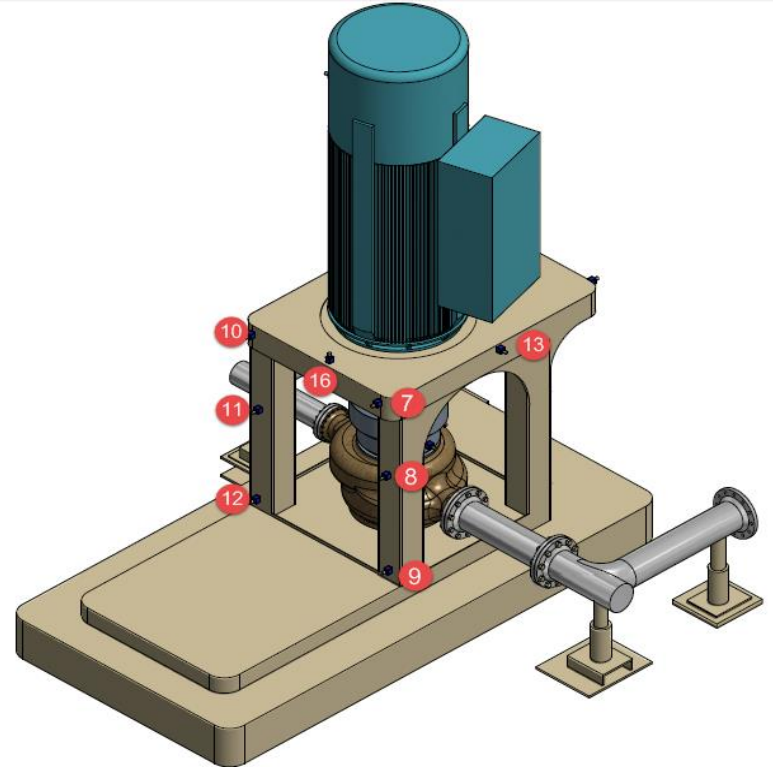
mm/sec Peak	Coupled Run		Solo Run	
	Overall	1X <sub>motor</sub>	Overall	1X <sub>motor</sub>
Str#7	13.7	12.4	12.6	12.4
Str#8	9.8	7.3	7.8	7.3
Str#9	1.4	0.7	1	0.7
Str#10	12.7	11.5	11.9	11.5
Str#11	10.2	6.8	7.3	6.8
Str#12	1.6	0.7	0.9	0.7
Str#13	10.1	10.1	10.4	10.3
Str#16	4.1	0.9	2.4	1.2

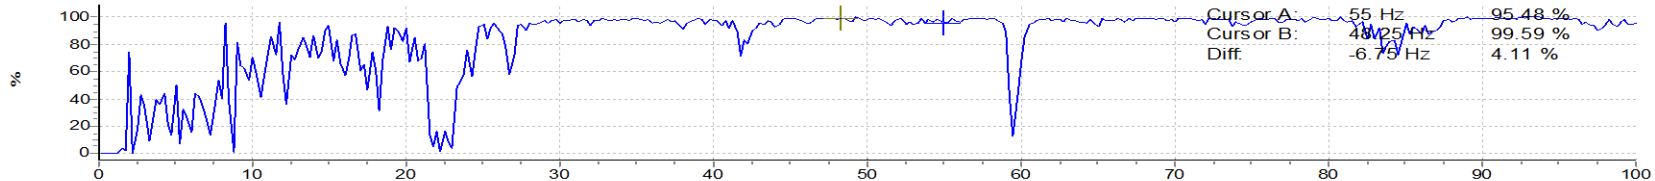
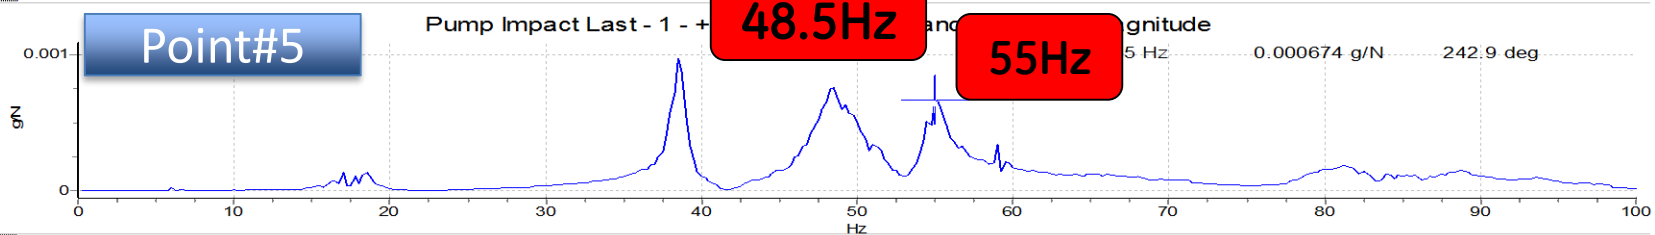
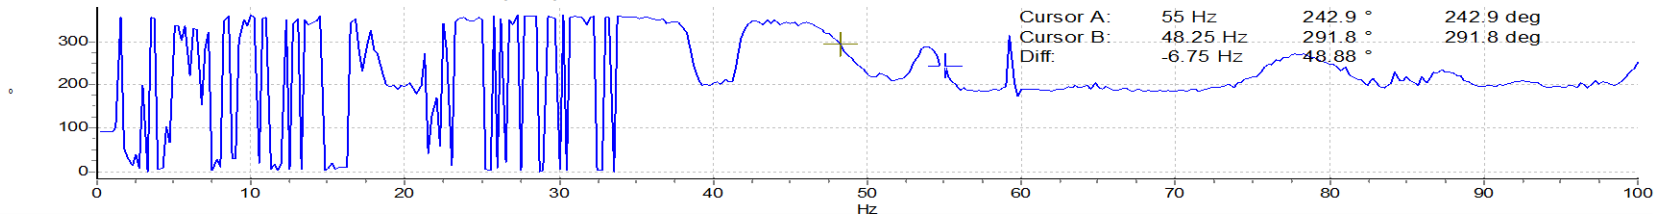
Pump Impact Last - 1 - +X - Modal Accelerance 100 Hz - Coherence

Point#5 Showed Natural Frequency Close to The Running Speed  
Other Points Showed Natural Frequency BUT Away from The Forcing Frequencies

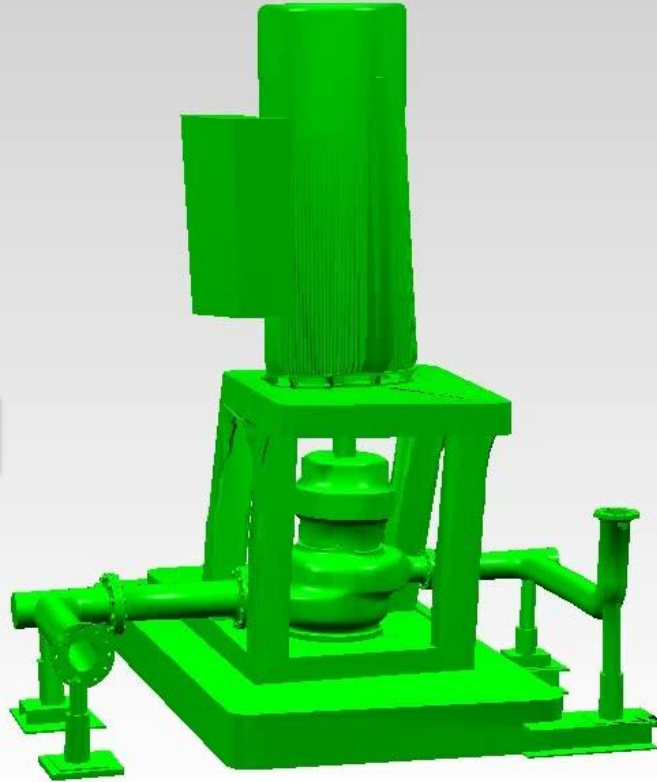
BLK Coupled Run\_Before  
Freq: 59.4 Hz, Damp: 0%  
Complex Shape

Circular Motion

Solo Run also showed the similar circular motion

- The extremely high vibration levels on the motor, pump and structure -mainly due to motor rotor residual unbalance.
- ODS showed circular motion due to unbalance response.
- In-situ balancing reduced vibration levels to acceptable values.
- After balancing, the twisting motion remained due to the natural frequency of 55 Hz.
- Structure design to be reviewed with the OEM to shift the natural frequency above 20% operating speed.

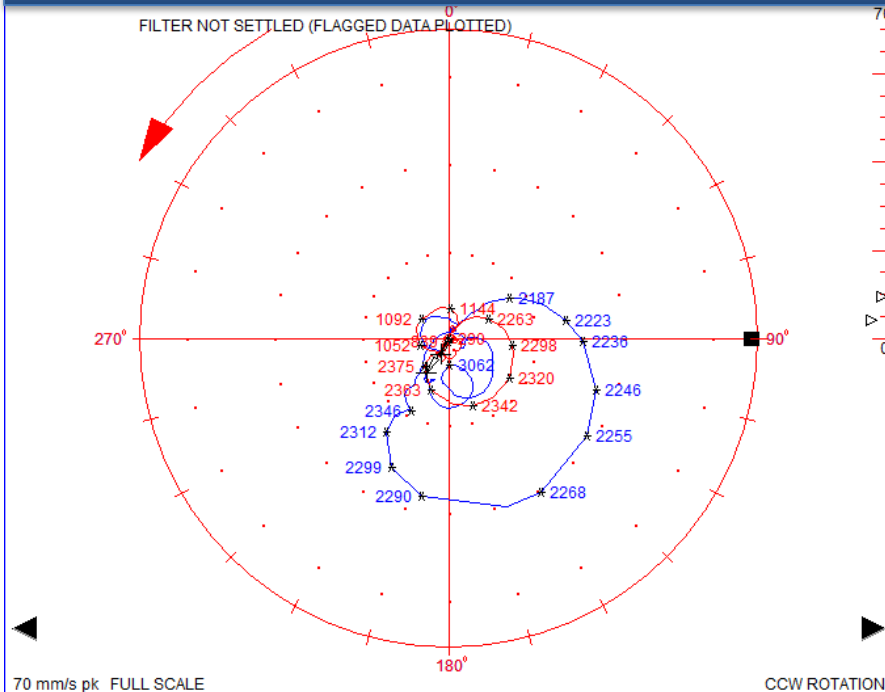
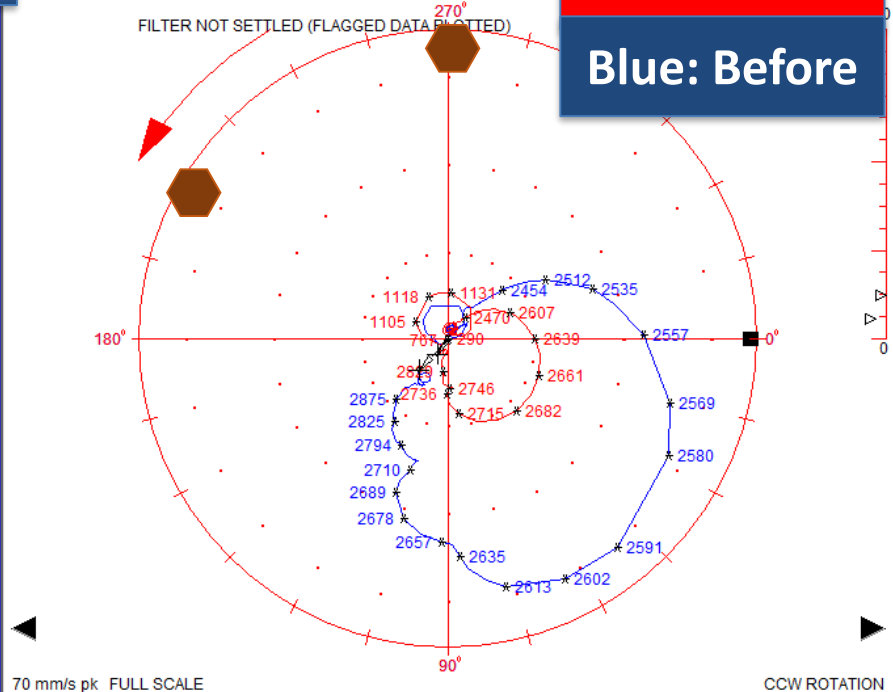
## Weights Added on the Coupling Hub

MIBV	—	∠90°	Right	1X	9.523 mm/s pk	∠133°	3
MIBV	—	∠90°	Right	1X	4.149 mm/s pk	∠124°	3

- Balancing shot was done by adding total mass of 178 g on the motor coupling hub (2 bolts were attached to the hub)
- Significant decrease in vibration levels on the motor and structure.
- The required final balance shot was 210 g as per vector calculations (at this balance plane; hub).
- There is no access to add final balance weights on the hub.
- It was decided to check the motor cooling fan as a balance plane in order to examine motor response to weights at NDE side.

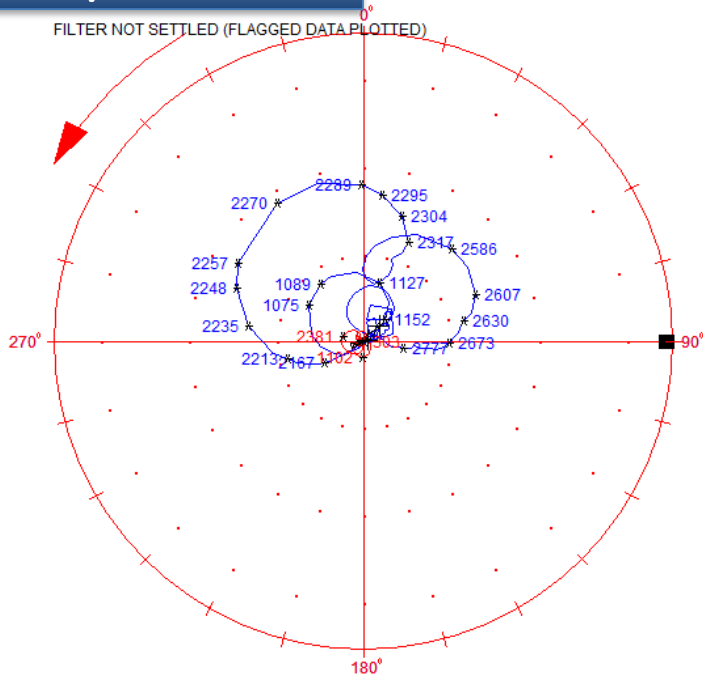
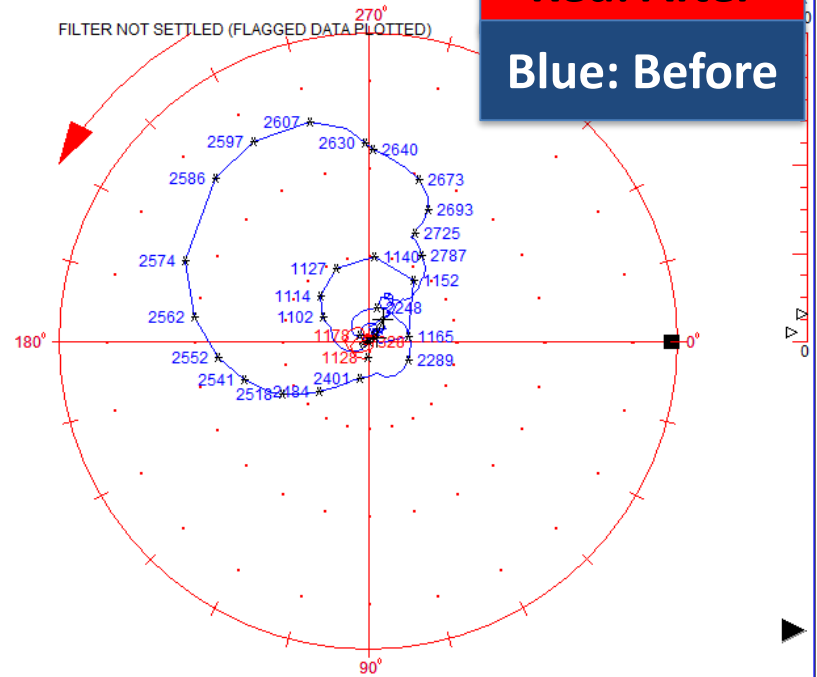
Coupled Run

MOBV —  $\angle 90^\circ$  Right 6.213 mm/s pk  $\angle 303^\circ$  3582 rpm  
 MOBV —  $\angle 90^\circ$  Right 1.939 mm/s pk  $\angle 335^\circ$  3584 rpm

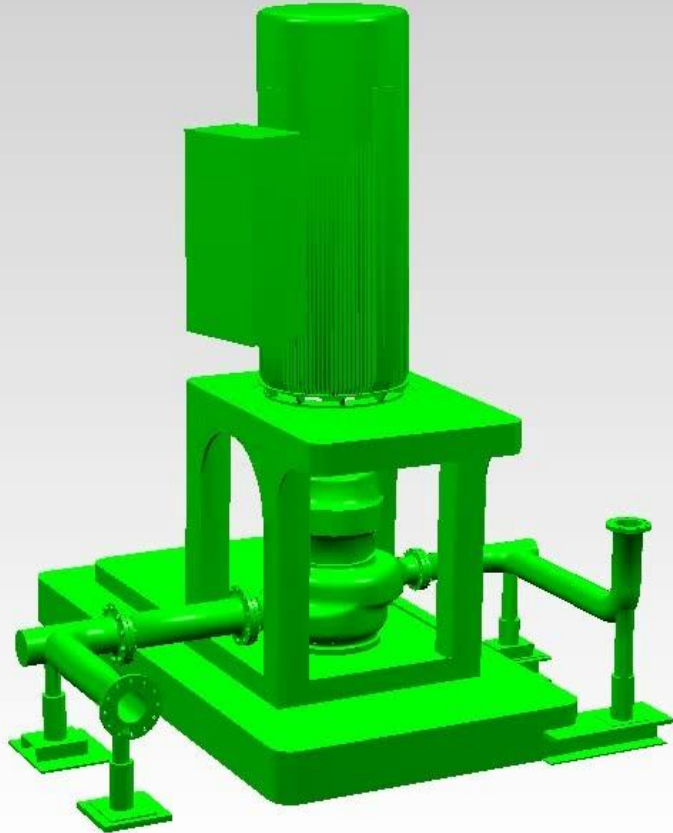
BLK: Coupled\_Run\_After  
Freq: 59.4 Hz, Damp: 0%  
Normal Shape

Twisting Motion

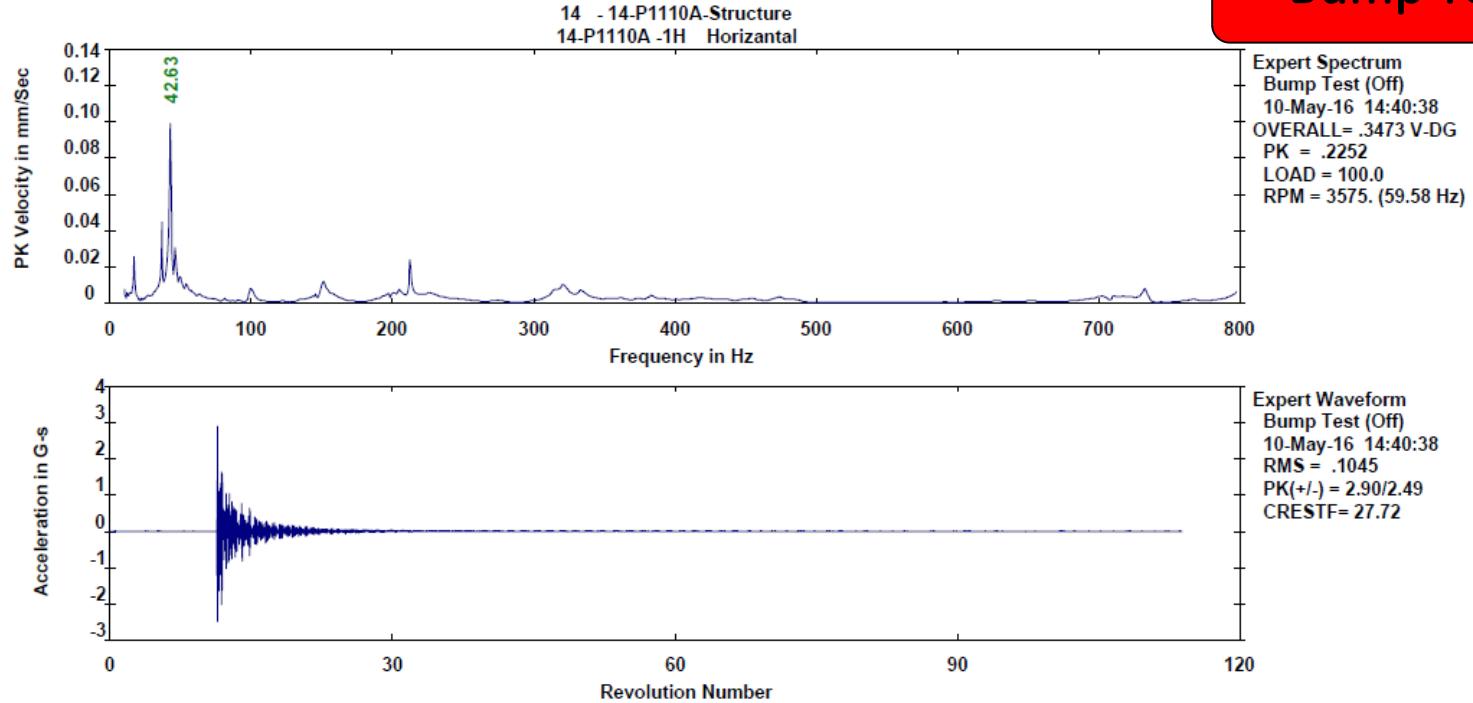
## Bump Test

- Bump test showed natural frequency at 43Hz
- Many trials were done by the End User to reduce the high vibration:
  - Total mass of 100Kg were added to the structure
  - Additional supporting braces
- Vibration levels remained as high as the original measurements

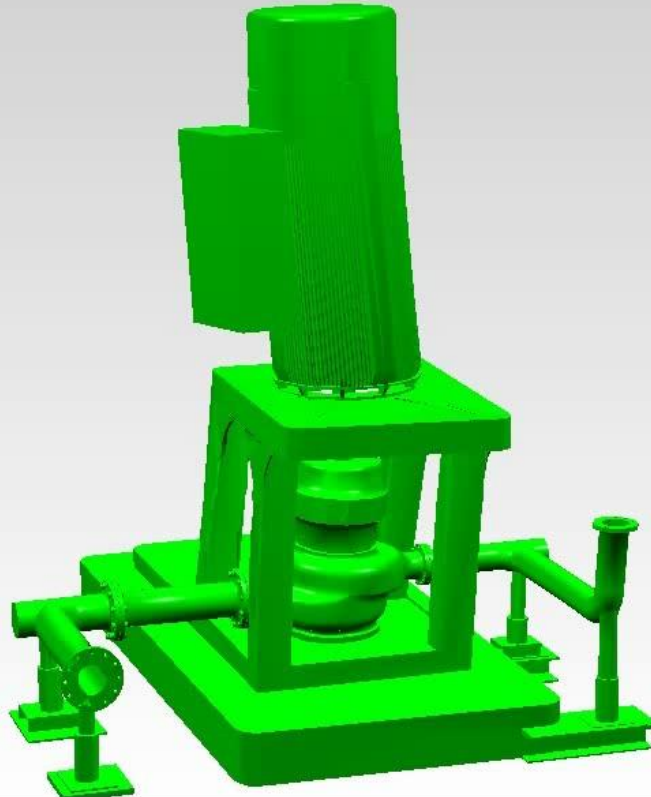
BLK\_Solo\_Before  
Freq: 59.4 Hz, Damp: 0%  
Complex Shape

Circular Motion

- ODS showed circular motion due to unbalance response.
- Extremely high vibration levels were observed on the motor, pump and structure with  $1X_{\text{motor}}$  dominant frequency are mainly due to motor rotor residual unbalance.

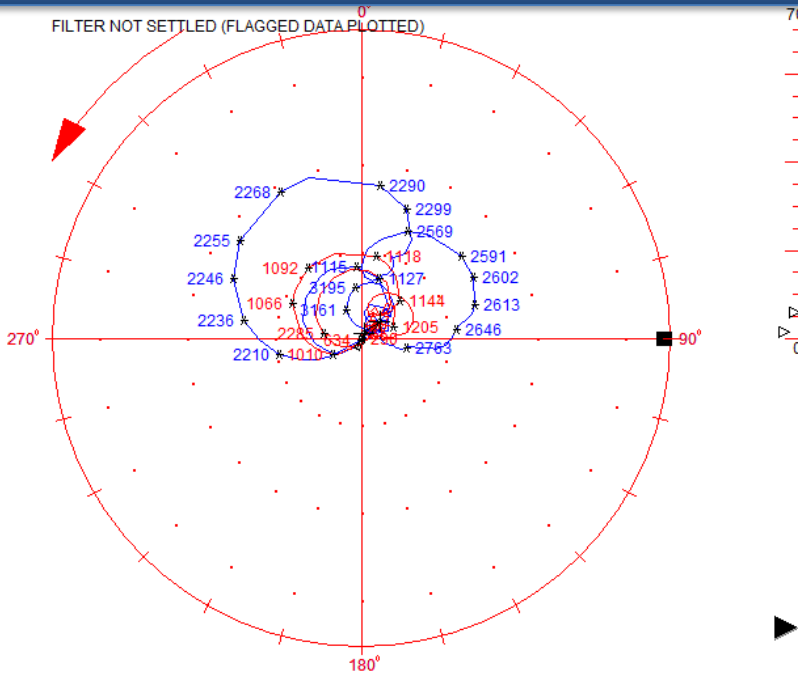
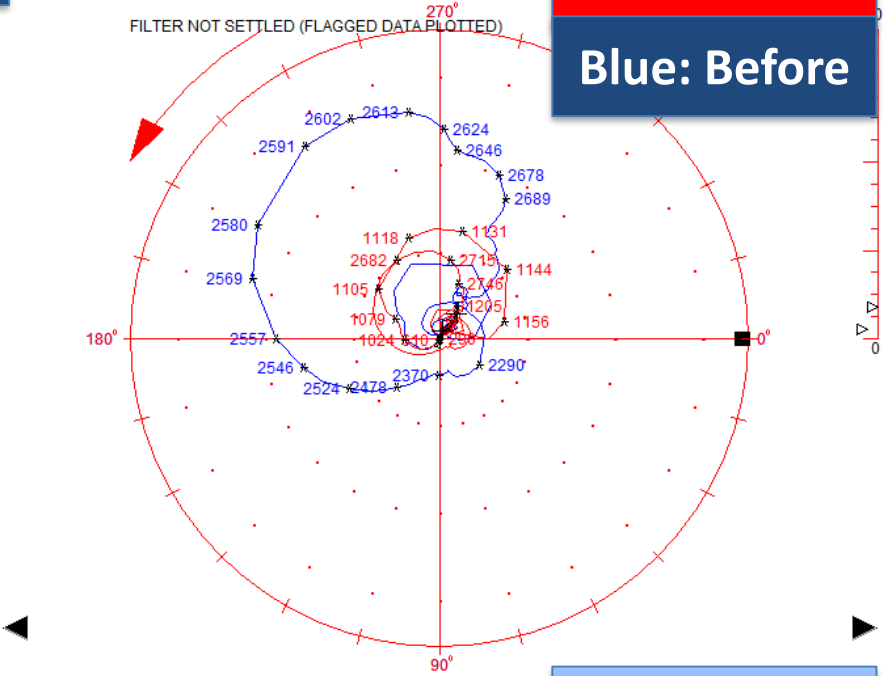
**OB-Solo Run**

MOBV	—	∠90°	Right	6.736 mm/s pk	∠304°	3602 rpm
MOBV	—	∠90°	Right	1.889 mm/s pk	∠284°	3599 rpm

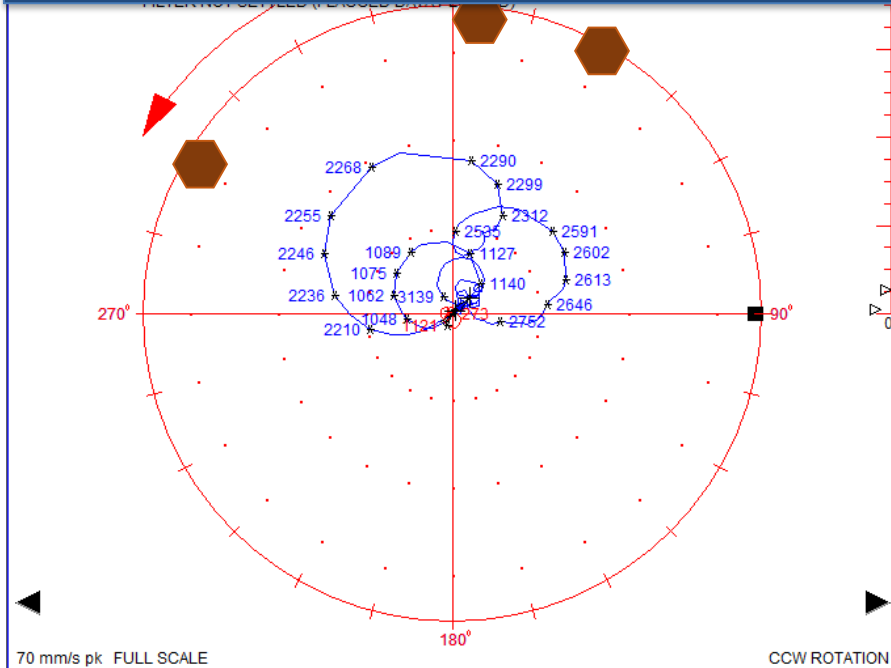
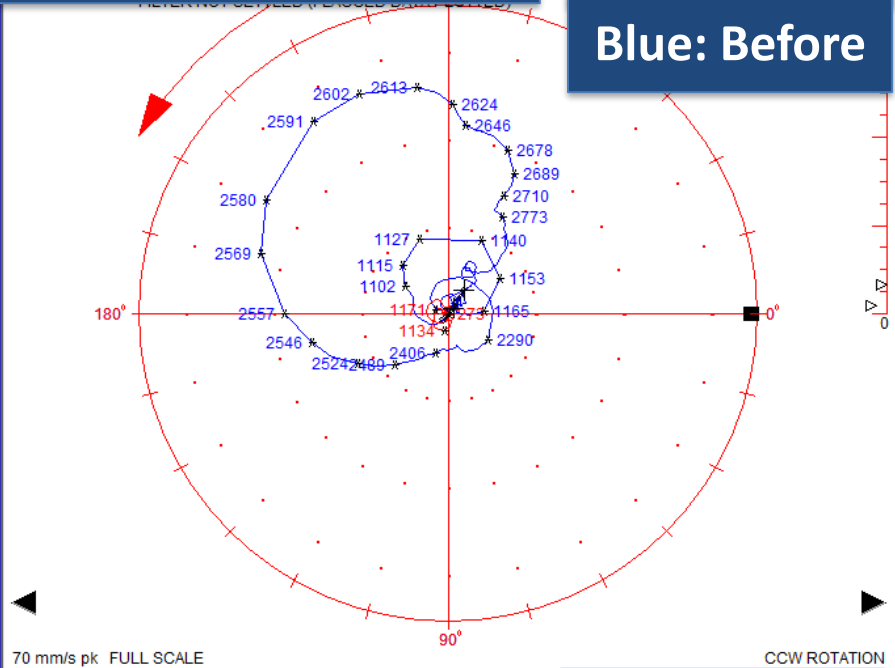
OB-Solo Run

Total of 186 g of Old Wrong Weights Removed from the Fan

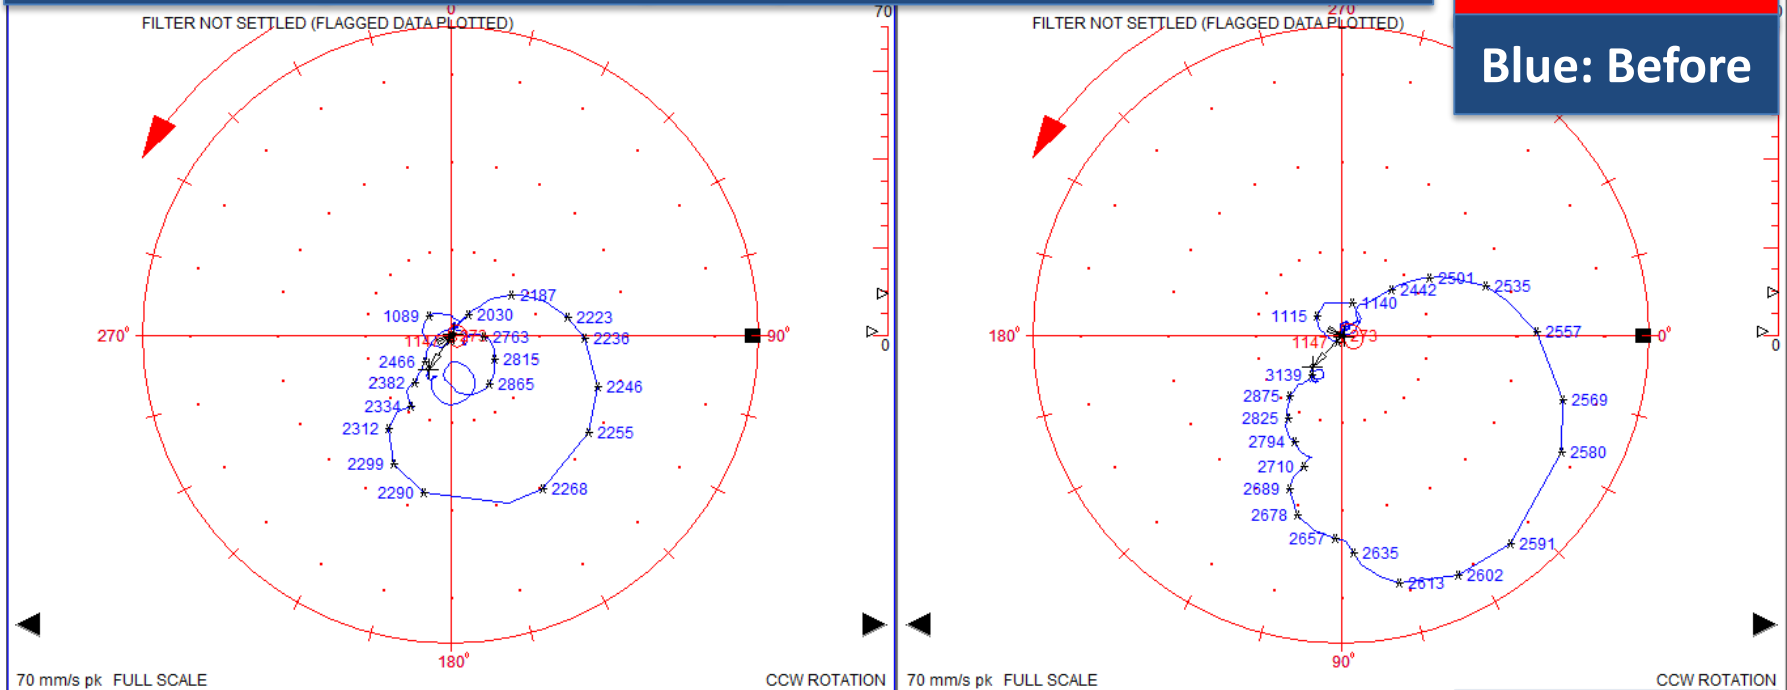
IB-Solo Run

Total of 186 g of Old Wrong Weights Removed from the Fan

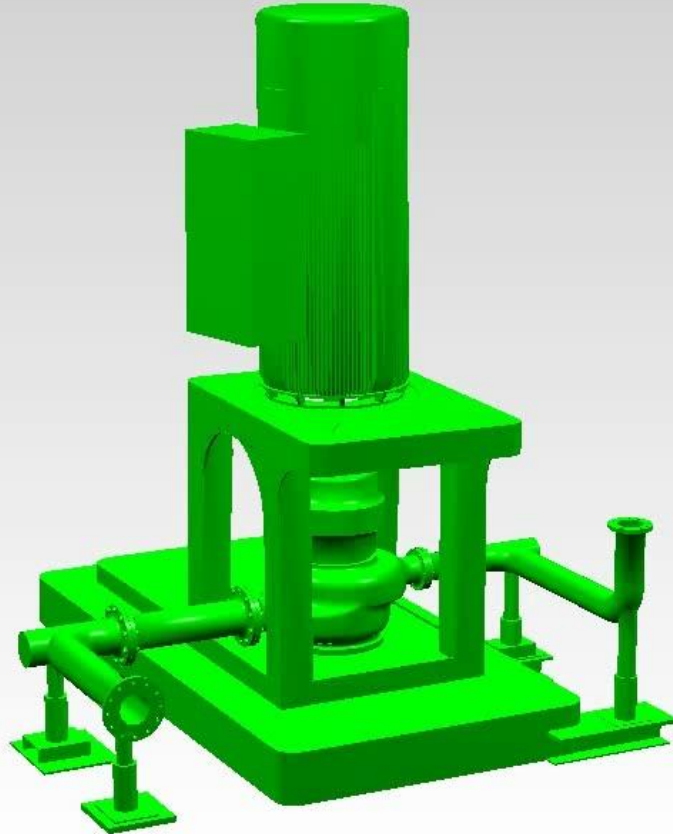
BLK: Coupled\_Run\_After  
Freq: 55 Hz, Damp: 0%  
Normal Shape

Twisting Motion

- ODS showed circular motion due to unbalance response in addition to slight structural twisting motion.
- After balancing, the twisting motion remained due to the natural frequency of 55 Hz as indicated from the impact test data.
- Structure design to be reviewed with the OEM to shift the structure resonance frequency to at least 20% above or below the operating speed frequency.
