ASIA TURBOMACHINERY & PUMP SYMPOSIUM
MARCH 2018 | SUNTEC SINGAPORE

Large Vibrations on Centrifugal Compressor Caused by Inappropriate Operation During Mechanical Running Test

Y. Bidaut, MAN Diesel & Turbo Schweiz AG

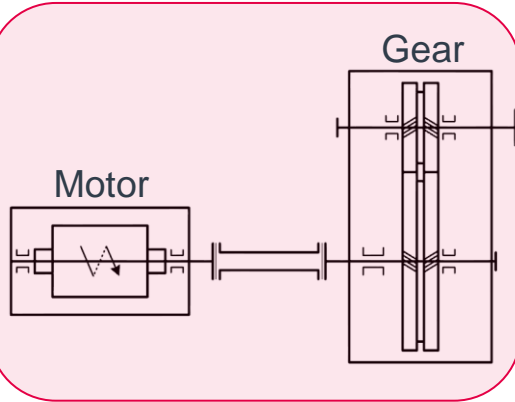
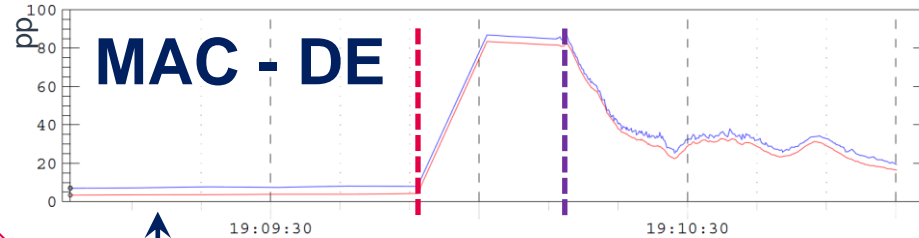
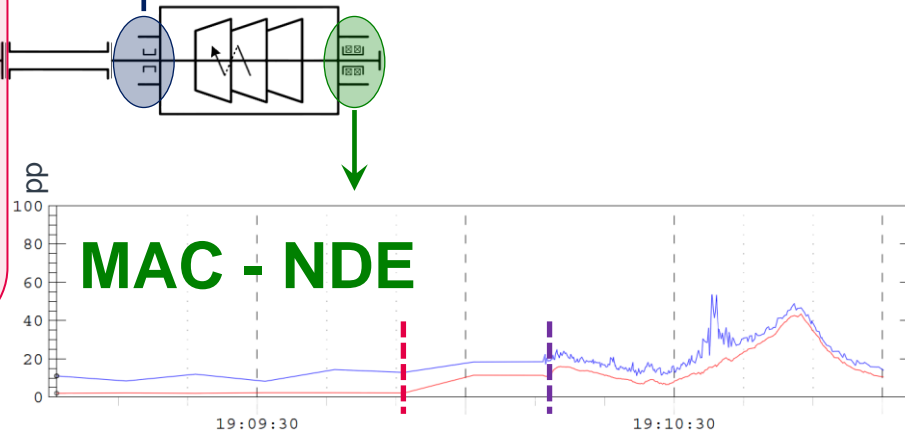
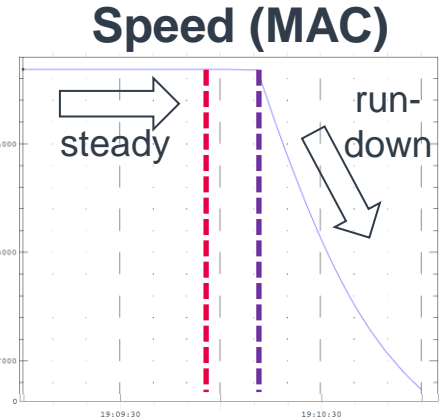
→ Sudden increase of vibrations at DE (constant speed)

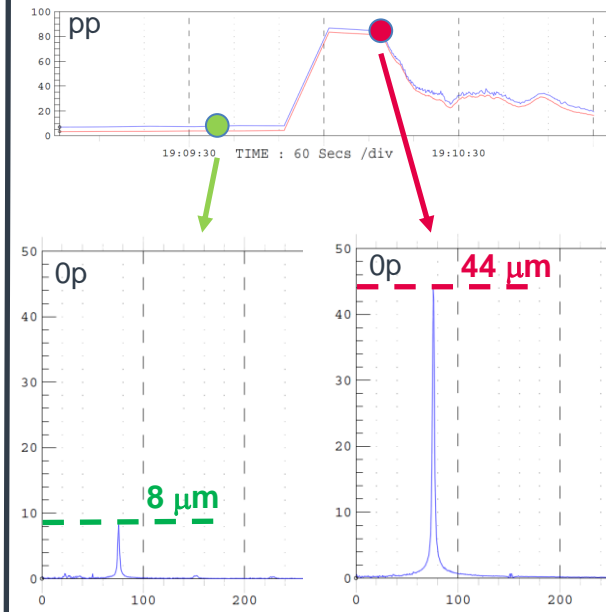
Vibrations @ 4'686 rpm

→ Vibration levels too high after re-start

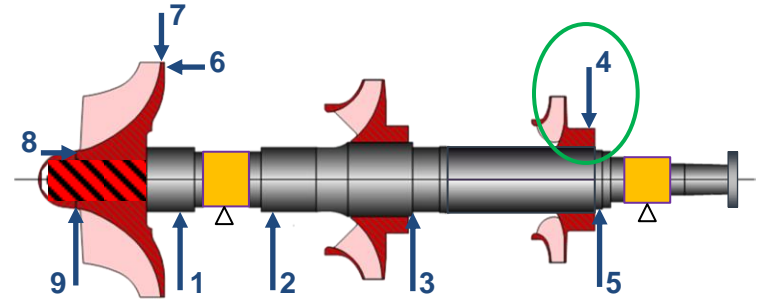
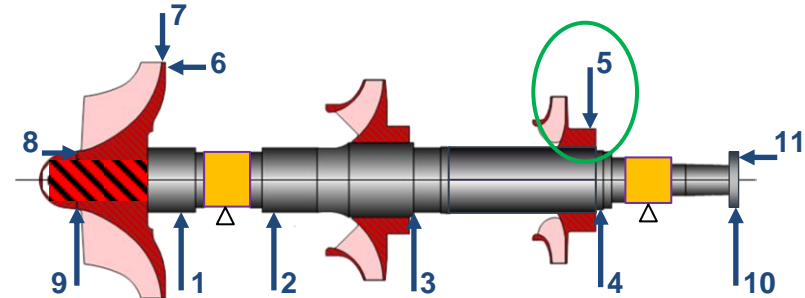
→ Run-out at Impeller 3 increased from 5 μm up to 34 μm !

→ Run-out just behind Impeller 3 increased only from 3 μm up to 12 μm

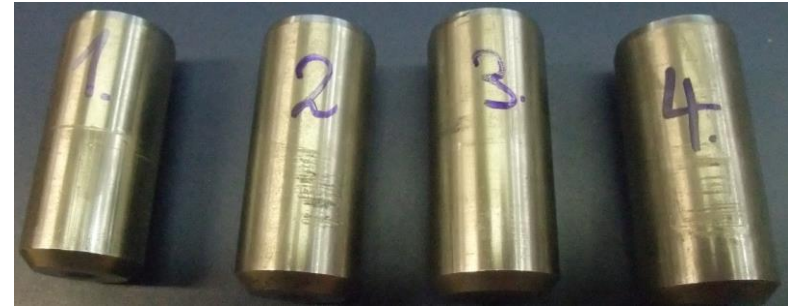
Removed pins from impeller 3

- Clear traces of shear on pins of impeller 3
- This confirms the impeller had moved on the shaft during the test

1. Shrink increased from 1.22 ‰ to 1.40 ‰
2. Mechanical test run carried out at trip speed for 15 minutes duration and well outside the stability limit

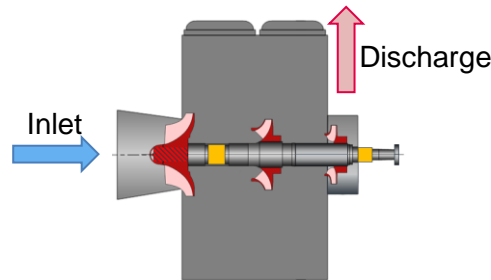
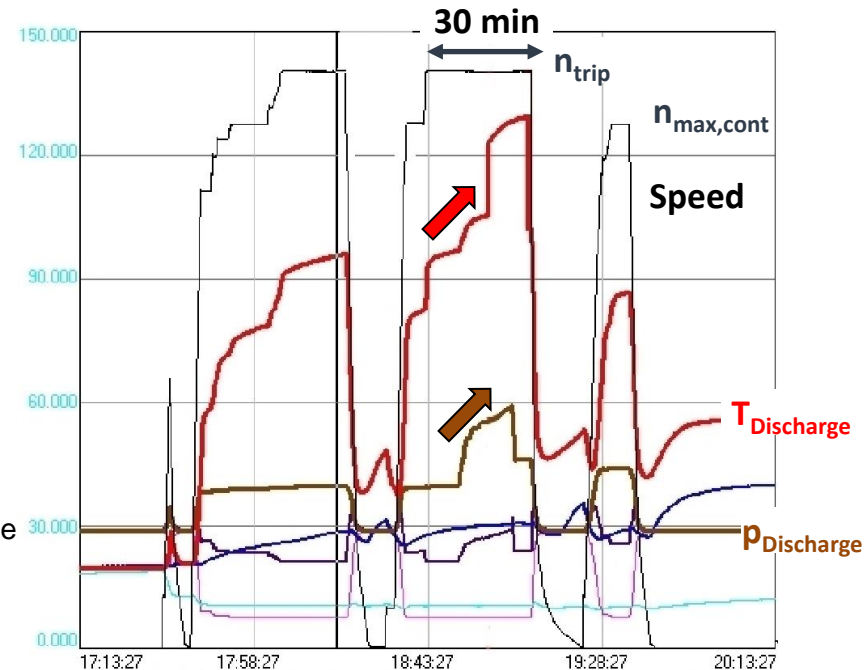
- For internal investigation purpose, a surge test at trip speed had to be performed (no customer specific requirement)
- Event happened after:
 - 30 min in operation at trip speed (4'686 rpm)
 - Continuous increase of discharge pressure and temperature

➔ High vibrations appeared while running at trip speed and close to surge

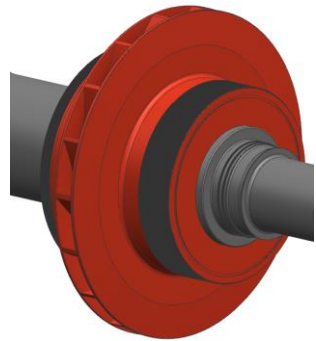
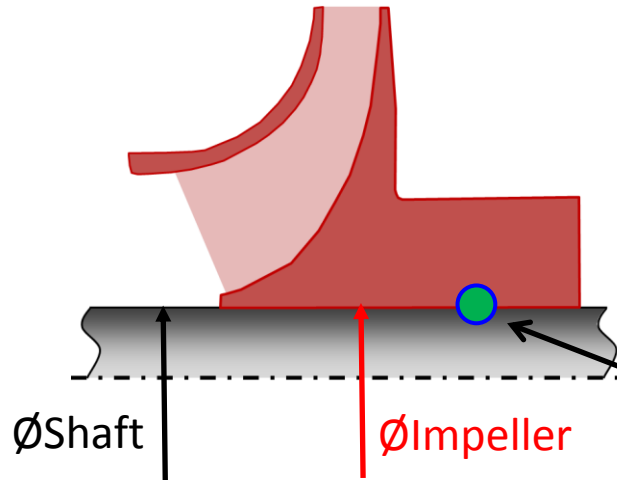
Interference fit evaluated from Manufacture Data records

Interference fit (realized shrink):

$$\frac{\varnothing_{\text{Shaft}} - \varnothing_{\text{Impeller}}}{\varnothing_{\text{Shaft}}} = 1.22 \%$$

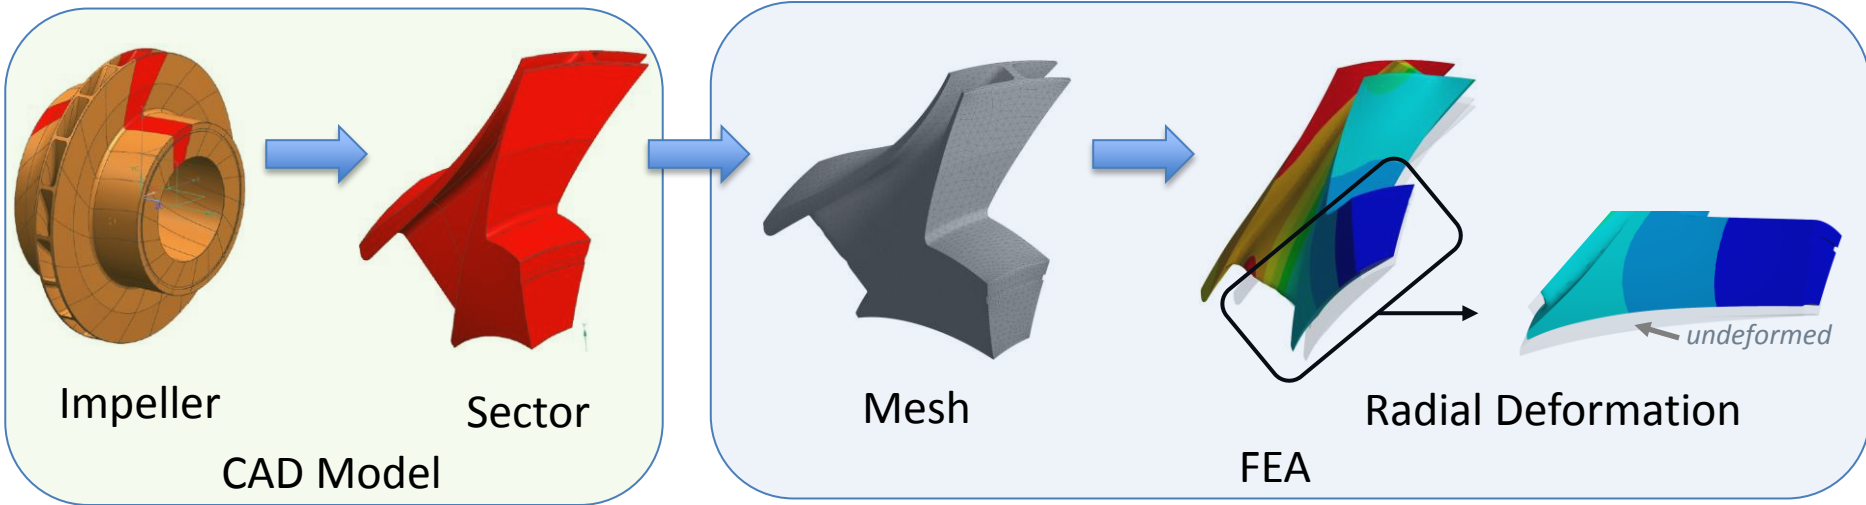
Evaluation of impeller radial displacement at the interference fit due to centrifugal forces

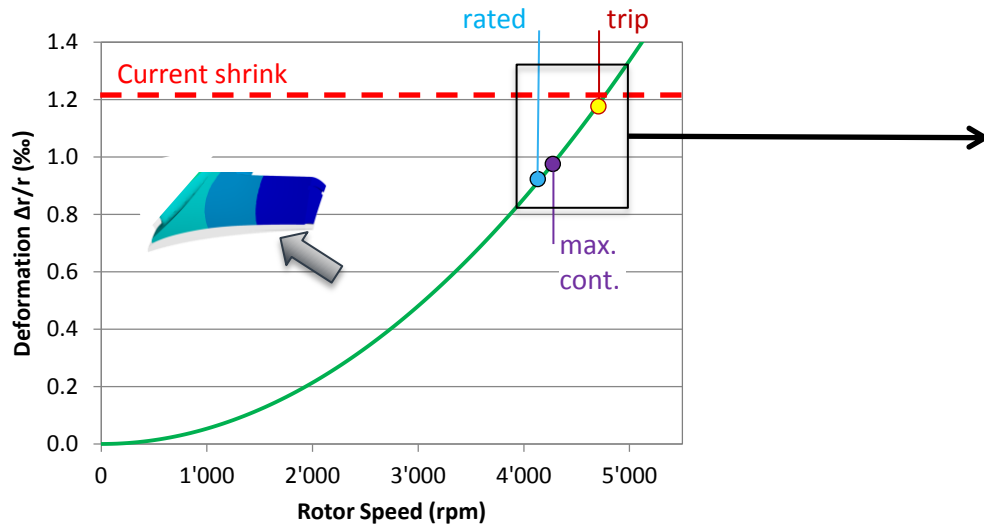
Radial displacement at impeller fit due to centrifugal forces (only)

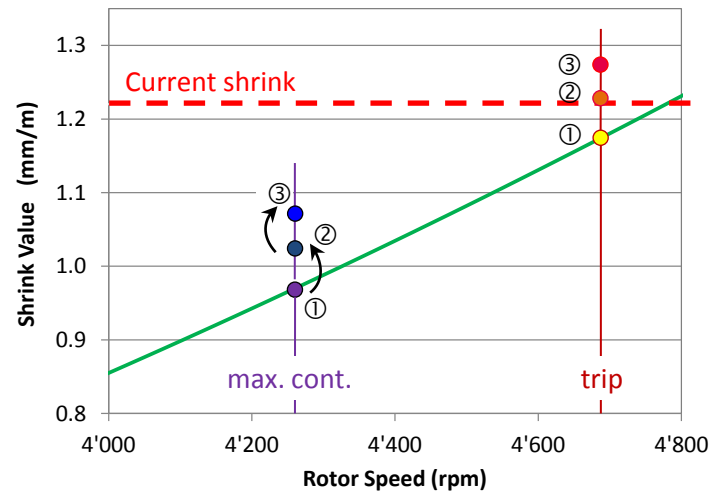
Required shrink at impeller fit due to overall loads

Loads	
①	Centrifugal
②	+ Torque + Thrust
③	+ Thermal (surge)

- Current shrink 1.22 ‰ is sufficient for normal operating conditions
- Shrink is not sufficient for operation at n_{trip} & surge !

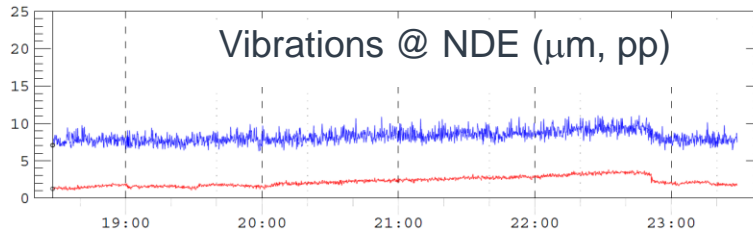
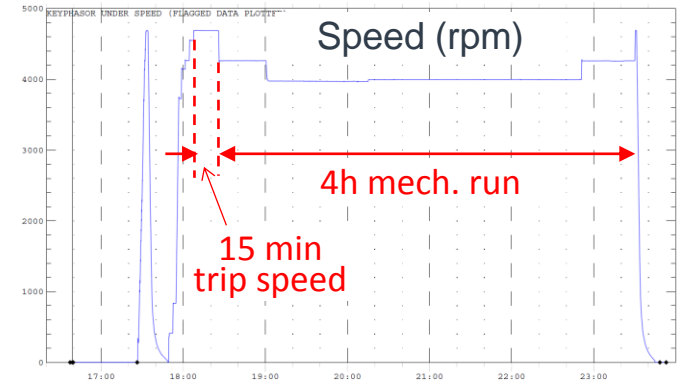
- Afterward, a second rotor (same geometry) with increased shrink was tested in the machine

→ No peculiar vibration observed, machine accepted and delivered
