46TH TURBOMACHINERY & 33RD PUMP SYMPOSIA
HOUSTON, TEXAS | DECEMBER 11-14, 2017
GEORGE R. BROWN CONVENTION CENTER

Pump Cavitation Severity Evaluation Using Accelerometers and Dynamic Pressure Transducers after Installation

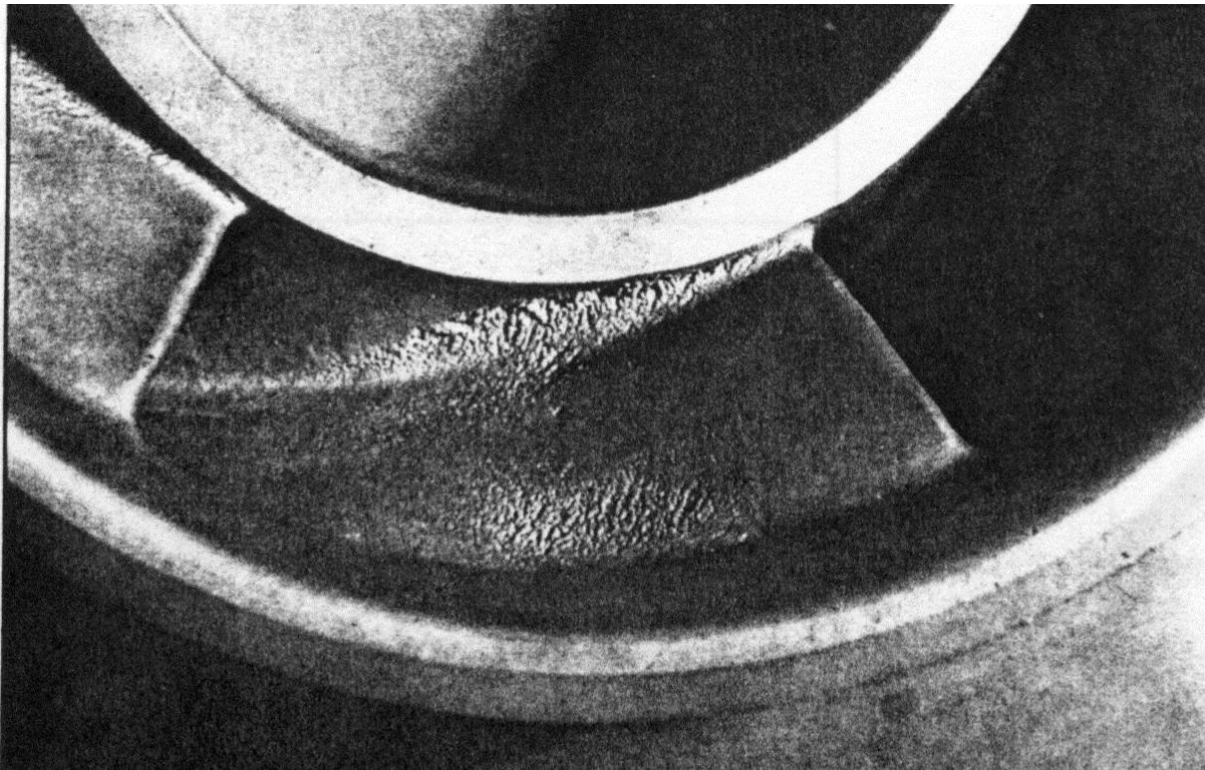
Figure 4. Classical cavitation erosion on the vane of a boiler feed pump (Sloteman, 1995)

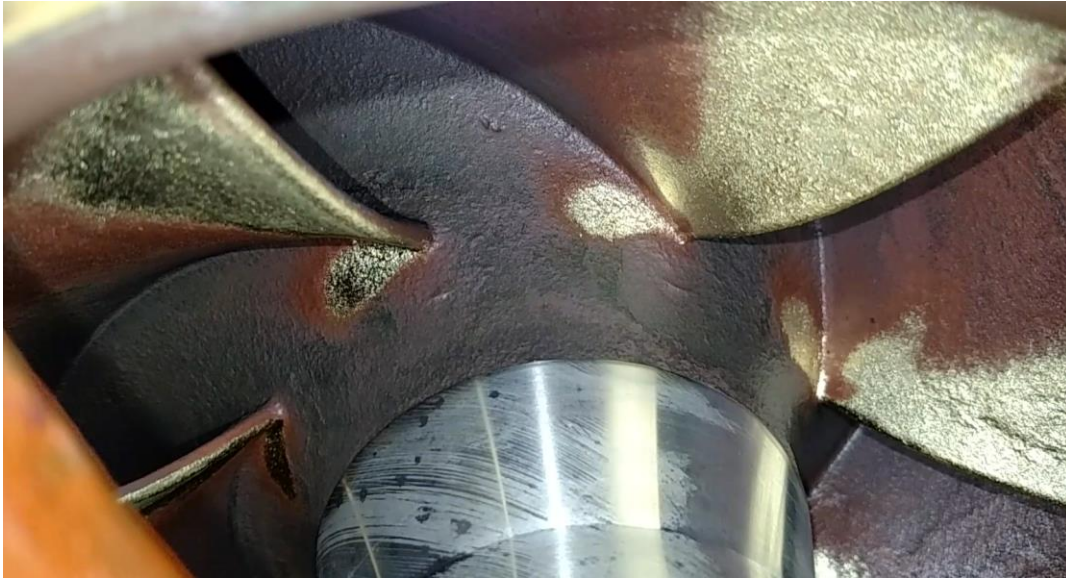
The time waveform from the accelerometer measuring structural vibration on the suction part of the pump casing, shown for "Pump A" in Figure 15, was taken on the outboard side of the casing "suction bay" wall, with line-of-sight to the impeller, using a small accelerometer which had a frequency response in excess of the data acquisition frequency. As can be seen in this plot, there is a peak acceleration level of more than 200 g's, which in the authors' experience typically indicates rapid erosion damage taking place, and which in fact was true in this pump.

Figure 14. Pump A impeller picture. Note the polished surface of the low pressure side of the vanes which extends onto the hub.

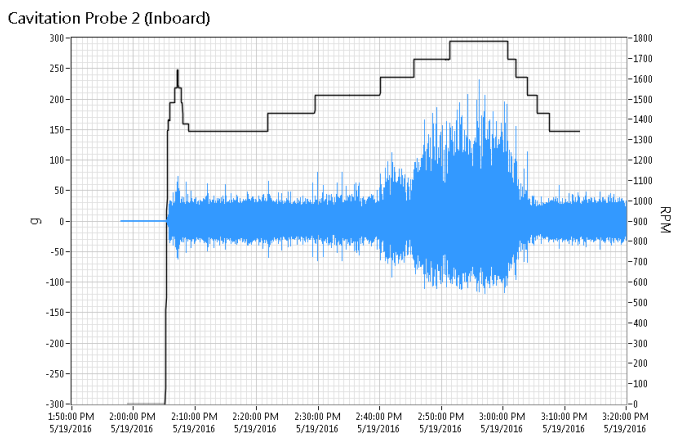
Figure 15. Pump A high frequency accelerometer time domain response. Note the g levels exceeded 200 g's as the pump went higher in speed, when NPSHR increased and NPSHA reduced.

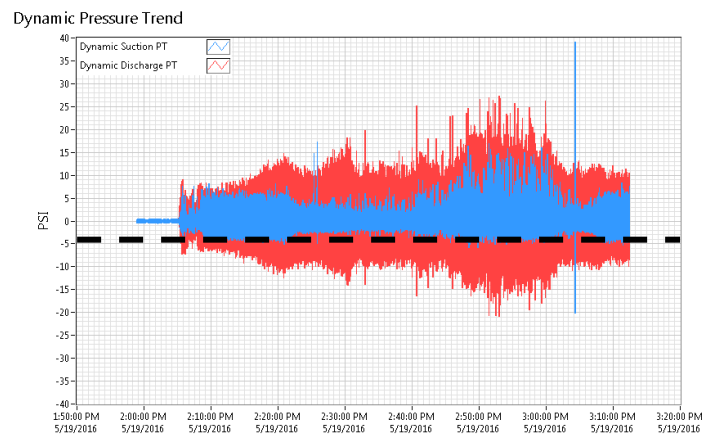
Figure 16. Pump A dynamic pressure transducer time domain response. Note the negative psig spikes on the suction transducer get clipped at just below -5 psi (except for the one anomaly near the end of the test). This shows the pump was experiencing cavitation and the pressure was dropping below the vapor pressure.

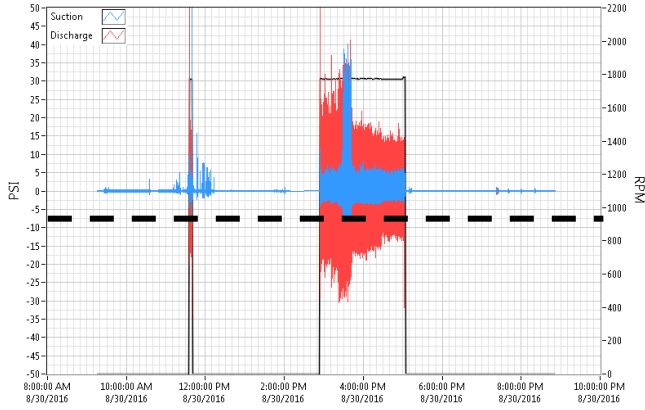
Pump 3 Time Domain Pressure Pulsation Levels

Figure 17. Pump B dynamic pressure response. Negative spikes clipped off because the suction pressure level fell below the vapor pressure of the water, indicating cavitation.

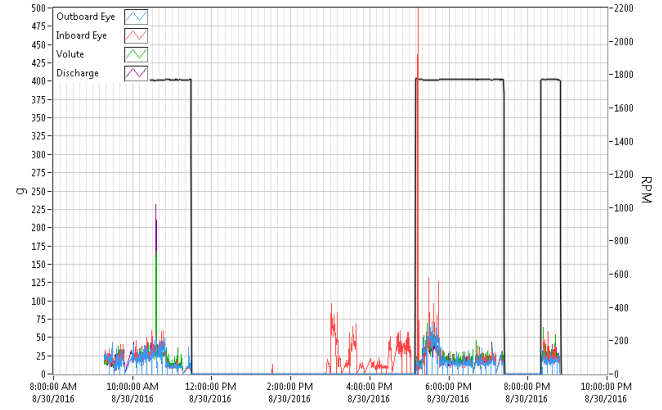
Pump 4 Cavitation Accelerometer Maximum Levels

Figure 18. Pump B casing high frequency accelerometer response

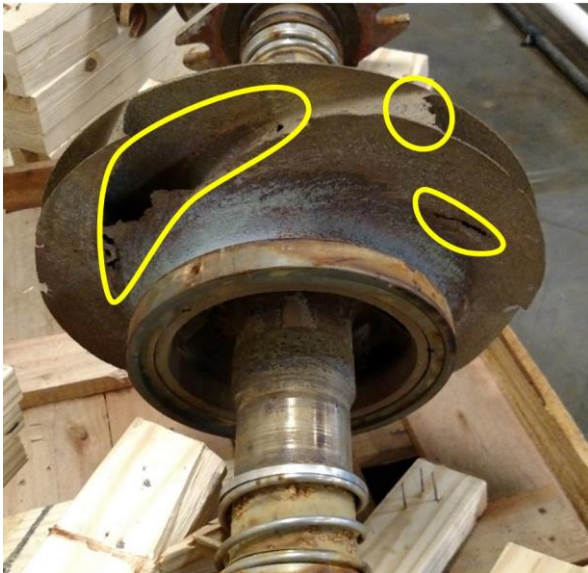
Figure 19. Pump B impeller exhibits cavitation damage from discharge recirculation (yellow).

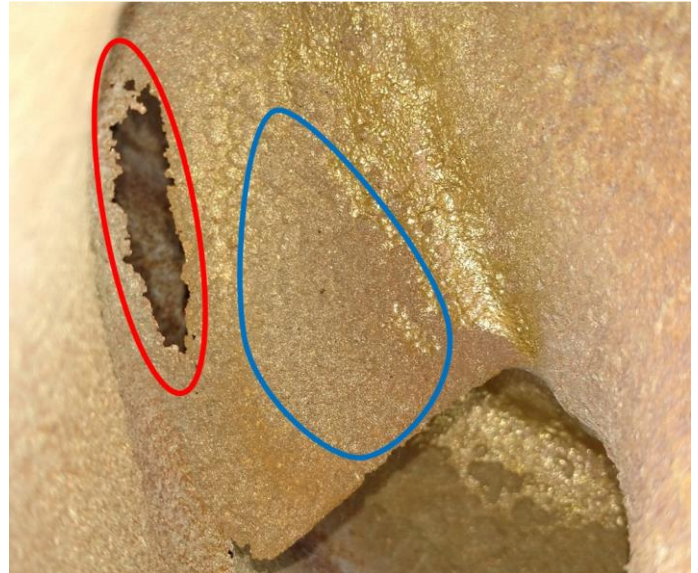
Figure 20. Pump B The red shows damage of suction recirculation. The telltale that the damage is mainly due to recirculation are the holes and pitting on the pressure side of the vane and/or shroud. Note that suction and discharge recirculation often are observed together. There is also some typical suction-side cavitation phenomena damage. This is shown by the discoloration in the area circled in blue.

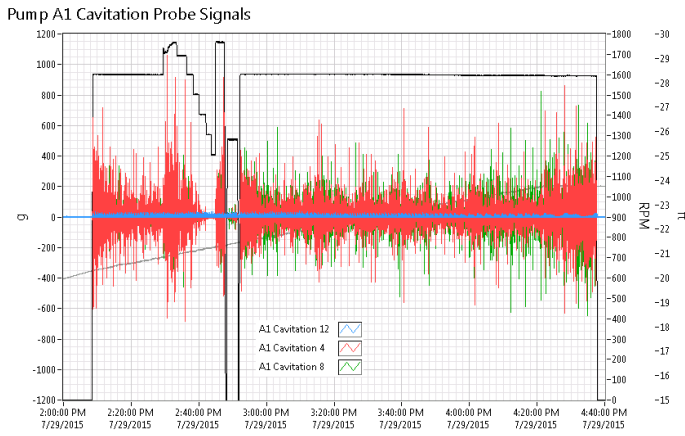
Figure 21. Pump C (axial flow circulator pump) accelerometer g level over time during operation. As can be seen, the g levels exceeded what the authors consider damaging levels, and are well above 100. The accelerometer was placed on the pump suction piping near the impeller, radial with respect to the impeller eye due to pump type.

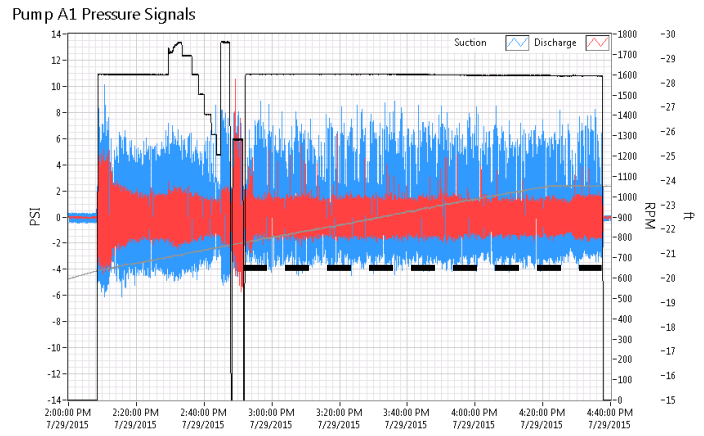
Figure 22. Pump C time waveform from dynamic pressure transducers indicated that localized cavitation was present at the suction end of the pump (+8/-4 psig). The negative spikes (clipped at -4 psig) were clipped off, which is indicative that instantaneous suction pressure was below the vapor pressure. The discharge end did not show large pressure pulsations (± 2 psi).

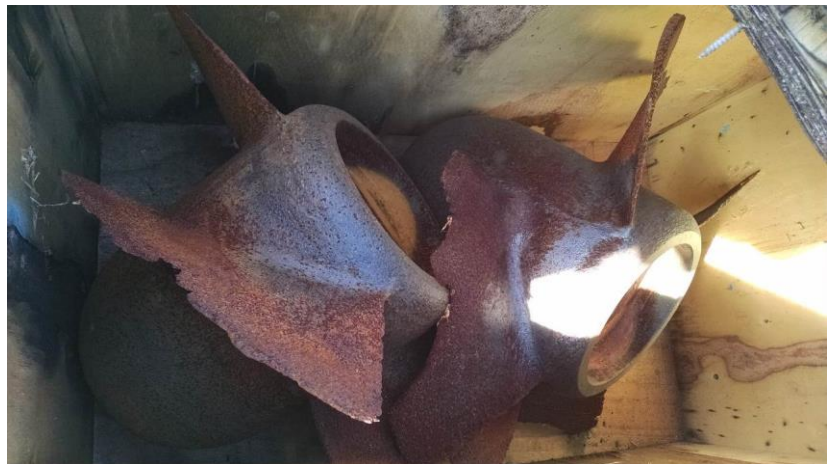
Figure 23. Pump C, used pump impellers (4000 hours of service). In both cases, large amounts of material were removed from the impeller due to the cavitation measured by the authors

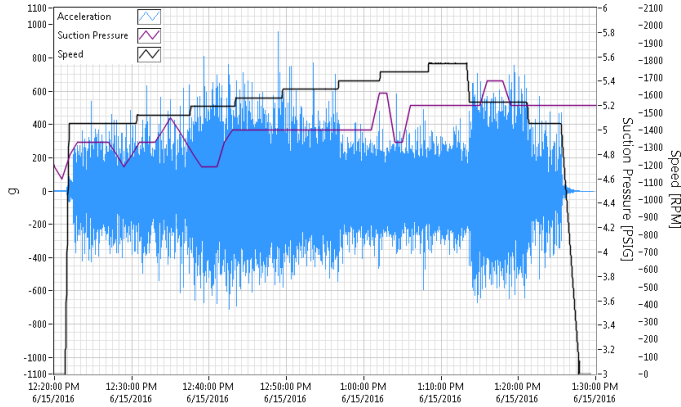
Pump 2 Bottom Impeller Eye, Discharge Side Acceleration Level

Figure 24. Pump D accelerometer g level over time during operation. As can be seen, the g levels exceeded what the authors consider damaging levels, and are well above 100. The accelerometer was placed on the pump volute casing near the impeller eye.

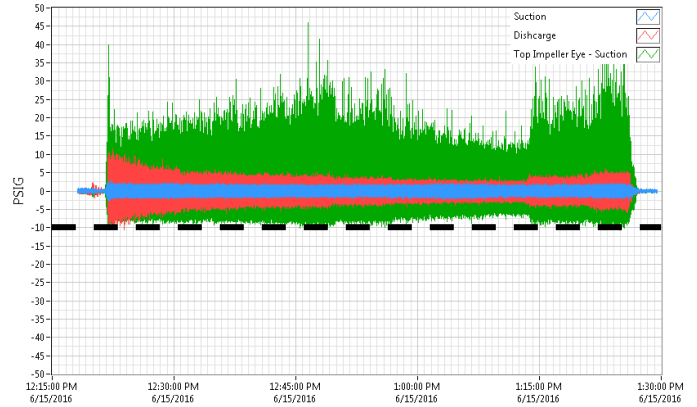
Pump 2 Transient Dynamic PT Trends

Figure 25. Pump D dynamic pressure time domain signal. The negative spikes at the “Top Impeller Eye” location were clipped off because the suction pressure fell below the vapor pressure of the water. This is a reliable indicator of cavitation phenomena.

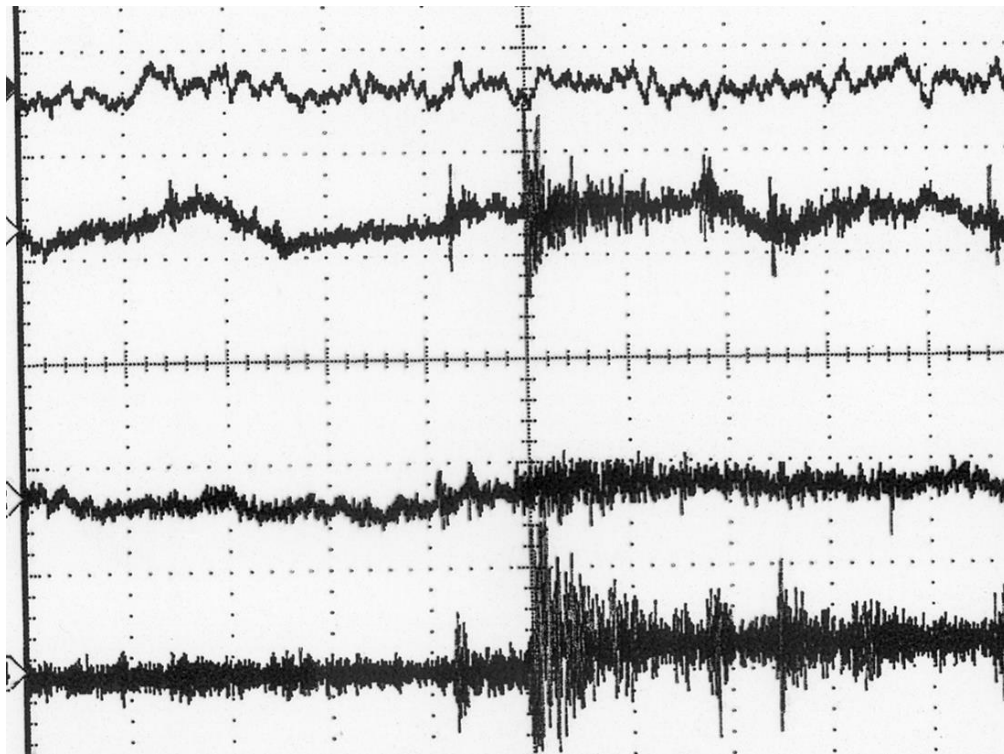
There was no opportunity for the authors to gather time-based surface acceleration data in the research lab in France, but at the installation site the time-based acceleration data provided unambiguous evidence of damaging cavitation. In spite of the pump's NPSHR being well below the nominal (without swirl) NPSHA, with adequate margin, the high G levels of the test results predicted damage to the long term reliability of the pump. Strong cavitation in the area of the impeller eye was evident by sharp, high amplitude suction pressure spikes, clipped on the negative side, and suction casing wall acceleration spikes at random intervals, at well over 100 G's, and as high as 400 G's. Upon opening the casing and inspecting the impeller, the problem was identified as classical cavitation, clearly evidenced by the severe rate of erosion on the suction-side of all impeller vanes, slightly behind each vane's leading edge. Cavitation damage depth measurements covered a consistent one inch by 1½ inch area on each 316L stainless steel vane, with a depth of material removal of between 0.18 and 0.22 inches at the worst location in each scar, after only 1000 hours of service.

Figure 26. Pump E: Double suction pump instrumented in each bay with multiple sensors types. 316L stainless steel impeller eroded 0.2 inch deep in 1000 hours of operation, in service in a water plant.

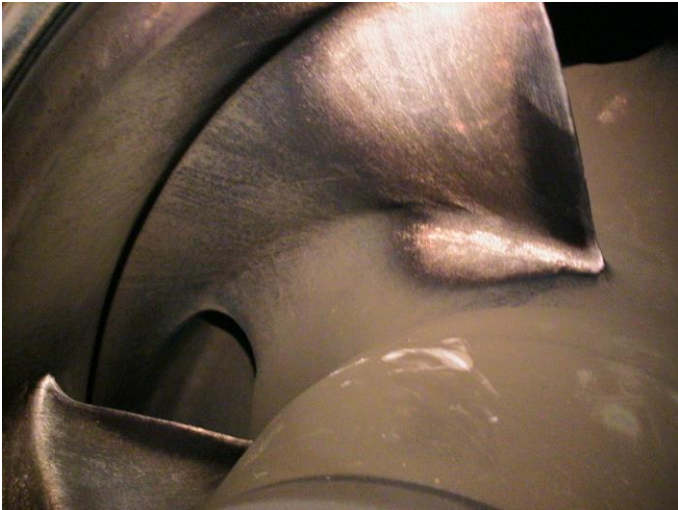
Figure 27. Pump F impeller, view is looking into the outboard impeller suction. Note the polished surface of the low pressure side of the vanes which extends onto the hub.

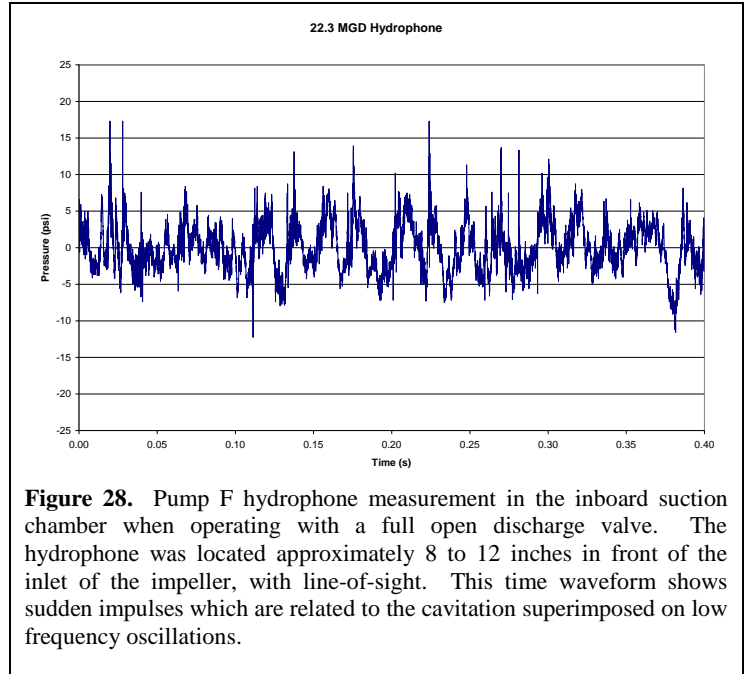
Figure 28. Pump F hydrophone measurement in the inboard suction chamber when operating with a full open discharge valve. The hydrophone was located approximately 8 to 12 inches in front of the inlet of the impeller, with line-of-sight. This time waveform shows sudden impulses which are related to the cavitation superimposed on low frequency oscillations.

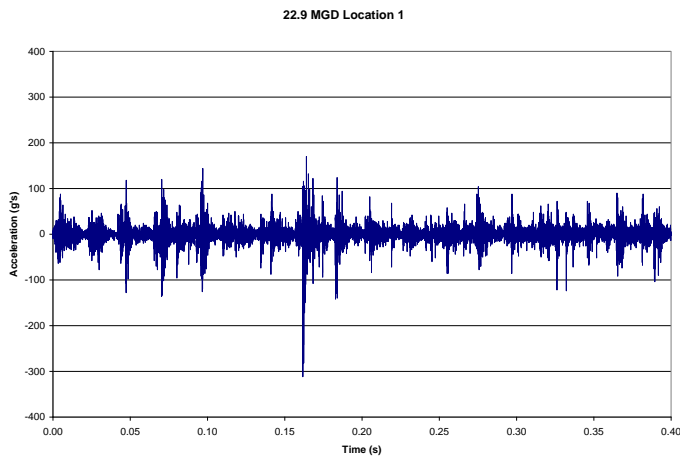
Figure 29. Pump F Structural vibration trace (amplitude in g's) taken on the suction of the casing while operating with full open discharge valve. Note that in this 0.40 second sampling time, the peak amplitude exceeded 100 g's for nine events, and exceeded 300 g's once. Note how much more evident the cavitation spikes are than they are in the hydrophone data.

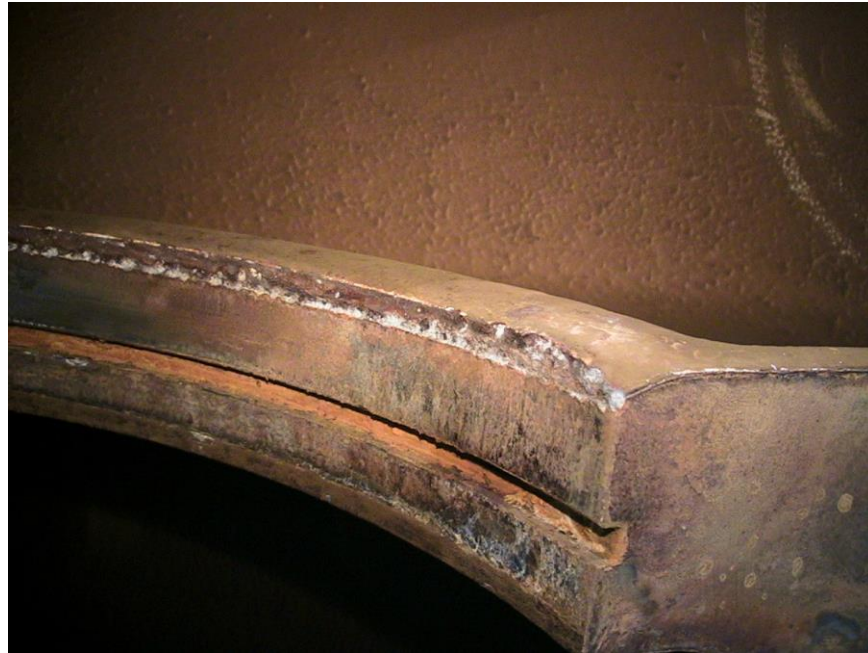
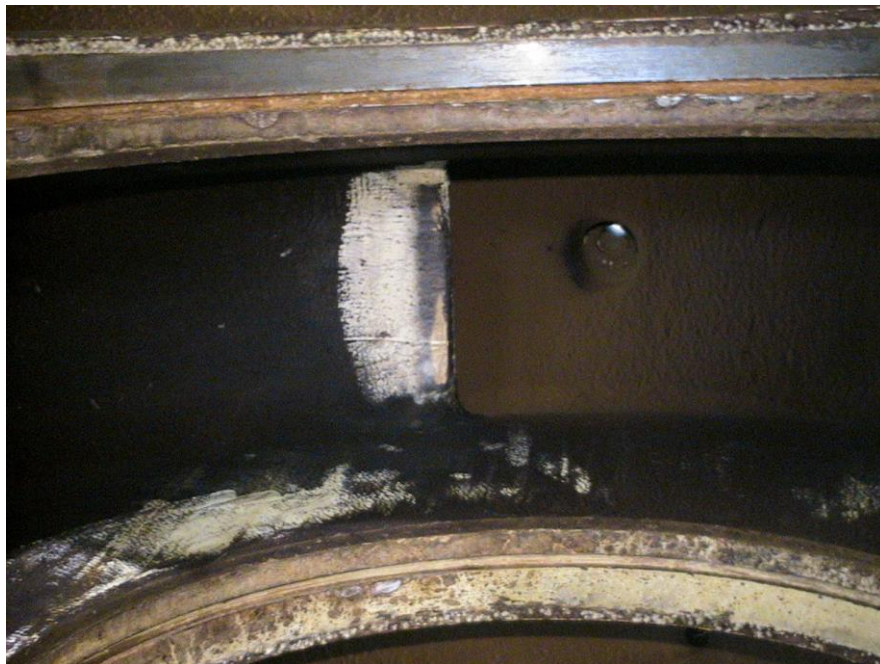
Figure 30. Pump F also exhibited cavitation damage on the wear ring exit (above), and the volute tongue (below). Accelerometer measurements on the casing indicated local acceleration peaks in these areas. The tongue erosion likely occurred due to discharge recirculation, since this pump often ran at 60% BEP flow.

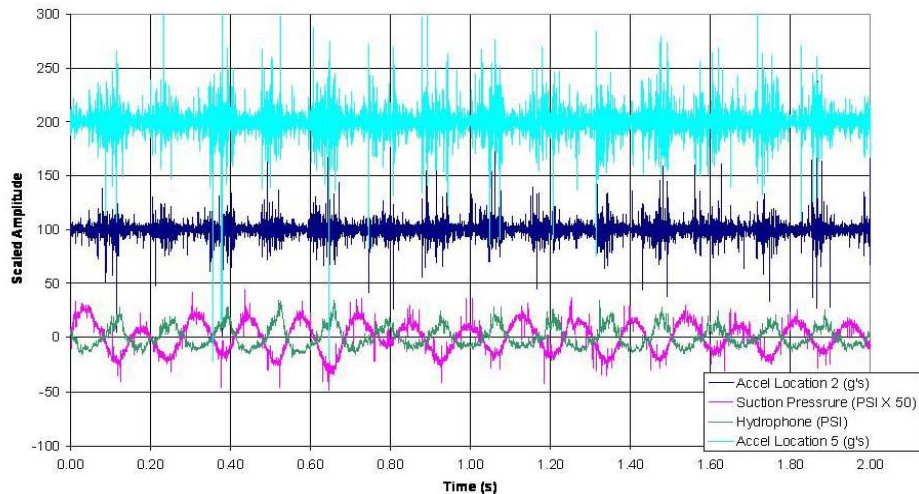
Figure 31. Pump F, exhibiting a phenomenon known as “cavitation surge”. Accelerometer readings at two locations on the suction bay are compared to output of a suction pressure piezoelectric transducer, and a line-of-sight hydrophone. Cavitation surge involves the cyclic occurrence of classical cavitation the vane passages, generally at the rate of 5 Hz to 20 Hz. The passages fill with cavitation bubbles, restricting further flow, which then reduces dynamic pressure drop. In response, static pressure in each vane passage increases above the vapor pressure, eliminating the cavitation and permitting full flow to develop again. The velocity associated with the full flow reduces the suction pressure below the vapor pressure in the vane passage, and cavitation returns, blocking the passage. This cycle continues with an audible chugging noise. The authors have encountered this unusual phenomenon primarily in double suction pumps.
