ASIA TURBOMACHINERY & PUMP SYMPOSIUM
MARCH 2018 | SUNTEC SINGAPORE

Mechanical Seal Failure in the oil flooded compressor

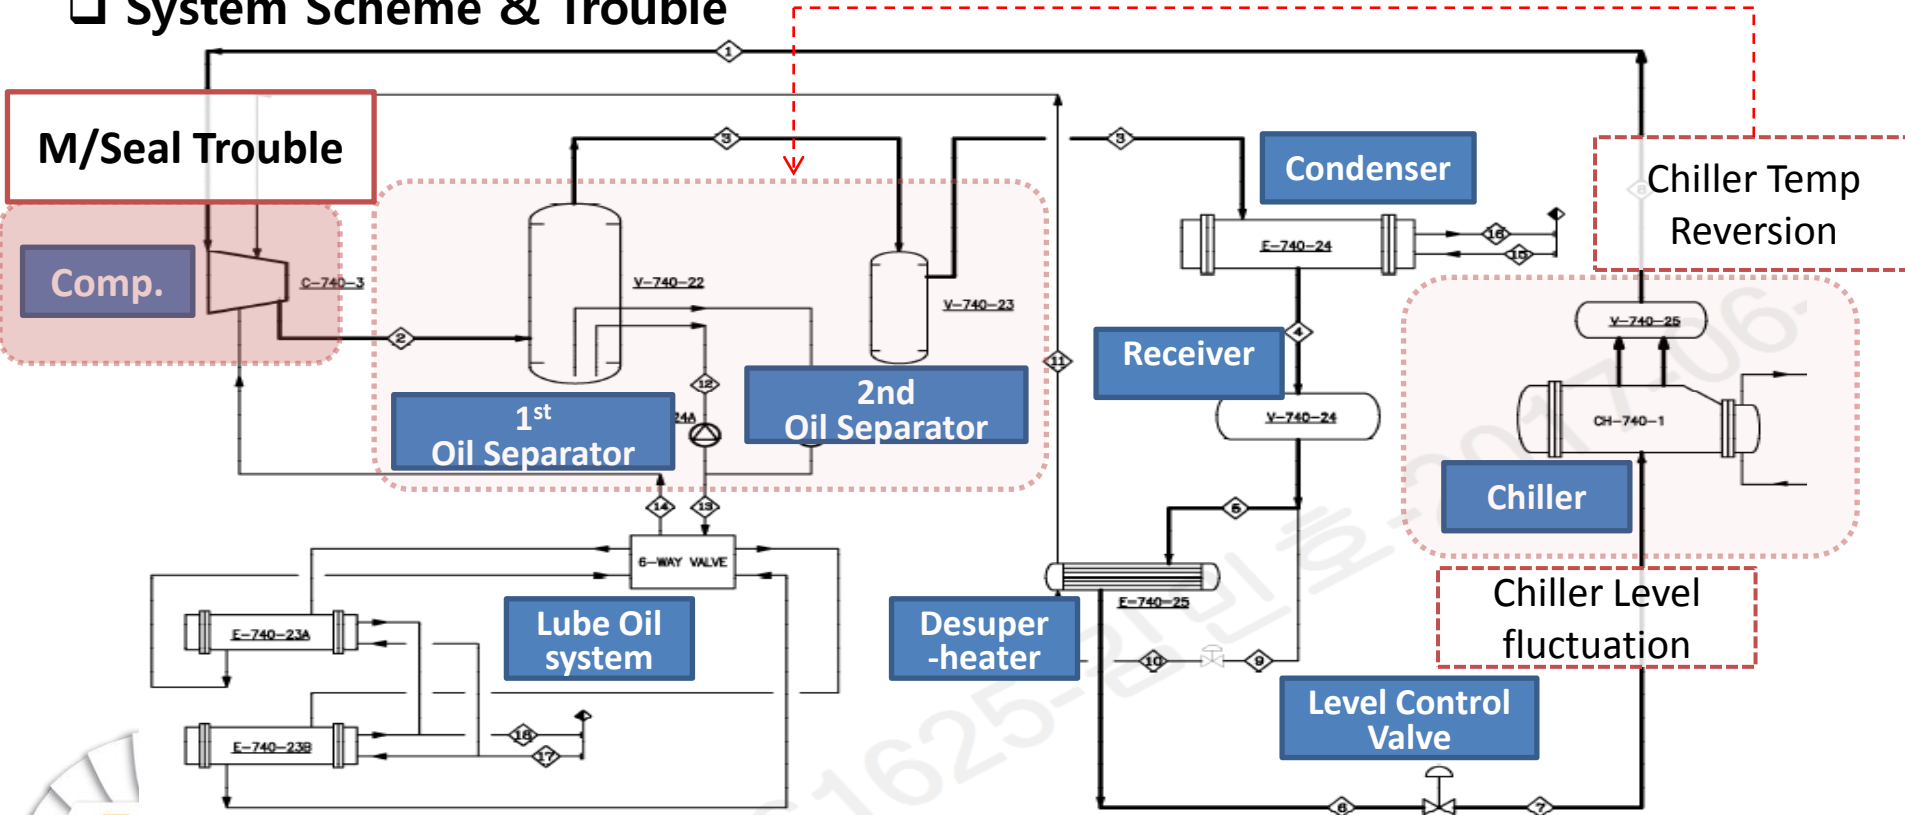
System Scheme & Trouble

- 1) **Jul. '2014 – The refrigeration system start-up**
- 2) **Jul. '2015 – 1st Mechanical Seal Trouble : Emergency shut down**
Mechanical seal replacement without any modification
- 3) **Oct. '2015 – 2nd Mechanical Seal Trouble : Emergency shut down**
Mechanical seal replacement without any modification
- 4) **Jan. '2016 – 3rd Mechanical Seal Trouble : Planned shutdown**
Mechanical Seal was modified to change the roughness from 30 um to 60 um and additional flushing line was installed → **Failed**
- 5) **Mar. '2016 – 4th Mechanical Seal Trouble : Planned shutdown**
Mechanical seal was modified to face flatness. The light band on seal face was adjusted as 7 L.B. → **Performed well**

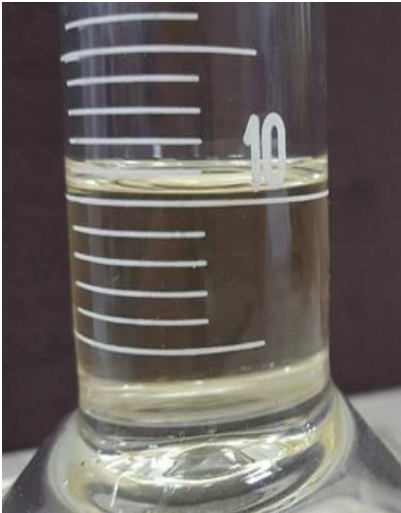
13. Jan. '16

53.3 cc/day

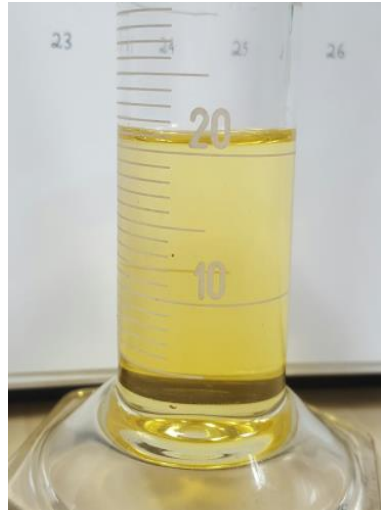
5. Feb. '16

55.9 cc/day

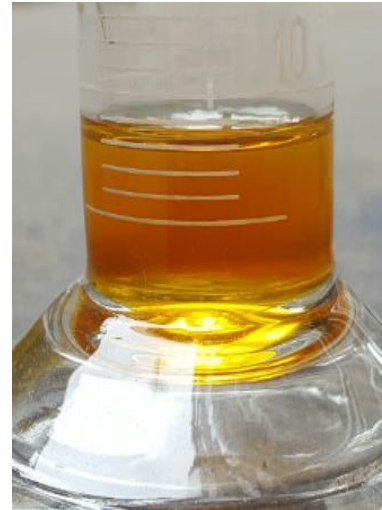
11. Feb. '16

43.2 cc/day

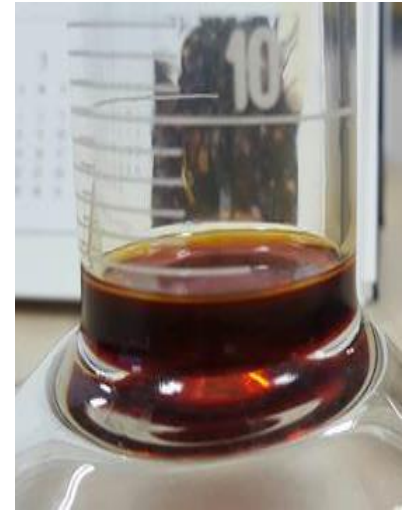
17. Feb. '16

19.2 cc/day

Dark !!

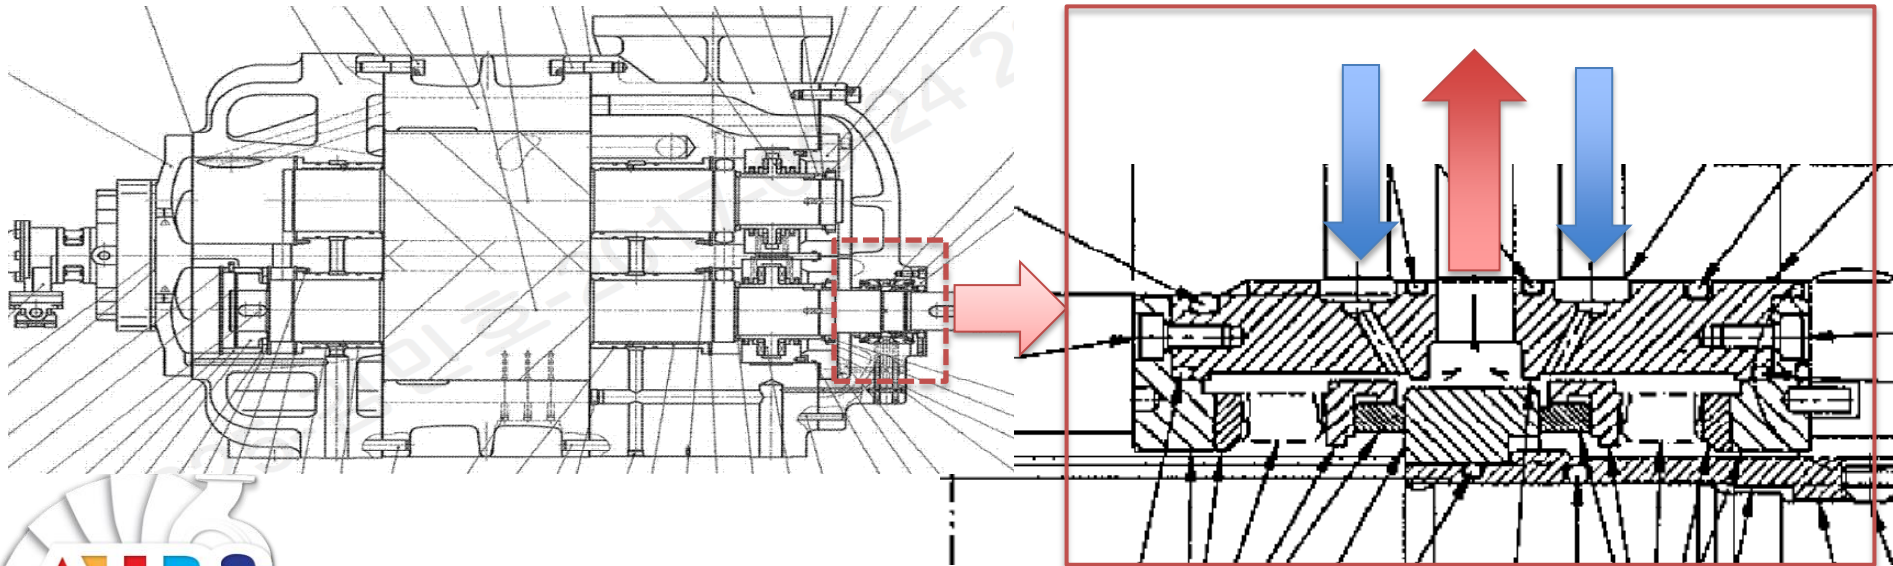
- Type : Dual Pressurized Seal / Face to Face
- **Oil Injection Rate = 21 LPM**
- Seal Face Material (Stationary / Rotating) = Carbon / TC

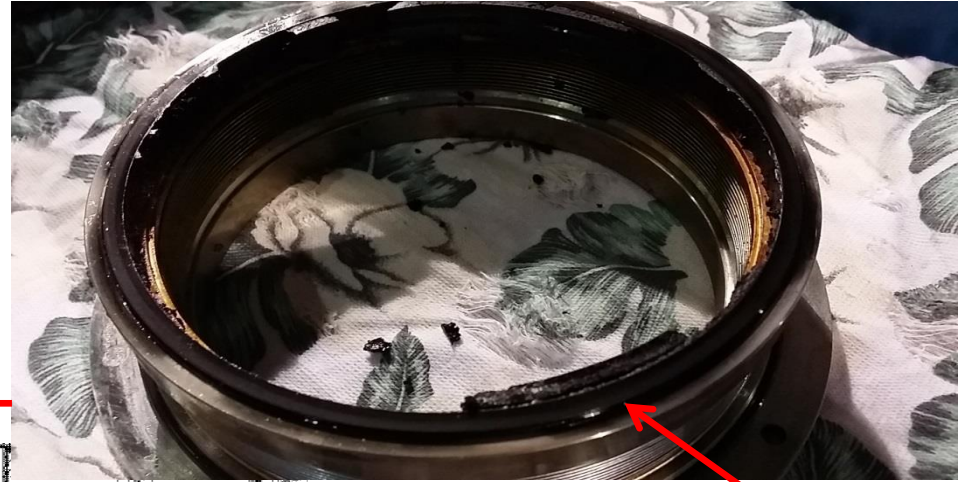
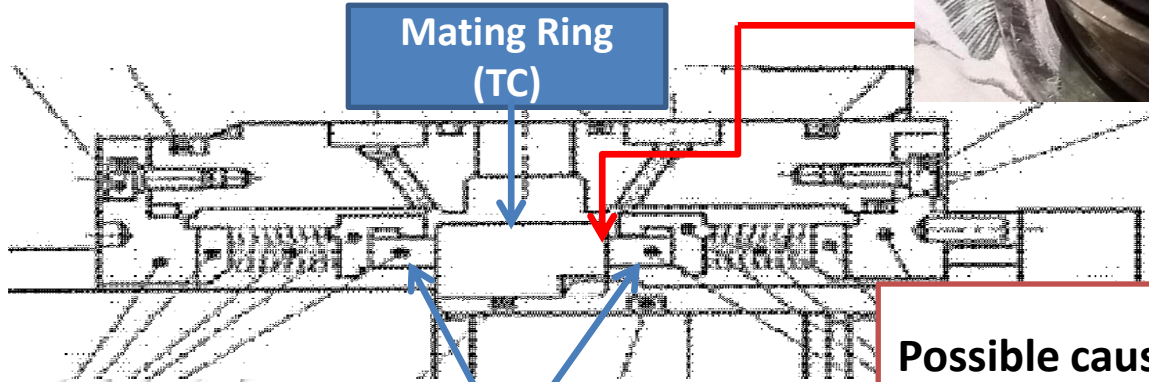
Carbonization
< Stationary Ring >

- The carbonization happened at the inner dia. of outboard seal
- Sealing Face looks good, not bad except for carbonization
- There is no carbonization on Inboard side and the Mating Ring was clean

**Oil
Carbonization**

- **Oil Carbonization** on the Stationary Ring by the Heat
- Carbonization deposit makes the seal faces opened

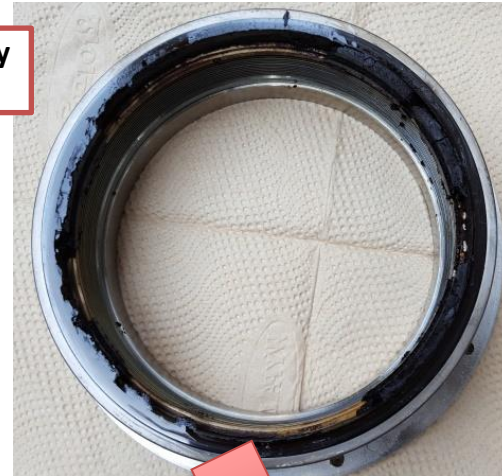
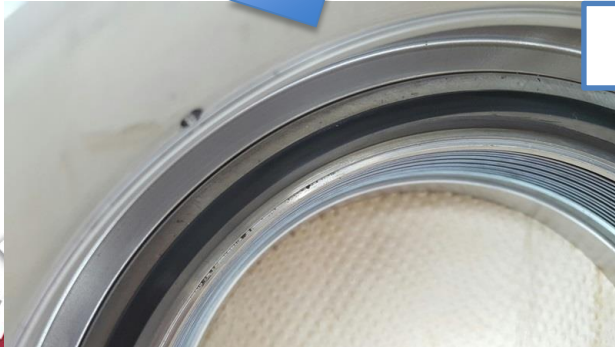
< Outboard seal >

Oil Carbonization

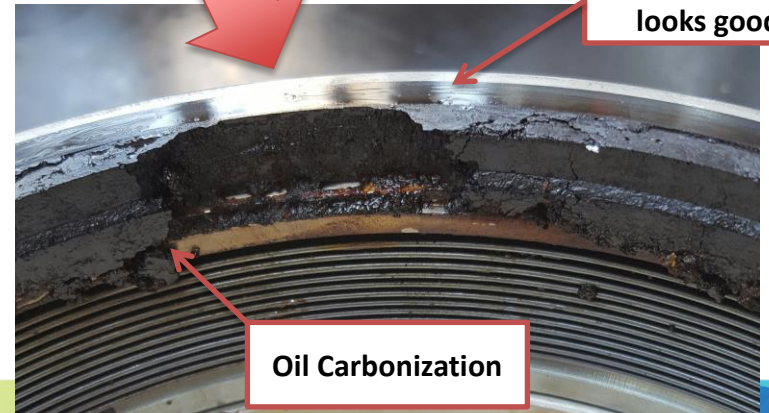
Mating Ring

Seal Face looks good

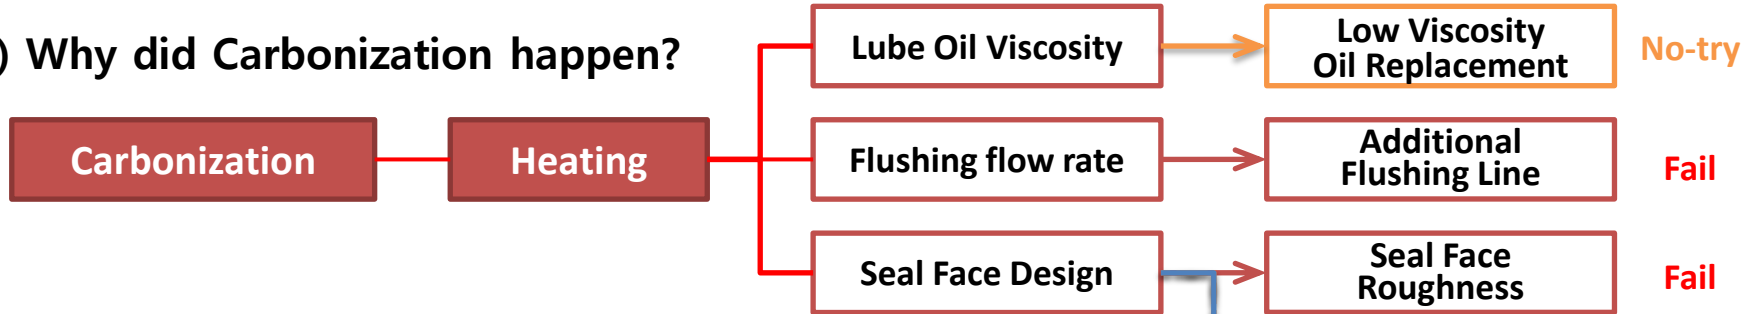
1) Why did Carbonization happen?

According to our analysis, the carbonization came from the high lube oil viscosity, low flushing flow rate, contact with air, and high differential pressure on the seal faces.

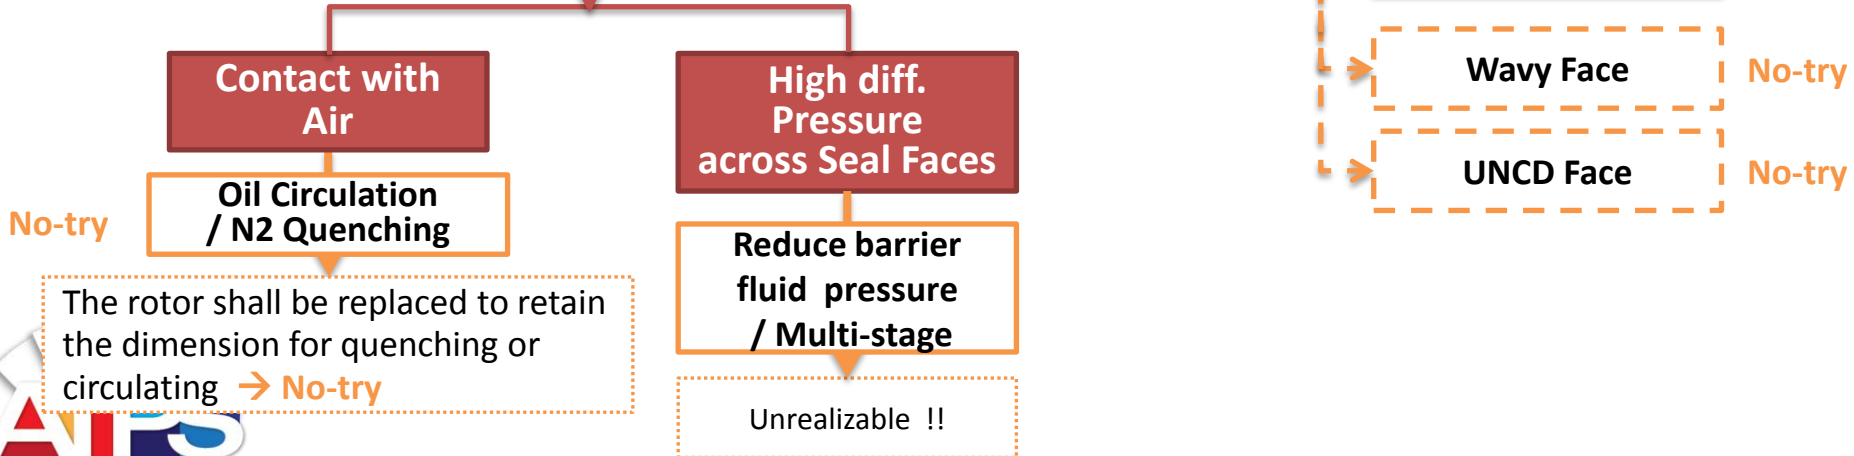
2) Why did the Carbonization happen on Outboard only ?

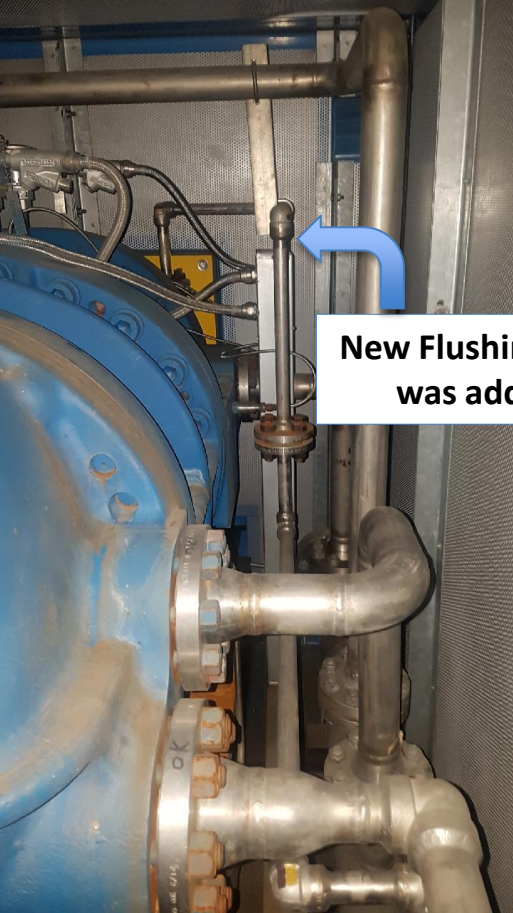
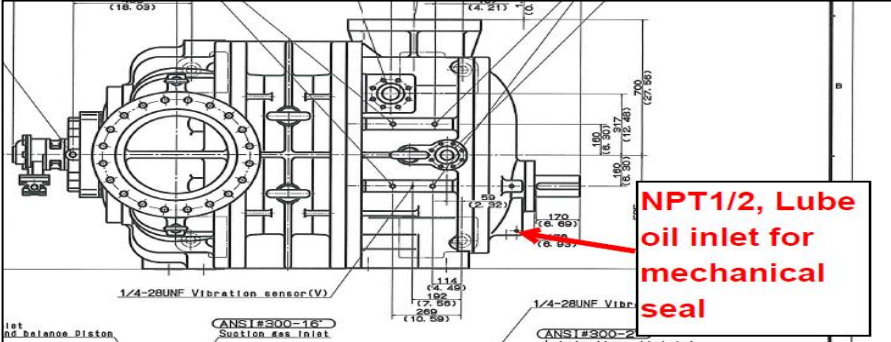
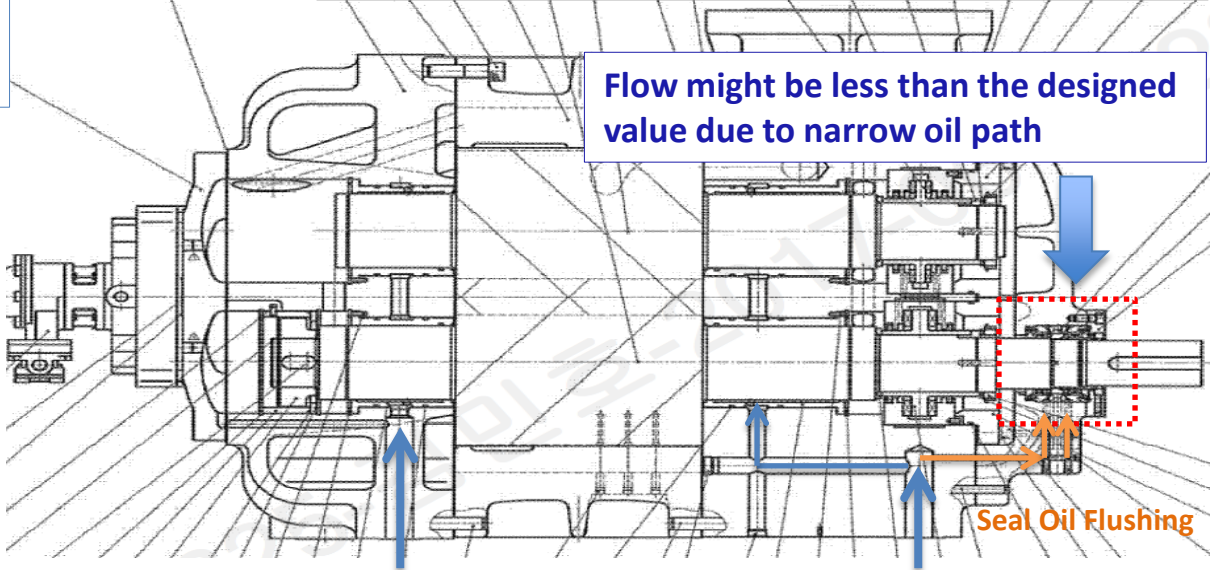
New flushing line

But these trials did not help and the carbonization happened again in 3 months

2) Installation of the additional flushing line

- In the oil-flooded screw compressor, the seal was located at the end of the main rotor's shaft.
- There is no oil injection line for mechanical seal only
- Oil was injected through the radial and thrust bearing.
- The new flushing line was added to increase the oil injection flow.

New Flushing Line was added
