ASIA TURBOMACHINERY & PUMP SYMPOSIUM
MARCH 2018 | SUNTEC SINGAPORE

Steam Whip phenomenon in Steam turbine

GE D11 180MW 3,600RPM

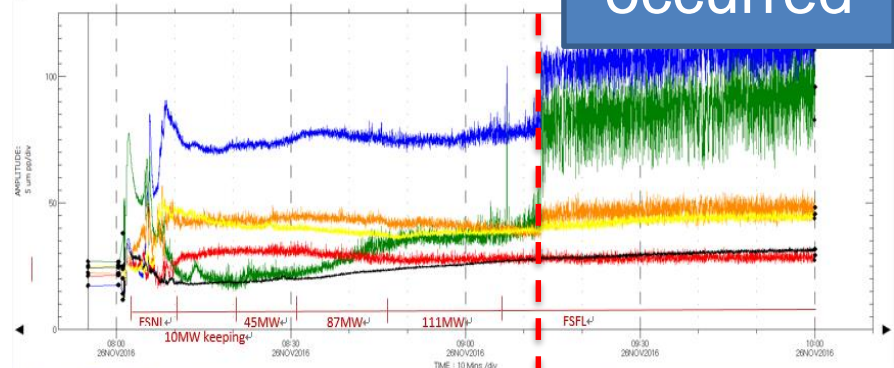
Start-Up and Loading

22.5Hz
occurred

While the load kept Full load, the high vibration situation was suddenly occurred. The vibration amplitude of BRG#2 was raised up 63um and BRG#1 also was observed raised 22um.

The 1X component did not change any vibration value at same time with this situation.

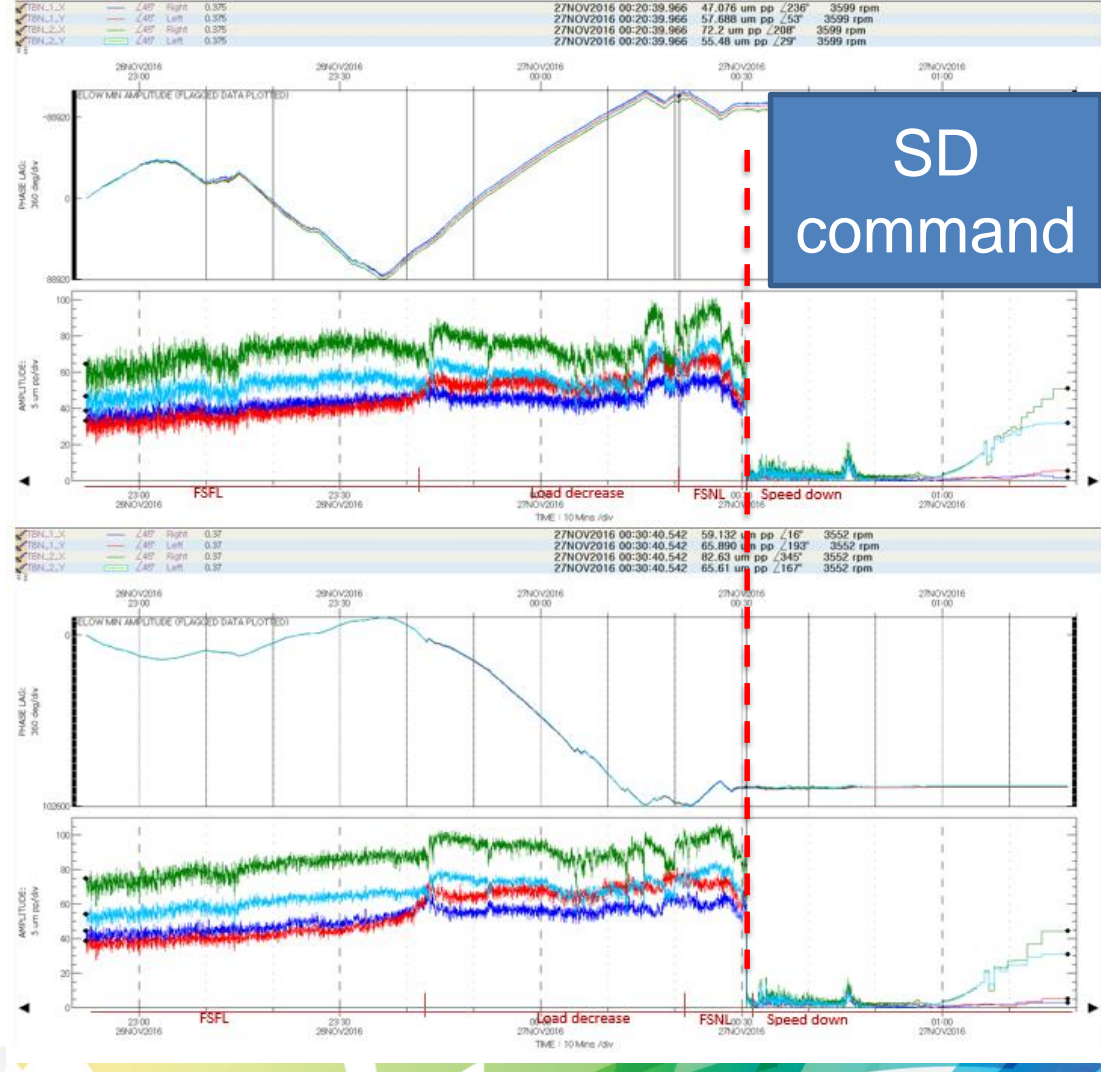
Shutdown

The high vibration level component disappeared immediately after SD command - at 3540 RPM.

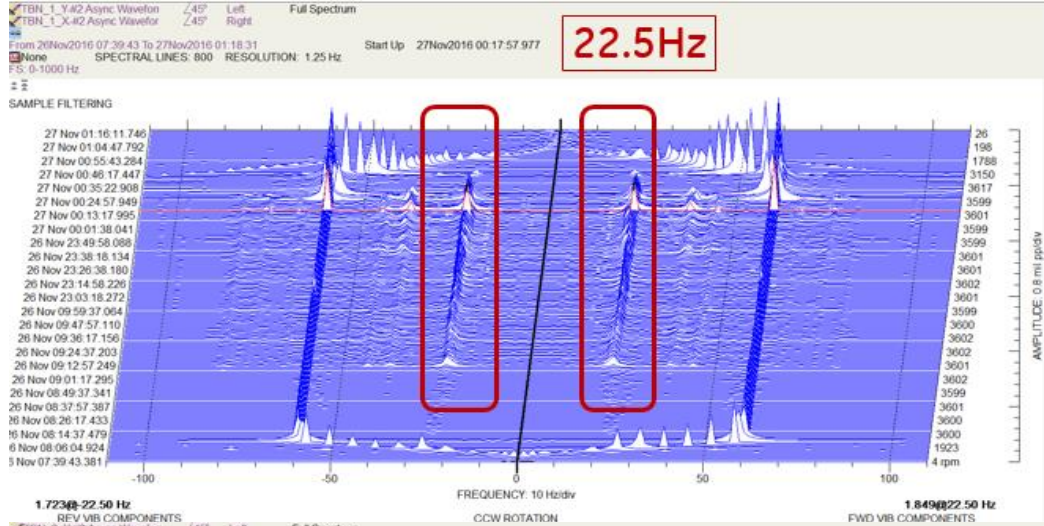
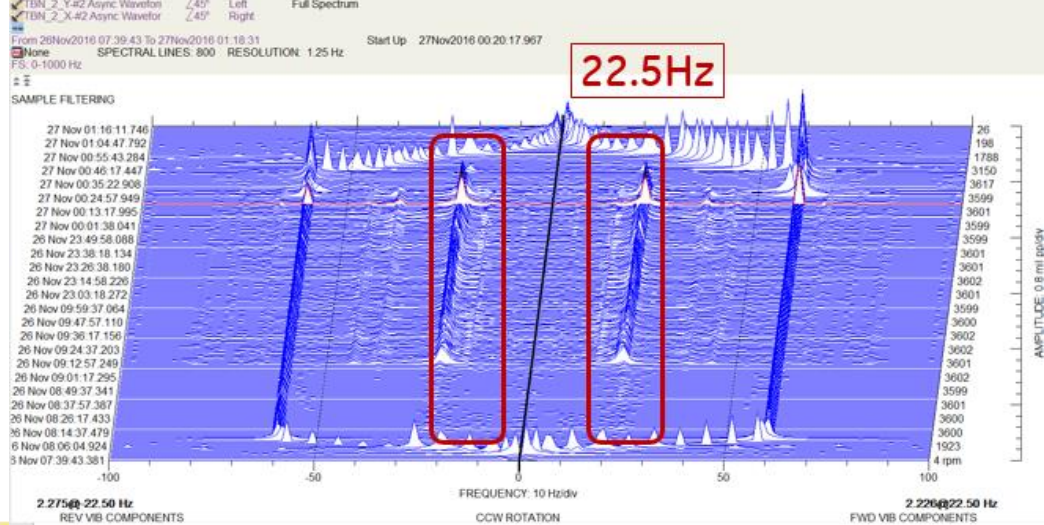
SU, Loading, SD

The dominant component of high vibration is 0.375X of shaft rotation speed(22.5Hz).

The high vibration level component disappeared immediately after SD command - at 3540 RPM.

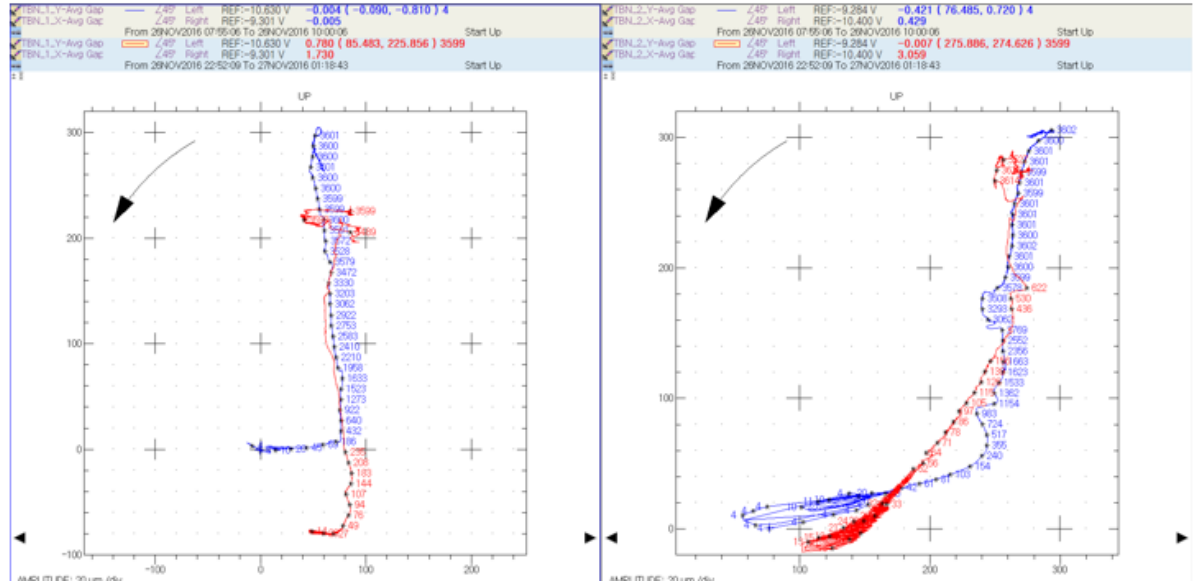
SU, Loading, SD

There are **no any significant changes** in the shaft centerline detected during mentioned 22.5Hz component appearing at FSFL and disappeared during SD.

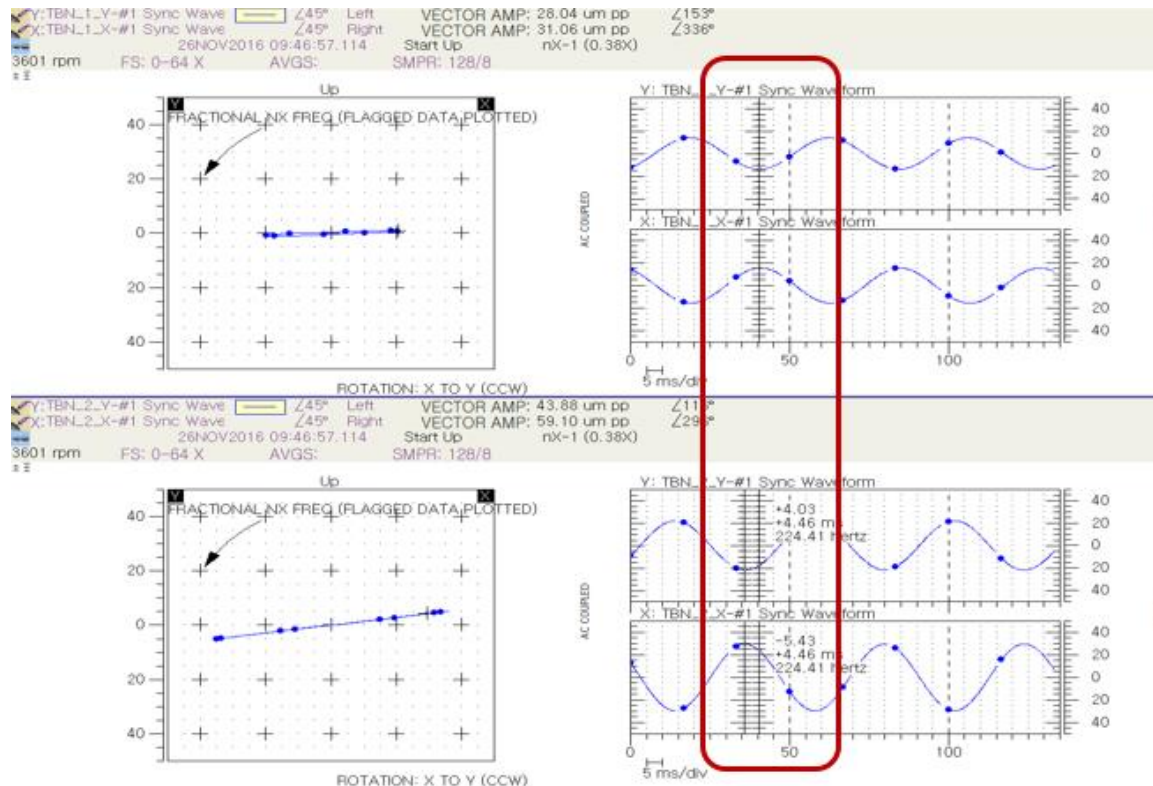
0.375X phase

The phase data analysis of filtered 22.5Hz shaft rotation component demonstrating app.35 degrees phase leading for BRG2 - the instability source location is close to BRG 2 plane.

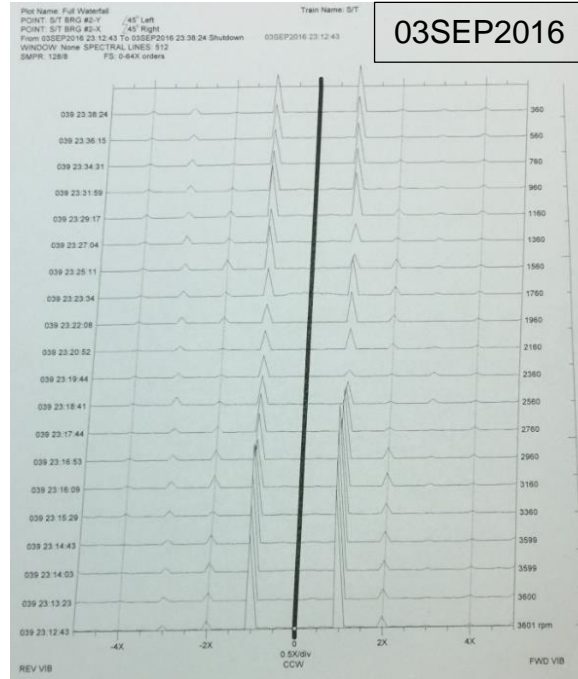
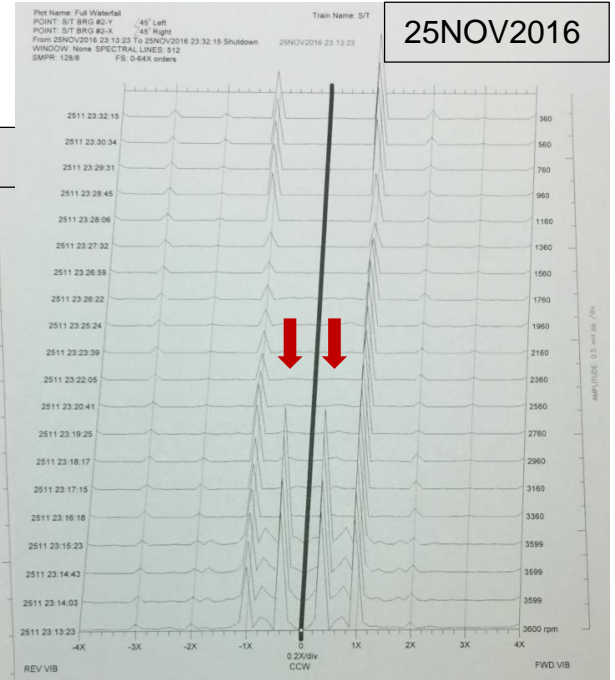
Before and after overhaul

There is clear sign of discussed 22.5Hz component in the waterfall plot for after overhaul condition, but before overhaul it was absent.

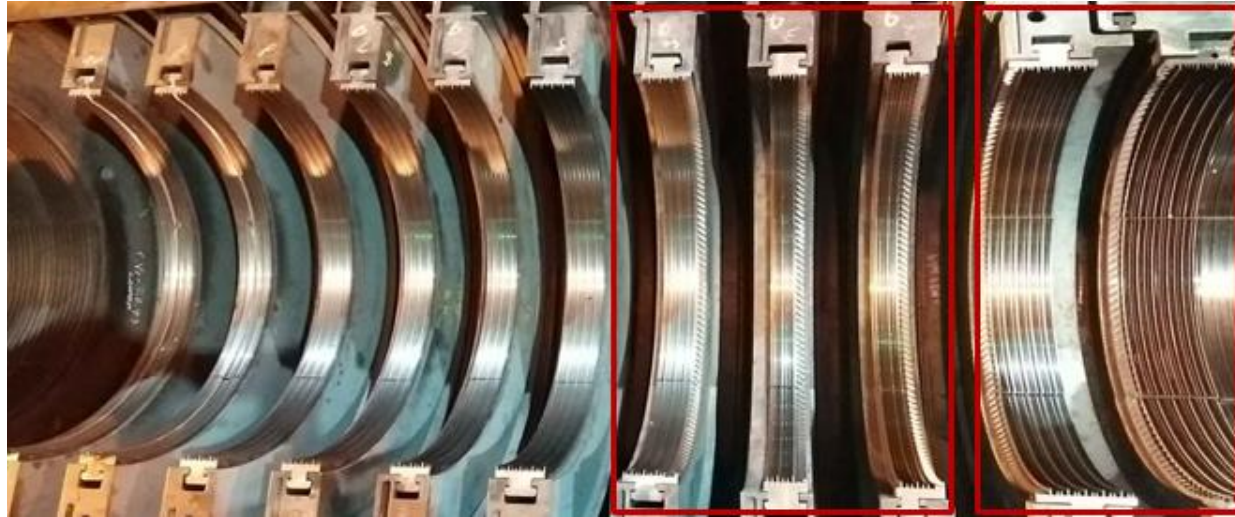
Anti-swirl

Resent overhaul data:
“Replace to H/IP
retractable packings (1
antiswirl conv./14 retr./2
brush) and N2
conventional packings.”

It is expected that this system is installed or operated not properly. Non-original spare parts were used and installed without OEM installation guide.

- Short term:
to limit Unit load, operate below stability threshold, MW
- Long term:
Steam turbine replacement by new, same model Unit, since the designed turbine resource is already expiring
