Engine Driven Pumps - Vibration Problem Resolution Using Specialized Testing Techniques

A. Aziz Al-Qattan, Bahrain Petroleum Company
William D. Marscher, P.E., Mechanical Solutions, Inc.
Andrew Savage, Bahrain Workshop Company
Eric Olson, Mechanical Solutions, Inc.

1st METS Turbomachinery Symposium
February, 2011

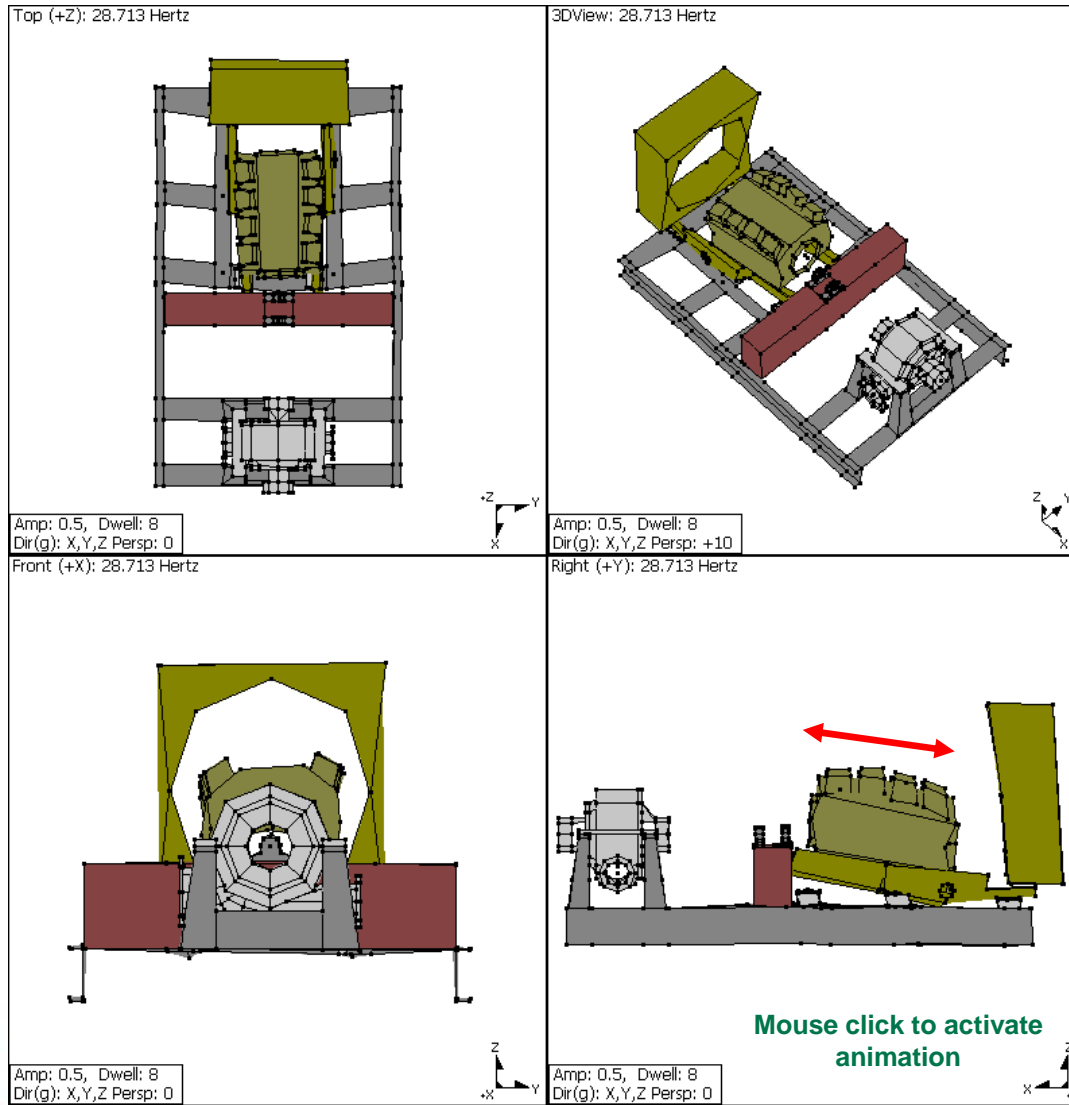
1x rpm (1722 cpm).

The animation shows flexibility of the diesel engine supports.

Pump remains stationary.

- Engines are moving considerably relative to the pumps due to flexible mounting pad support of engine feet.
- Transmitted motion through shaft to other system components including the P2952X steady bearings and their support beam, and the pump/pedestal.
- Vibration greatly amplified at select operating speeds leading to strong engine-driven harmonic response at multiples of $\frac{1}{2}$ x engine rpm.
- Engine mis-firing caused $\frac{1}{2}$ x rpm force response excitation (“picket fence”).
- Engine soft-mounting amplified the response levels.

- Replace flexible mounts with single or two-piece shim pack of equal height (no stacking of thin multiple thin shims). Retune engines to minimize mis-fire ($1/2 \times \text{rpm}$) excitation.

- Flexible rubber mounting pads replaced with appropriate metal shims.
- Engine tuning verified.
- Grout added under the engine.
- Engine rpm reduced.
- Impeller diameter increased to meet flow and head requirements at lower engine rpm
