ASIA TURBOMACHINERY & PUMP SYMPOSIUM
MARCH 2018 | SUNTEC SINGAPORE

Molten Urea Transfer Pump Seal Failures – Case Study

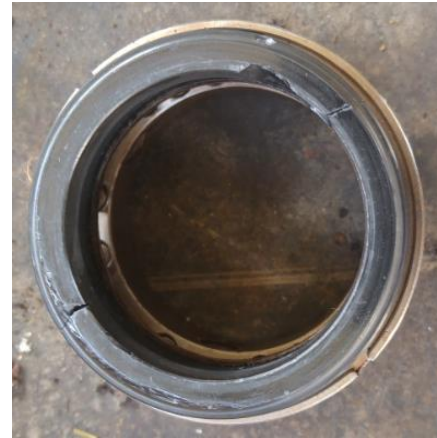
- Inspection of failed seal components was conducted of a recent failure to help in narrowing down the cause of failure. Mentioned below are the salient findings:
 - Pump **bearings** found in okay condition, **excessive axial or radial movement not observed**
 - All **secondary sealing** elements found okay
 - **Runout** on Seal area of shaft found within acceptable limits
 - **Even wear marks** observed on the seal faces **without deep scratches**
 - **Both seal faces found shattered**
 - **Hold tank level drops observed in Level monitoring record**

Shattered Rotary Seal Face

Root cause of shattered seal faces is
heat shock by pump cavitation. (2)

Mode of Failure	Measure	Combined Effect
Cavitation	Alarm Level increased from 10% to 20% level of Holdup Tank	Zero seal failures in the last 6 startups and changeovers
Variation in Conc. Of Urea solution	Urea melt pumps are now lined up post confirmation of high concentration

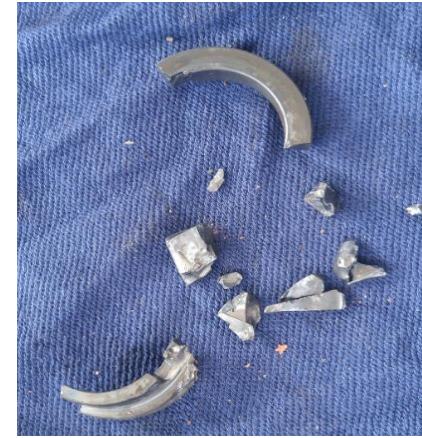
Shattered Stationary Seal Face

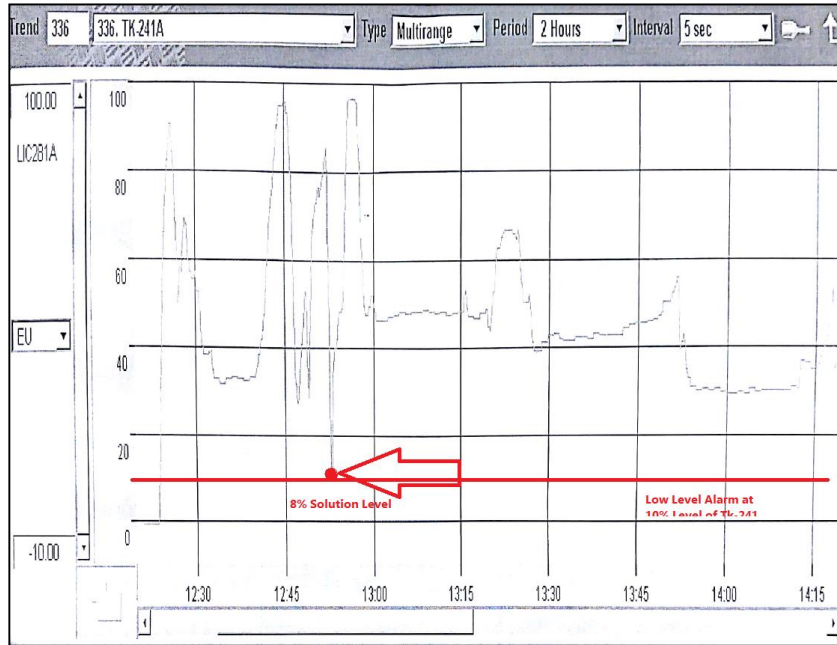
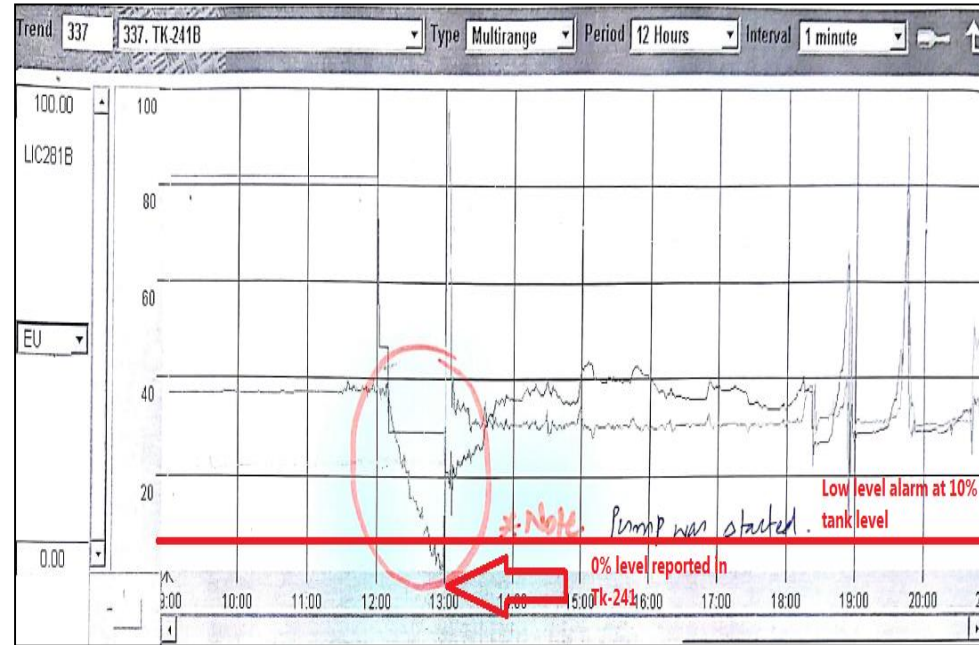
Hold up vessel level monitoring during O2 separate startups with reported seal failure

- The biggest contributor of Mechanical Seal failure was finalized as **Cavitation and variation in Concentration of Urea solution** as:
 - Neighboring industries also confirmed failure mode to be **shattering of seal faces**
 - Failure instances corresponded with **Low liquid levels in hold up tanks**
- Following is the breakup of the improvements made so far:
