Blade failures on an axial compressor by unexpected gas compositions

Marco Schwarz, MAN Diesel & Turbo SE

A fifteen stage axial compressor including a bleed extraction was subject to a major overhaul after nearly 20 years of trouble free operation. Shortly after recommissioning and resumption of the production the compressor faced three major failures within two weeks.

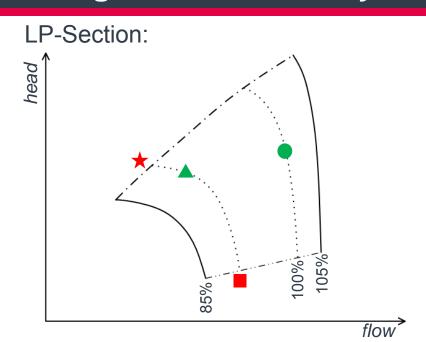
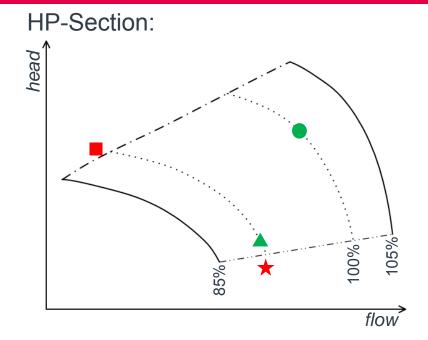
Background: Thermodynamic consideration

IB closed 24 g/mole,

IB partially open

(correct)

IB too little open

(faulty)

IB too much open

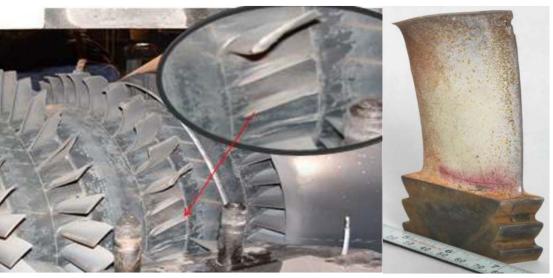
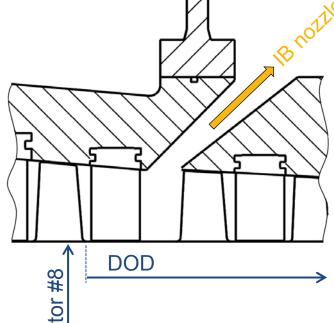
Failure #1, January

Compressor tripped after 2,5 days of operation from the re-start after a planned outage

due to high vibrations:

- Four blades of rotor #8 liberated
- Several blades of rotor #8 fractured
- Downstream rows damaged by Domestic Object Damage (DOD)

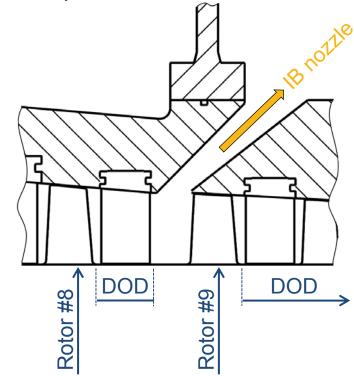
Failure #2, February

Compressor tripped after 3 days of operation from compressor re-start:

Rotor #8:

Rotor #9:

- Rotor #8 liberated completely
- Four blades of rotor #9 liberated
- Downstream rows damaged by DOD

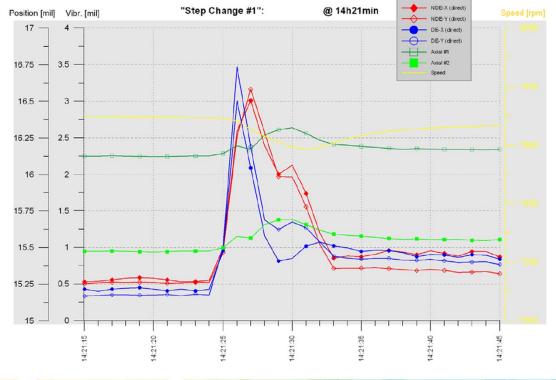
Failure #3, March

- For the third re-start, several immediate countermeasures implemented. However...
- Significant step changes in vibrations shortly after third restart but no compressor trip
- Step changes in vibrations indicate further liberation of four blades of rotor #8...
- Due to non-availability of further spare parts: Keeping the unit in operation as long as possible (goal: ~7 month)

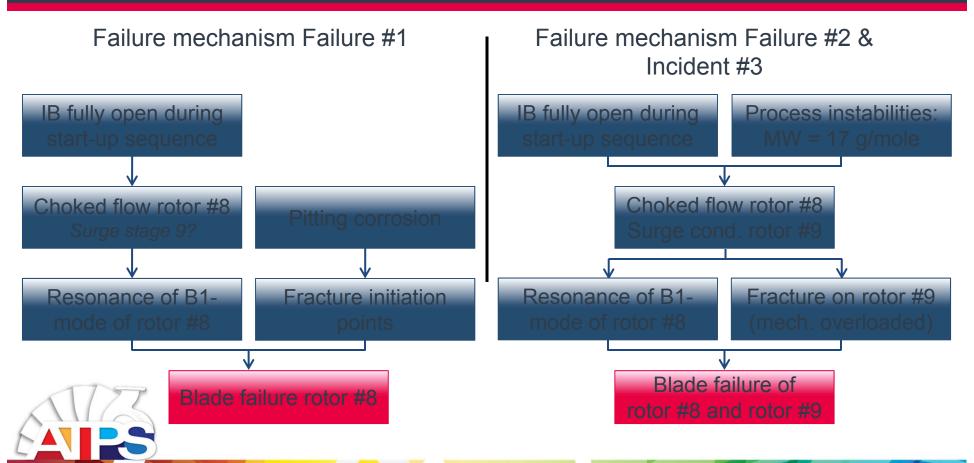
RCFA: Failure Mechanisms

A root cause failure analysis was conducted and revealed that the process plant start-up procedures caused gas compositions which deviated strongly from the design conditions. The valve designs as well as the available control parameters were not able to protect the compressor from off-design operating conditions.

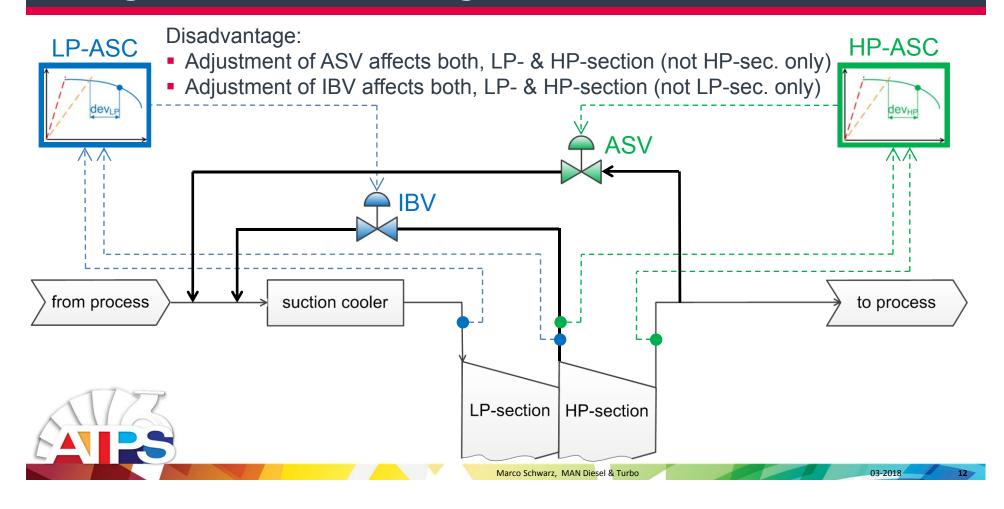
Original Valve Control Logic

The existing control logic was not capable of controlling the safety valves during periods with heavy gas composition fluctuations

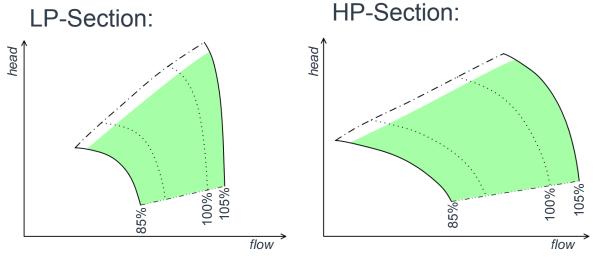
Results After Field Implementation

No more adverse operations outside of the operation envelopes, not even at low molecular weights

No further failures or compressor trips due to related issues
