46TH TURBOMACHINERY & 33RD PUMP SYMPOSIA
HOUSTON, TEXAS | DECEMBER 11-14, 2017
GEORGE R. BROWN CONVENTION CENTER

Thrust Balance Line Bolts Failure

Felix Cestari, Compressor Design Engineer, Siemens
Robert Briggs, Pipeliner Product Line Manager
Regis Fowler, Head of Product, MTO
Ge Jiangang, Production Manager, PWPC PetroChina

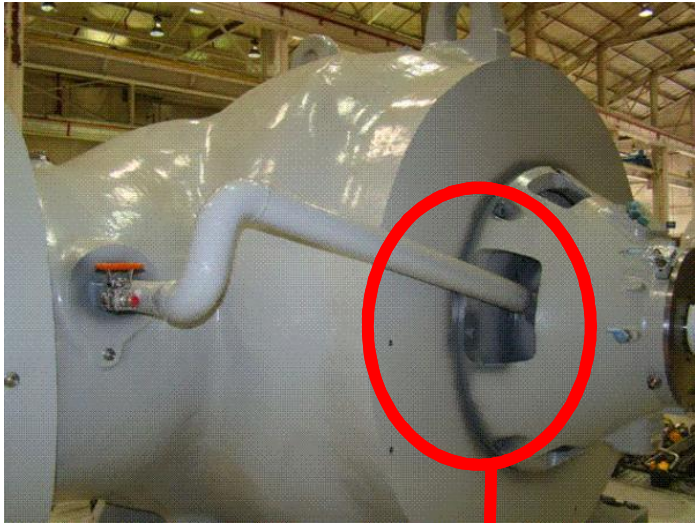
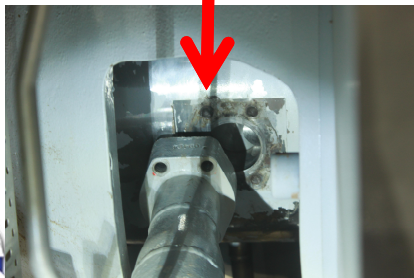
- High gas leak tripped the gas detectors safety system of the building.
- The station was evacuated for a Level I hazard (potential for gas ignition and explosion).
- Thrust balance line (TBL) detached from its flange connection allowing the gas to escape.
- Bottom picture shows the permanently deformed TBL, as found after the failure.

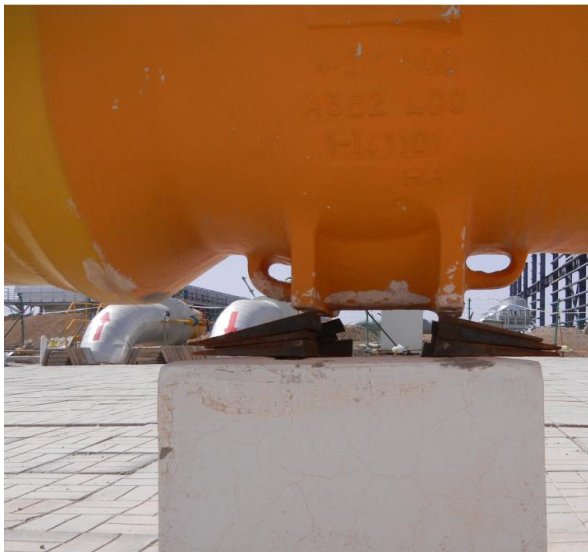
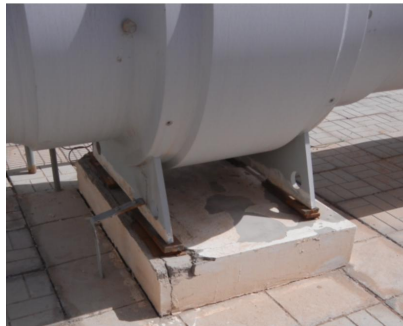
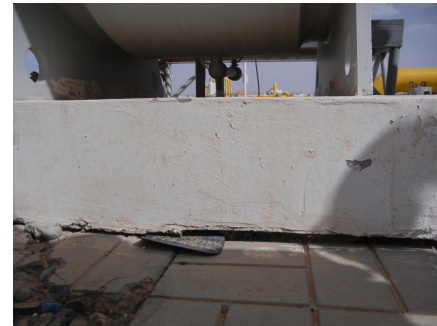
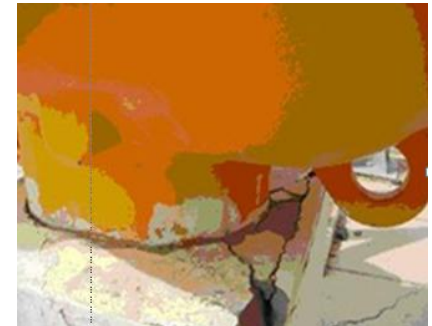
Site Visit September 2014

- Unsupported piping & valves.
- Soil settling in the valve yard.
- Severe damage in yard valve supports.
- Sandy soil composition.

- Restore and secure the piping support system.
- Inspect periodically the piping support system for cracks, looseness of nuts, piping movements.
- Keep existing damper at the thrust balance line.

- Provide solid foundation for the station piping system.
- Assure the piping supports system are at design conditions.
- Inspect the piping support system integrity.
 - ✓ Check nozzle flange-to-flange alignment.
 - ✓ Remove existing damper at the thrust balance line.

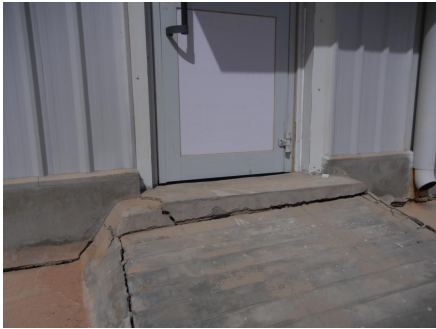
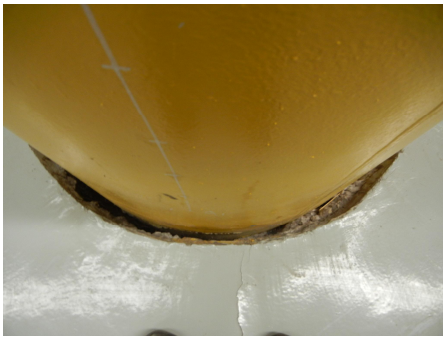
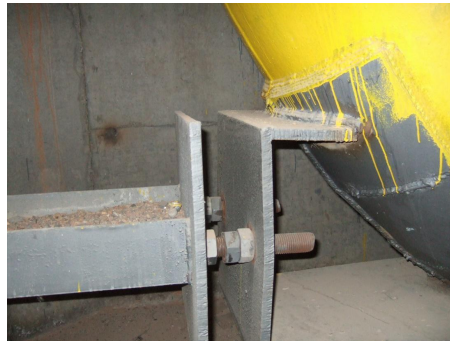
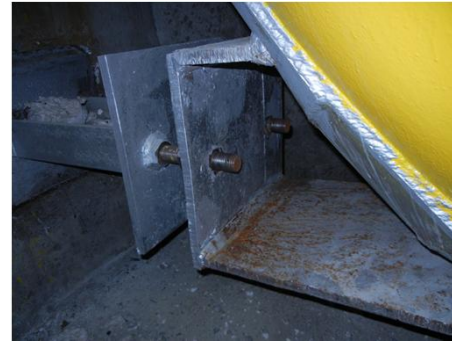
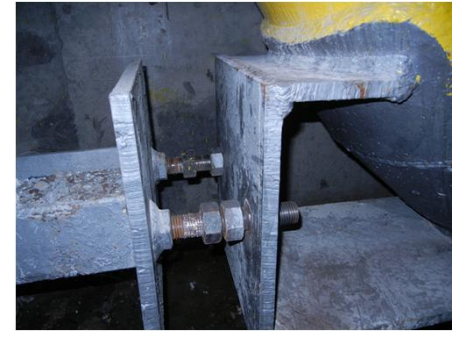
Site Visit (Cont.)

- Building floor with large cracks.
- Weakened piping supporting structure.
- Pipe underground support bent.
- Pipe underground support unsecured/loose.
- Loose / detached nuts from plate studs.

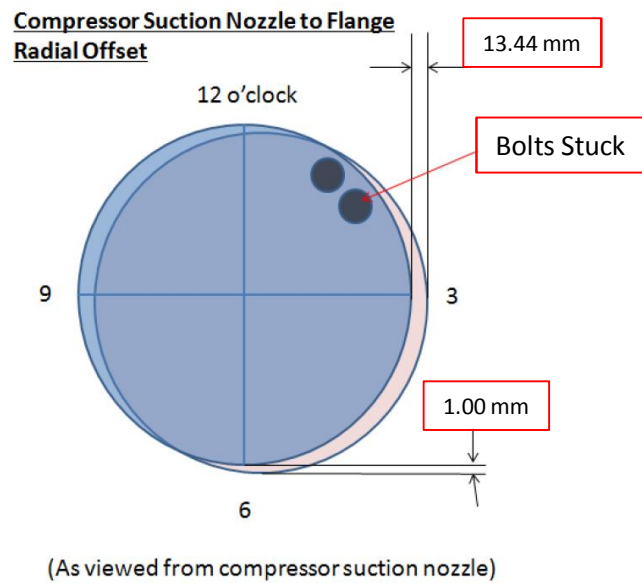
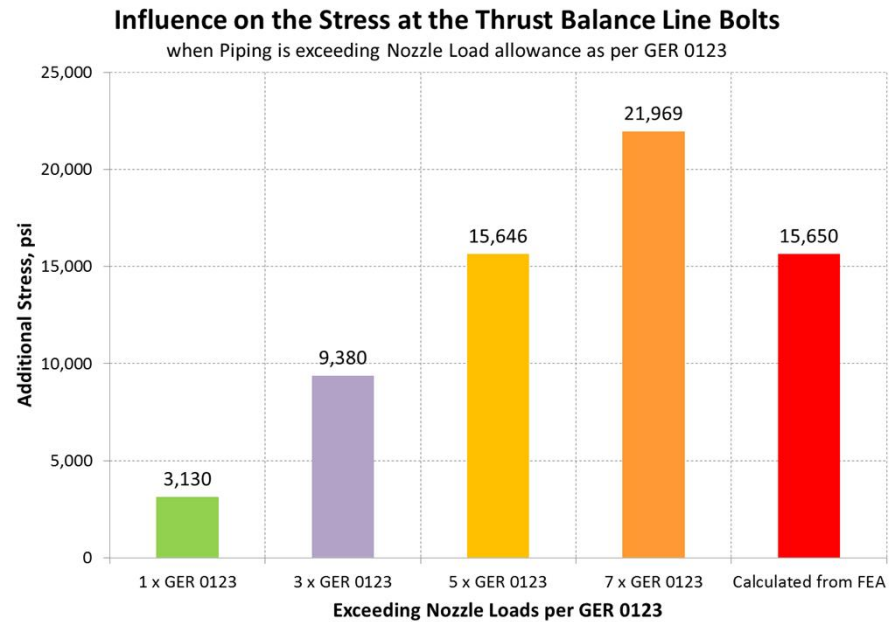
Site Outcome

Calculated stress equivalent to five (5) times allowable nozzle load.

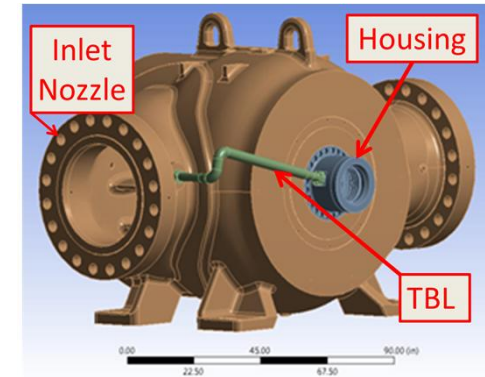
- Nozzle loads are the net forces and moments exerted on the compressor flanges from the connected piping.
- These forces and moments are transferred to the casing at the connection flanges.
- The casing deforms, which also distorts the TBL, leading to stress at the TBL cap screws.
- The figure on the right shows the rigid TBL connected to the casing nozzle and housing.
