ASIA TURBOMACHINERY & PUMP SYMPOSIUM  
MARCH 2018 | SUNTEC SINGAPORE

# Failure, Repair and Overhaul of 5 MW Right Angle Reduction Gear Box

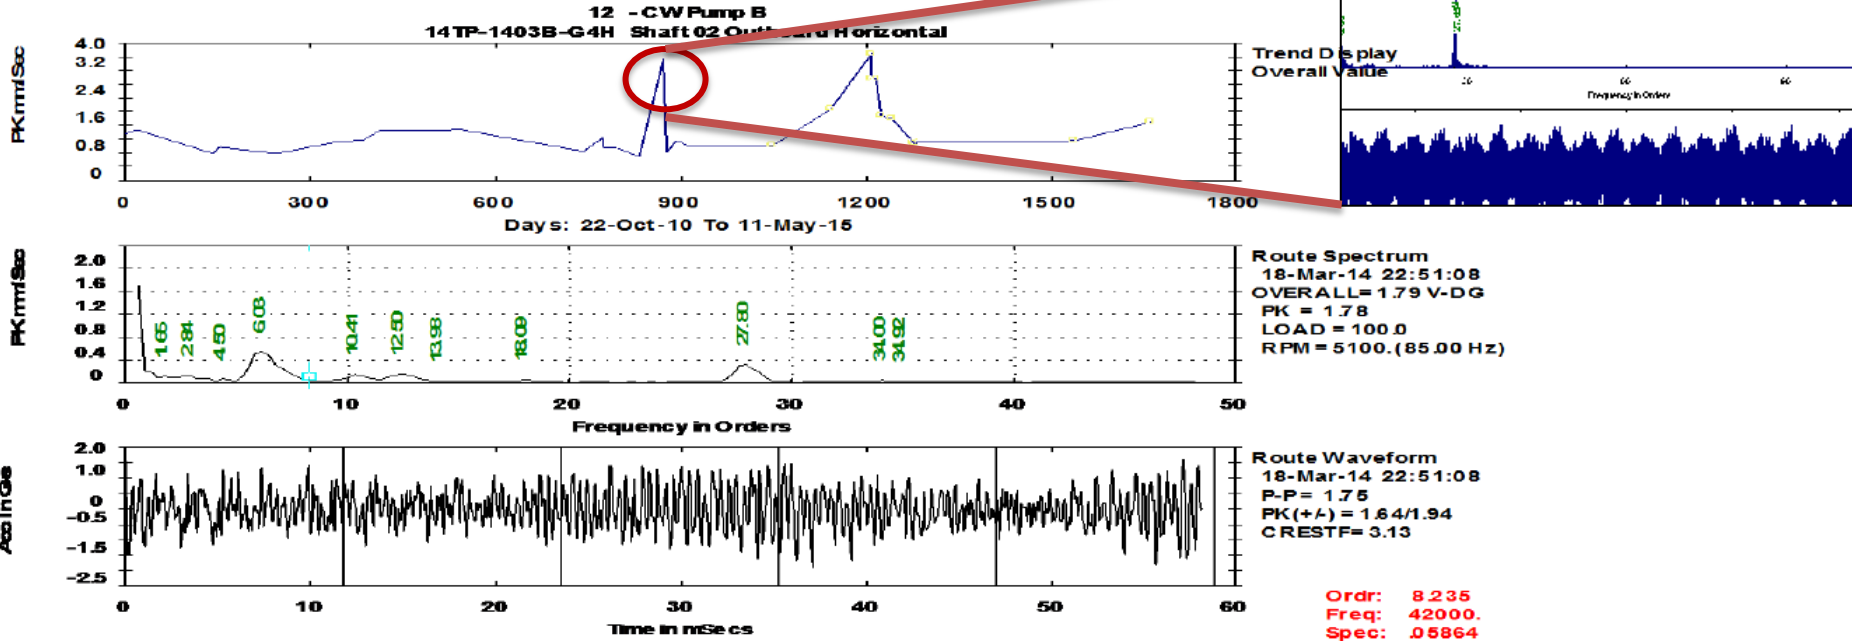
Typical trend of Broken tooth-Fish Tail wave forms

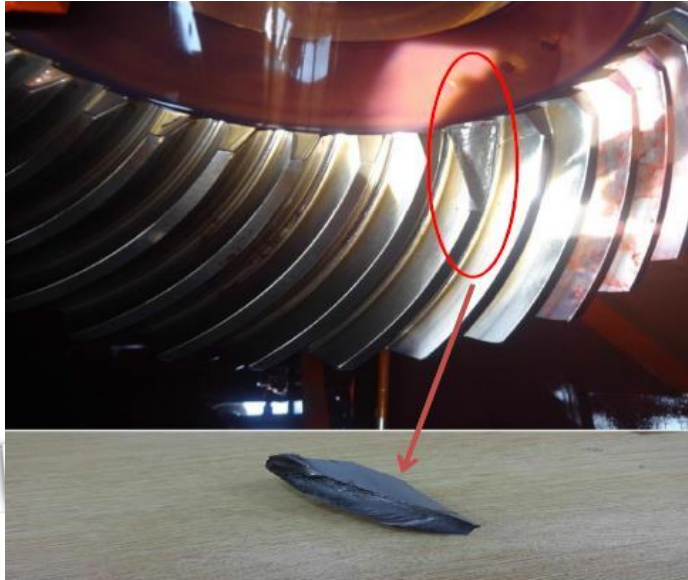
L-1403-B, Broken LS  
Bevel Gear tooth

- Loose pinion on shaft had resulted in repeated cyclic loading on the LS gear which eventually generated the high stress points on gear teeth
- During Startups, the initial torque on gears are normally high, therefore post black out, upon TP-1403B startup the high stressed portion on a LS gear teeth had given away, resulting in high noise & vibration
- Bevel gear pinion interference with the shaft was not adequate (which is a design Work-man ship related flaw). That further aggravates during the course of time & eventually resulted in failure.

- Machining of Internal Diameter of Bevel Pinion to ensure uniform Diameter
- Build-up of Shaft using Electrode E-6010 followed by PWHT
- New Keys and Keyway Machining. Keys to be Snug fit
- DPT & MPI of all parts
- Increased interference to 0.003" between shaft and pinion
- Smoothing of broken tooth area on Bevel Gear.

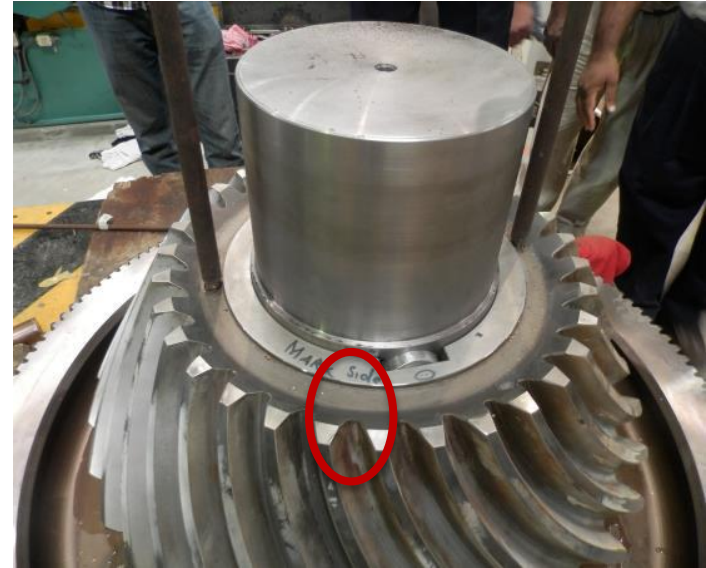
L-1403-B worn HS  
Bevel Pinion Teeth

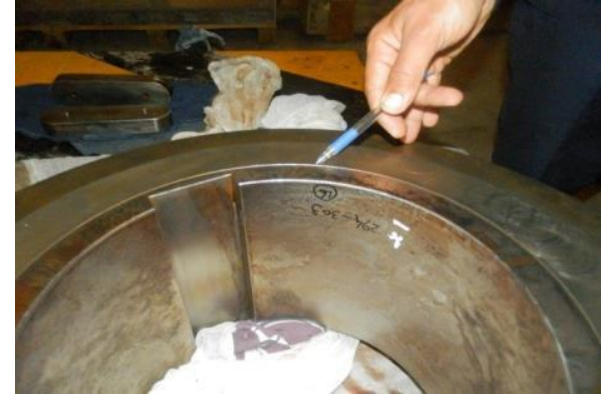
Extruded Keys – High Torque

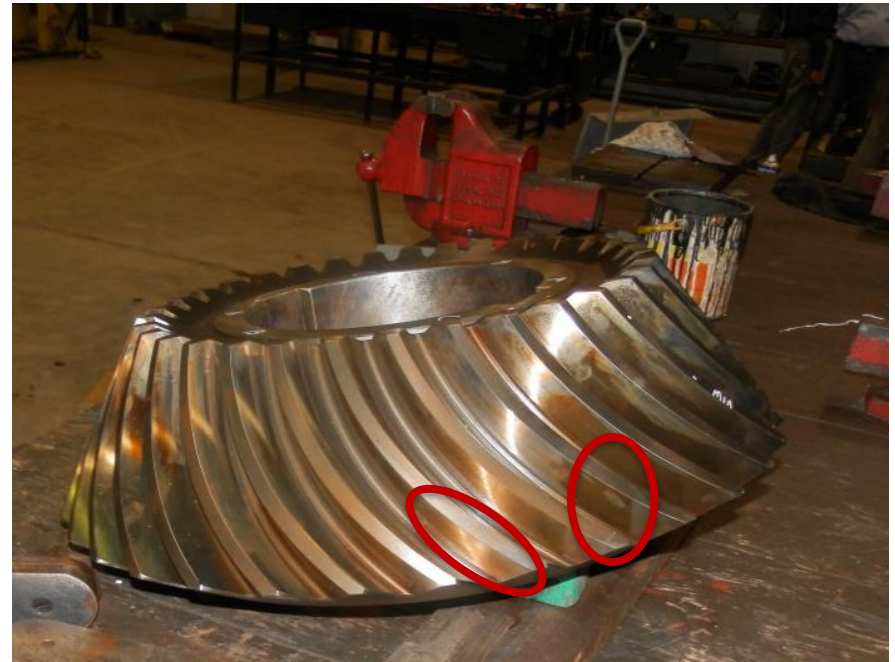
L-1403-B

Bevel Pinion (which meshes with LSS gear) was found **0.018"** loose on shaft (which ideally should be interface fit with the shaft)

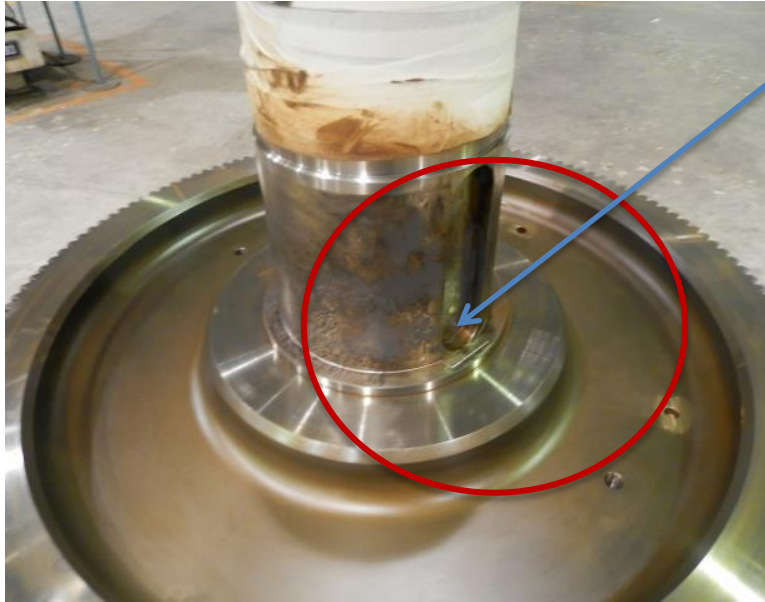
L-1403-A

Fretting  
Corrosion

- One of the critical observations taken during the removal of HS Bevel Pinion was the evidence of fretting in the Hub of Bevel gear and Shaft.
- "Fretting is a special wear process that occurs at the contact area between two materials under load and subject to minute relative motion by vibration or some other force." ASM Handbook

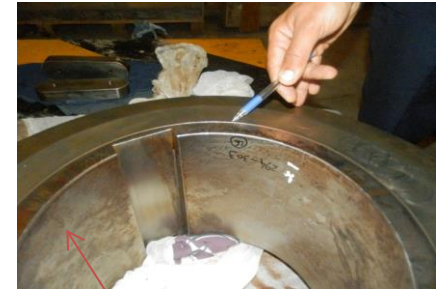
- Fretting Corrosion aggravates in
  - Presence of lubrication
  - Cyclic loading
  - High Torque
- All of the above was present in this case.
- Case was then taken up with OEM for his review and in parallel in house repairs were done.
- Immediate solution to address this was to increase the Fit.

Fretting  
Corrosion

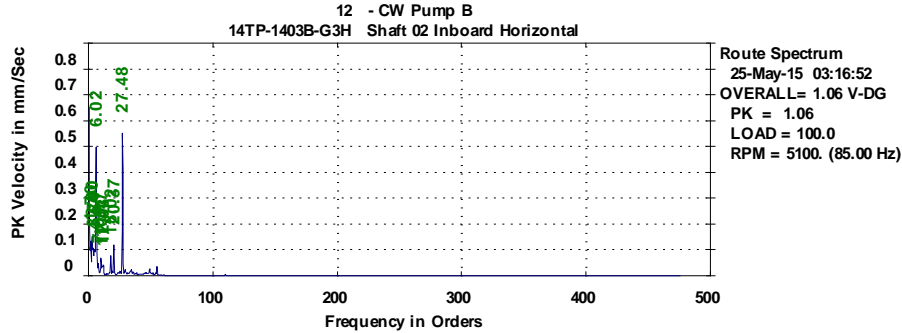
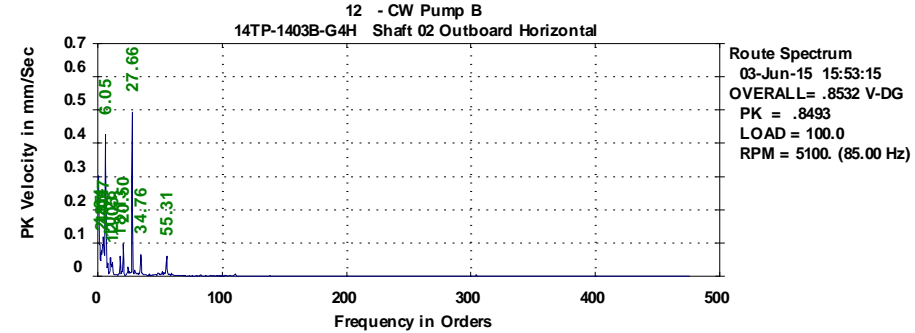
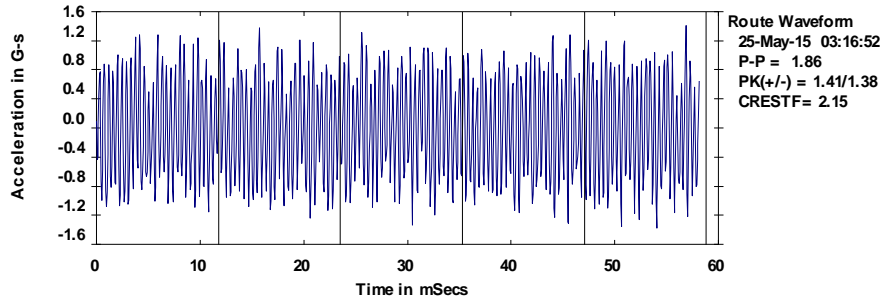
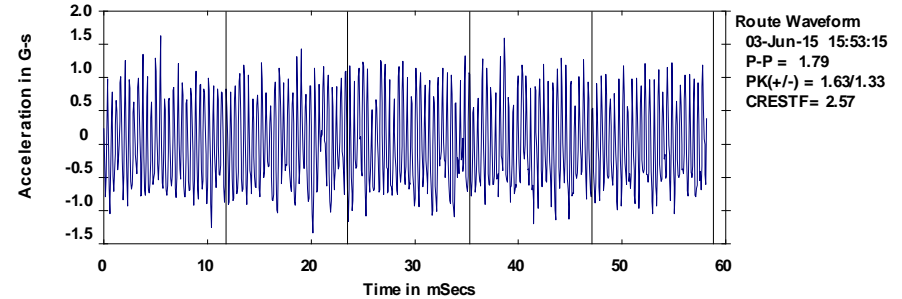
- The maximum vibration recorded post startup was less than 1 mm/sec RMS value. With PK-PK value of about 1.8 mm/sec.
- No impacting in waveforms
