ASIA TURBOMACHINERY & PUMP SYMPOSIUM  
MARCH 2018 | SUNTEC SINGAPORE

# Case Study:

## Recip Pump on Unstable Condensate

# Two (2) API 674 Quintuplex Plunger Power Pumps

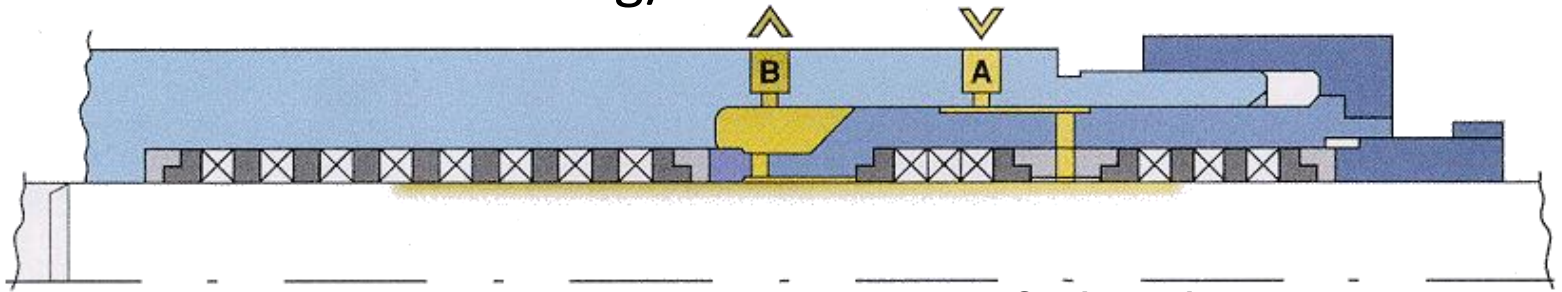
- Noticed smoke and condensate leakage from the packing area within 4 hours
- Found braided rings with white and yellow color
- Carbograpthite coating completely burned away
- Hypothesized that condensate was unstable and created a vapor condition in the sealing/lubrication fluid

A: Inlet Sealing Fluid  
B: Outlet Leakage Recovery

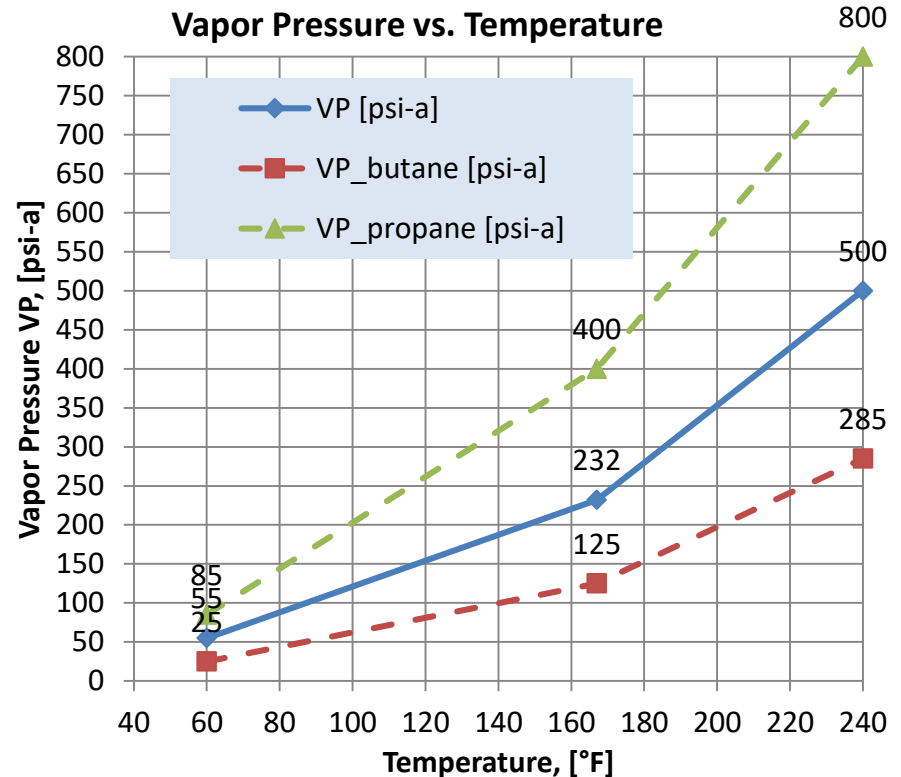
- Vapor pressure within operating range
- Temperature rose to 201°F from packing friction
- Consequent vapor pressure rise...led to cavitation

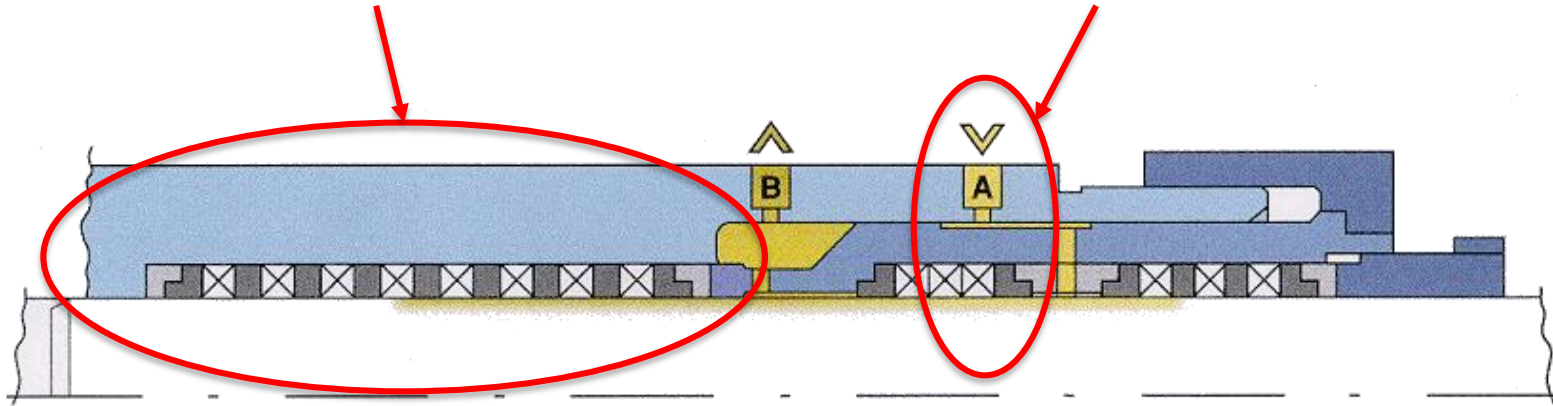
Process fluid drops  
vaporized in this region

Low seal pressure allowed  
migration of process fluid  
into packing

**A: Inlet Sealing Fluid**  
**B: Outlet Leakage Recovery**

- Changed seal pressure from 70 psig to 7 psid over suction pressure: eg. 280 psig + 7 psid = 287 psig seal oil pressure
- Created independent system

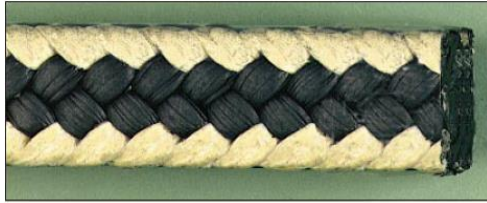
INITIAL

Aramid PTFE yarn  
Graphite PTFE yarn  
PTFE  
Silicone oil

Aramid yarn  
PTFE yarn  
PTFE resin  
Parafinic lubricant
