ASIA TURBOMACHINERY & PUMP SYMPOSIUM
MARCH 2018 | SUNTEC SINGAPORE

Investigation of unexpected Trips in Steam Turbine

A 56 MW steam turbine tripped several times over a short period of time although the trip signal was not sent.

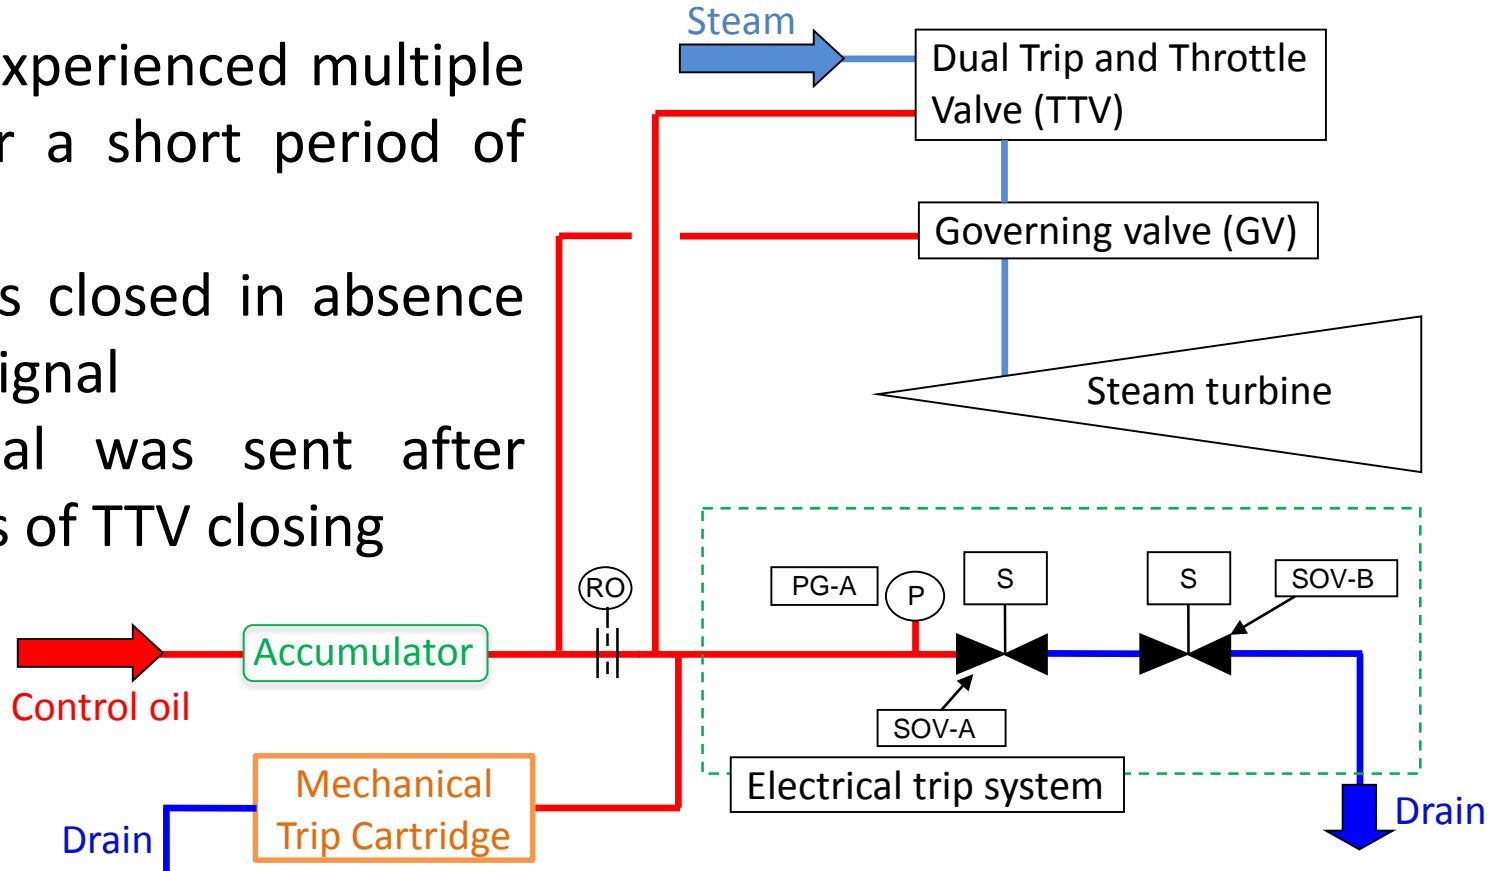
- Turbine experienced multiple trips over a short period of time.
- Both TTVs closed in absence of a trip signal
- Trip signal was sent after 3 minutes of TTV closing

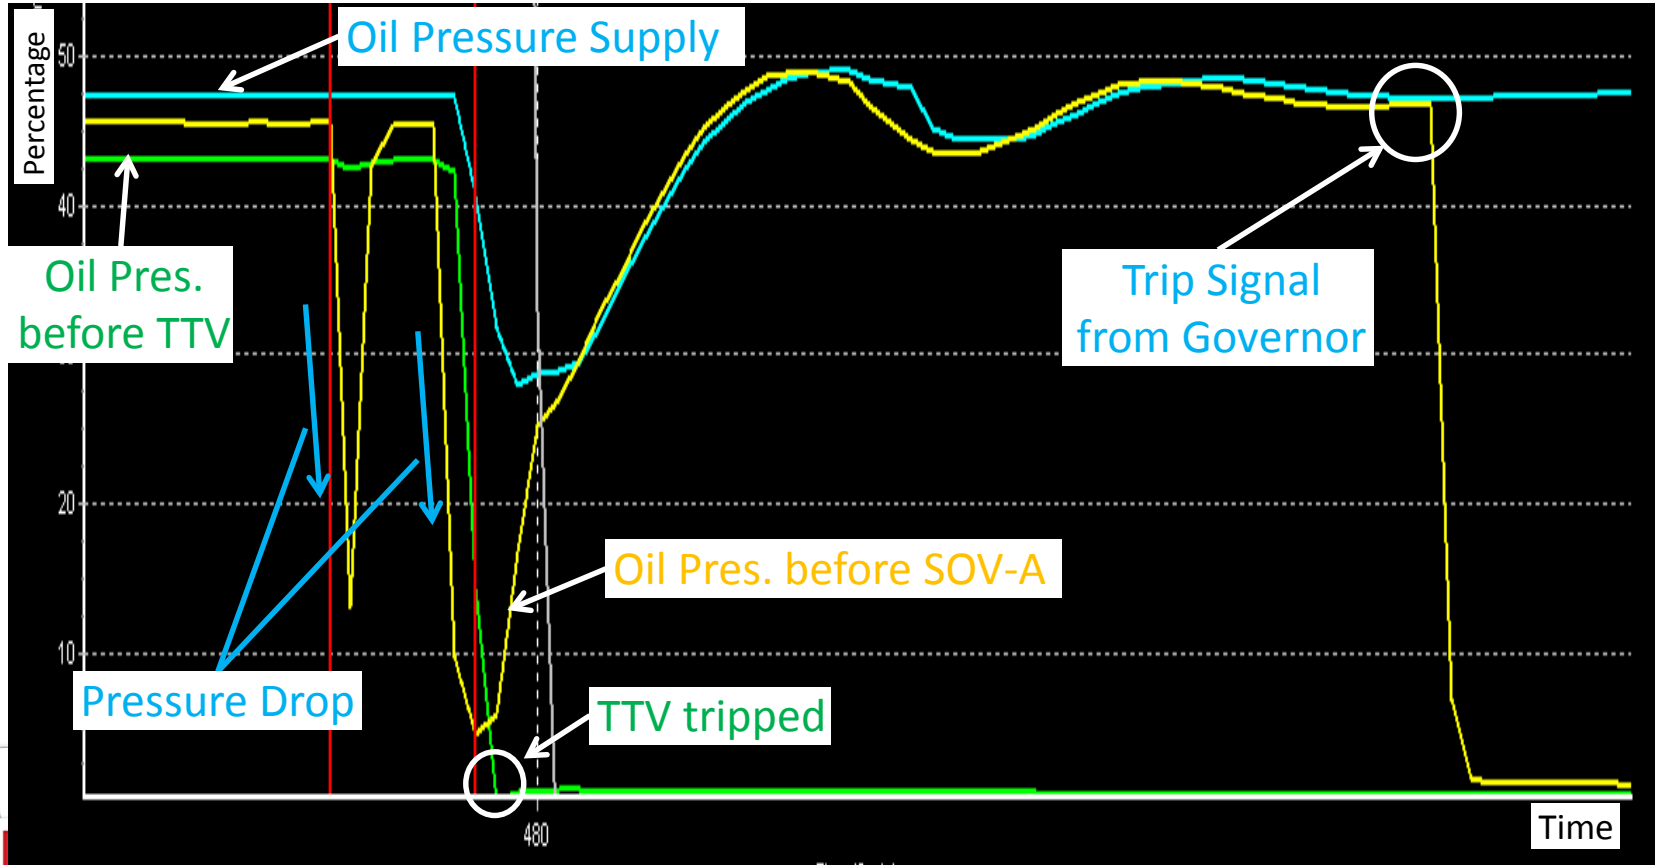
Trend Data

- Oil Pressure before SOV-A dropped for a few milliseconds before coming back to normal until the trip signal was sent
 - **Trip Cartridge** – No issue as oil pressure would have remained low (later verified by testing)
 - **SOV Malfunction** – Solenoid valve was tested and no errors were found out
 - **Pressure drop (TTV trip) due to GV motion** – Possible
 - ✓ Single Accumulator for GV and TTV line case
 - ✓ Separate Accumulator for GV and TTV line case
 - **Unstable Trip Signal** – Possible

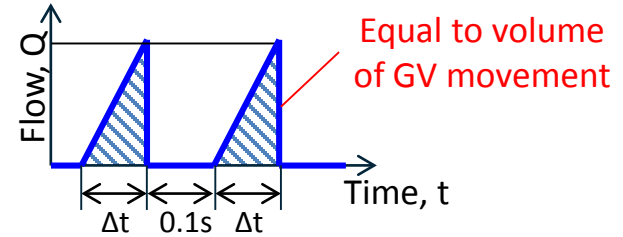
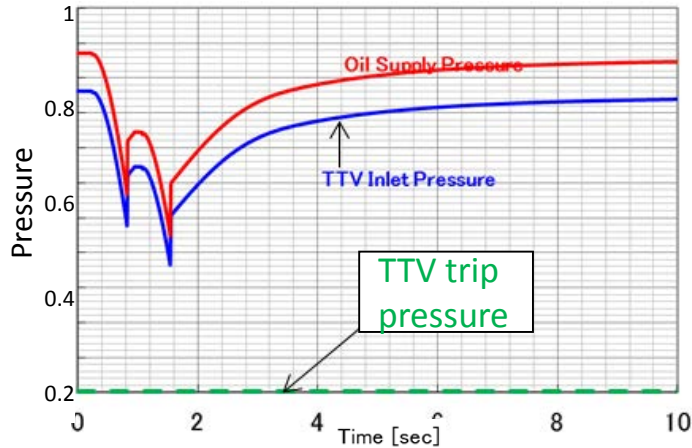
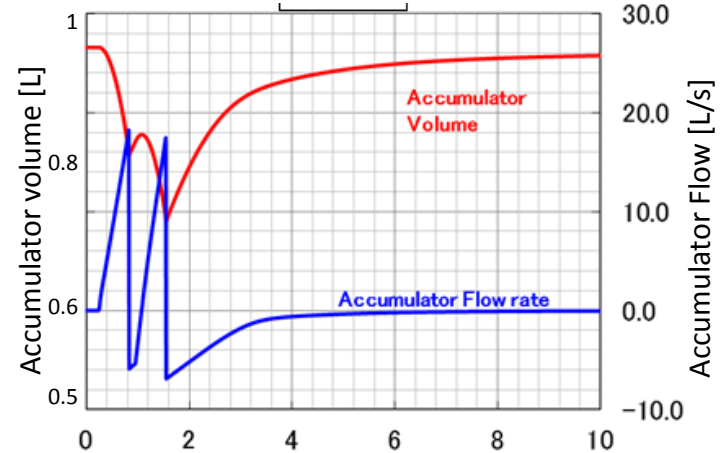
Dynamic Simulation (GV motion)

Single Accumulator	Accumulator Initial Charge Pressure	G.V Stroke [%]	Stroke Times	Δt [sec]
	414 kPaG	48%	Twice	0.6

The oil pressure at TTV didn't decrease to TTV trip pressure when the Actuator movement was 48% of the maximum stroke in 0.6 sec. with initial charge pressure of 414 kPaG which means **sudden increase of GV oil consumption didn't trip the TTV.**

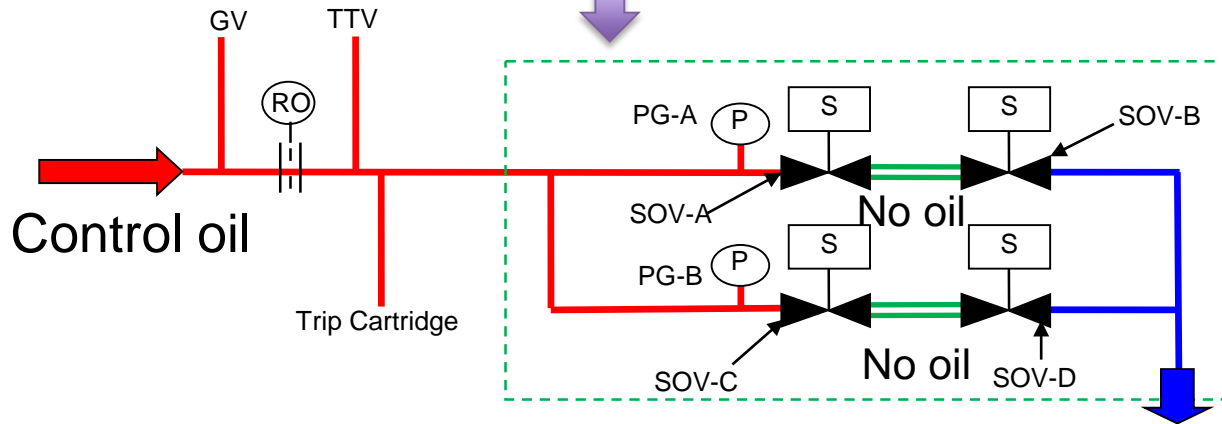
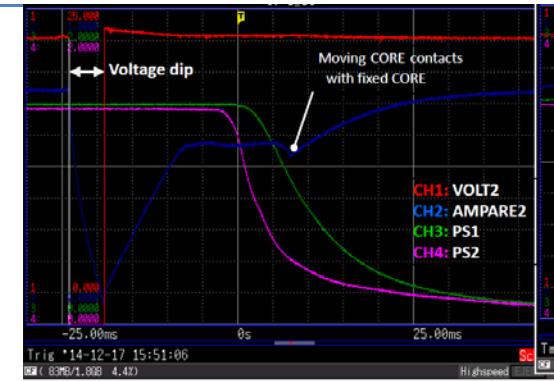
Possible Scenario: Trip signal to the SOV-A dropped from 20 mA to 4 mA for few millisecond thus opening the SOV. Using SOV test, it was found that the trip signal longer than 5 ms will open the SOV.

From -24ms to -19ms (approx. dt=5ms), SOV got unlatched

SOV seat: pilot type

High pressure difference across SOV -> Low leakage and vice-versa

Initially, low quantity of oil is present between the two SOV, length of piping between SOV is larger than 600 mm. Due to oil leakage across SOV, the piping between the SOV has no oil left (atm. press.)

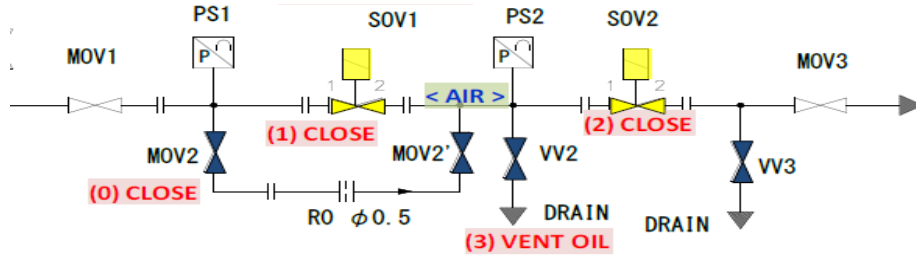
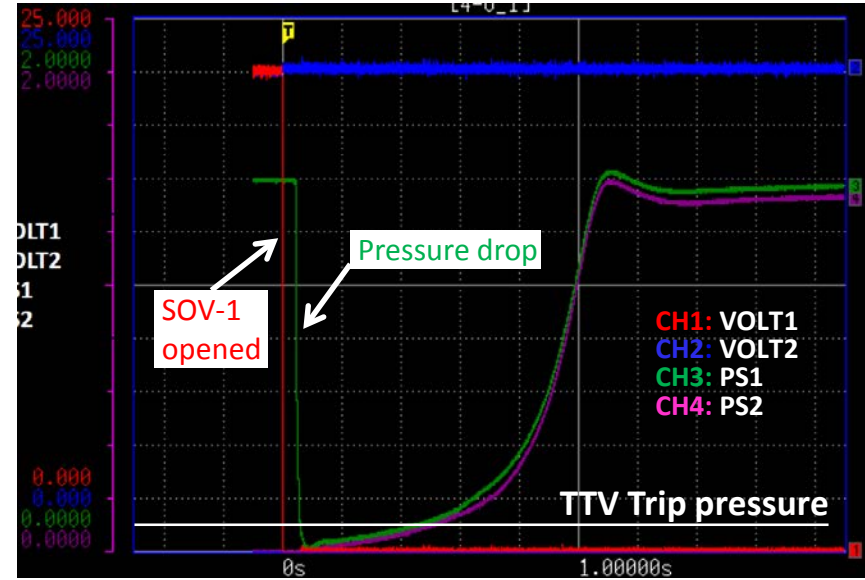
Simulation Schematic

Dynamic Simulation and testing was performed to study the effect of closing of SOV-A in the **absence of oil** between the two SOV's.

Unstable Trip signal, SOV1 got unlatched. P1 and P2 dropped to 0.1 bar which tripped the TTV (TTV trip pressure: 4 bar). The pressure recovered in 1.2 to 1.5s as SOV-2 was still closed.

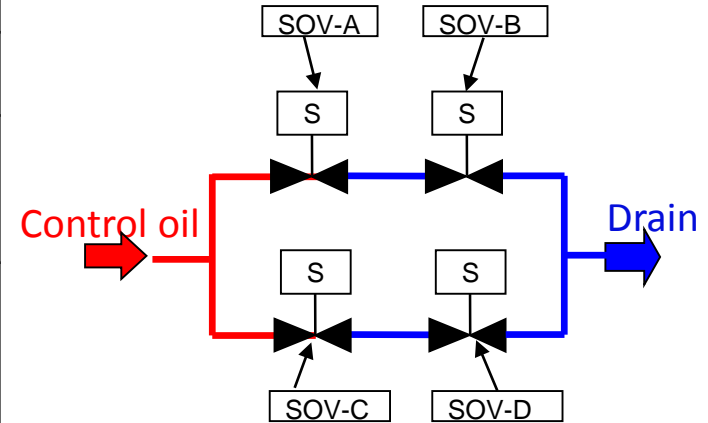
TEST RESULTS		
Test No.	SOV action	T.T.V
1	SOV-A and SOV-B open. SOV-C and SOV-D close.	Trip properly
2	SOV-A and SOV-C open. SOV-B and SOV-D close.	Abnormal trip (Trip system malfunction)

This simulated result matches the FLP577 Turbine pressure trend data with sharp recovery condition, it can be concluded that the main cause of instrument issue is unstable trip signal and absence of oil in piping between the two SOV's.

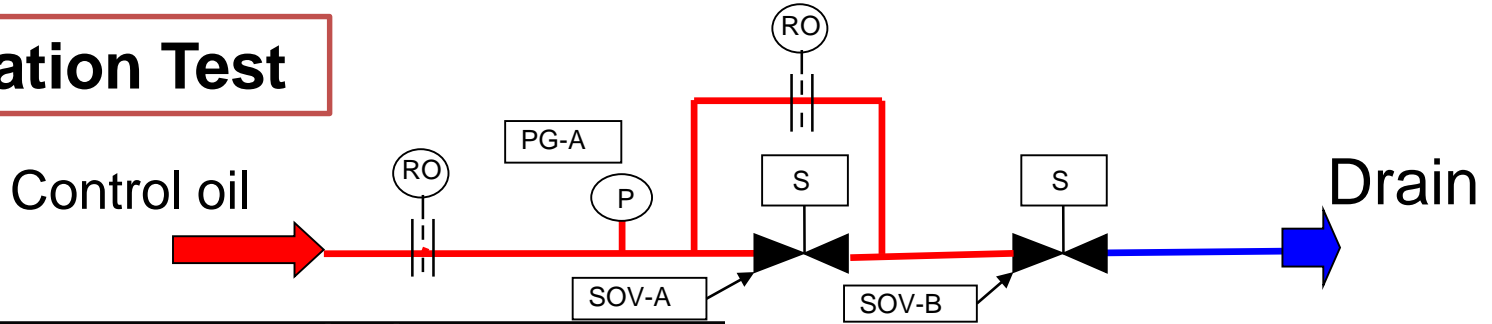
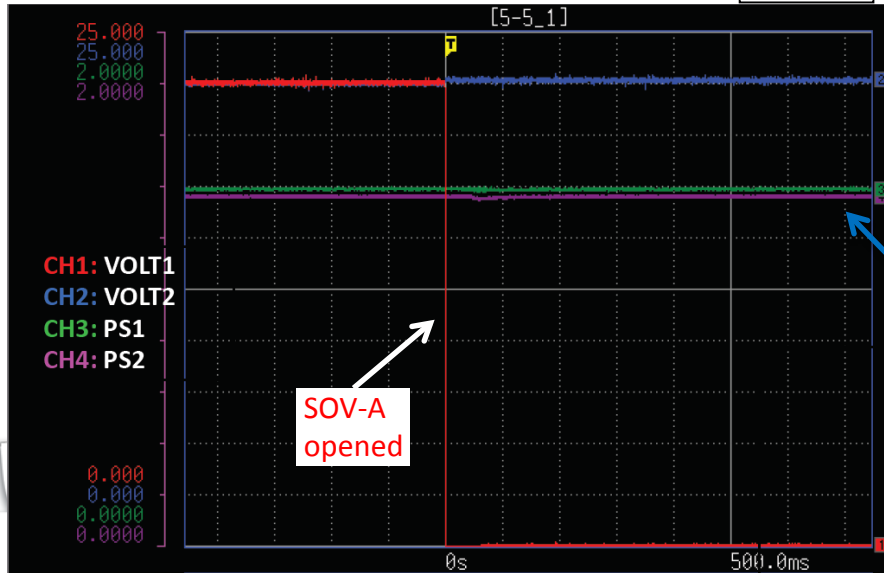
Verification Test

De-energized the SOV-A

Result
Pressure drop of PS1 (green line) was almost zero.
