Large Vibrations on a Centrifugal Compressor Caused by High Windage Heating on a Flexible Coupling

Root Cause Analysis and Solutions

Yves Bidaut and Urs Baumann

Business Unit Oil & Gas
MAN Diesel & Turbo Schweiz AG

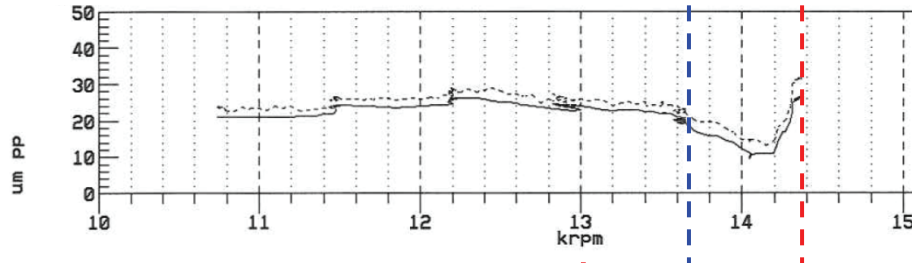
Pinion - DE

→ Important increase of vibrations above 97% speed

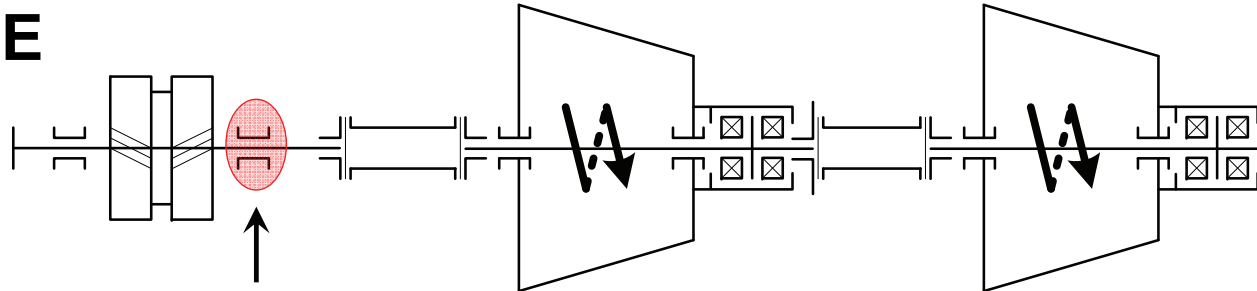
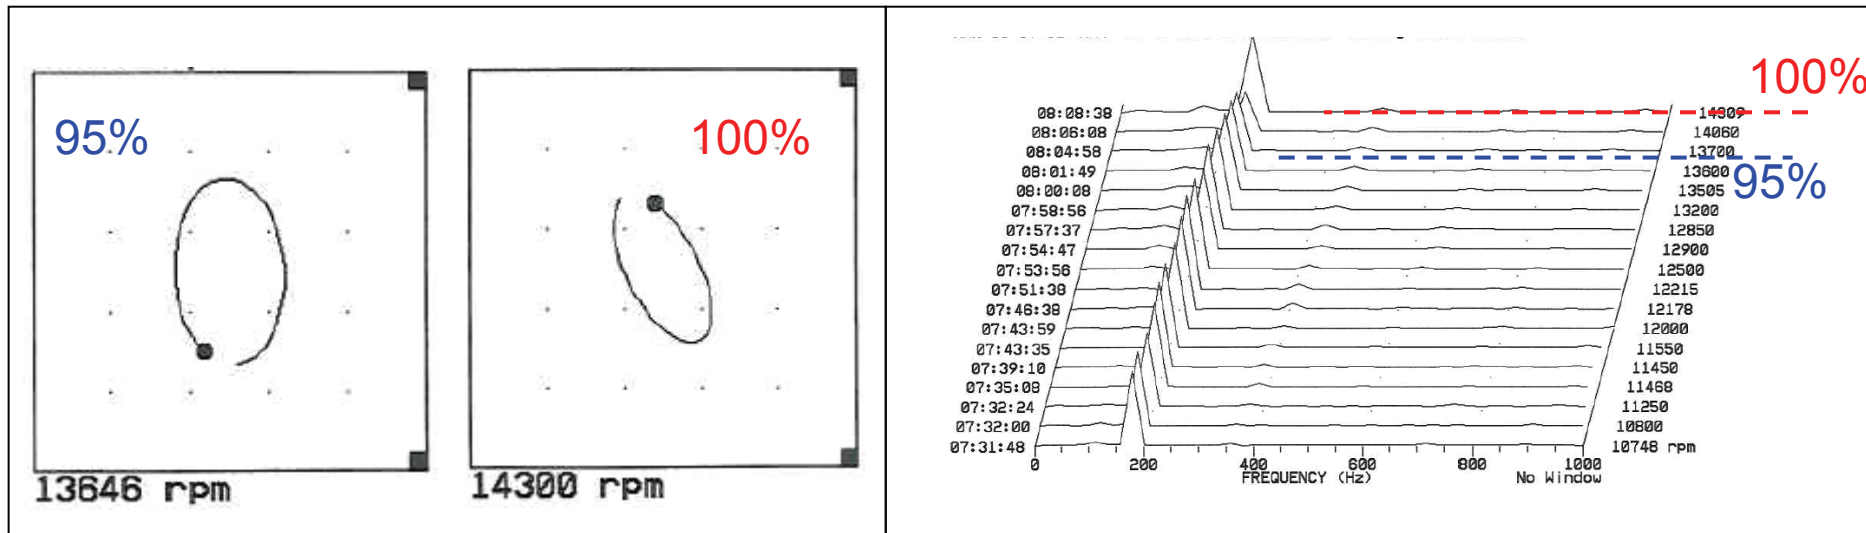
Pinion, DE

- Phase change
- Resonance in Speed range?

- No sub-synchronous

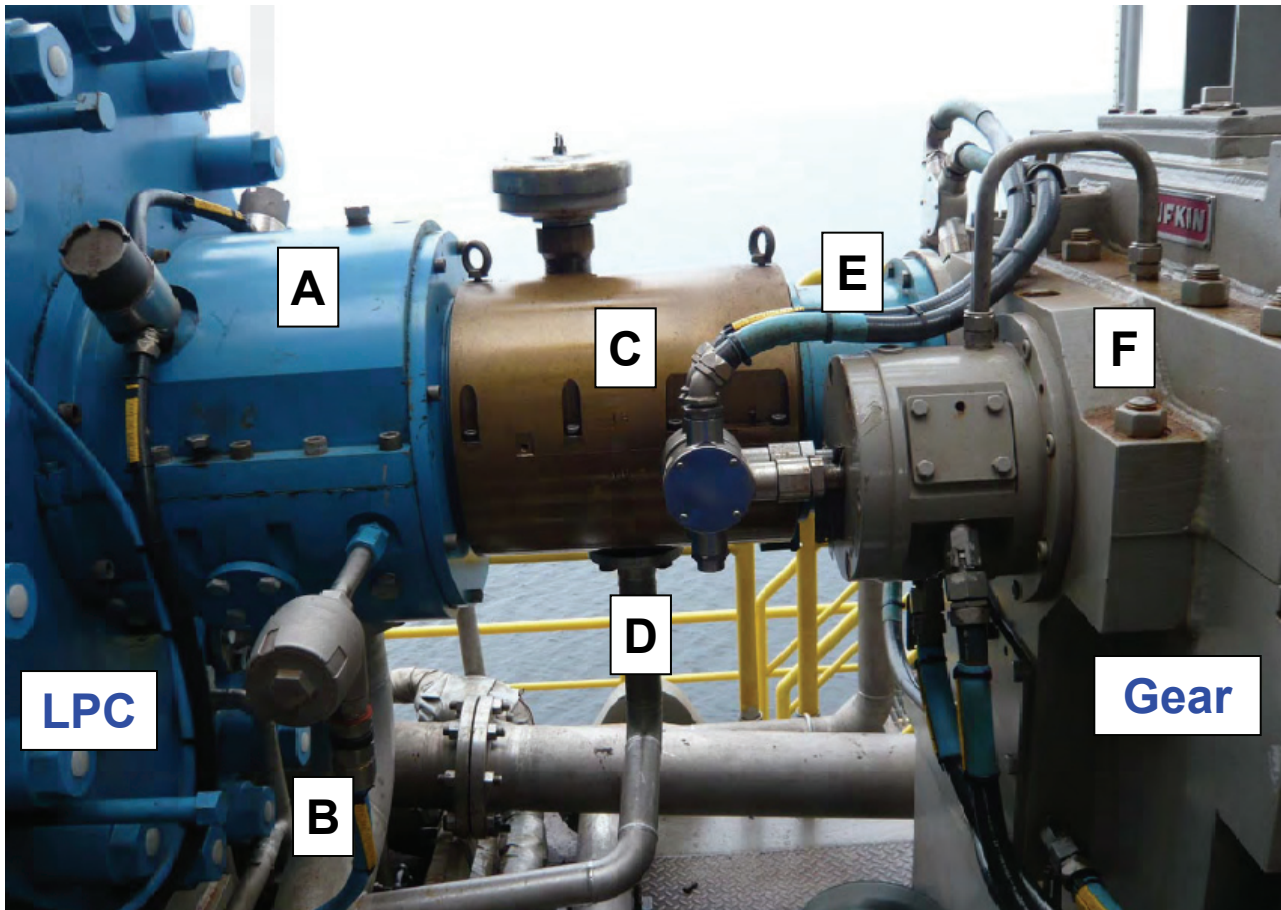
Point n°	Train		°C
	A	B	
A	84	77	°C
B	72	64	°C
C	101	88	°C
D	83	84	°C
E	136	126	°C
F	69	72	°C

→ Too high temperature on adaptor Pinion / Coupling guard

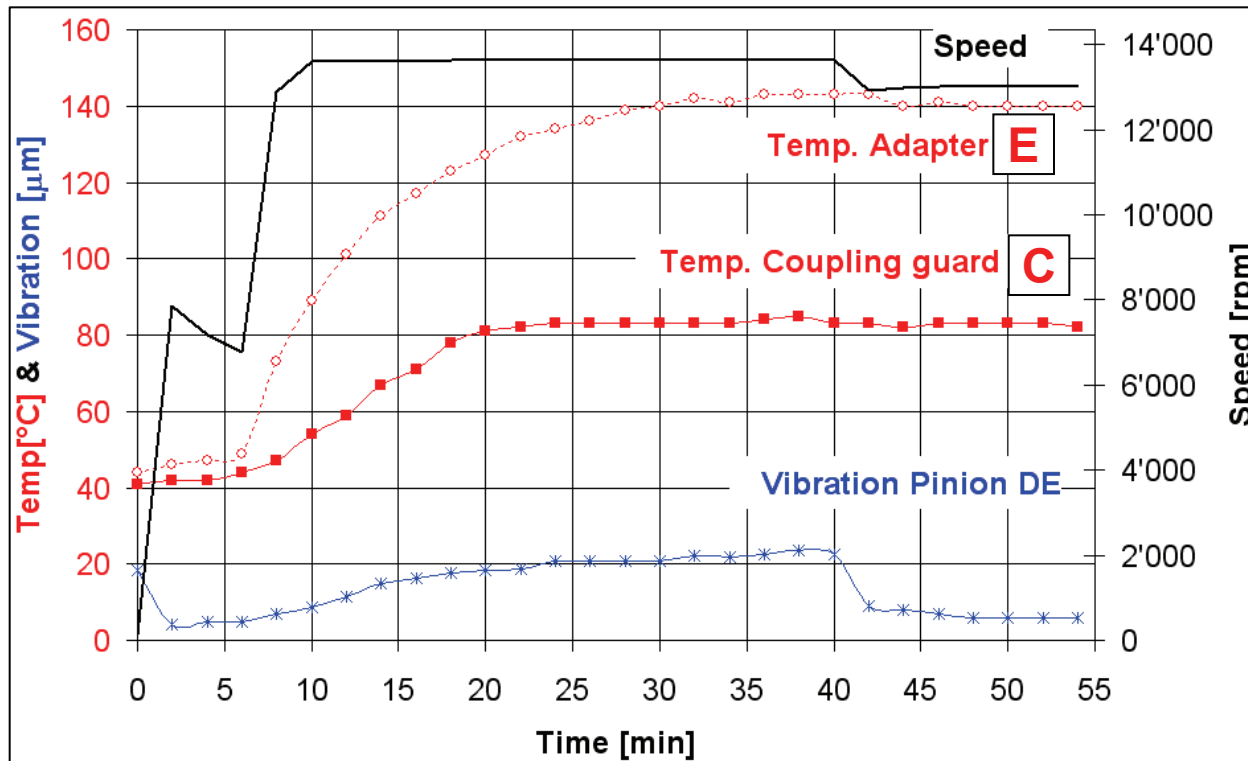
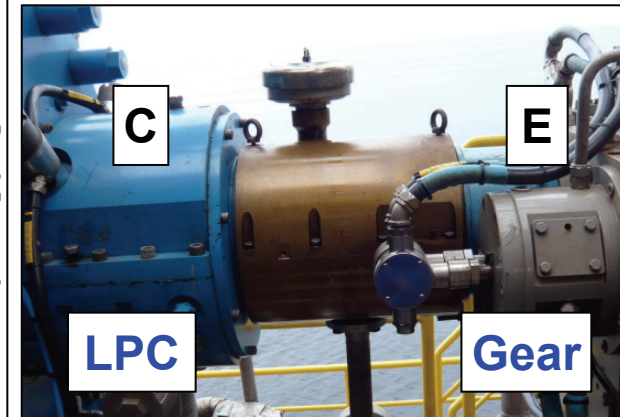
- Speed hold at maximum continuous for 30 minutes

- Vibrations increase as coupling becomes hotter

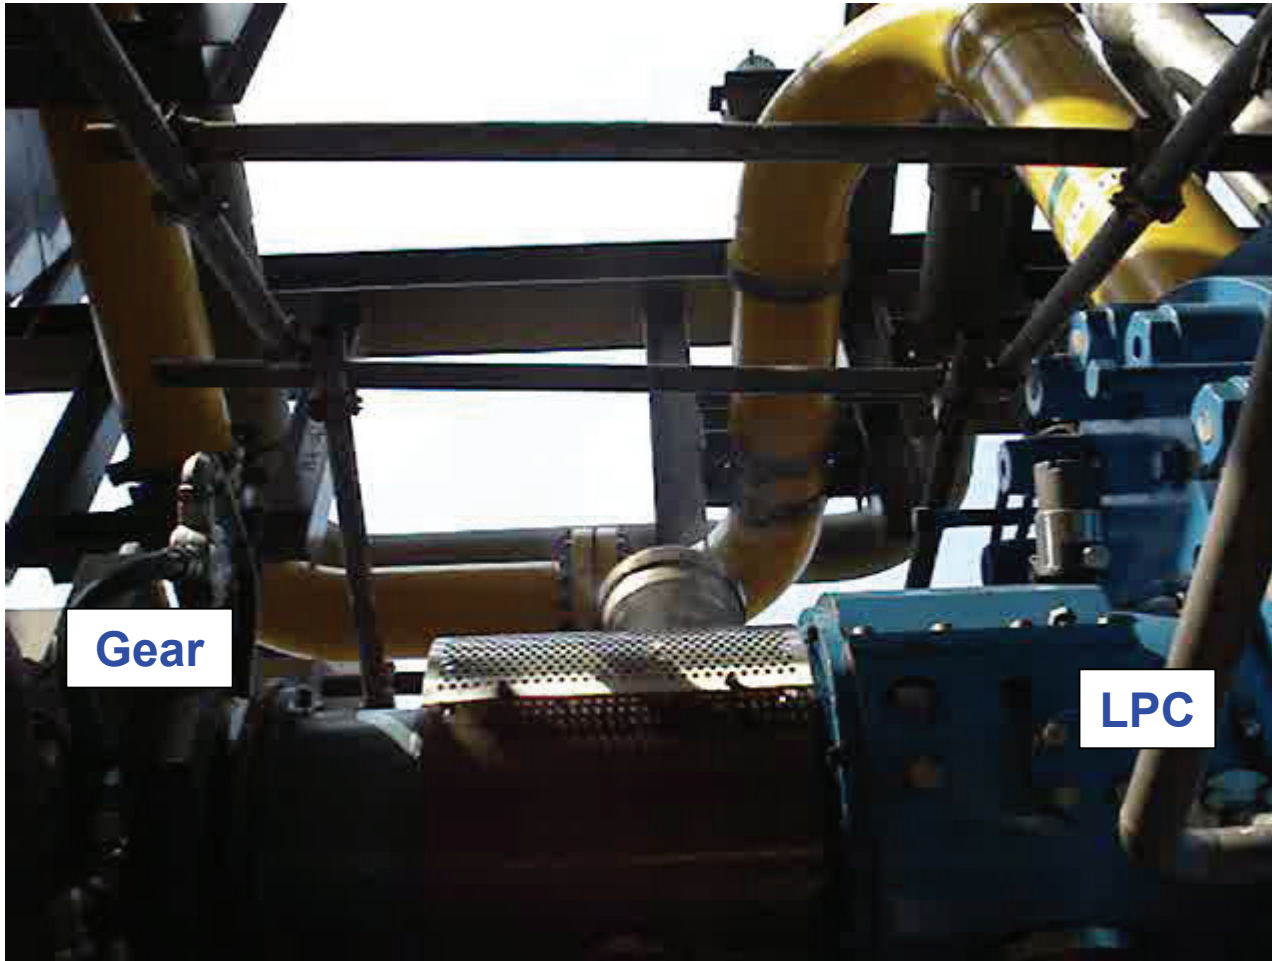
→ Oil – mist comes out from breather !

1. Change the coupling to get
 - lighter overhang mass → shift the resonance
 - less windage heating → avoid / eliminate unbalance
2. Include a ventilation system on the Lube oil reservoir to provide cooling flow into the coupling guard.

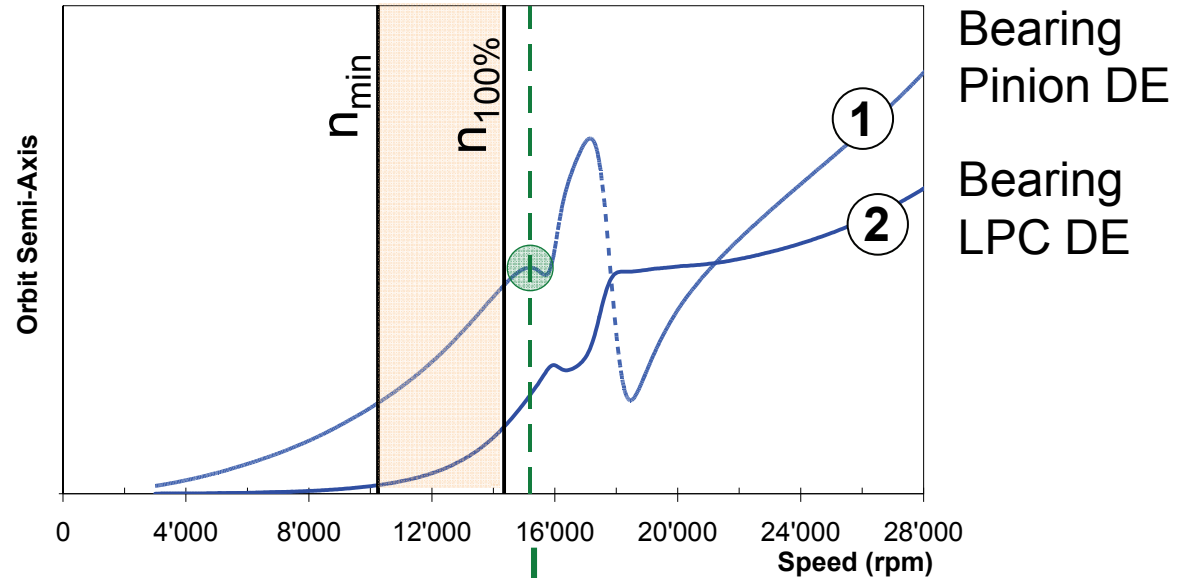
Unbalance Response Plot

- Resonance corresponding to overhang mode near $n_{100\%}$

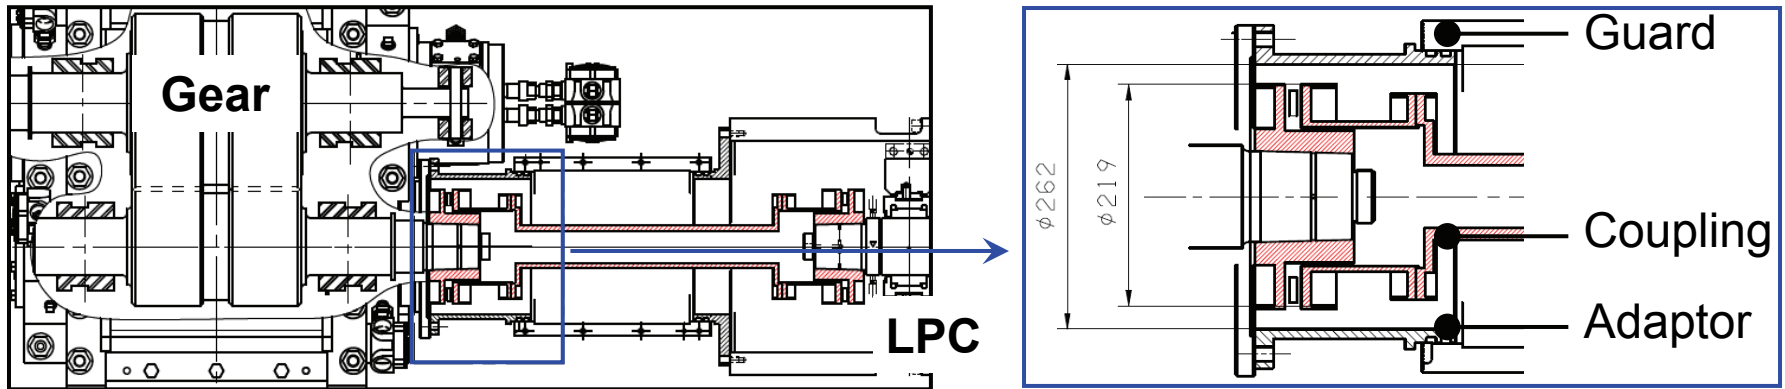
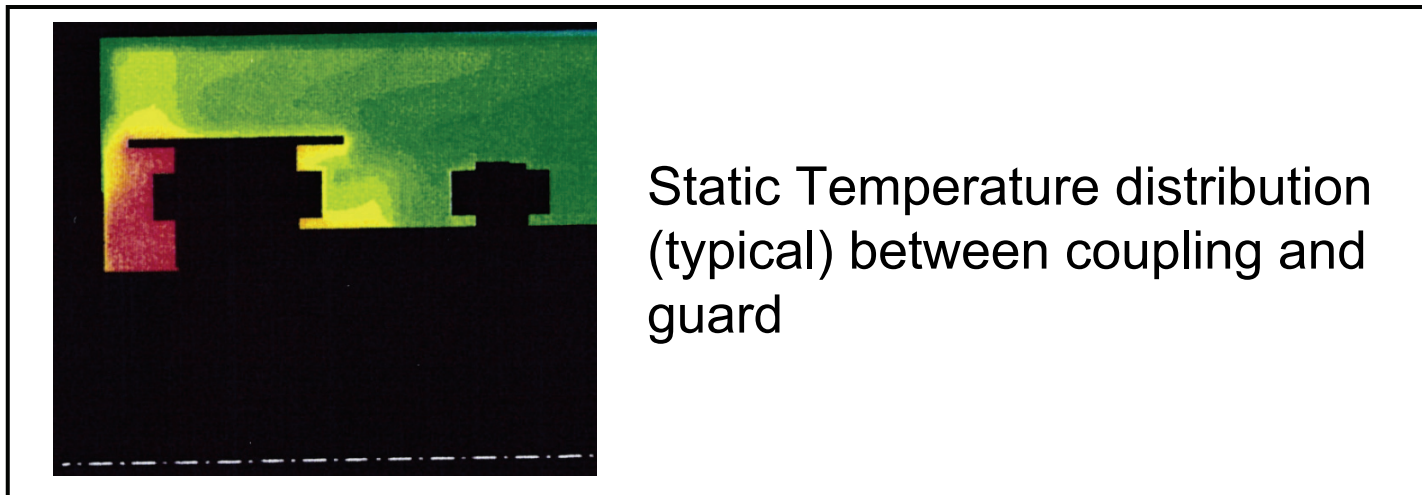
- Restricted space between flange (rotating part) and adaptor/guard + high circumferential speed at flange (165m/s) → high windage heating generated.

- This leads to a high temperature at the guard and coupling (including the flexible element) itself and thus to an unbalance in the coupling.

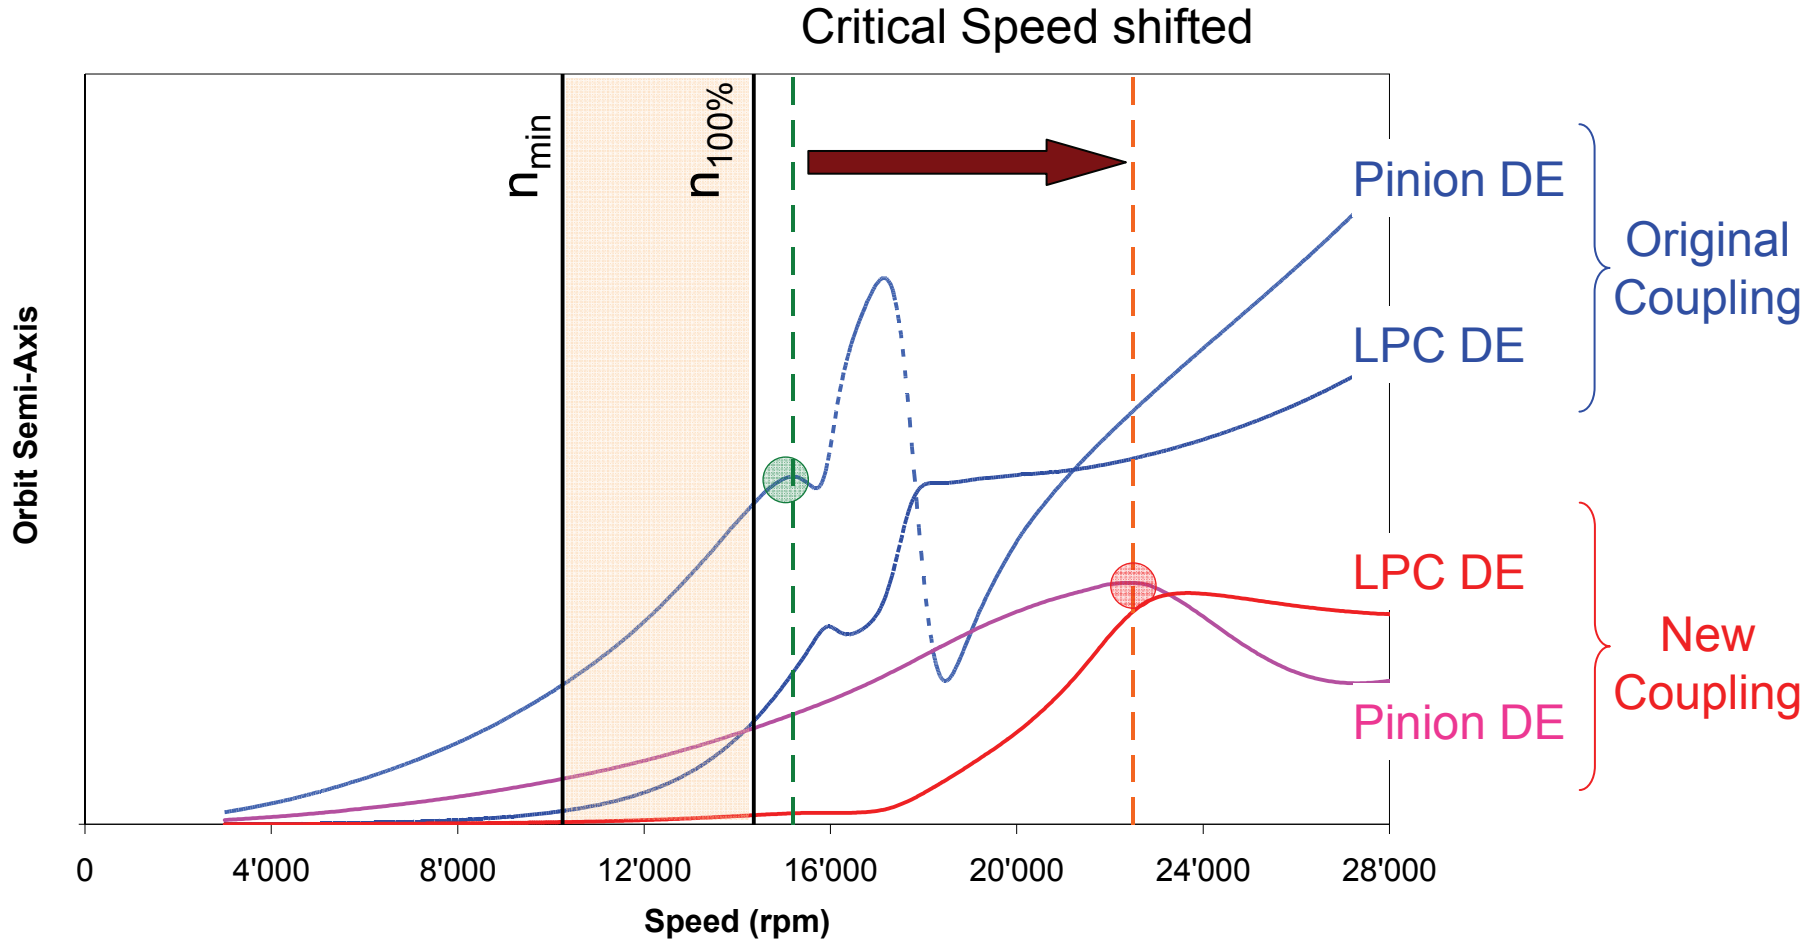
→ Thanks to the new coupling the critical speed is shifted from 15,200 rpm up to 22,500 rpm

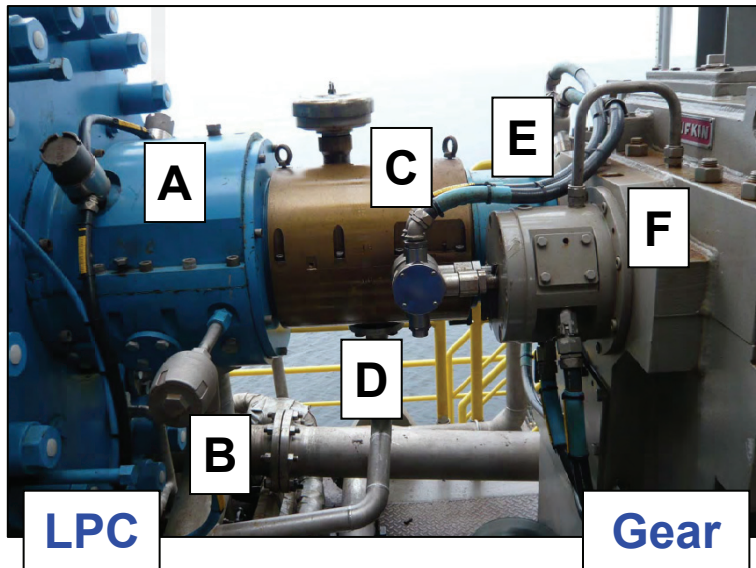
Point n°	Train				°C
	Original		After modifications		
	A	B	A	B	
A	84	77	72	69	°C
B	72	64	59	57	°C
C	101	88	62	67	°C
D	83	84	61	64	°C
E	136	126	83	78	°C
F	69	72	59	62	°C

- Both units are now running with reduced coupling guard temperatures.

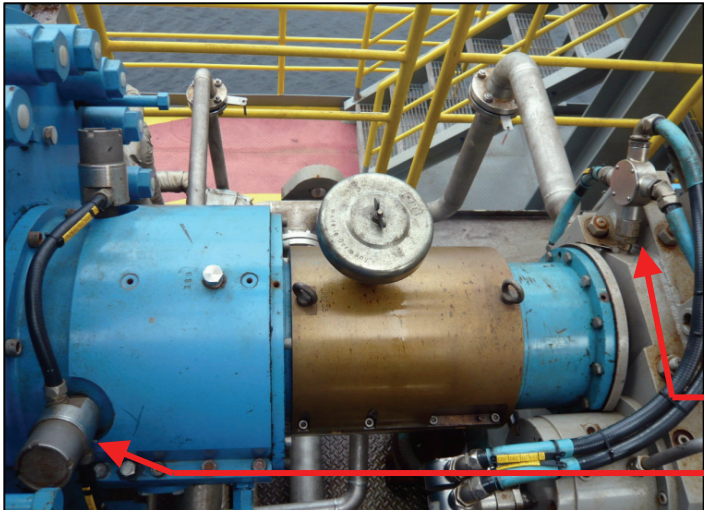
<i>Original</i>		After modifications	
Date	05.2008		10.2009	
Speed	13687 rpm	14202 rpm	13281 rpm	14290 rpm
	94%	99%	93%	100%
Max. vibration (unfiltered)				
LPC DE	9	16	7	8
Pinion DE	22	23	16	17

- All shafts are now running with good vibration levels.
- A balancing run is not necessary any more.
