HIGH FLOW PROTECTION FOR VARIABLE SPEED PUMPS

Amer A. Al-Dhafiri
Rotating Equipment Engineer
Saudi Aramco
Dhahran, Saudi Arabia

ABSTRACT

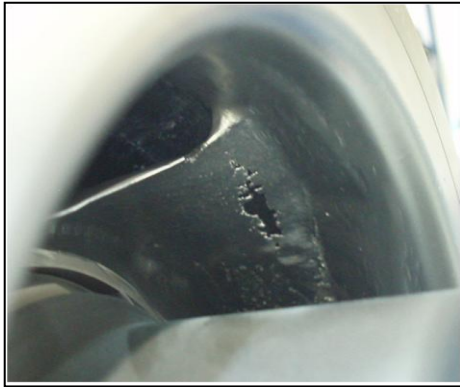
- Cavitation damage on the vanes back side (pressure side) of all the second stage impellers and some of the third stage impellers as shown in figure 1. It should be highlighted that no cavitation damage was found on the first stage which is a double suction impeller.
- Cracks on some of the second and third stage impellers vane inlets and vane outlets and breakage of some of the second stage impellers vane inlets as shown in figures 2, 3 and 4.
- Cracks on some of the second stage impeller shrouds and breakage of some of the impeller shrouds as shown in figures 5 and 6.

Figure 1: G-3001 2nd stage impeller cavitation

As the NPSHA for the second stage is a result of summing the pump NPSHA and the first stage differential pressure, the high flow operation of these pumps while running the pumps at lower speeds than rated caused a significant reduction in the NPSHA for the second stage. This reduction is mainly due to the decrease in the pump NPSHA as the flow increases, in addition to the reduction of the first stage differential head due to high flow and low speed operation which also cause an increase in the NPSHR. To illustrate the last point, the NPSHR requirement for G-2001 new rotor actual operating condition, which was running at 14,400 GPM and 87% of rated speed, was added in figure 11. As can be seen in this figure, for any high flow operation above 11,500 GPM, the NPSHR equipment for the 87% rated speed curve is higher than that for rated speed. For G-2001 actual operating condition, the NPSHR requirement is much higher than 700 FT. This reduction in NPSHA and increase in NPSHR is believed to be the reason for the observed cavitation damage on the second stage impellers for all the four failed rotors.

- The impeller material was upgraded from duplex to super duplex stainless steel (ASTM A 890 Grade 5A), which has higher fatigue and corrosion resistance than the original duplex stainless steel material.
- Implemented better control on the new impellers casting and casting repair quality.

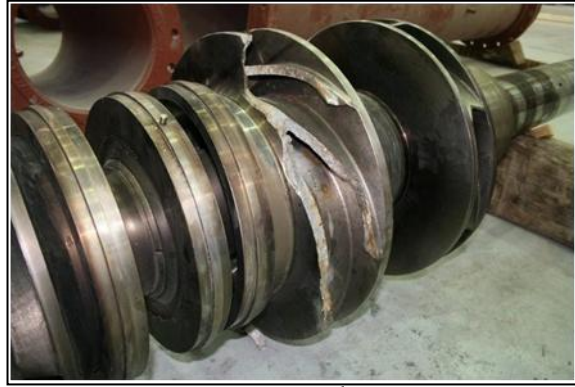
Figure 5: G-2001 new rotor 2nd stage shroud breakage

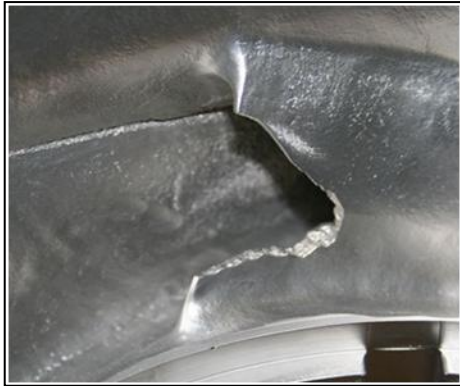
Figure 2: G-2001 old rotor 2nd stage vane inlet

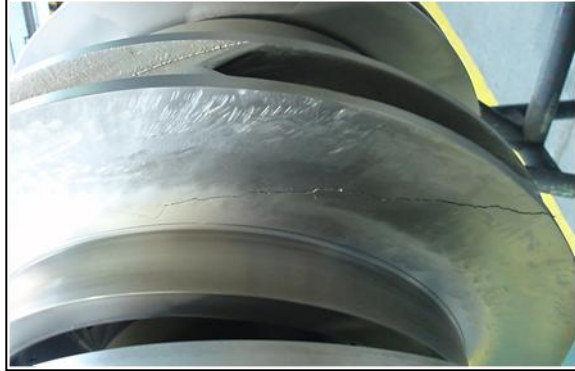
Figure 6: G-3001 2nd stage shroud crack

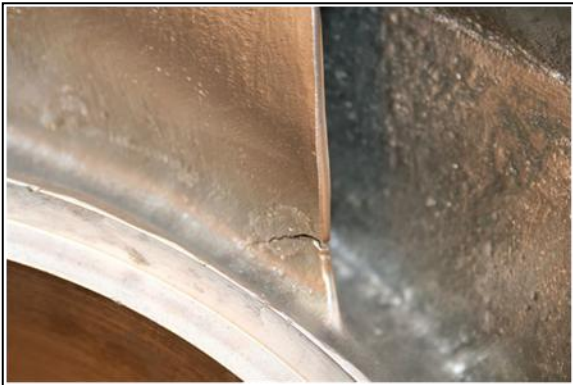
Figure 3: G-2001 old rotor 3rd stage vane inlet

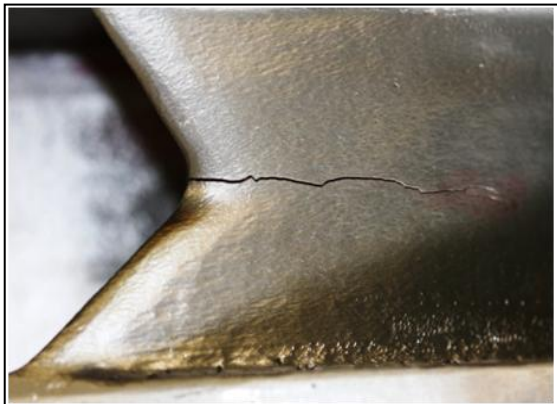
Figure 4: G-1001 2nd stage vane outlet

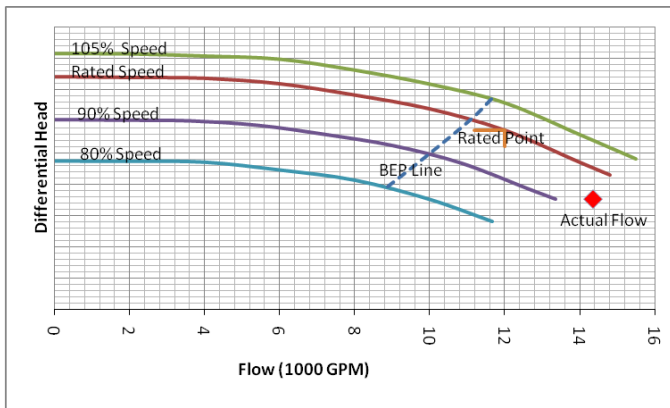
Figure 7: Operating Condition for G-2001 New Rotor

To illustrate the above point, let's take a look at the operating parameters for G-2001 new rotor shown in figure 7. The pump was designed to have a normal flow of 12,000 GPM at rated speed and to be capable of achieving 15,000 GPM by increasing its speed to 105%. The actual time averaged flow for this pump was 14350 GPM, which was achieved while operating at 87% of rated speed. Due to the low process back pressure, the pump was able to achieve high flow than rated while operating at lower than the rated speed. This actual flow is approximately 148% of the BEP flow which falls outside the allowable operating region for this pump at that reduced speed.

The pump allowable operating region is typically limited to a maximum of 120% of BEP flow. Operating at higher flow rates than this limit, such as in this case, is not recommended since it will reduce the life of the pump significantly in addition to the deterioration of the pump performance. The high flow operation for these pumps is believed to be the main contributing factor to the four failures. This conclusion is supported by the operating data, which showed that shorter life and higher damage was found on the pumps that were operated for longer portion of their life at high flow rates.

- A monitoring system was added to the Distributed Control System (DCS) to show the pump operator whether the pump is operating within or outside its allowable operating range at the running speed.

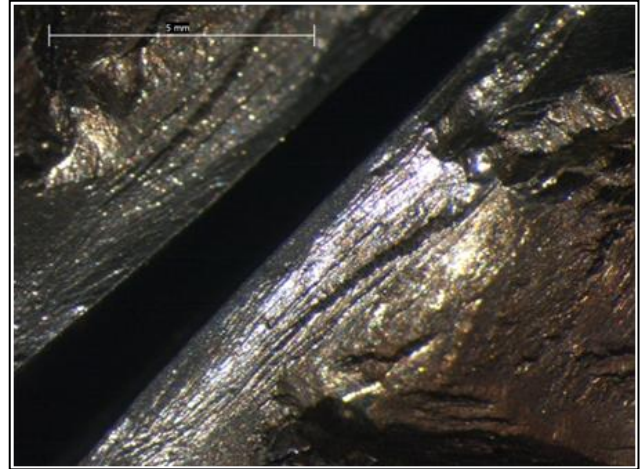
The material failure analysis was conducted on the two rotors that were used in G-2001. The first rotor lasted for 623 days of operation while the second rotor lasted for only 97 days. The analysis showed that many of the impeller cracks were caused by a combination of stress corrosion and fatigue cracking (see figure 8), which are believed to be influenced by high dynamic loading. It also showed some impeller casting and machining defects such as casting weld repairs and

reduction of vane wall thickness by grinding. These deficiencies have contributed to these failures.

Figure 8: Beach marks on the fracture surface indicative of fatigue

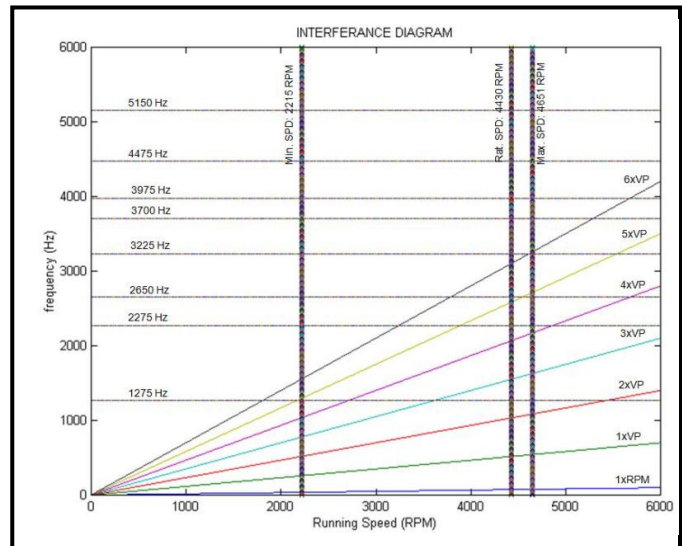
Figure 9: 2nd and 3rd Stage Impeller Interference Diagram

The interference diagram shows that there are many possible high frequency excitations that can meet the impeller natural frequencies due to the wide pump operating speeds. The diagram shows that the nearest excitation mode is much higher than the vane pass frequency. Although there are possible excitations at some of the natural frequencies, these frequencies are considered very high, which reduces the possibility for their contribution to the second stage impeller failures.

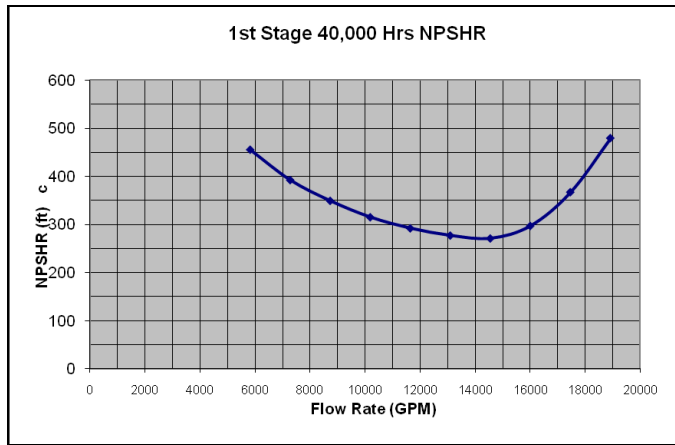
Figure 10: Predicted First Stage Impeller 40,000 Hours NPSHR Curves

When looking at figure-10 and figure-11, it becomes clear why the high flow operation caused the cavitation damage on the second stage and not at the first stage. As was stated previously, the subject pumps were operated at high flow rates exceeding their 12,000 GPM rated flow. Figure-10 shows that the NPSHR for the first stage impeller reduces as the flow exceeds the rated flow until it reaches the shockless entrances capacity which is 14,550 GPM. For the second stage impeller, the shockless entrance capacity (10,570 GPM) is low, which causes exponential increase in the NPSHR as the flow increases above the 12,000 GPM, as shown in figure 11.

If the pumps were operated at their design condition then the first stage impeller will see a Net Positive Suction Head Available (NPSHA) of more than 900 ft while it requires an NPSHR of approximately 270 ft. Even at higher flow rates, the NPSHA is higher than the NPSHR. Having a higher NPSHA than NPSHR will help in preventing many cavitation modes. The second stage impeller has an NPSHA of approximately 2400 ft at the rated flow and speed due to the added head by the first stage impeller. During normal operation, the second stage impeller should not have cavitation even if the pump was to operate at 120% of rated design flow rate since the NPSHA significantly exceeds the NPSHR.

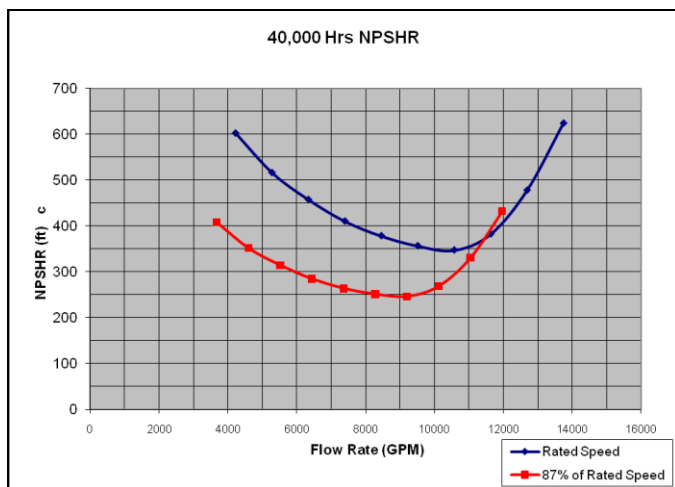
Figure 11: Predicted Second Stage Impeller 40,000 Hours
