ASIA TURBOMACHINERY & PUMP SYMPOSIUM
MARCH 2018 | SUNTEC SINGAPORE

Cooling water pump gearbox diagnostics, failure and remedial actions

Failure of an industrial scale bevel gear assemble in 2.5 years of its commissioning. The gear box drives a pumps rated at 16240m³/h at 47.5 meter of head. The unit developed an abnormal noise with slightly higher impacting (vibration waveform) on the gearbox. However upon inspection, increased back-lash (still in recommended limit) was observed on the unit and the machine was kept in operation.

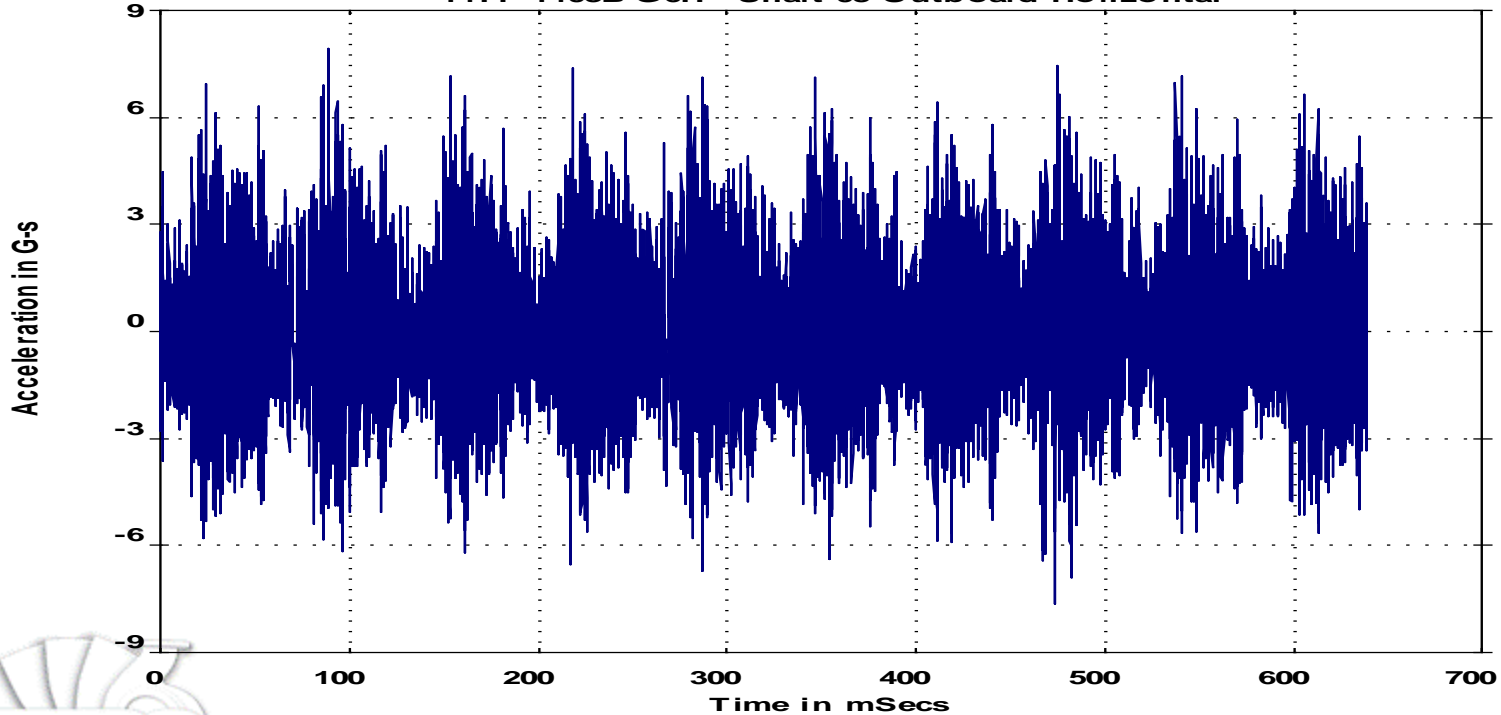
After tripping data of 3rd shaft

P-P = 6.24
LOAD = 100.0
RPM = 595.0

PK(+) = 7.93
PK(-) = 7.63
CRESTF = 3.6

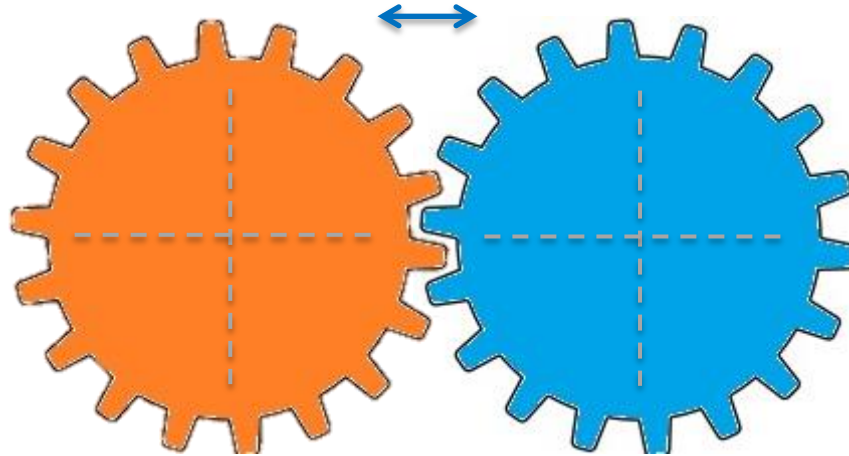
Amplitude modulation

- While measuring Axial of Intermediate shaft it was observed that the **bevel gear was loose on the shaft** (in clearance). According to vendor documentation this was set to 0.002 inches.
- This explains the **Amplitude modulation** in gearbox shaft, however does not explain why the gear broke in reverse direction.
- Keys used to lock pinion had extruded on one end due to high torque and loose pinion.
- A step had been generated near the ID of the Gear due to the continuous rubbing of the gear against the shaft collar. The depth of the step ranges up to **0.025"**.
- Uneven wear was observed on the teeth of the pinion gear.

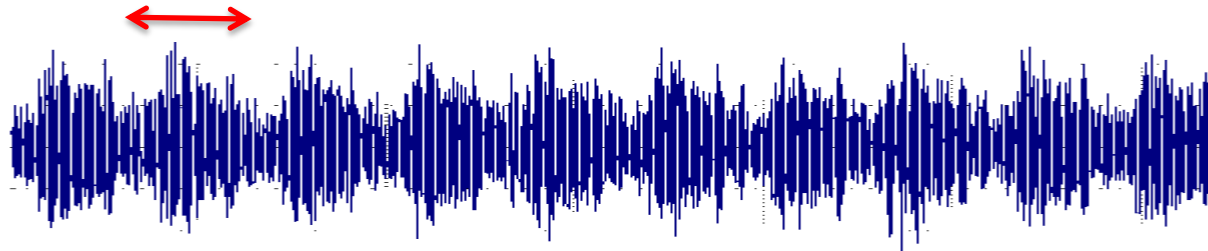
Running RPM of loose teeth

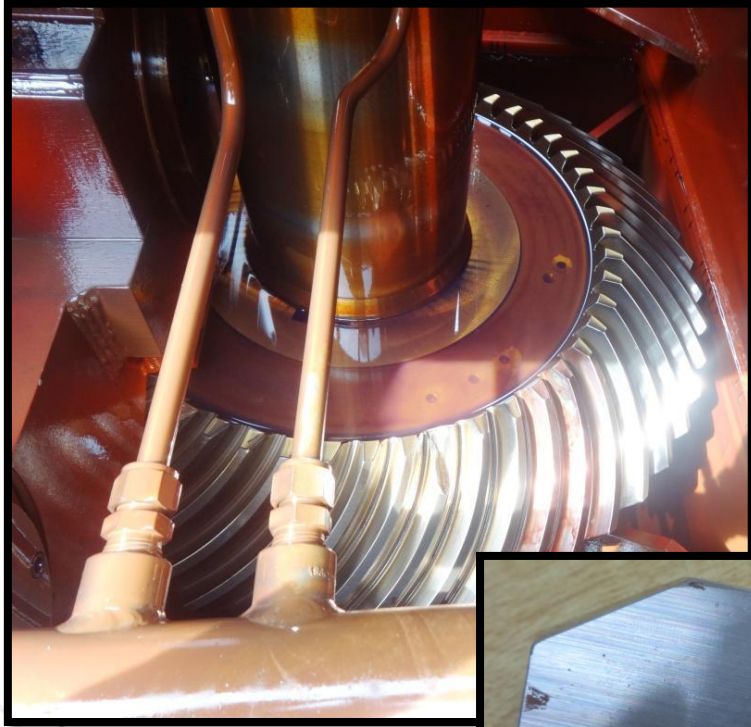
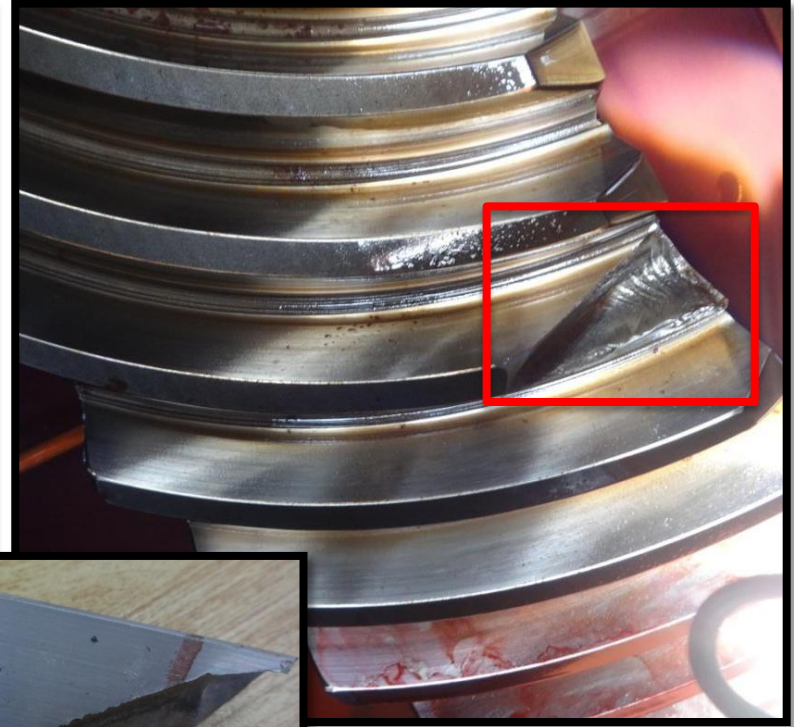
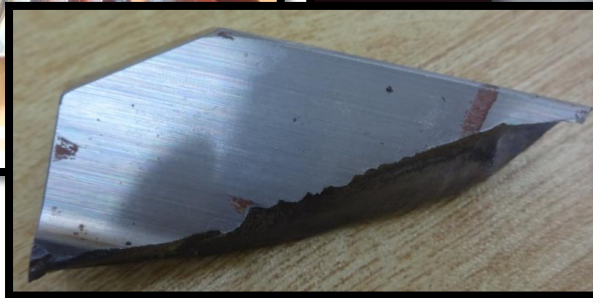
Broken teeth in reverse direction

- Due to non-availability of spare rotor, the same gear set had to be **reused**, while a new gear set was immediately ordered.
- Machining of the Shaft to a depth of 1/16” to remove shaft ovality.
- Machining of the Bevel Pinion I.D to remove the ovality inside.
- Welding buildup of shaft and final machining to adjust the **interference between the Shaft and the Pinion to 0.003” to 0.0035”**.
- Fabrication of New Keys.
- Machining of the Pinion near the ID of the gear to remove the uneven surface.

- Polishing of broken tooth area and wear on other gear teeth with fine emery paper.
- Re-adjusting mounting distance as per the original drawing.
- Ensure best possible backlash figure (which was hard to attain due to varying backlash).
- Contact check was performed to bring the gear contact area back to the middle of teeth (~40% from the toe).

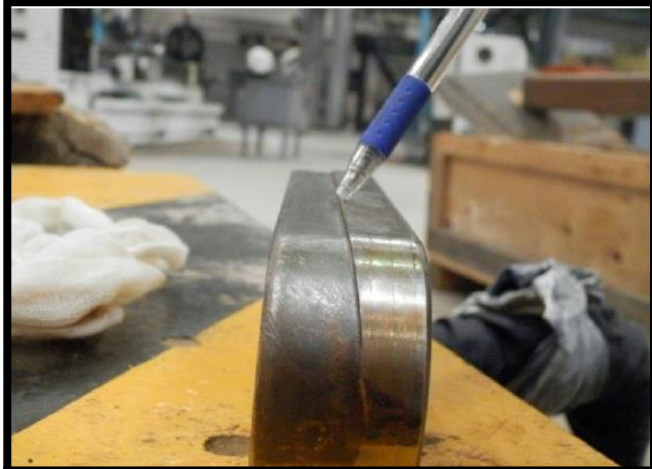
Keys used to lock pinion had extruded on one end due to high torque and loose pinion.

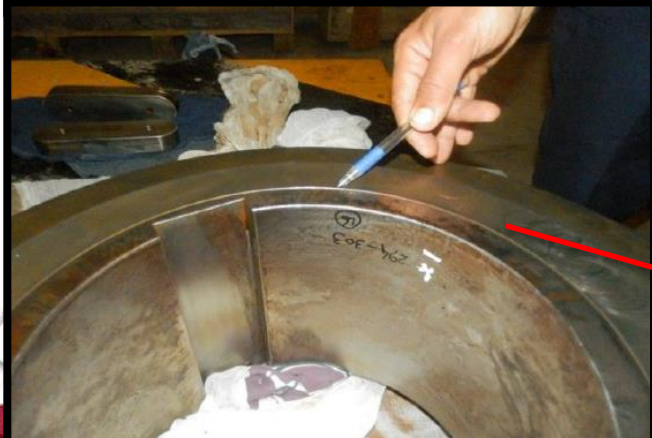
Step had been generated near the ID of the Gear

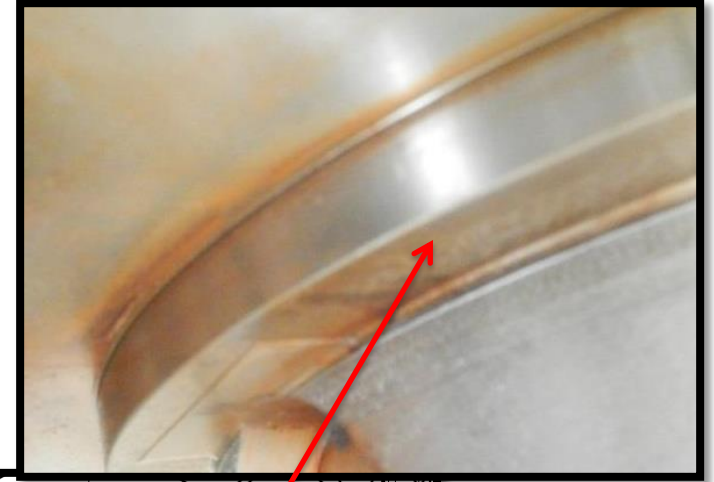
Material removed from step / collar on shaft which is provided as a gear stopper

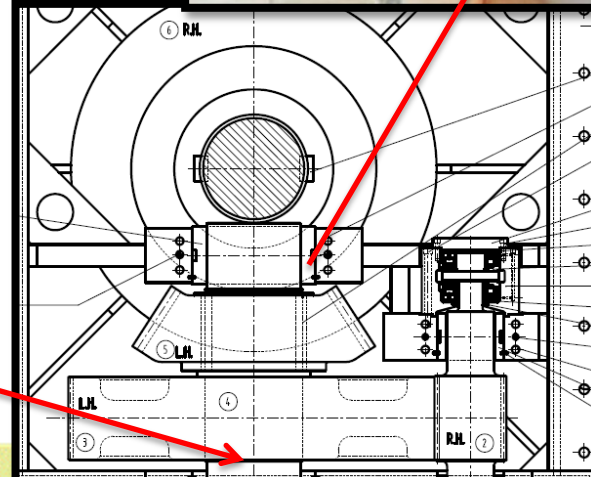
Teeth contact profile

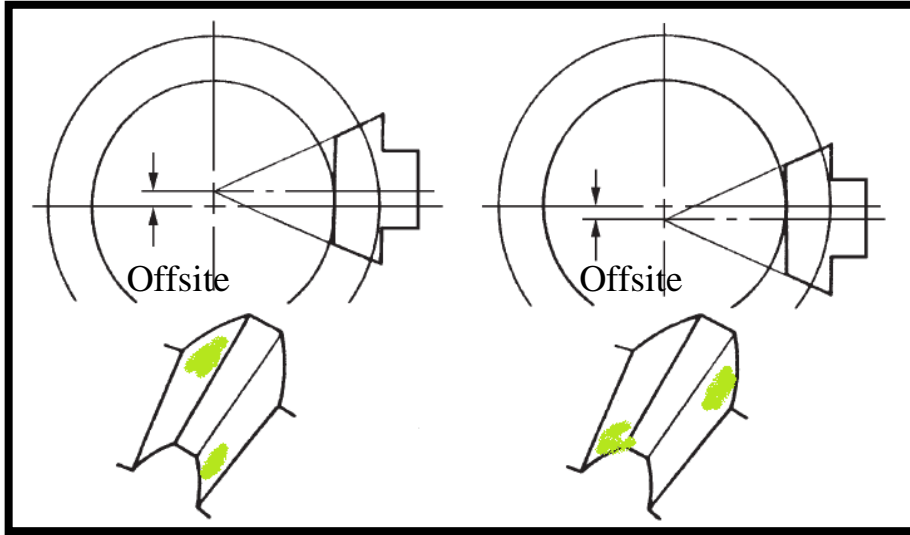
Offset error

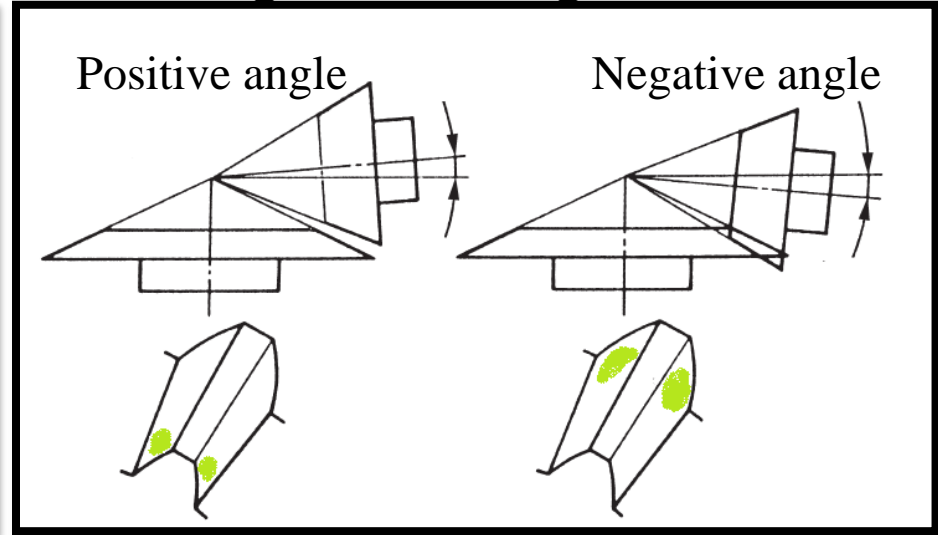
Angular misalignment

Contact area shown in green

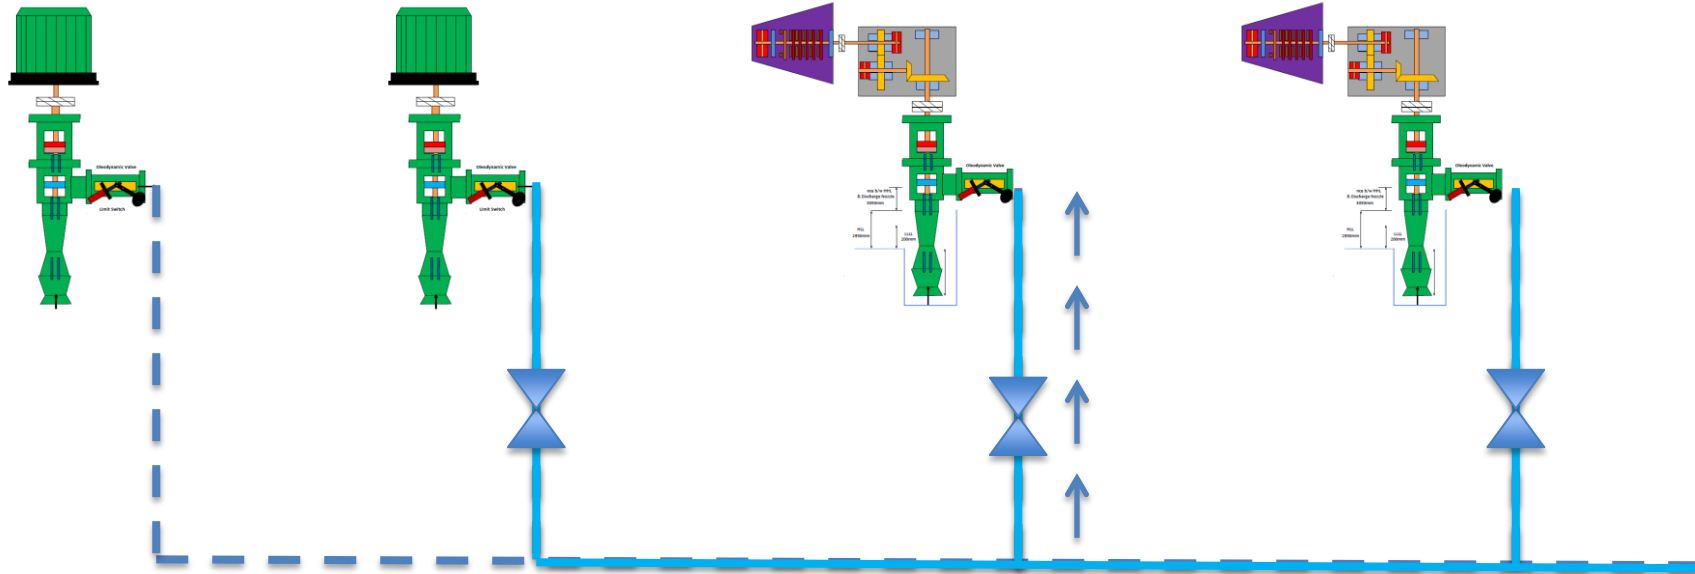
How teeth broke in reverse

In case of tripping, the valve takes 40 seconds to shutdown while the pressure from the header breaks the momentum of the unit

- Upon discussion with the vendor it was revealed that the interference (0.002”) for this level of torque transfer was less and was increased to 0.005-0.006” in the new gear set.
- Meanwhile the other pump was also inspected. Same problem was found in that gear box and the interference was increased to 0.003”.
- Waveform (AM) **indicated bend shaft** with heavy impacting at the running speed of main bevel gear. However the issue was different. This could have been discovered/rectified before the secondary damage.
