46<sup>TH</sup> TURBOMACHINERY & 33<sup>RD</sup> PUMP SYMPOSIA  
HOUSTON, TEXAS | DECEMBER 11-14, 2017  
GEORGE R. BROWN CONVENTION CENTER

# Torsional Failure on Reciprocating Compressor Package

Engineering Dynamics, Inc.

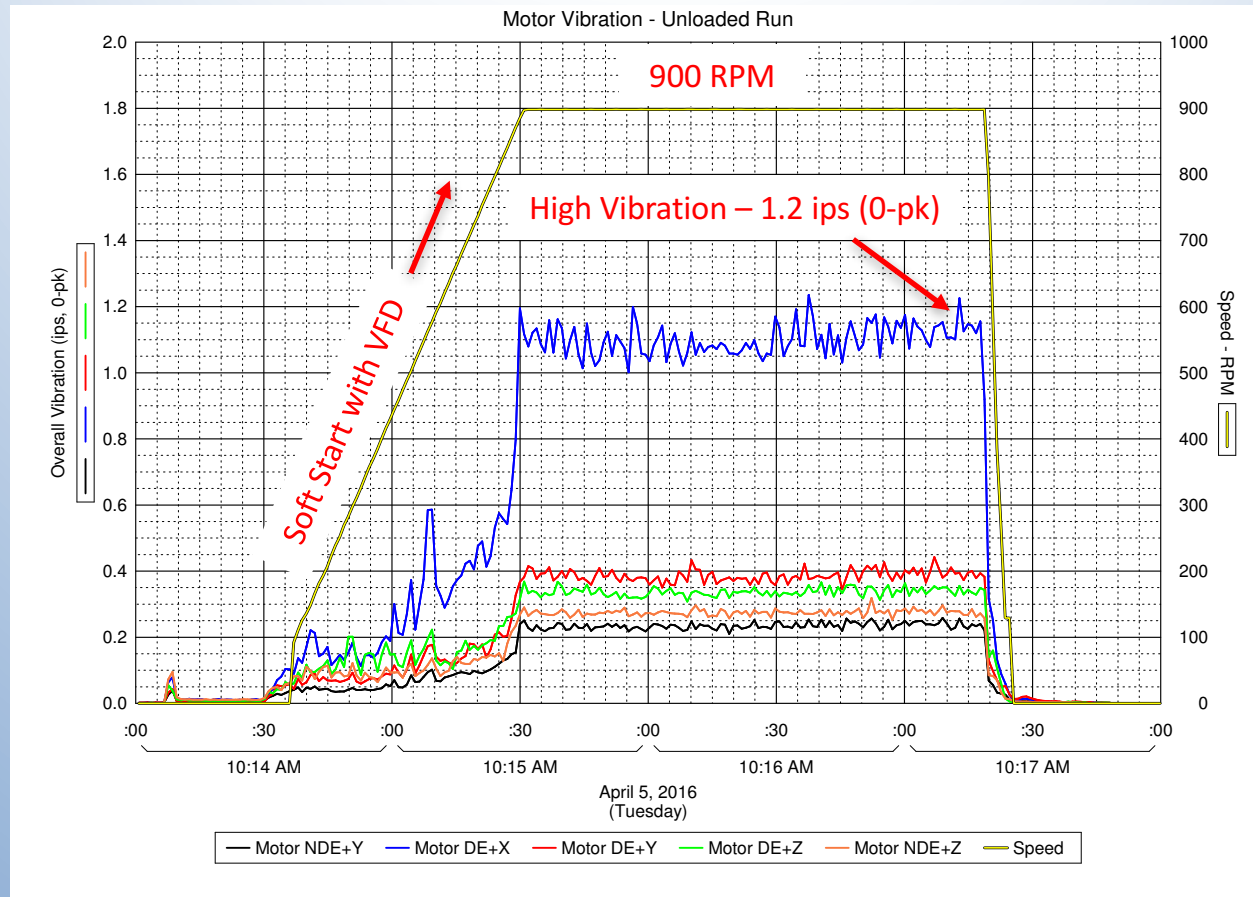
# 1<sup>st</sup> Run - Unloaded

- High vibration on motor drive end – axial direction (1 – 1.2 ips, 0-pk)
- Vibration in other directions and on Motor NDE bearing in the 0.2 – 0.4 ips, 0-pk range

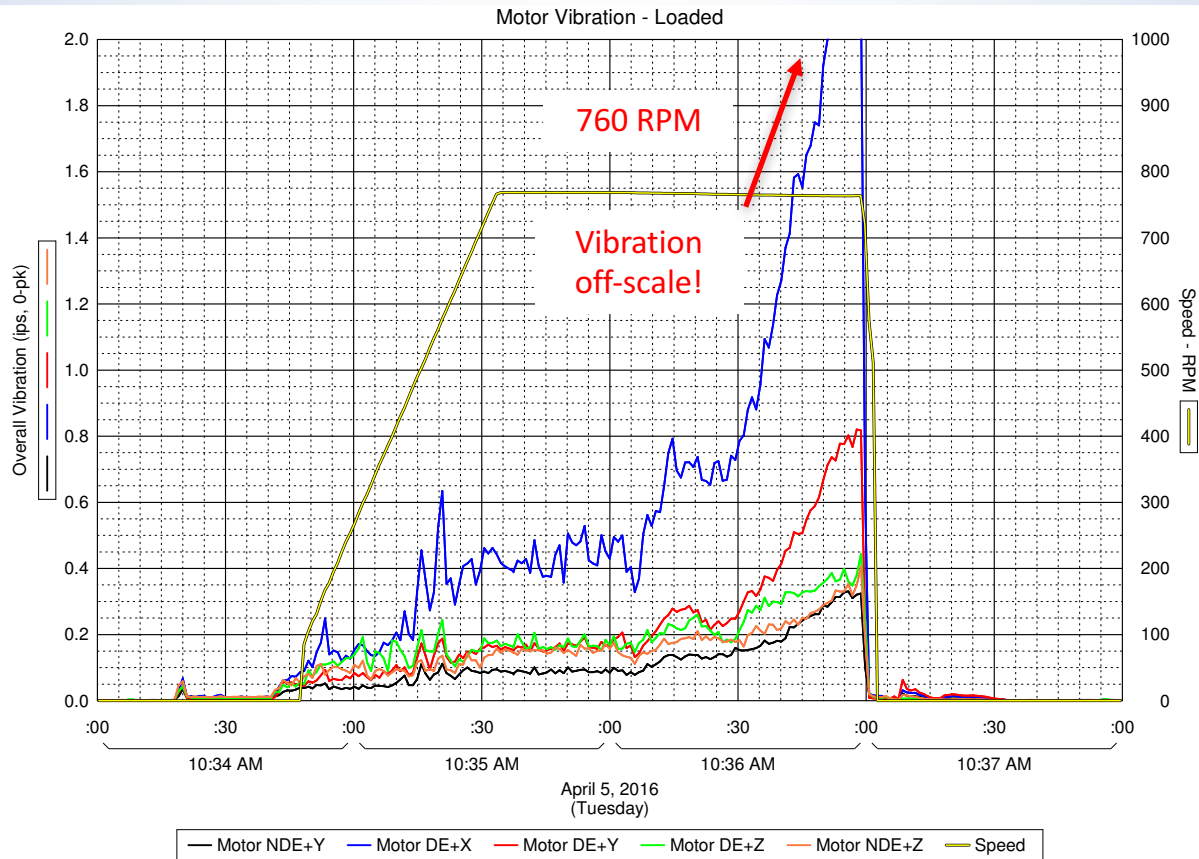
# 2<sup>nd</sup> Run

- Speed run to ~760 RPM, then load
- Motor DE bearing vibration excessive
- Shutdown to inspect system

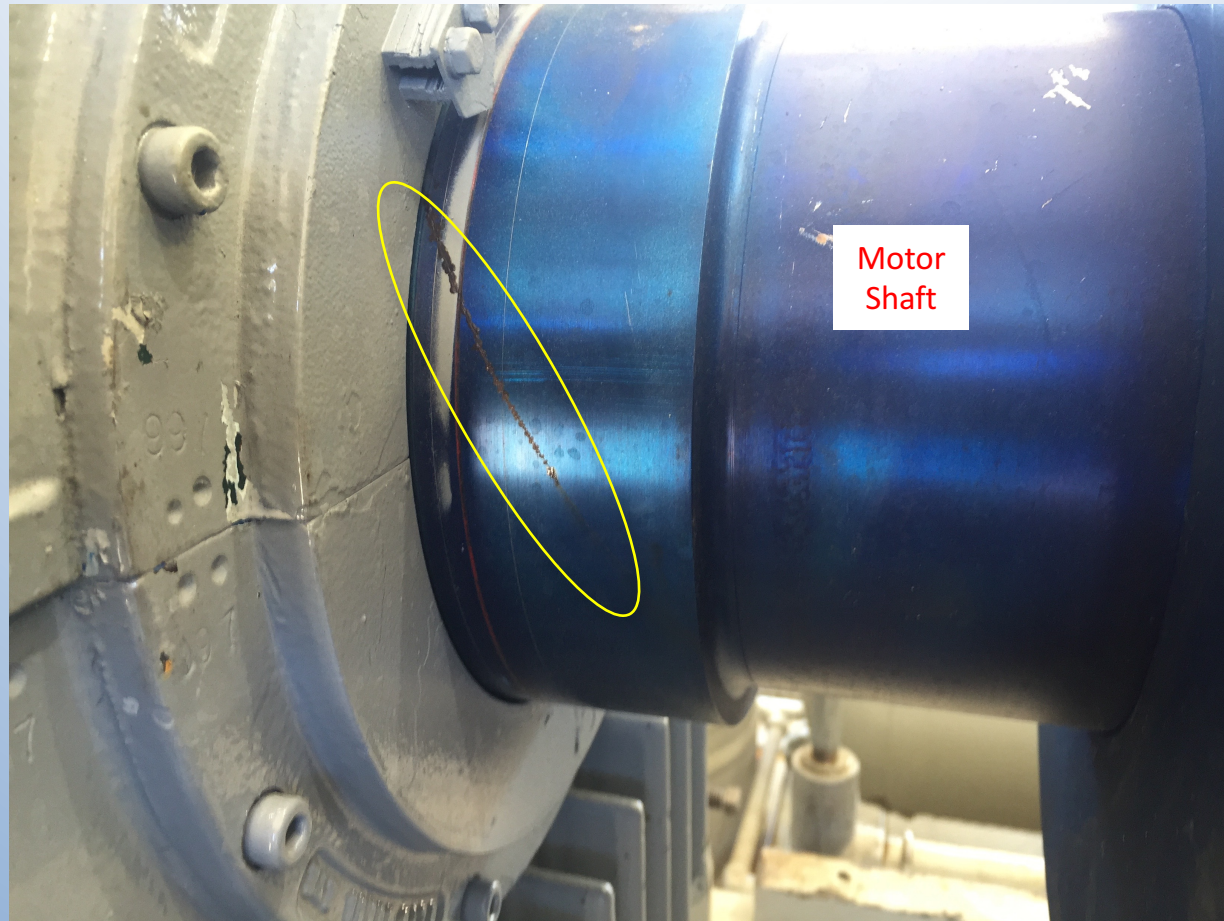
This case history describes a vibration problem on a skid mounted high-speed reciprocating compressor package. The initial concern was high vibration on the motor. When the coupling guard was removed for further testing, a 45-degree crack was noticed on the motor shaft. This is a classic indication of a torsional fatigue failure.

# Classical Torsional Failure

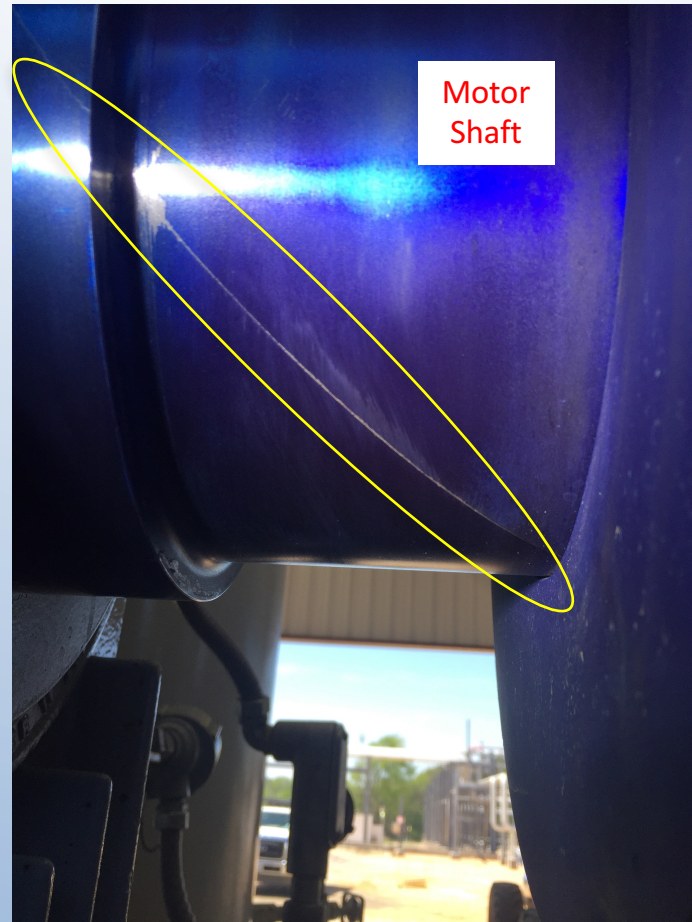
# Classical Torsional Failure

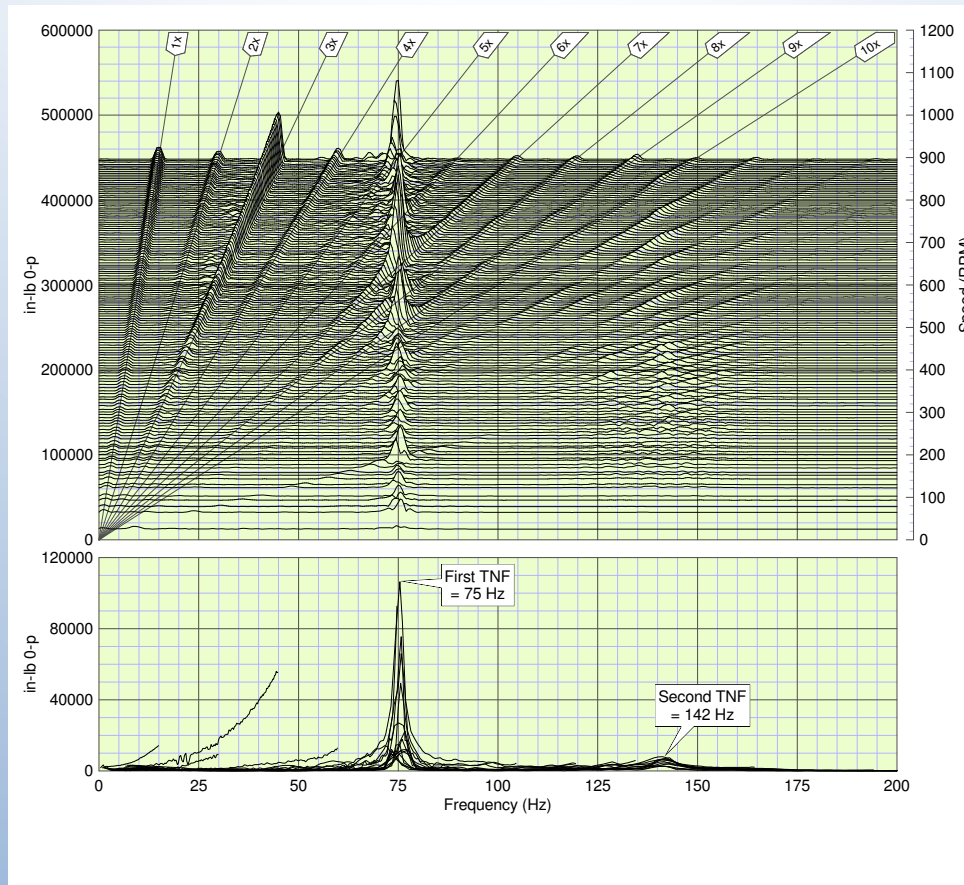
# Torsional Measurements (cont'd)

- 1<sup>st</sup> TNF = 4500 CPM (75 Hz)
- Excitation of concern was 5x (from TVA)
- 1<sup>st</sup> TNF excited by 5x @ 900 RPM
- Uh-oh!

- Short Term:
  - Limit compressor speed to 750 – 850 RPM
- Long Term:
  - Trim flywheel to increase TNF (target ~80 Hz)

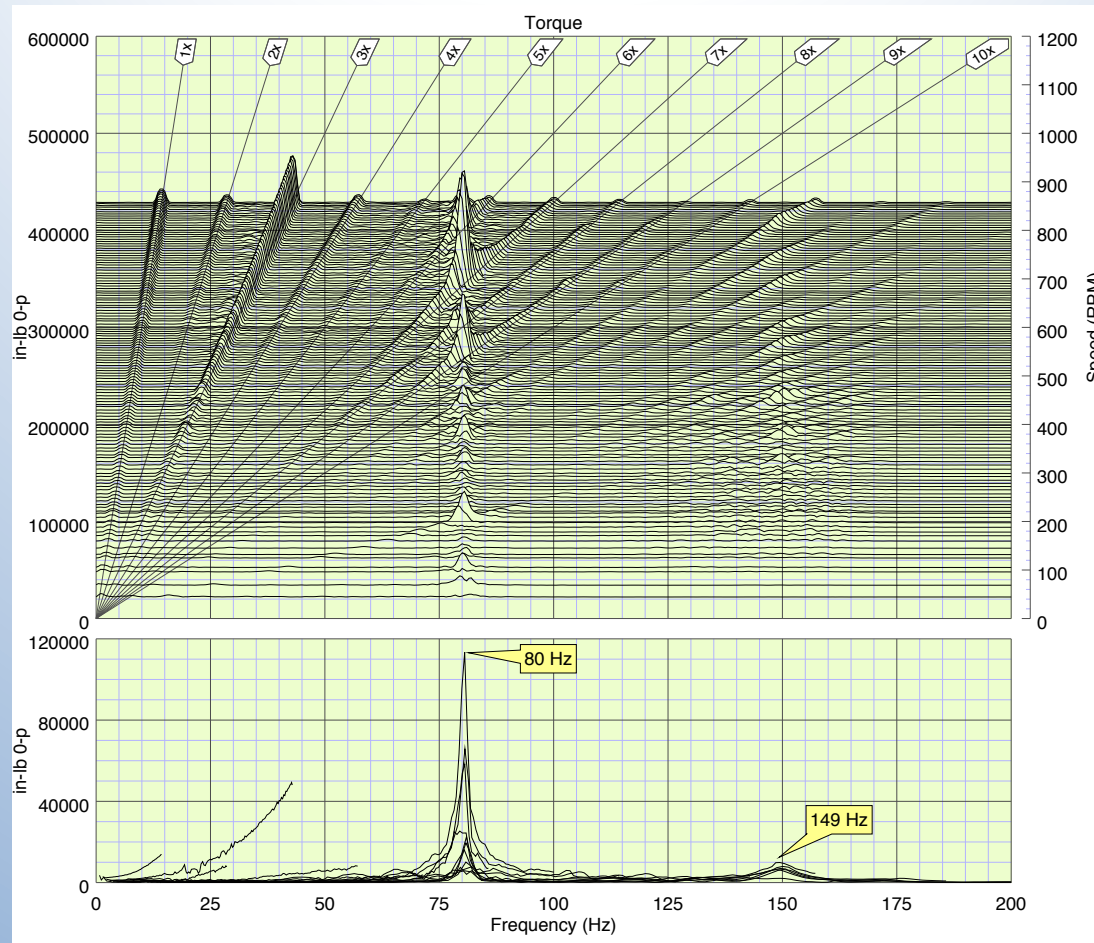
# Results – 1<sup>st</sup> TNF Increased to 80 Hz

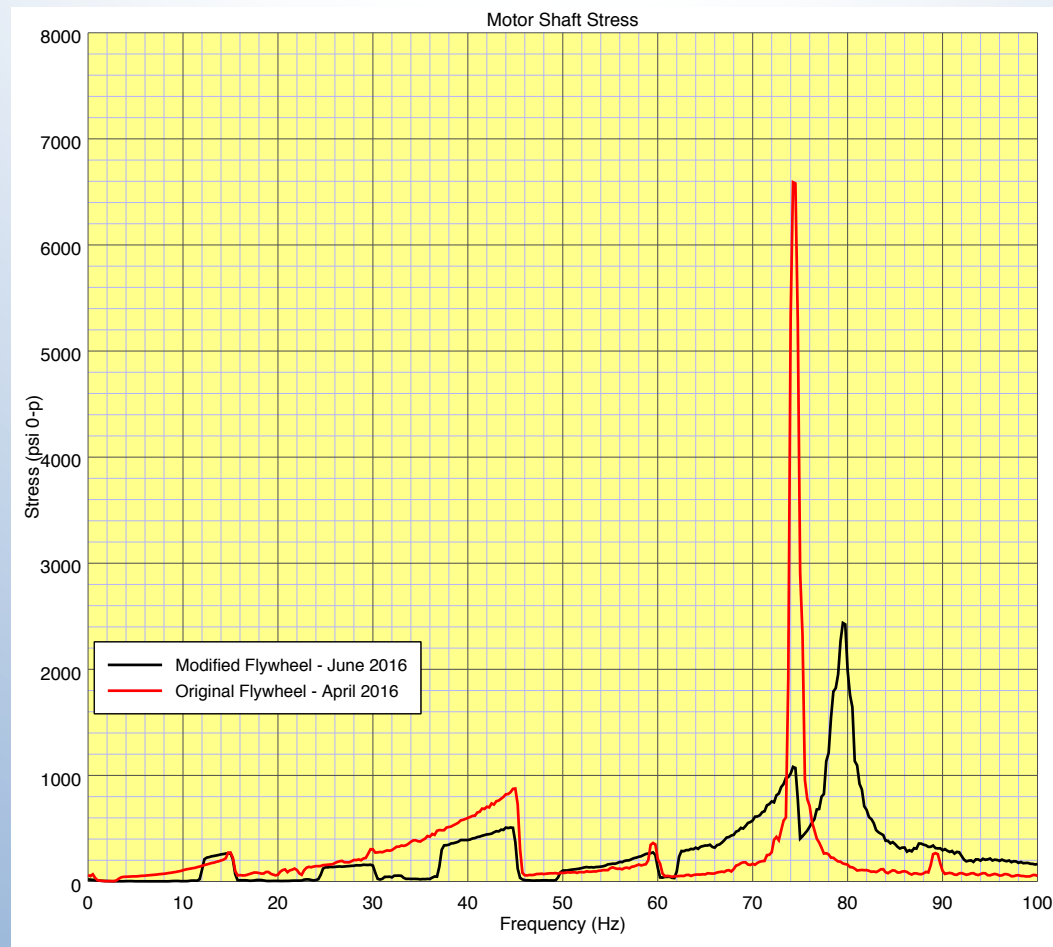
# Results – Motor Shaft Stresses Reduced
