ASIA TURBOMACHINERY & PUMP SYMPOSIUM
MARCH 2018 | SUNTEC SINGAPORE

Dry Gas Seal (DGS) Separation Seal Failure

Case Study from ExxonMobil Singapore

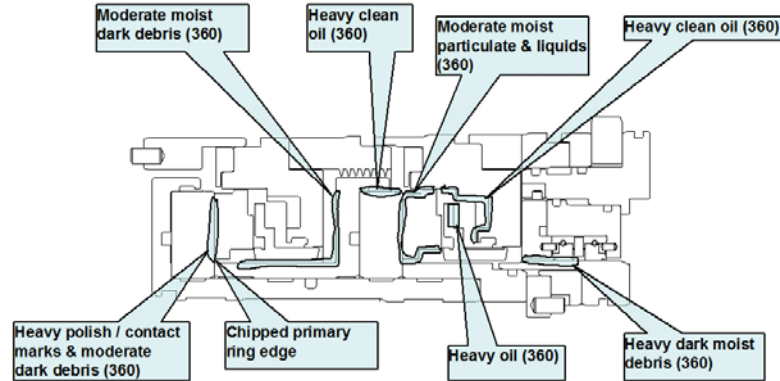
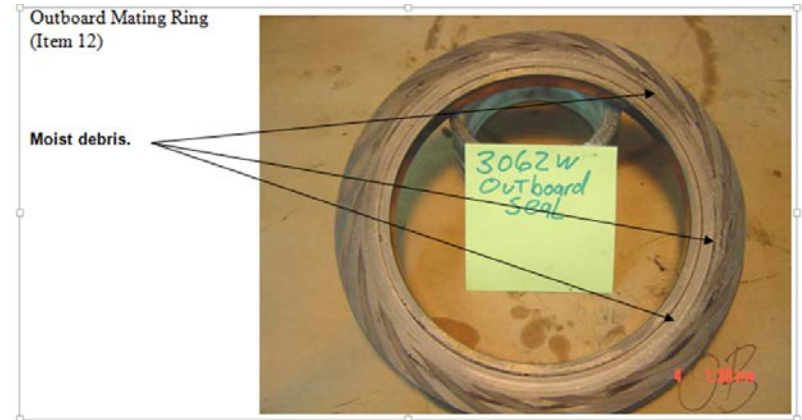
2005:

- Heavy wear observed in DGS inboard/outboard seal head during every seal replacement (4-yearly)
 - Oil observed migrated past secondary seal faces into DGS assembly
 - Heavy contact marks are present on the primary ring-sealing surface
 - Dark debris and polish marks are present on the sealing surface of the mating ring.
- Contact type separation seals observed to have significant wear

Accelerated wear of carbon bushing resulting from the lack of lubrication through use of ultra-dry cryogenic nitrogen as separation gas. Excessive wear led to less than adequate sealing capability.

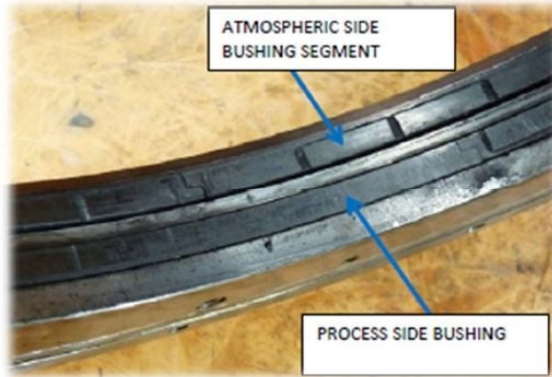
The close up on the bushing segment of the barrier seal. Initial findings shows heavy wearing marks on the contacting surface of the segment rings. Liquid contamination is visible on the surfaces of the components.

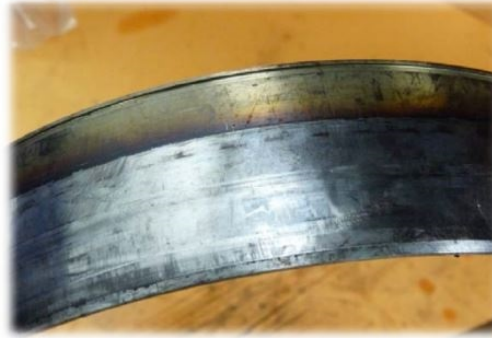
Picture shows the barrier seal sleeve. Contact wear mark on sleeve outer diameter coated surface.

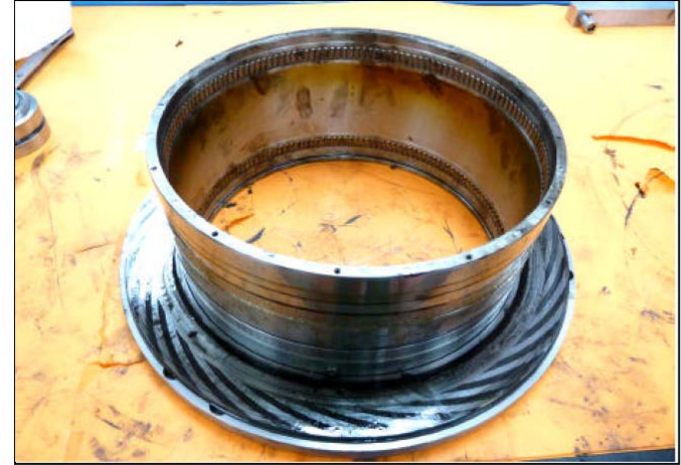
Picture 1 shows the inboard mating ring assembly. Thick traces of wet hydrocarbon contaminants (suspected to be mixture of hydrocarbon contaminants & bearing lube oil) is visible on the polished surface of the mating ring.

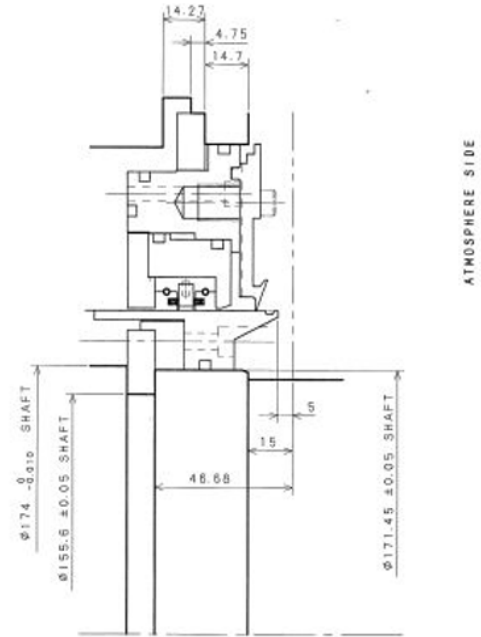
After 2009 modification

- Secondary drain sight glasses installed
- Modified Barrier seal with Oil baffle
- Oil observed in sight glasses after few months of start-up (new seals) and required 4 Pcs of mating rings to be scrapped out of 10 pair of seals
- **Modifications did not help in oil migration to dry gas seals**

- Contact type bushing separation seals were replaced with conventional labyrinth seals with following axial clearance between separation seal and bearing
- **Modification successfully prevented oil migration to seals**

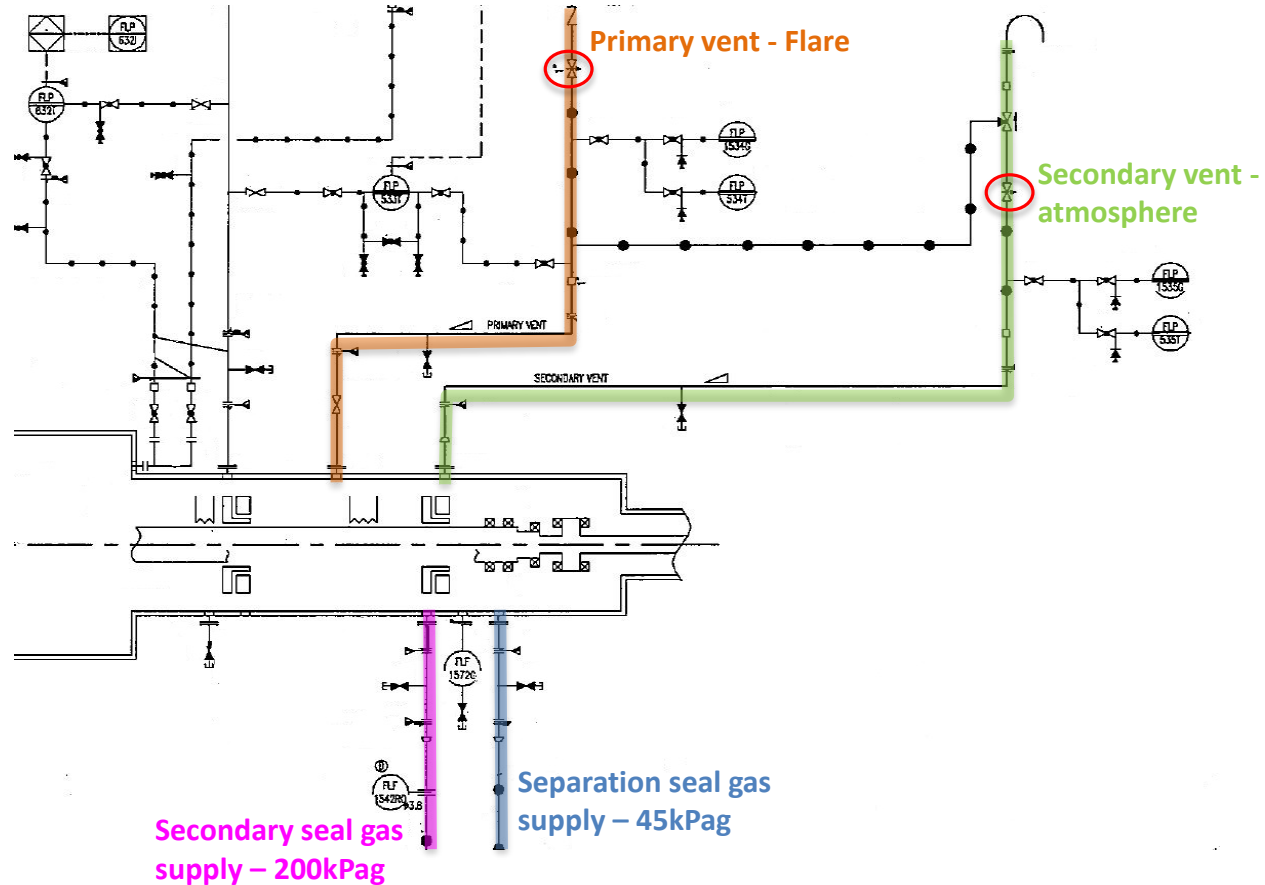
- All 10 units have been in service since 2013 and no oil has been observed in the secondary drain sight glasses.

- Use of needle valve in secondary vent to maintain low pressure of 5 – 15kPag in secondary vent line
- Primary vent pressure maintained at about 20 ~ 50kPag
