# Case Study

## Solving a Coupling Unbalance Problem in the Field

# Abstract

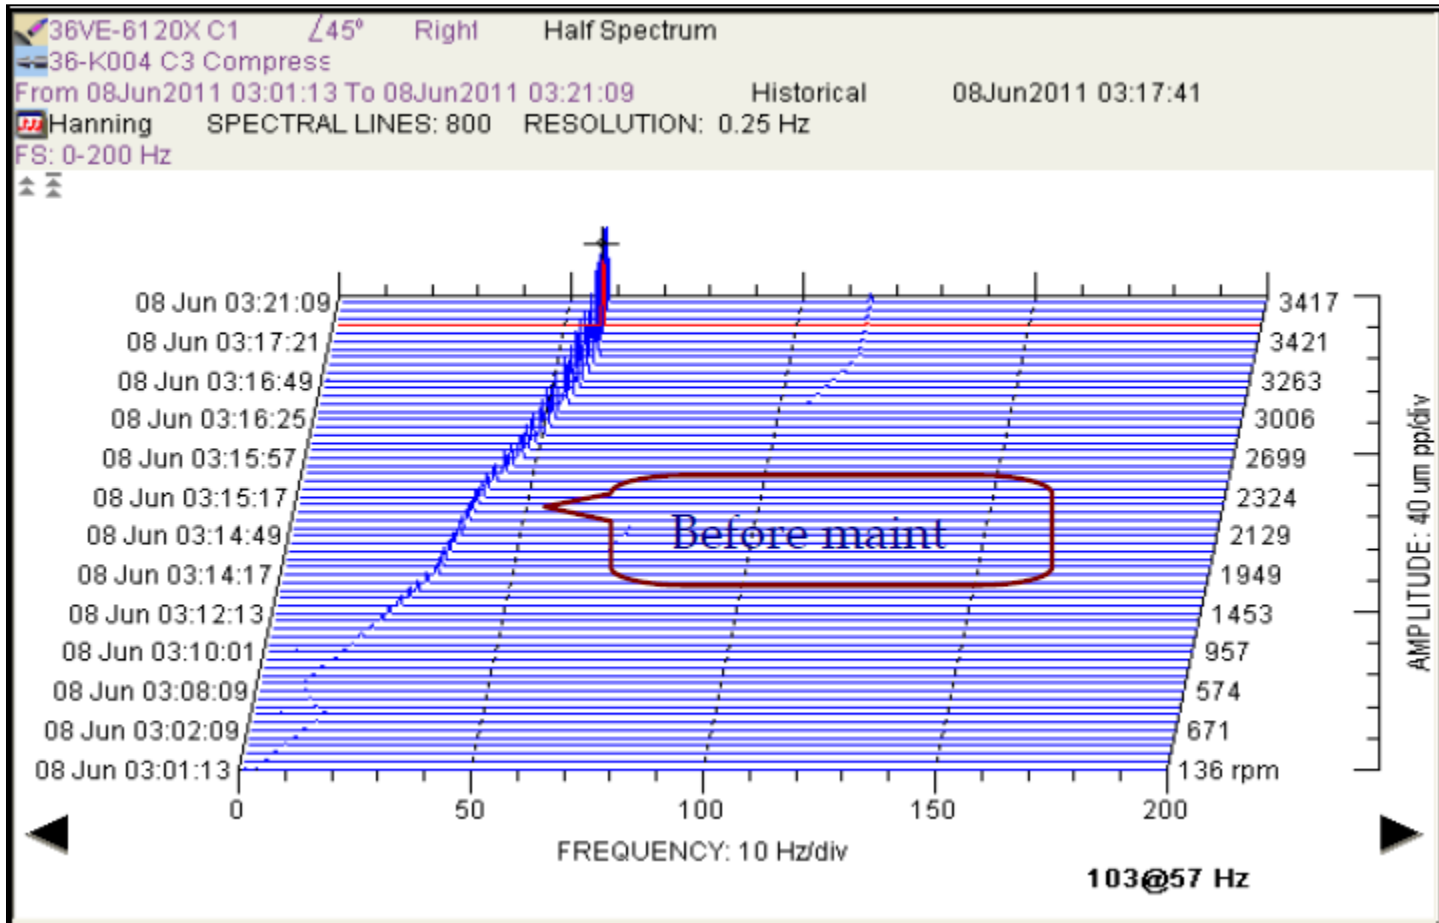
- Only DE radial vibration of the 88M rotor was extremely high – increasing rapidly with increasing speed / load; other bearings-vibe readings were normal.

- Strong suspect was load coupling #5.5 MSMH-J based on possible coupling imbalance as seen via 88M DE vibe plots: new spools & adapter but *old coupling-hub* were assembled; wrong pre-stretch gap; and poor run-out. Coupling components individual balance records observed to be “perfect”.

# High Vibration – Coupling Suspected

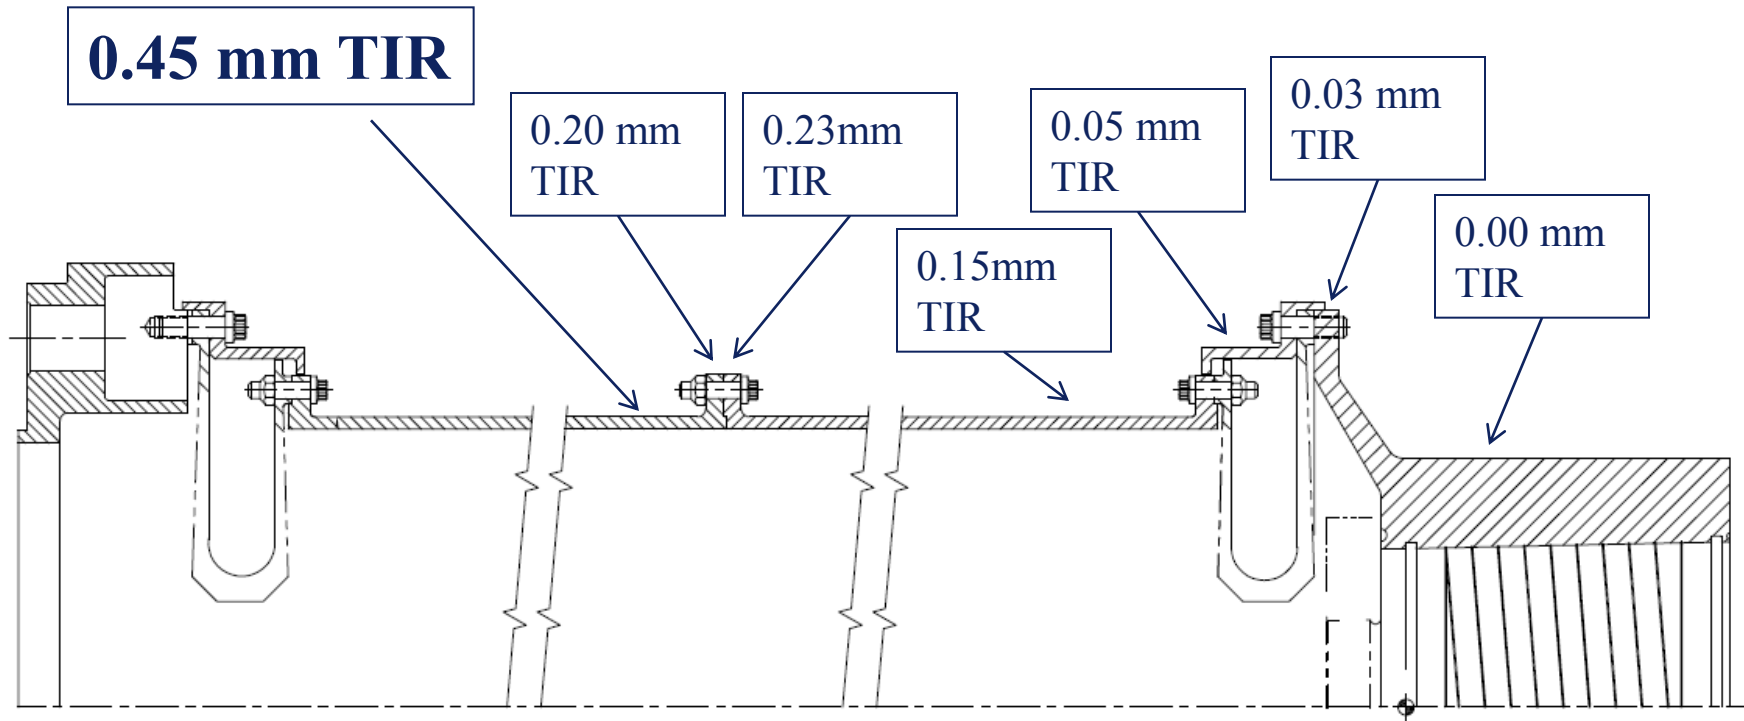
- On attending the unit, installed couplings run-out checks clearly showed the coupling straightness was grossly out-of- straightness (0.018”) in mid-span point.

**Run Out Should Typically be No Greater Than  
0.002” TIR at Flange Connections**

**0.001” TIR at Hub Bodies**

# Field Installed Run Out Check of Coupling Confirm a Problem

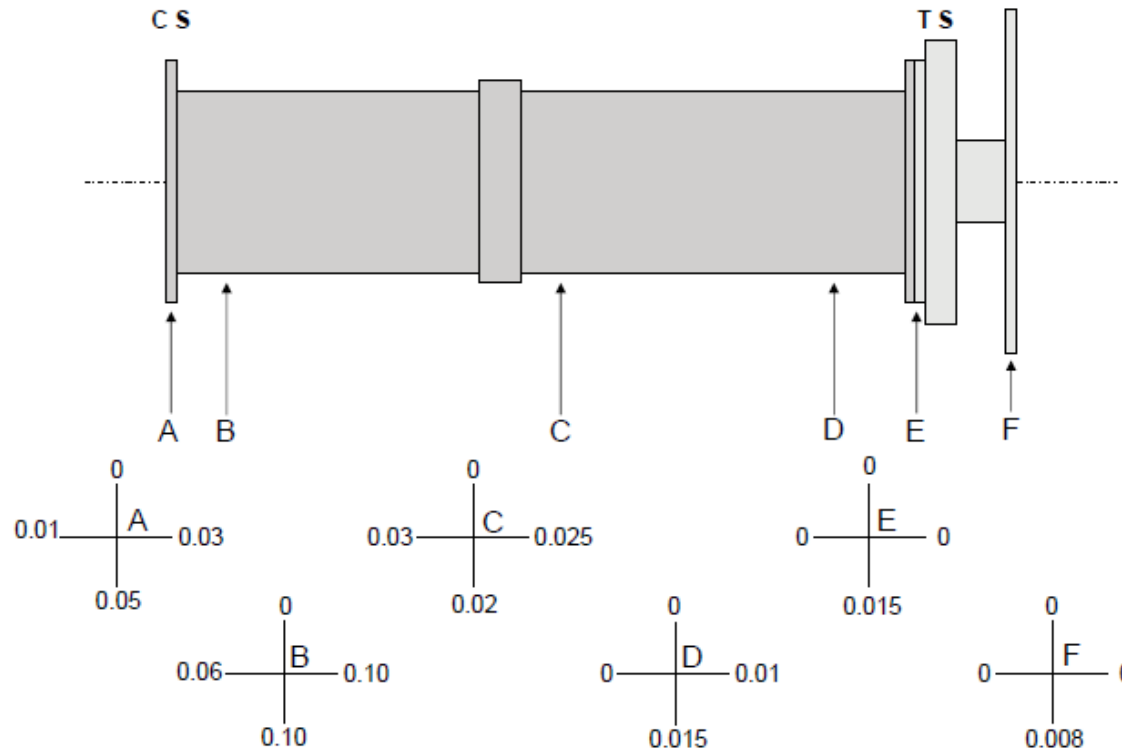
## 36 KT-004 COUPLING SPACER

# Next, Previously Installed Coupling was Checked to Reinstall to Get Train Running

Checked on Calibrated Acceptable Balance Machine

Minor Issue w/ Length Capacity of Available Balance Machine

Run Outs O K

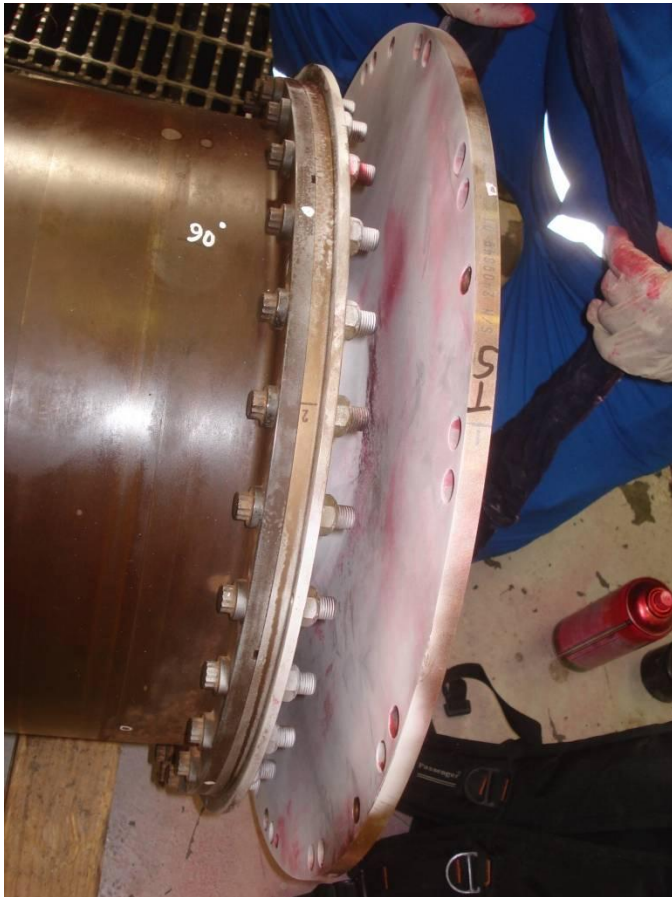
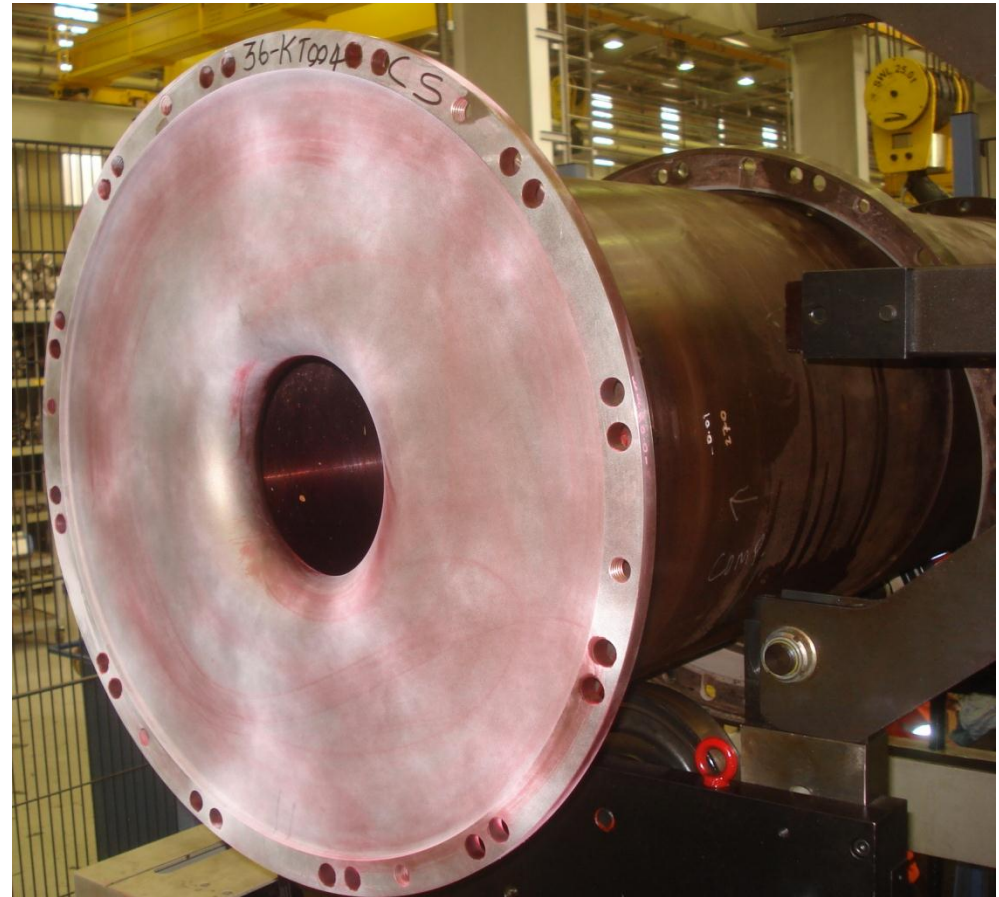
# *Then Dye Penetrant Checks of Diaphragms*

**Important Check On Used Diaphragms After Handling**

**No Indications, Cracks, or Unacceptable Scratches**

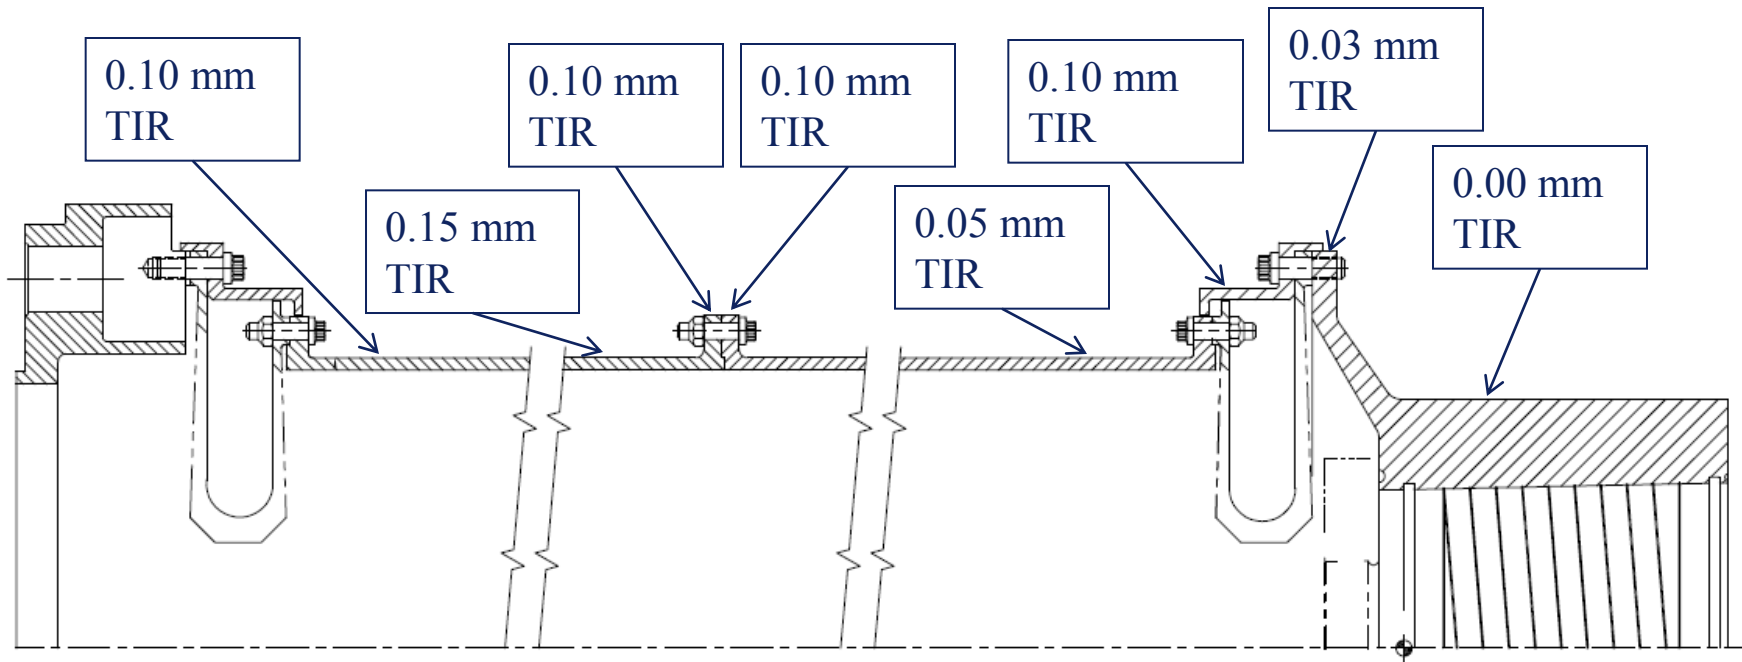
# Installed Replacement Coupling Run Out Checks

**No Problem**

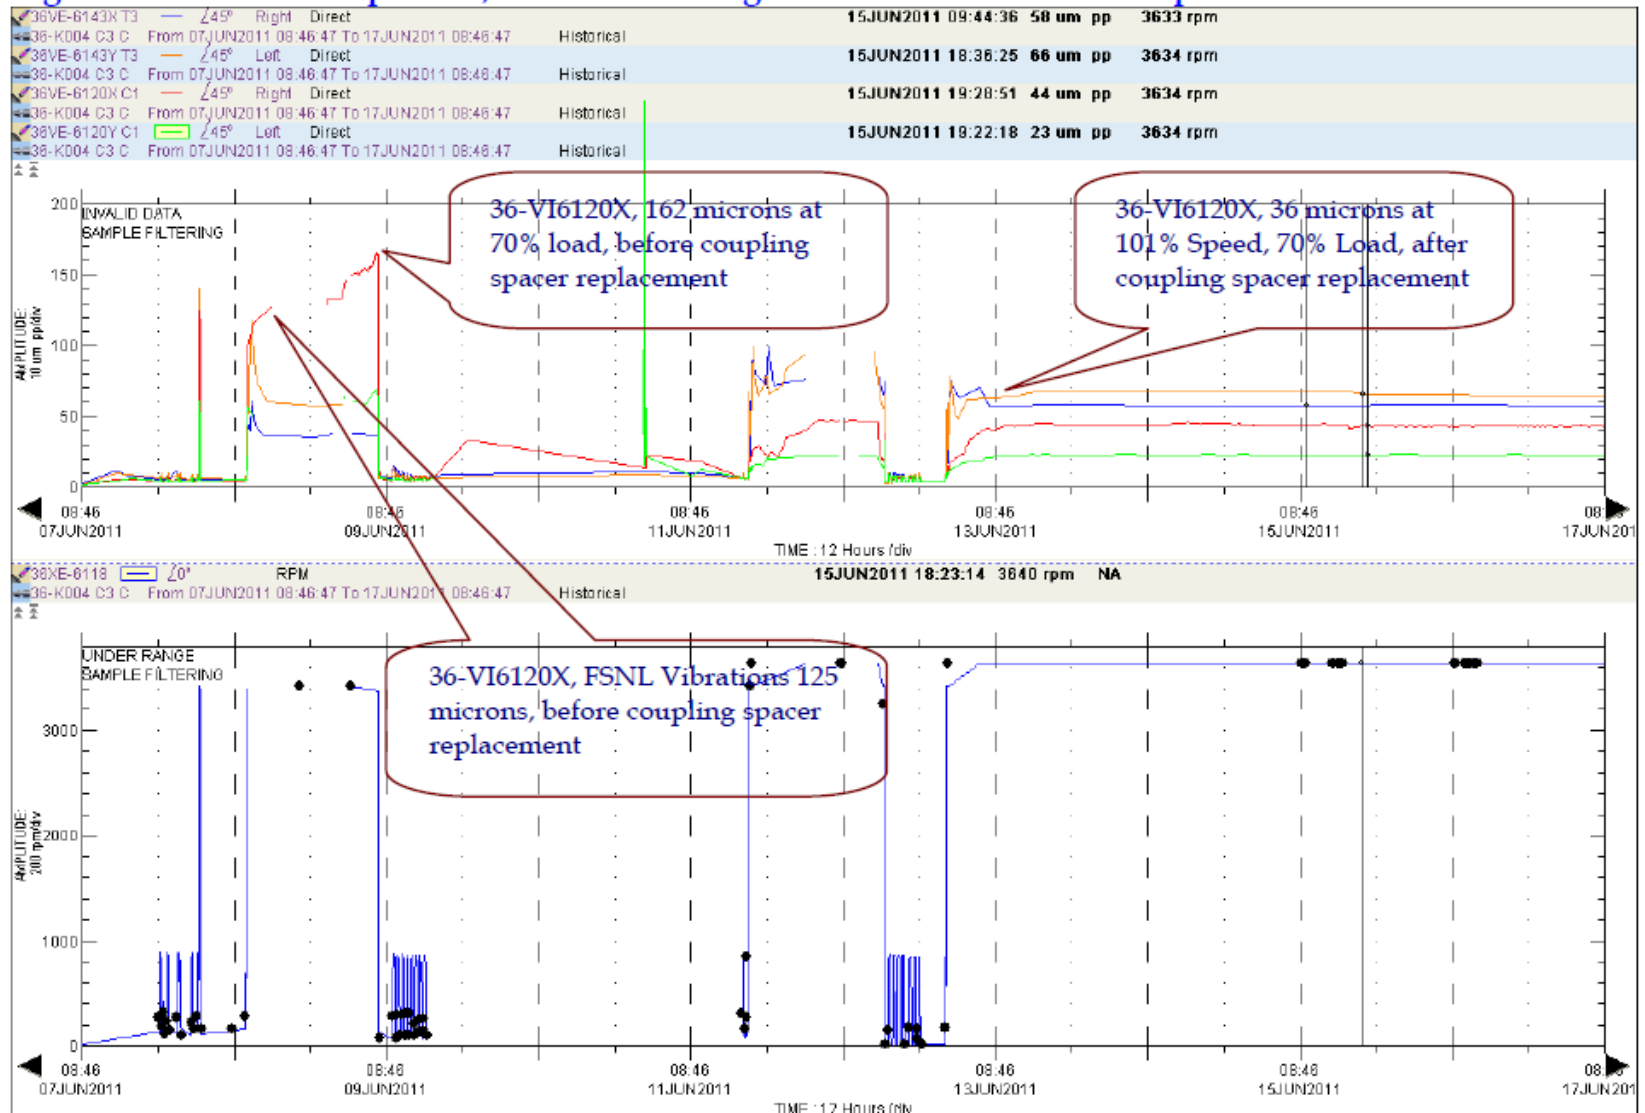
Figure 1: 36-K004 Compressor, Turbine Bearing # 3 radial vibration and Speed trend

# Runout Checks are Good and New Vibration Plots are Good

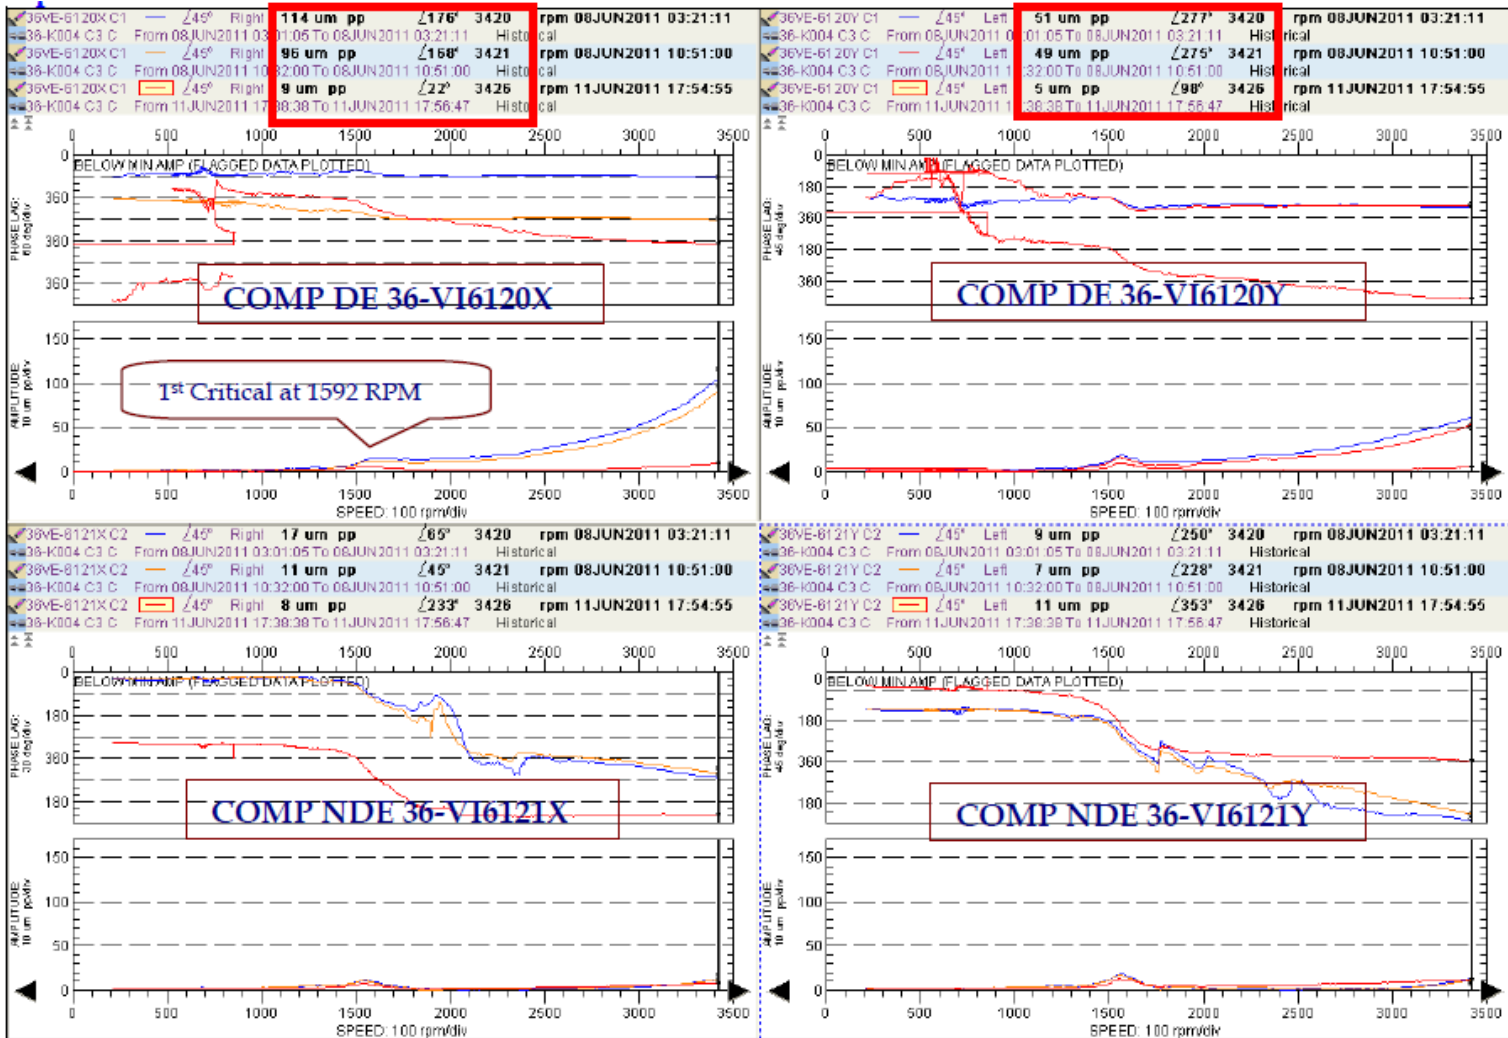
17  
Before and After

# Proof: Vibration Plots are Good

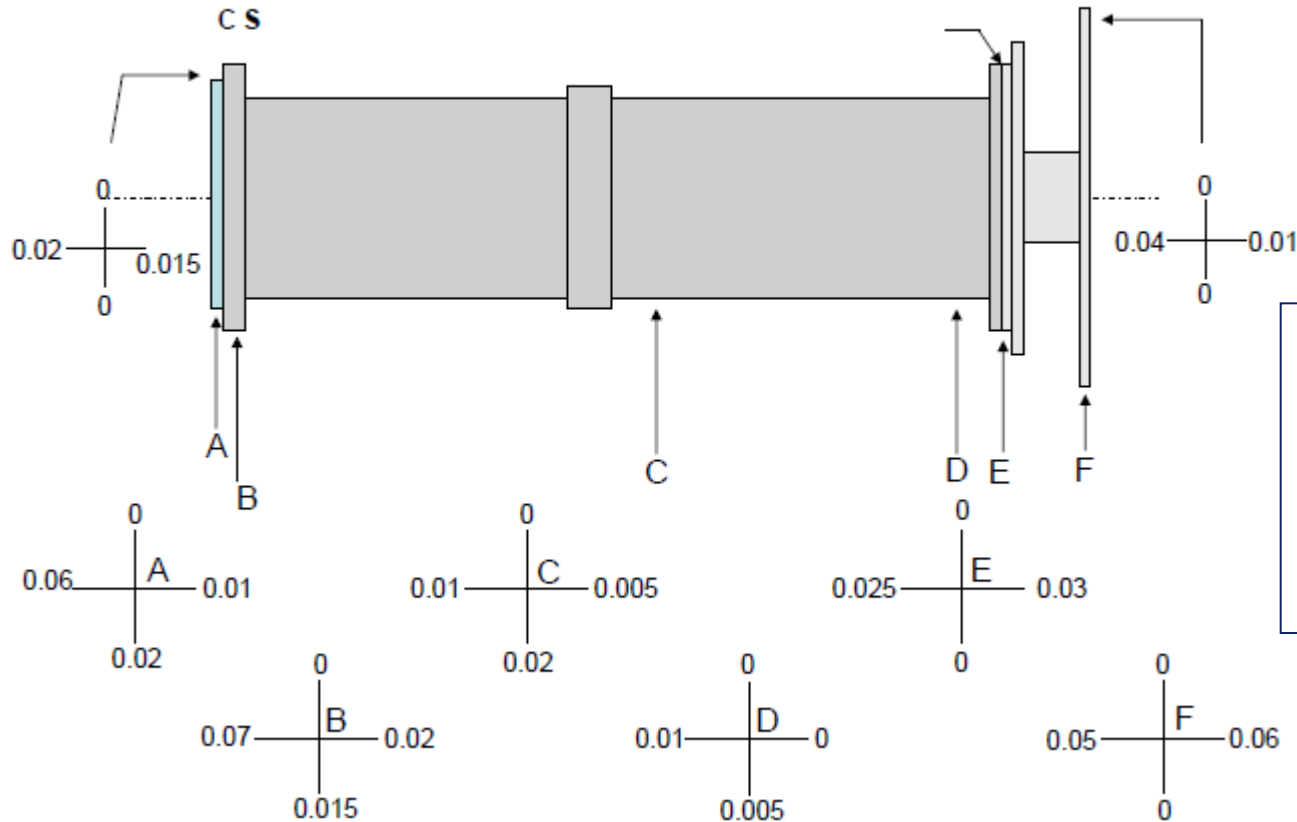
36 KT-004 NEW COUPLING SPACER T S

**OK Too !!**

**What is the Problem ??**

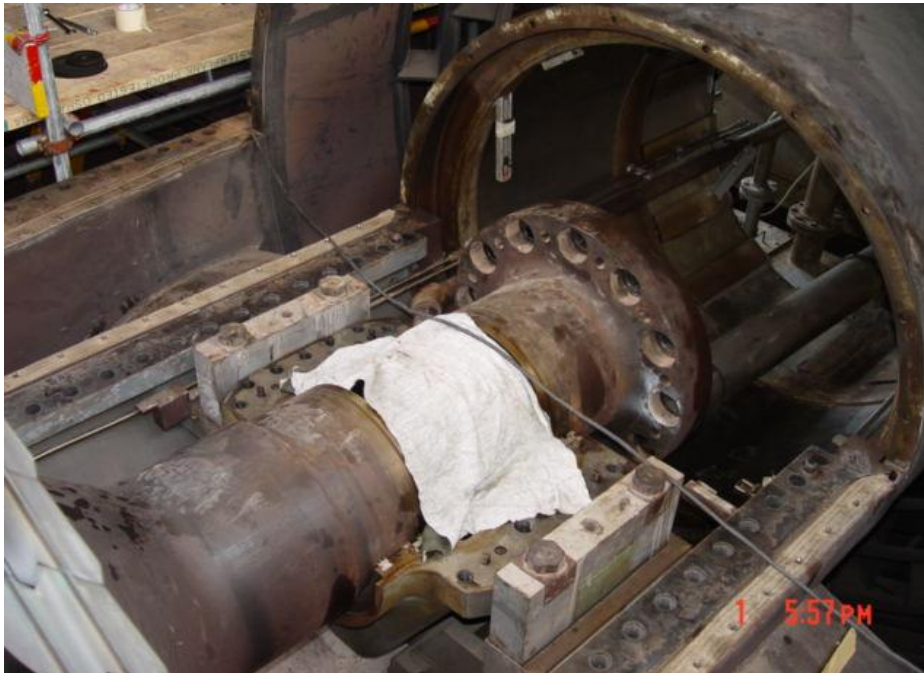
- Installed Run Outs at Positions Other Than Spacer - OK
- Mounting Flange and Adapter - OK
- Hub Mounting Surfaces - OK
- Then we remembered a comment about the difficulty of connecting to the Turbine flange
- Re-look at Coupling/Turbine Mounting Surfaces

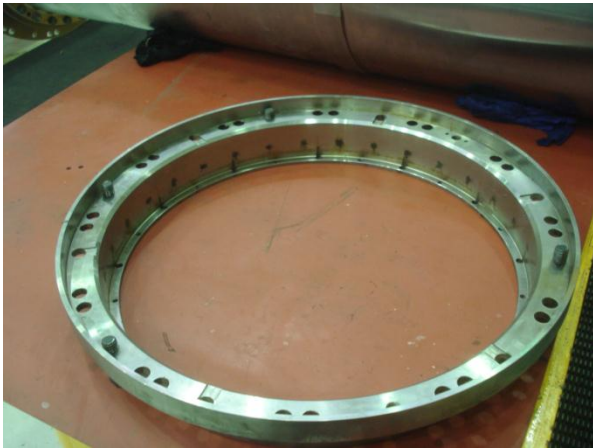
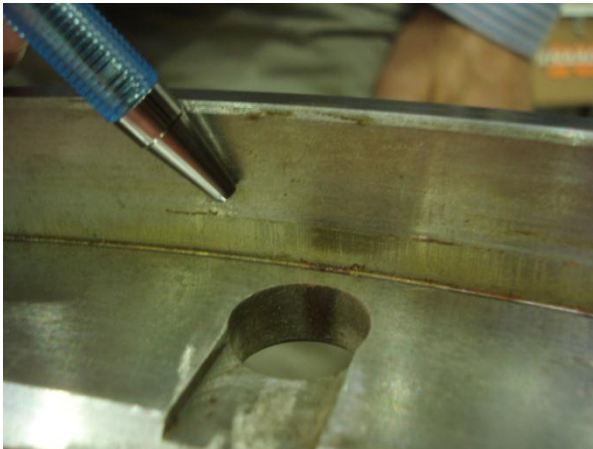
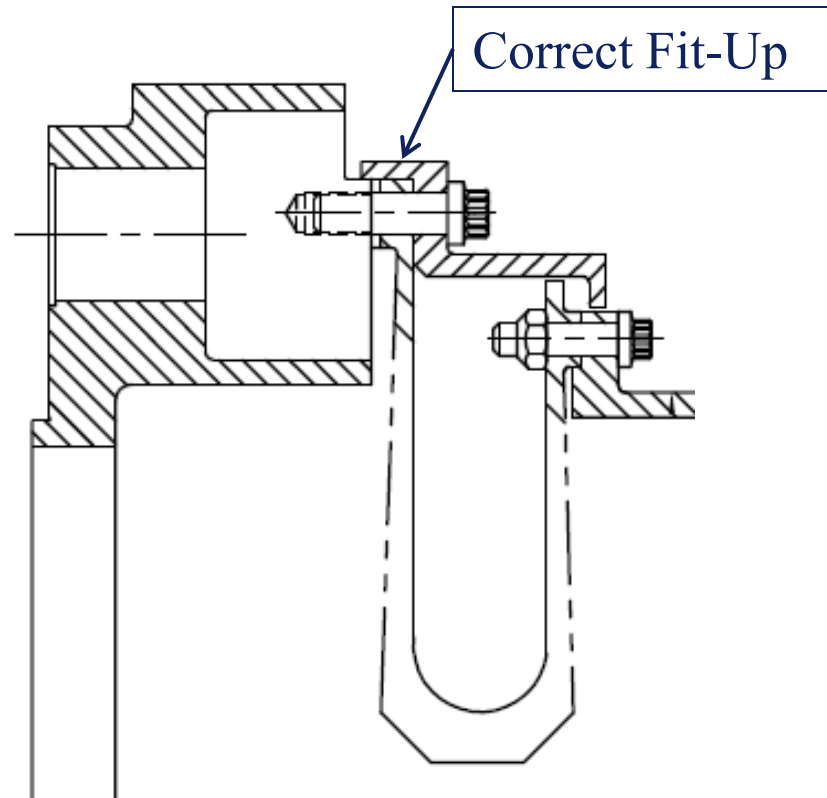
# ***Aha !! ; Clear Evidence of a Mounting Problem***

**Connecting Flanges were not Contacting and were out of Square Even Though Bolts Were Tightened Properly**

**This out of Square caused the Mounted Center Flange High Runout**

- Improve Existing Turbine Flange Connection for Ease of Assembly
  - Reduce Width of Guard Pilot
  - Reduce Amount of Interference at Pilot
- Improve Overall Flange Connection Design
  - Use Standard Design Bolting
- Improve Procedure
  - Leave Coupling Adapter in Place
- Handle Diaphragms “Gingerly”
