# Lessons learned on the diagnosis of pathologies in concrete dams: 30 years of research and practice

A. Blanco<sup>1</sup>, F. Pardo-Bosch<sup>2</sup>, S. Cavalaro<sup>1</sup>, A. Aguado<sup>3</sup>

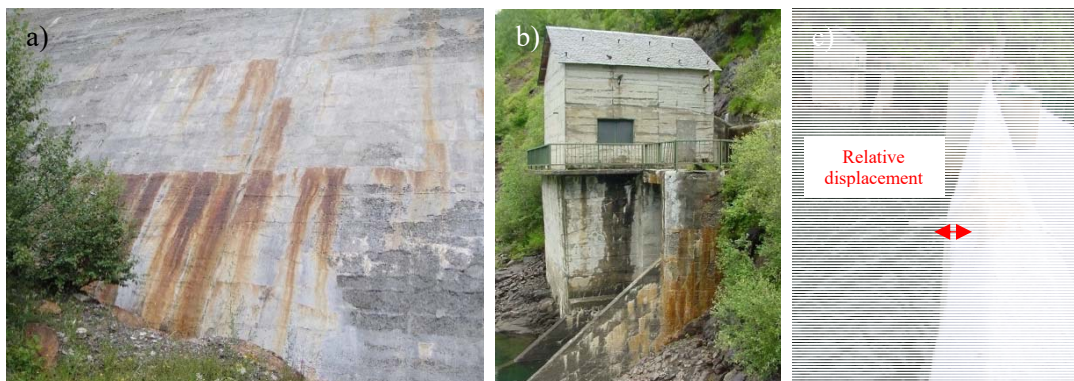
Several visual inspections conducted over the years indicated signs of damage in the dam (both externally and internally in the gallery). Externally, map cracking was clearly visible in the downstream face of the dam, combined with deposition of ochre shading precipitates (see Figure 2a) most likely related to the oxidation of iron sulfides from the aggregates used in the concrete. The same was also detected in nearby auxiliary structures, such as shown in Figure 2b.

Figure 2. a) Map cracking in the downstream face and ochre shading precipitate found in 2011, b) same signs in auxiliary structure inspected in 2004 and c) relative displacement between blocks.

Additional evidence of a pathology was detected in the crest, where fixed elements such as the safety railing suggested relative displacements between the blocks. This is clearly visible in the picture taken in 2011 from the crest of the downstream face (Figure 2c) despite the maintenance operations performed in previous years. Periodical visits to the gallery of the dam allowed assessing the state of the concrete inside the dam, which also exhibited cracking and deposition ochre shading precipitates, as shown in Figure 3. Upon entering the gallery, a strong sulfur-like odour is perceptible - an evidence of the presence of sulphides precipitates in combination with a potential biologic action.

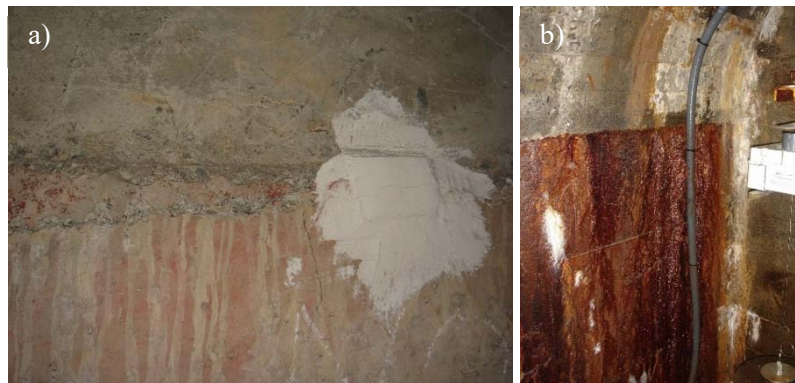
Figure 3. a) Cracking and b) ochre shading precipitate in the gallery.

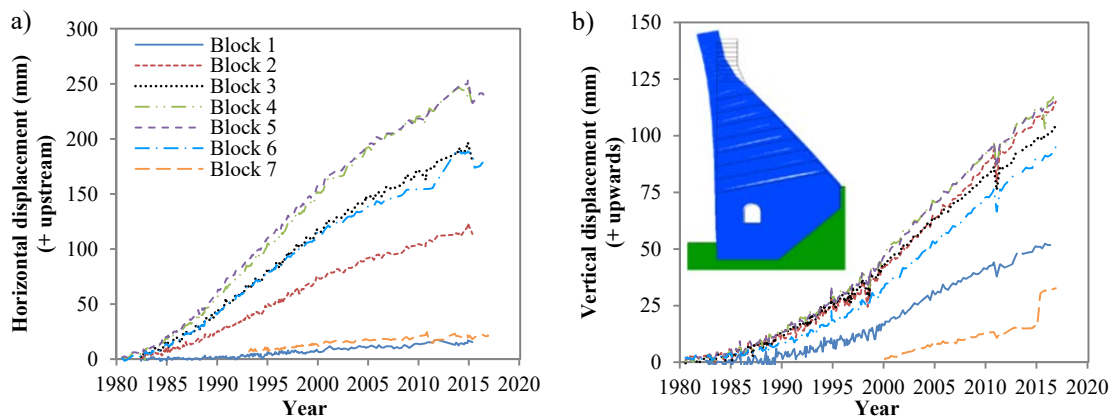
Figure 4 shows the evolution of the vertical and the horizontal displacements at the crest of the dam since 1981 for Blocks 1 to 7. The curves reveal significant, non-recoverable displacements in both directions. Horizontal displacements towards the upstream direction are approximately 2 times bigger than the upward vertical displacements. Until 2015, the former reaches 249 mm, whereas the latter approach 115 mm in blocks 4 and 5. Based on the authors' experience, such displacements are remarkably large for a dam with only 28.9 m of maximum height, equating to an average vertical strain of nearly 4‰. Notice that this strain is beyond the limit strain in compression typically allowed for concrete in structural design codes (e.g. Euro Code 2 that indicates 3.5‰ for normal strength concrete in the ultimate limit state).

Figure 4. Evolution of a) horizontal and b) vertical displacements including a schematic representation of the displacements [11].

However, a different trend is observed from 1993 to 2017. While horizontal displacements at the crest of Block 5 increased by almost threefold, vertical displacements increased by fivefold (see Figure 4). Additionally, in 2009, cracks in the vertical shafts and non-recoverable displacements (approximately 10 mm) in the gallery were also observed. This gallery is located at a low level, near the reservoir and close to the upstream face, where the availability of oxygen should be limited. Such evidence contradicts the expected due to the ISA, suggesting the presence of another deleterious phenomenon.

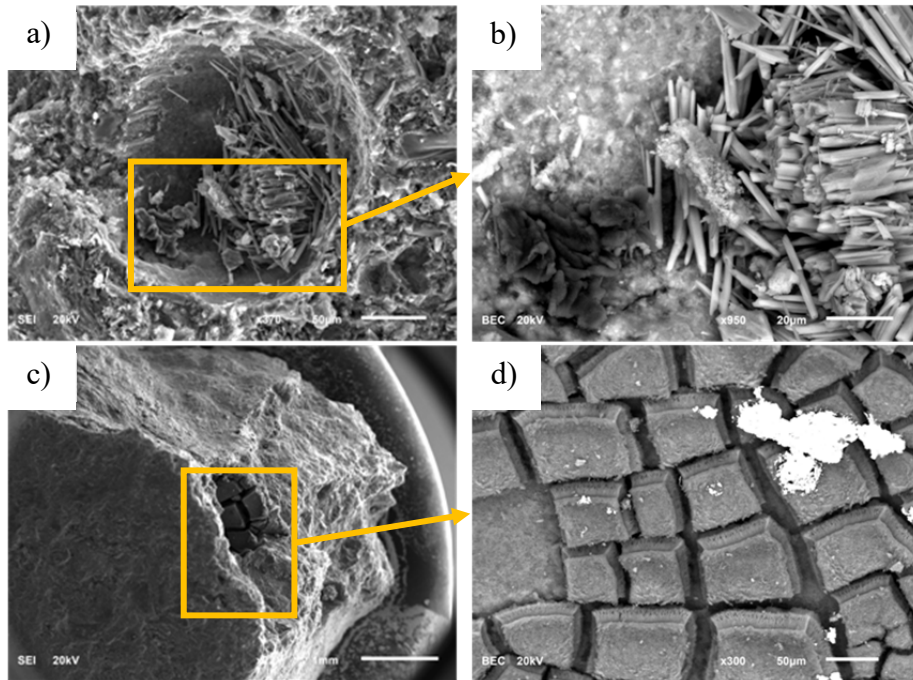
To verify this hypothesis, samples extracted from the dam in 2011 were characterized by scanning electron microscopy (SEM). As an example of some of the results obtained in this study, Figure 5 shows SEM images of two samples. Figure 5a and 5b show a pore of the concrete matrix with ettringite needles (confirmed by Energy Dispersive X-Ray Analysis - EDX), potentially a consequence of the ISA. Figure 5c and 5d show a region of the sample where alkali-silica gel from the AAR was found (confirmed by the EDX analyses). In several samples, the gel was covering the ettringite needles, thus suggesting that the ettringite was formed prior to the gel. These findings support the hypothesis described above, suggesting that

the bulk of the ettringite formation due to the ISA came first and was succeeded by the gel formation in the AAR. This hypothesis was also confirmed through numerical simulations [15].

Figure 5. SEM from samples of concrete from the dam: a) pore, b) detail of the pore with ettringite, c) area with alkali-silica gel and d) detail of the area confirming the presence of the gel.

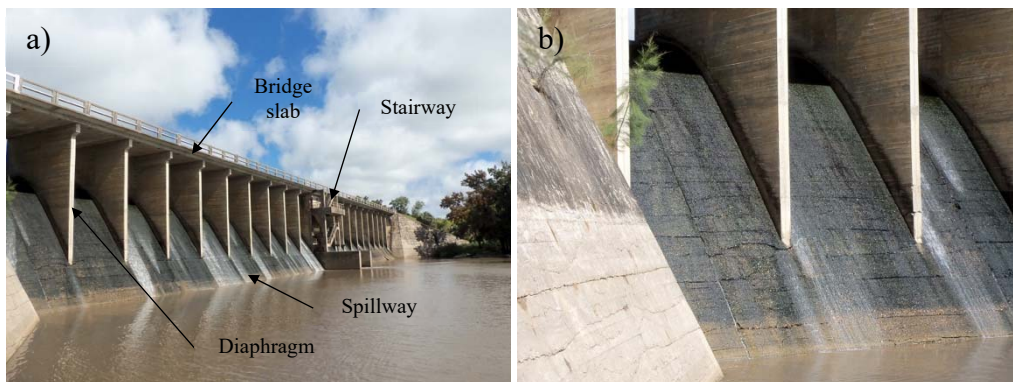
Figure 6. a) General view of the downstream face and b) detail of the horizontal cracking in the spillway and retaining walls.

At the time of the study, the spillway exhibited horizontal cracks along the construction joints in the downstream (see Figure 6b) and visible area of the upstream faces. These cracks were already reported in 1989 and 1996, being described as non-continuous since no water egress was identified. Map cracking was also observed at the upstream face (see Figure 7a) and the walls of the dykes (see Figure 7b).

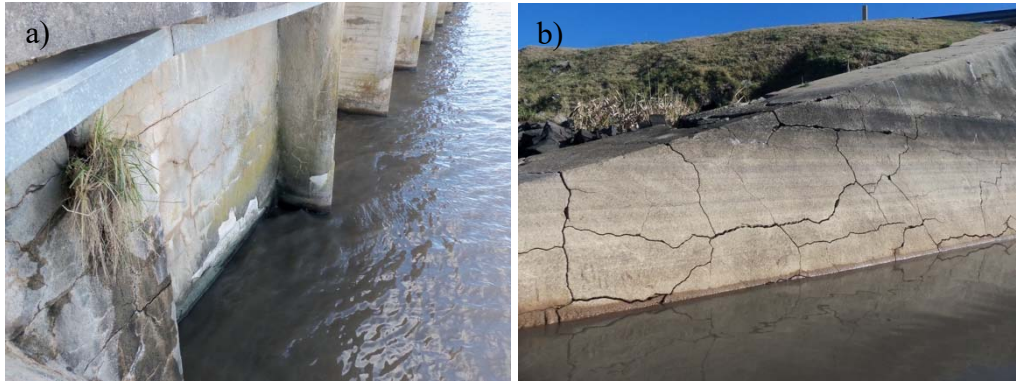
Figure 7. a) Map cracking in the upstream face and b) at the walls of the dykes.

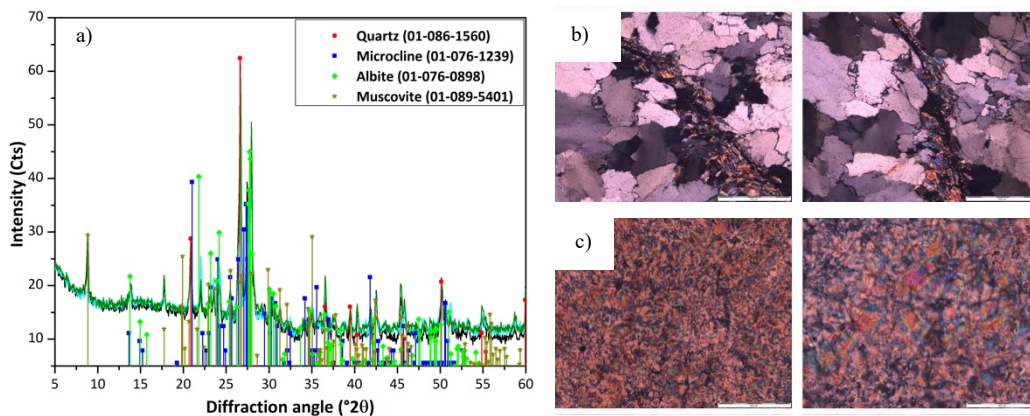
Among the 16 aggregate samples analysed with XRD, 12 were identified as quartzitic rocks given that quartz was the main crystalline phase. Feldspar was also detected as a minor phase in 11 of the quartzitic samples but it was not possible to identify the specific type of feldspar. The other aggregate samples were quartzitic schists with a large presence of feldspars (albite) and variable quantities of mica (muscovite). No other crystalline phases were identified. Figure 8a shows the XRD patterns of the quartzitic schists. The analyses of five thin sections with the optical microscope confirms the presence of quartz, albite and mica. Undulate extinctions, which are a characteristic feature from quartzitic samples with small size crystals and dislocations, were also identified (see Figure 8c). Additionally, one sample exhibited a fibrous structure that is typical of chalcedony with microcrystalline grains (see Figure 8b). Also, some of the samples with feldspars contained clayey phyllosilicates, which is a sign of alteration.

Figure 8. a) XRD patterns of the quartzitic schists, b) quartzitic aggregate sample with the presence of chalcedony and c) undulate extinction characteristic from quartz.

All the above indicates that the aggregates selected are not adequate to produce concrete, suggesting a potential reactivity with the alkalis of the cement. Even though amorphous silica was not observed, other characteristics described in the literature as signs of possible alkali-silica reactivity were detected. Moreover, the reactivity of the aggregates was confirmed through accelerated mortar bar tests [16]. Further detail on the tests and the results obtained may be found in [1].

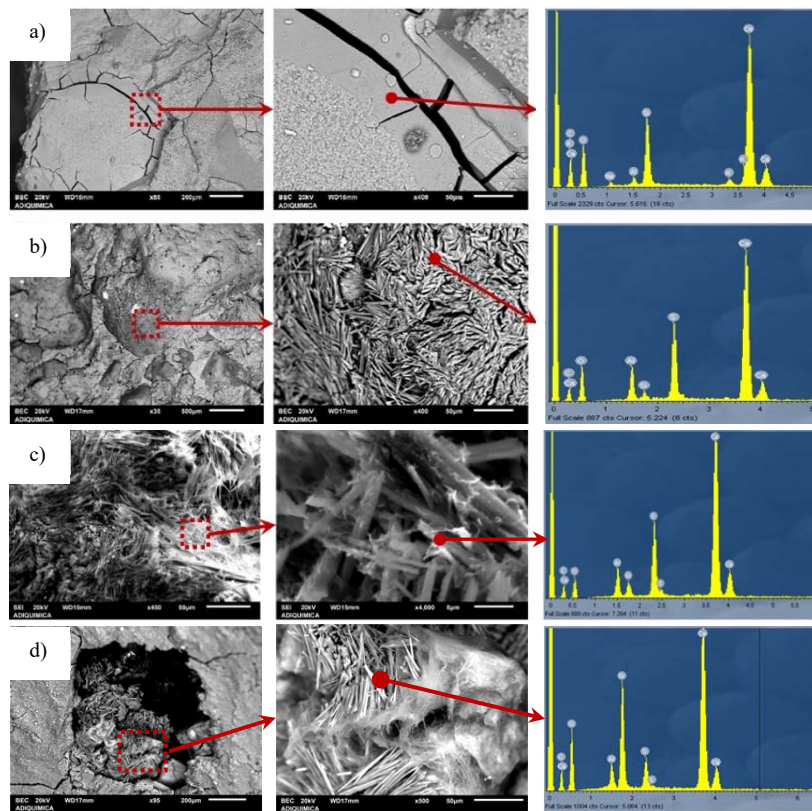
Abundant AAR gel was found in the SEM and EDX analyses of all samples (see Figure 9a). The high relative intensities of potassium and calcium peaks suggest the reaction was in an advanced stage since the concentration of these ions in the gel tends to increase as the reaction progresses [18]. In some cases, the gel appeared together with ettringite, which was dispersed in the cement paste and precipitated in pores (see Figure 9b). In some samples, ettringite needles are covered by different neoformed products whose morphology and composition suggest a product of the ASR in an initial stage of the reaction (see Figure 9c). Ettringite was also found in the form of long, well-defined needles inside pores (see Figure 9d).

Figure 9 SEM images of mortar samples: a) AAR products, b) ettringite, c) ettringite covered by AAR products and d) long ettringite needles inside a pore.

The high content of ettringite and its distribution throughout the matrix suggest a delayed ettringite formation (DEF). Previous studies reporting DEF show similar SEM images [19,20]. The DEF is a phenomenon that occurs when the temperature during construction and curing exceeds 70°C, thus blocking the normal formation of ettringite during the first hours of hydration. Instead, ettringite forms at later ages once the temperature drops and water is available to mobilize the ions. At this stage, the microstructure has limited space to accommodate the ettringite that produces internal stresses and may lead to expansions [21-23].

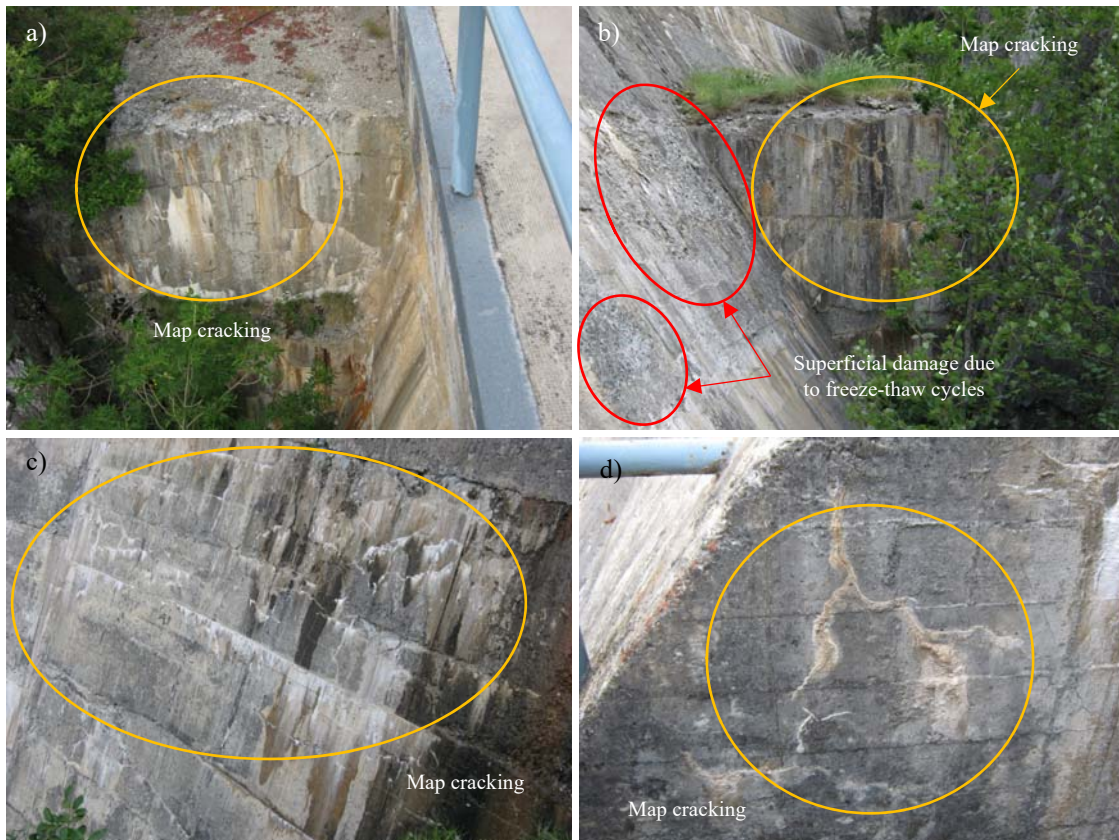
In the visual inspection, degradation due to different phenomena was observed in the downstream face. On one hand, superficial damage due to freeze-thaw cycles was detected, as shown in Figure 11b. On the other hand, map cracking and ochre shading precipitates appeared in the blocks near the abutment (Figure 11a and 11b), both in the downstream face (Figure 11c) and in the entrance to the upper gallery (Figure 11d).

Figure 11. Map cracking localized in specific areas of the dam: a) block beside the right abutment, b) block beside the left abutment, c) downstream face and d) entrance to the upper gallery.

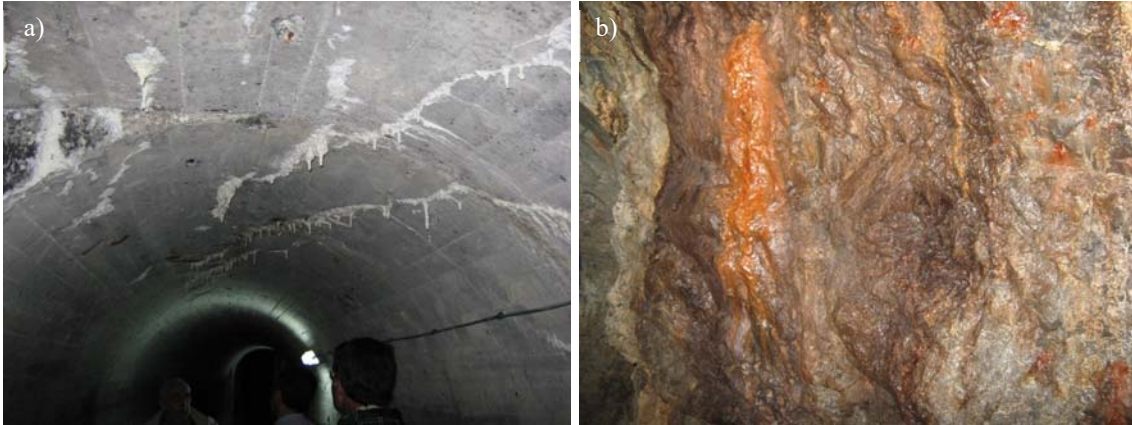
Inside the dam, oblique cracks were observed in the upper gallery (level 1350 m) near the left abutment, as shown in Figure 12a. In the second gallery (level 1330 m), inside the right abutment, the rock exhibits signs of oxidized iron sulfides (see Figure 12b). This phenomenon was also detected in the two lower galleries (at levels 1311 m and 1292 m).

Figure 12. a) Oblique cracks in an upper gallery near the left abutment (level 1350 m) and b) state of the rock in the right abutment seen from the second gallery (level 1330 m).

In the upper gallery near the left abutment, the dam exhibits oblique cracks that are usually associated with torsion forces. Torsion may occur in a block of the dam due to differential displacements within the block or due to the interaction with the abutments or other blocks that exhibit different behaviour. The fact that the expansions due to ISA are localized in certain areas of the blocks (hatched region in Figure 14) supports this argument. Furthermore, in the case of the cracks located in the upper gallery, the block between joints J12 and J13 presented clear signs of ISA (see Figure 12b) and could, consequently, contribute to a torsion effect of adjacent blocks.

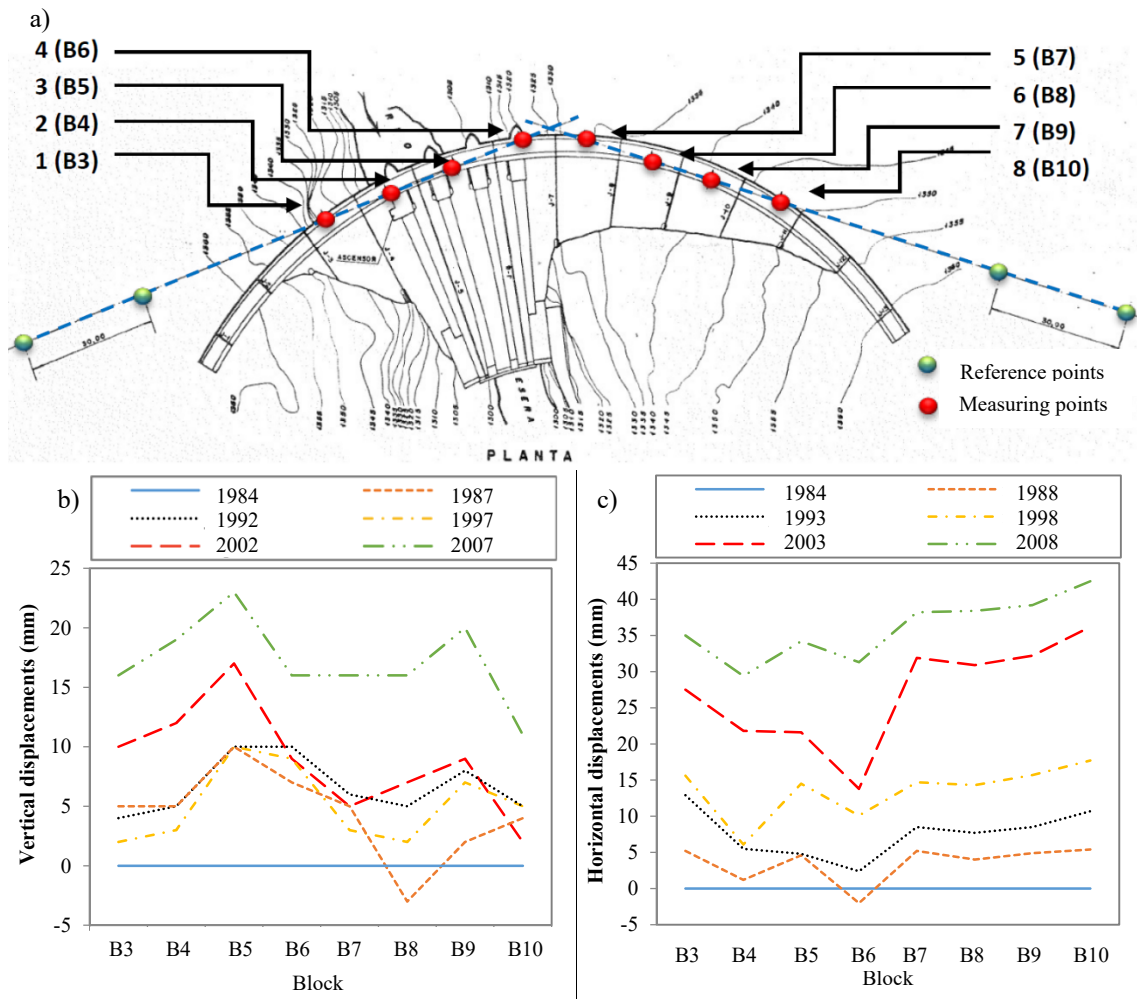
Besides the visual inspection of the dam, the historical records and the data registered during the years of monitoring the dam were analysed, revealing an unusual behaviour. Figure 13.a shows the location of the points of measurement and the evolution of the vertical (Figure 13.b) and horizontal (Figure 13.c) displacements. Notice that there is a 1-year difference between the vertical and the horizontal measurements.

Figure 13. a) Location of points of measurement and blocks [11] and b) vertical and c) horizontal displacements per block at the crest of the dam.

The curves indicate that the displacements of the dam are non-recoverable, reaching vertical values of 23 mm in B5 and horizontal values of 42.5 mm in B10. Notice that displacements caused by expansive reactions are usually symmetric when plotted as in Figure 13 (if the dam is symmetric) and proportional to the height of the dam (see case study I). In other words, the central blocks usually present the largest displacements with regards to the blocks near the abutment, which contradicts the behaviour observed in this case study. Consequently, the curves in Figure 13 suggest that, in this case, the dam presents a non-uniform response either due to the material or the interaction with the soil.

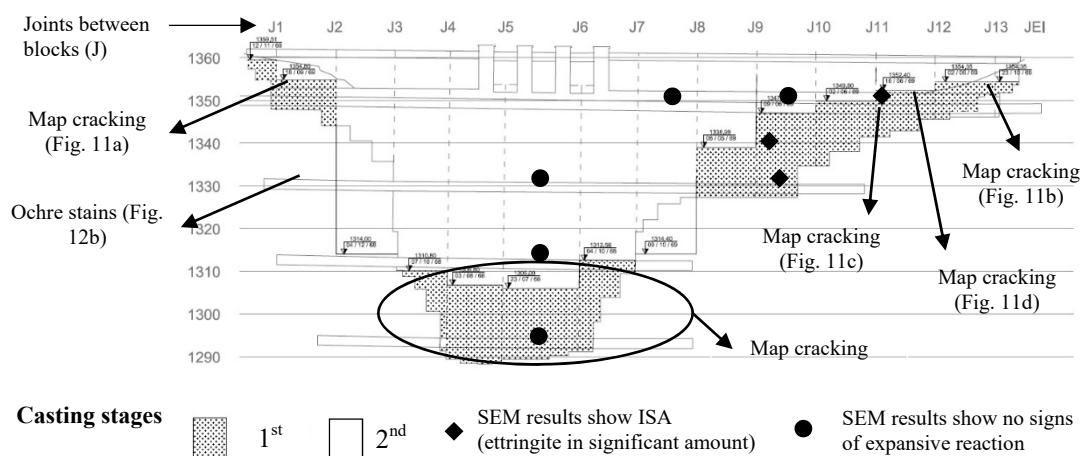
This dam is an example of the importance of reviewing “clinical history” to reach a successful diagnosis (see Table 1). Historical records indicate that the aggregates used in the concrete were obtained from two locations at the quarry near the dam (see locations in Figure 10b). Figure 14 depicts the areas of the dam constructed with aggregate from each location and the position of the most significant damage found in the visual inspection conducted in 2008. The aggregates extracted from the first quarry location shown in Figure 10b were used to produce the concrete for the first stage of construction (hatched areas in Figure 14). Aggregates from the second quarry location shown in Figure 10b were used in the following construction stages (white area in Figure 14). Interestingly, all signs of damage were detected in areas corresponding to the initial stage of construction.

Figure 14. Stages of construction depending on aggregates used.

Therefore, it is possible that the aggregates used during the first stage of construction were potentially more reactive and led to expansive reactions in the concrete. This hypothesis was supported by the current state of the rocks in the quarry, which exhibited signs of oxidization of iron sulphides in the first location, whereas rocks in the second location remained unaltered. An experimental program was conducted on concrete samples extracted from the dam using SEM and EDX to verify the presence of an expansive reaction. Figure 14 shows the location of the extraction points classified as without (marked with the symbol ●) or with (marked with the symbol ◆) signs of expansive reaction based on the microstructural and mineralogical analysis. All samples with signs of expansion were in the region within the 1<sup>st</sup> construction stage, having iron sulfides in the form of pyrite and a significant amount of secondary ettringite either filling cracks and pores or on the surface.

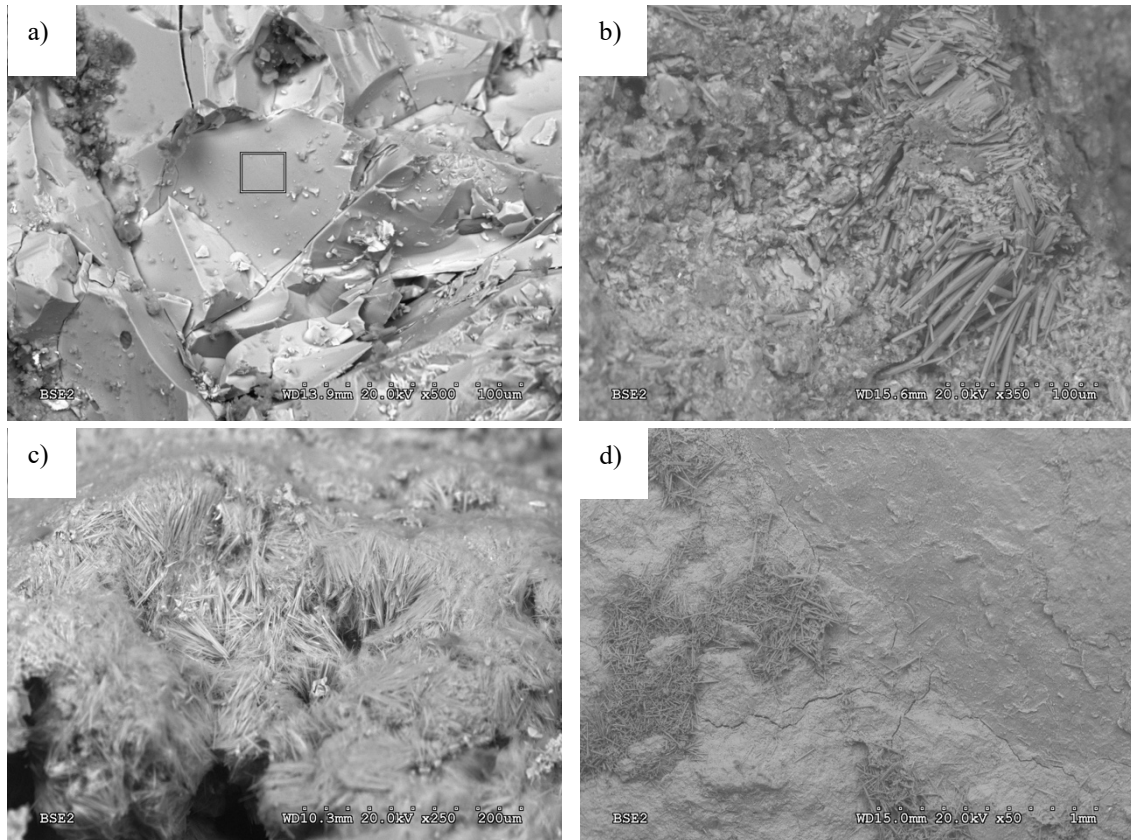
Figure 15a shows iron sulfides in a sample located in the second gallery (level 1330 m) between J9 and J10, near the left abutment (see Figure 14). The microanalysis with EDX confirmed this was pyrite. Figure 15b shows ettringite needles found in the same sample. Figure 15c corresponds to a sample obtained from the upper gallery (level 1351 m, see Figure 14) also in the area cast during the 1<sup>st</sup> stage and shows a significant amount of ettringite needles. Figure 15d was obtained from a sample that exhibited a halo around the aggregate associated to a possible AAR. The SEM and EDX analyses confirmed the presence of AAR gel and ettringite needles. The limited formation of gel suggests an incipient AAR.

Figure 15. a) Iron sulfides, namely pyrite, b) c) ettringite needles and d) ettringite needles and AAR gel.

Such outcome confirms an ISA in the concrete corresponding to the first stage of construction due to the iron sulfides contained in the aggregates used at that stage, which justifies the unusual characteristics of some of the signs of damage (e.g. map cracking localized in certain areas downstream face and the non-symmetry displacement of the dam).

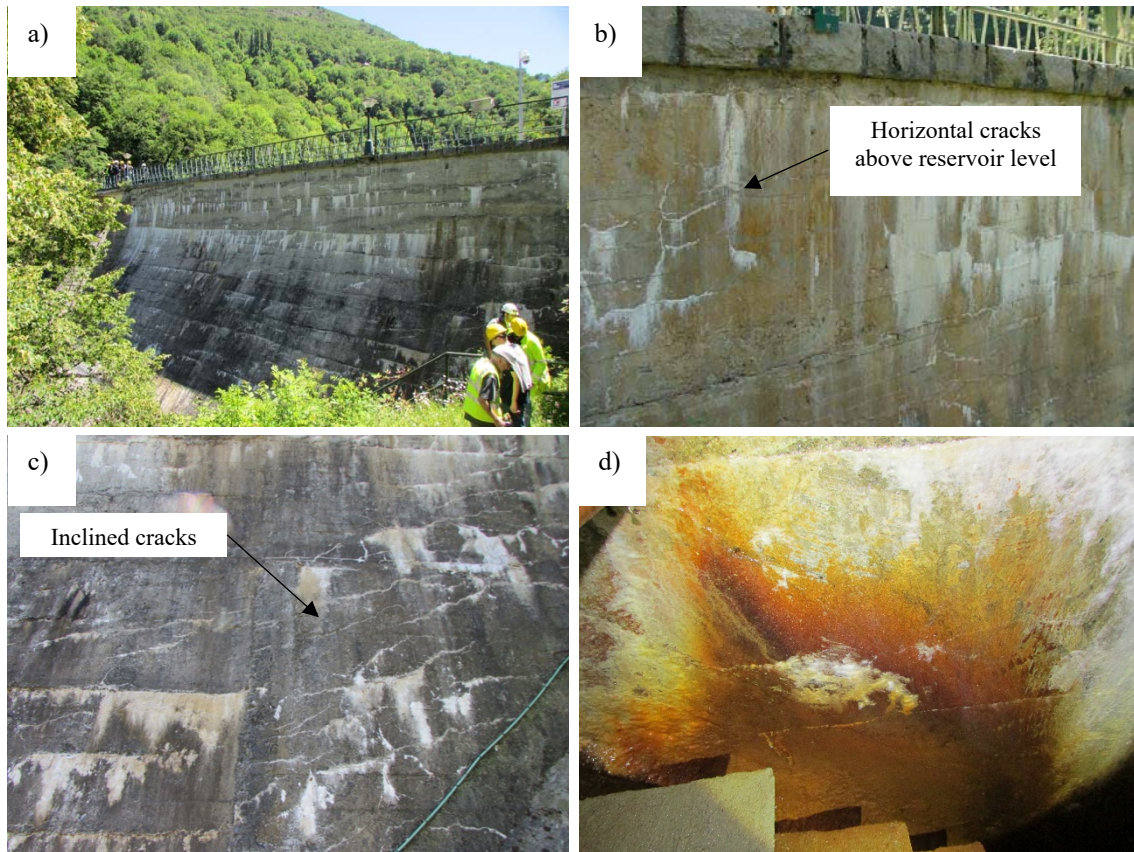
Figure 16. a) General view of the downstream face, b) map cracking at the downstream face, c) inclined to crack near the abutment, d) stains associated with oxidization of iron sulphides at gallery wall.

Field inspections conducted over the years revealed map cracking in the downstream face and auxiliary elements of the dam. Either horizontal (see Figure 16b) or slightly inclined cracks were observed near the crest of the dam, at the downstream face. The inclination of these cracks increases near the abutments, as shown in Figure 16c. Despite the application of a waterproofing layer during maintenance operations, a photograph taken in 1984 confirmed the existence of these cracks also in the upstream face above the water level. The white precipitates in the cracks (Figures 16b and 16c) indicate the accumulation of calcium carbonate. In the gallery of the dam, horizontal cracks were also detected on both walls (on the downstream and upstream sides). Additionally, the concrete walls exhibited stains commonly associated with the oxidization of iron sulphides, as shown in Figure 16d.

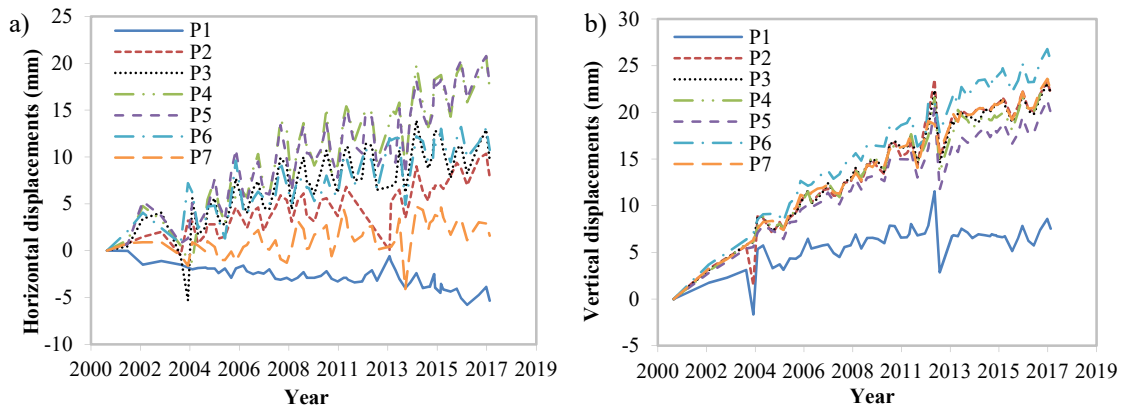
Figure 17 shows the displacements measured at the crest of the dam from 2000 to 2017 (previous measurements were not available). The analysis of the data reveals non-recoverable movements, beyond the cyclic variations due to thermal effects or the level of the reservoir. The

central blocks of the dam (Blocks 4 and 5) accumulated horizontal displacements towards upstream of 20 mm in the period (monitoring points P4 and P5 in Figure 17a, respectively). The opposite behaviour is detected for the blocks located near the abutments that presented either displacement with small variations around 0 mm (monitoring point P7 near left abutment) or towards downstream (P1 near the right abutment). Figure 17b indicates that all monitoring points, except for P1, register a non-recoverable upward movement of the blocks. This elevation ranges from 20 to 25 mm in the period considered. Considerable smaller vertical displacements are observed in P1, near the right abutment. This may be attributed to the smaller size of the block combined with the influence of the restraint applied by the rock.

Figure 17. a) Horizontal and b) vertical displacements registered in the period 2000-2017.

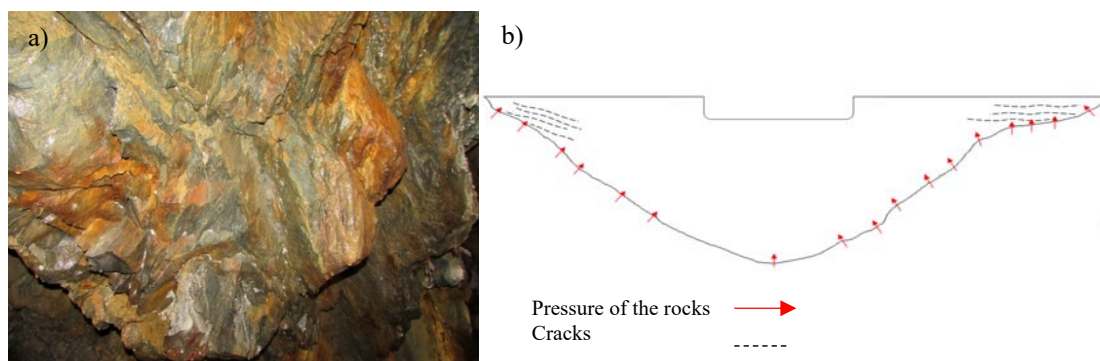
Several pieces of evidence described previously are consistent with an ISA, including map cracking, oxidization of iron sulphides and non-recoverable displacements towards upstream. The study of the historical records indicates that the aggregates used in the concrete were extracted from the local area, which according to the geological maps is predominantly constituted by slate and limestone. Moreover, during the field inspection of the gallery, rocks located in the left abutment exhibited signs of oxidization (see Figure 18a).

Figure 18. Detail of a) rock on left abutment and b) effect of the pressure of the abutments on the dam.

Rock samples extracted from the abutments and aggregates extracted from the concrete were characterized through XRD and SEM to evaluate the presence of potentially expansive products. The analyses reveal veins of iron sulphides (pyrrhotite) cutting through the schists of the rock. This indicates the aggregate and the surrounding rock might trigger expansive movements. In this case, the expansion from the concrete and the movements induced by the

oxidation of the surrounding rock (see Figure 18b) might contribute to the displacements of the dam. The contribution of the surrounding rock could explain the cracks near the abutments and the movements observed at P1 for Block 1 [25].
