ROCK SLOPE STABILITY PROBLEMS IN NATURAL SIGHTSEEING AREAS - AN EXAMPLE FROM ARVANITIA, NAFPLIO, GREECE

Key words: rockfall, natural sightseeing areas, Arvanitia walkway, Nafplio city.

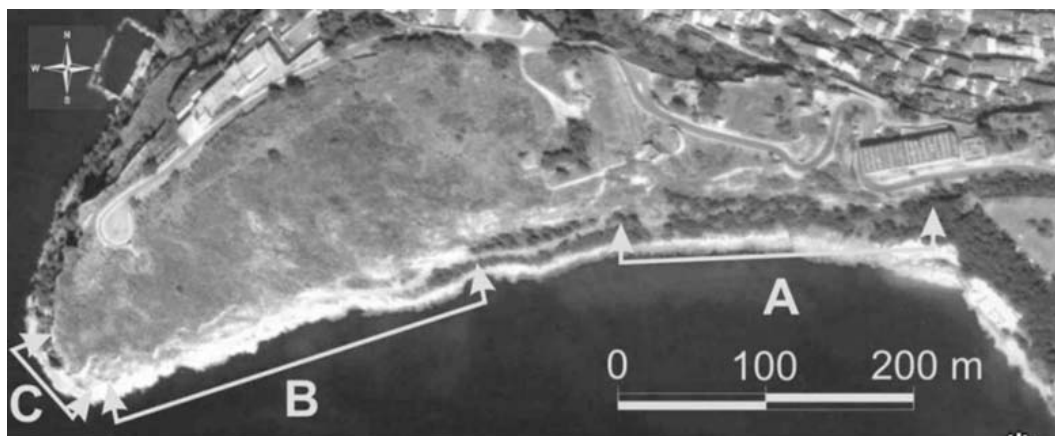
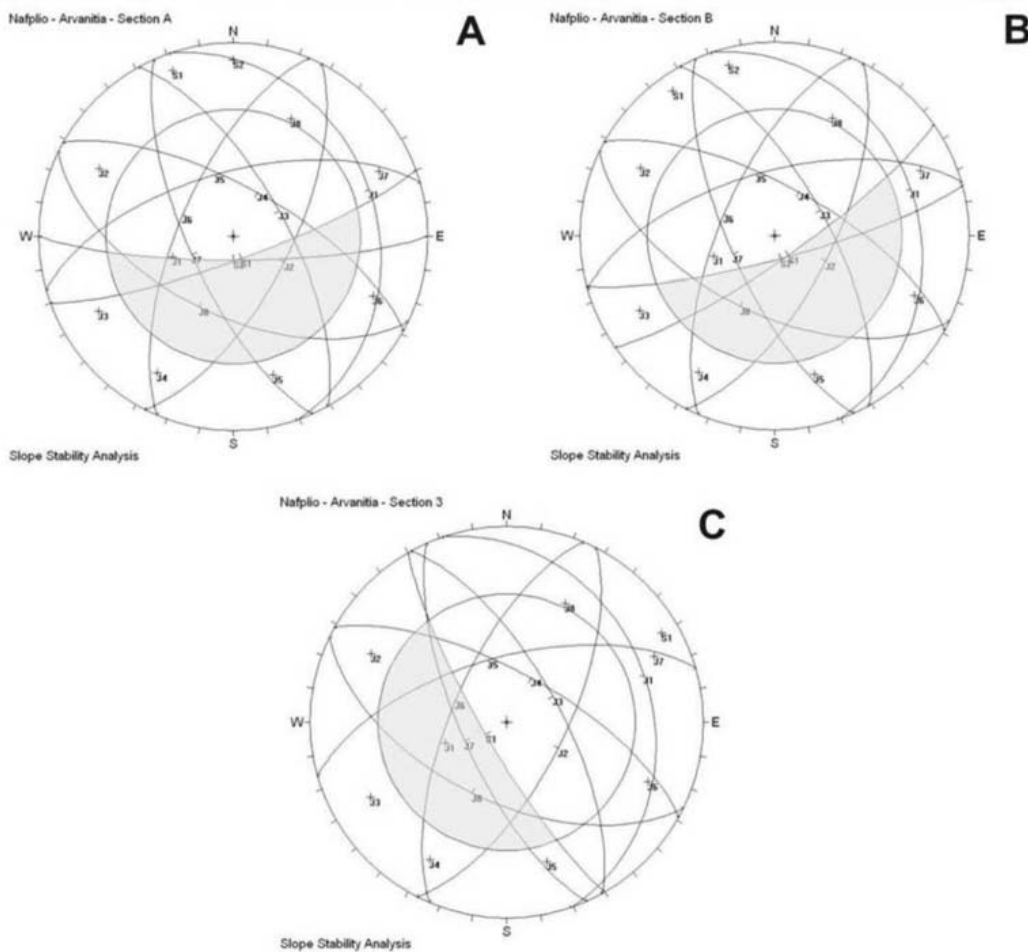
Fig 3. Satellite picture (Google Earth) pointing the parts of Arvanitia walkway (A, B and C) constructed along the base of the slopes. The Schmidt stereo diagrams presenting the numerous joint sets intersecting the A, B and C parts of the slopes. The numerous unstable wedges are clearly presented by checking the intersected major planes in the "zone of potential instability" (grey area) (Hocking, 1976; Hoek & Bray, 1981).

The Schmidt stereo-diagrams presented in figure 3 prove that the A, B and C parts of the slopes are intersected by multiple joint sets. Most of the joints appear very high persistence (>20 m), wide spacing (1-2 m), no separation (< 0.1 mm) and lack of weathering. Those parameters explain the high RQD values (reaching up to 80-90%) and justify the also high RMR ratings (75-80) that classify the limestones in the “good” rock mass category (Kolligri, 2008). Based on the before mentioned characteristics of the joints, the wedges formed along the slopes are common and almost always oversized.

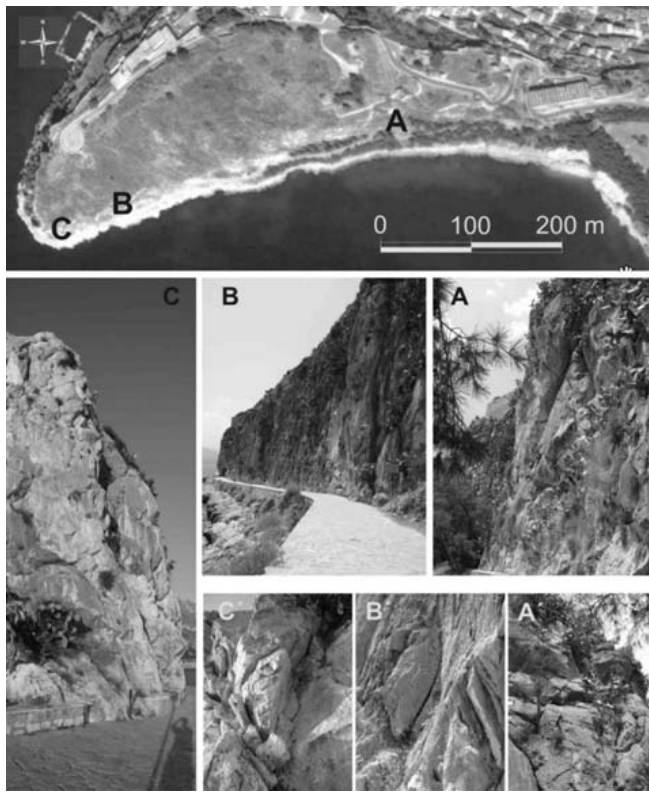
Fig 4. Photos presenting the condition of the rock mass in the before mentioned parts A, B and C of the walkway. Pictures A', B' and C' present focus on main wedges in the corresponding slopes.

and C are constructed attached to the base of the slopes without leaving any space for the installation of any protection measure. Those sections appear serious stability problems, due to the rock mass fracturing, and the disturbance caused by the excavation procedure.

Beside the tectonics, the rock mass condition was affected by unadvised excavation procedure. The lack of any pre-splitting technique during the cutting of the artificial slopes (figure 5c), led to the intensive cracking of their rock mass. The abundance of the overhanging blocks, the height of the slopes (reaching up to 40 m) and the installation of the road on the base of the slopes without keeping any safety distance, cause serious safety issues.

Unfortunately, the above mentioned stability problems require the application of remedial measures causing disturbance to the natural sightseeing character of the site. Indeed, the actions needed to be applied are: a) removal of all overhanging detached rock blocks, using controlled quarrying b) ap-

plication of spot bolting in order to stabilize all the big rock wedges and c) installation of a high strength rockfall protection uniaxial netting along the entire slope (Fig. 7B, C).

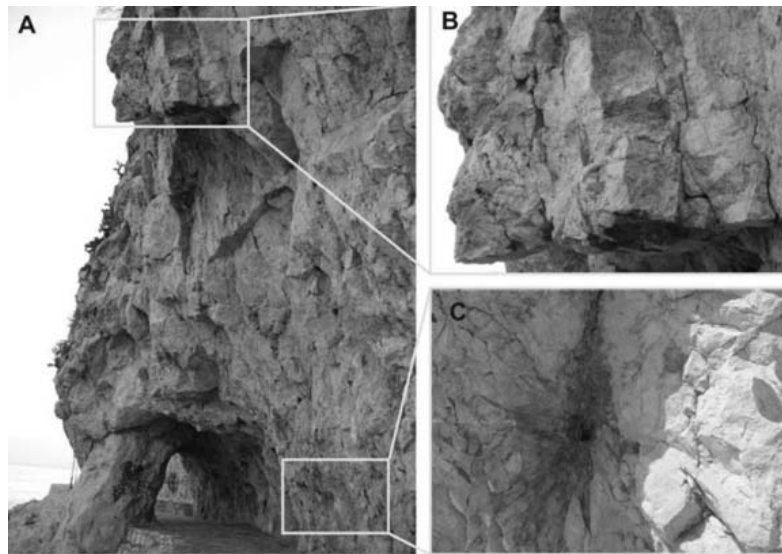
All these problems are even more intensive along section C. Several meters of the walkway are constructed not only attached at the base of the slope, but along overhanging parts. Even a small tunnel was constructed in order to cross a ledge of the rocky slope (fig. 5).

Fig 5.: A) A small tunnel constructed along section C. B) Wedges hanged over the entrance of the tunnel. C) the intense artificial fracturing around a drill used for the installation of explosives.

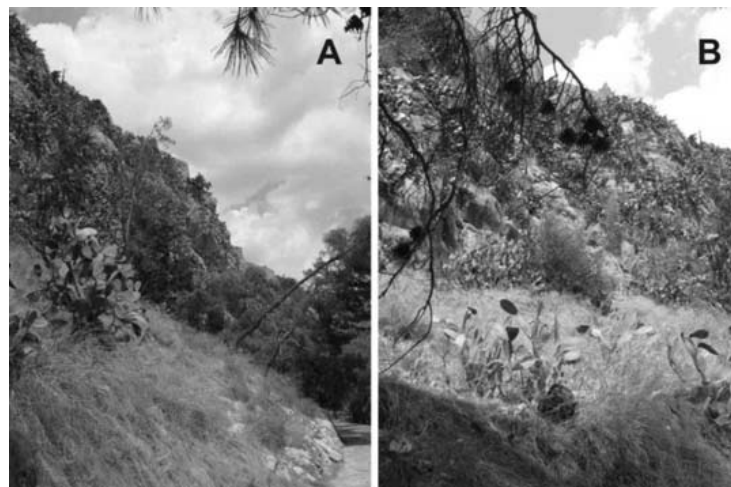
The slopes along the rest of the walkway (except parts A, B and C) manifest the same tectonic fragmentation but they are not disturbed by any excavation procedure. Further more the available space along the base of these slopes, as well as the tree cover, allow the installation of all necessary protection measures without causing any aesthetic destruction to the site (fig. 6).

Fig 6.: Photos taken from the slopes extending between section A and B. The available space allows the installation of camouflaged protection measures.

The selection of the proper protection measures for the slope parts being at a distance longer than ten meters from the walkway can be easily confronted. The available modern protection fences systems (Fig. 7D) could be very effective without causing any aesthetic distraction to the sightseeing site. These fences could be installed along the base of the slopes within the limits of the declivity extending between the slope base and the walkway, and can be camouflaged by planting trees or bushes. Along the western part of the walkway, with the larger available base declivity space, gabion boxes embankments (Fig. 7E) can be installed instead of fences. The installation of these embankments is cheap and they require no maintenance expenses, unless they are damaged.

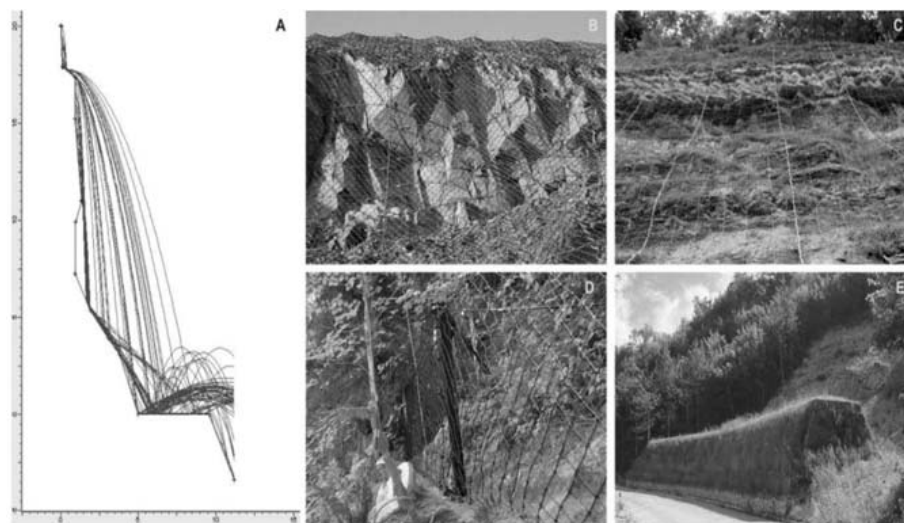
For the selection of the proper support measures of sections A, B and C, besides the stability analyses, rockfall propagation analyses were conducted (Fig. 7A), using the *RocFall* statistical analysis program. These analyses revealed that the spreading of the falling rocks covers the entire road width.

Fig 7.: A) Analysis for the estimation of the rock fall propagation in a typical cross section of the slope, B, C, D and E) typical support and protection measures. Wire nets (B and C), fences (D) and gabion boxes embankments (E).

Alternatively, as the net, causes a visible aesthetic demission, it could be substituted by the installation of a metallic frames shelter, covered on top with wavy sheet iron. Metallic frame constructions could be designed to take over the impact of a rock fall and at the same time their architectural design could make them fit the natural sightseeing setting.

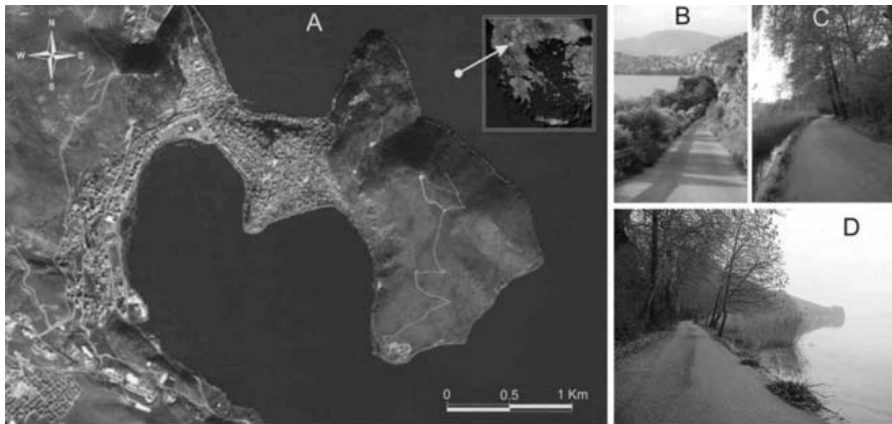
Unfortunately, the ignorance of the engineering geological characteristics and the underestimation of the stability problems led to the inappropriate land planning design of many other natural sightseeing areas all over Greece (Rozos & Nikolaou, 1996; Koukis et al. 1997; Koukis & Rozos, 1997; Koukis et al., 2005; Loupasakis & Karfakis, 2007). Figure 8 presents as an example, the sightseeing site of Kastoria lake walkway exhibiting similar geotechnical problems. The Kastoria lake walkway is a, 8,5 km long, narrow road surrounding the peninsula. The stability problems vary from section to section, but generally they are not so intensive as these reported in Arvanitia walkway. The slopes are sorter and gentler and the distance between the base of the slope and the road is sufficient

Fig 8.: A) Satellite pictures - taken from Google Earth - pointing the Kastoria peninsula surrounded by the, 8,5 km long, lake walkway, B, C and D) variant views of the walkway sections.

for the installation of proper protection measures, such as metallic fences, sort concrete walls or excavated trapping ditches (Fig. 8C & D). Limited sections with steep slopes (Fig. 8B) can be protected with wire nets, without causing serious aesthetic alteration to the site because of their reduced contribution to the total length of the road. Most of the before mentioned geotechnical problems could have been avoided if during the construction of the road the condition of the rockmass was taken under consideration. For example the road could have been constructed 1m higher in order to give space for a trapping ditch. Also, due to the shallow depth of the lake, limited section could have been constructed over the lake, avoiding the excavations.
