### The engineering geological behaviour of disturbed and weathered gneiss in slopes. The case of the "vertical axis" of Egnatia motorway, Komotini - Nymfea, Northern Greece.

## THE ENGINEERING GEOLOGICAL BEHAVIOUR OF DISTURBED AND WEATHERED GNEISS IN SLOPES. THE CASE OF THE “VERTICAL AXIS” OF EGNATIA MOTORWAY, KOMOTINI – NYMFEA, NORTHERN GREECE

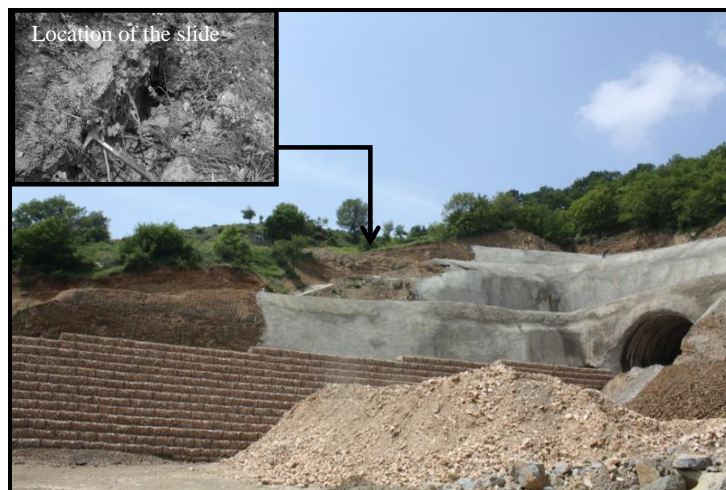
The first case study discusses a slide that occurred close to the entrance portal of Nymfea tunnel (Figure 1). The rock mass in the area is comprised of gneissic schists in the surface and schistosed gneiss in depth. The rock mass is highly to completely weathered at the surface (type V and VII) and becomes moderately weathered (type III) in depth. Six boreholes with inclinometers and piezometers were drilled to investigate the slide. The identification of weak zones, the thickness of the weathered cover in the specific area and the evaluation of inclinometer and piezometer measurements were of primary importance. Taking into consideration the above parameters, it was evaluated that the slide was driven within the weathered zone, occurred after the excavations of the tunnel portal. It started several meters above the cut and ended in the second bench of the excavated cut, developing several cracks in the already applied shotcrete. The weathered zone, other geological features and the tensile cracks are highlighted in the Figure 2. It is highlighted here that sliding could have been also assisted by the weathered schistosity that is favourable dipping with  $30^{\circ}$  towards the slope.

**Figure 1 - View of the entrance portal of Nymfea tunnel. The gabion wall is used here for the stabilization of the whole slope. The slide occurred above the gabion wall.**

The scope of the back analysis is to estimate the geotechnical properties of the completely weathered gneiss (type VII). The slide was driven within the weathered cover, starting several meters above the cut and ending in the second bench of the excavated cut, developing several cracks in the already applied shotcrete after the excavations of the tunnel portal. From the grain size distribution analysis of the completely weathered soil-like geomaterials it is found that the percentage of sand is around 50-70% and of silt and clay around 20-30%. Plasticity index is around 5-7. The shear strength properties that resulted from laboratory tests (cohesion  $c=31$  kPa and angle of friction  $\phi=37^\circ$ ) are considered high and not representative for the material within the failure plane. An important parameter that influences the analysis results is the status of the pore water pressure at the time of the failure. The piezometric surface was assumed along the contact of the weathering cover and the more fresh bedrock. Moreover, due to intense raining before the slide and some infiltration within the weathering cover, a  $r_u$  coefficient of 0.25 was considered. It is noted that the weathered cover has some small cohesion since clayey-silty material are present in the mass. The concluded values from the analysis are  $c = 5$  kPa,  $\phi = 28^\circ$ . It is highlighted that the analyses were done for circular and non-circular surfaces. The results from both the analyses were almost similar (0.998 for the non-circular and 1.029 for the circular surface with the Janbu-corrected method). The actual sliding surface seemed to be the non-circular one as it resulted from the tension cracks, the depth of the bedrock and the cracks in the shotcrete above the portal cut.

Due to the large area and the great depth of the slide it was found, that retaining measures are the economic way to stabilise the slope. Reinforced concrete walls with pre-stressed anchors were combined with the Cut&Cover structure of the tunnel portal and constructed from the road level.

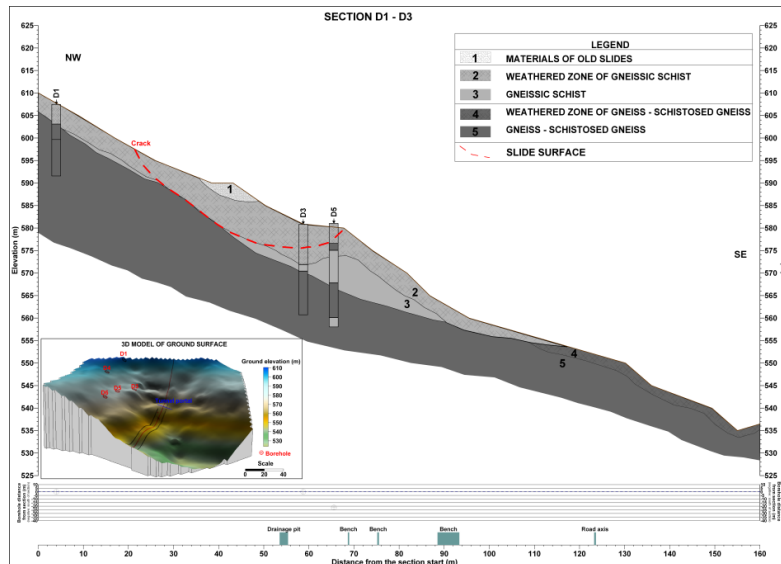
Figure 2 - Geological section along the slide of the Nymfea entrance tunnel portal cut (Case Study 1).

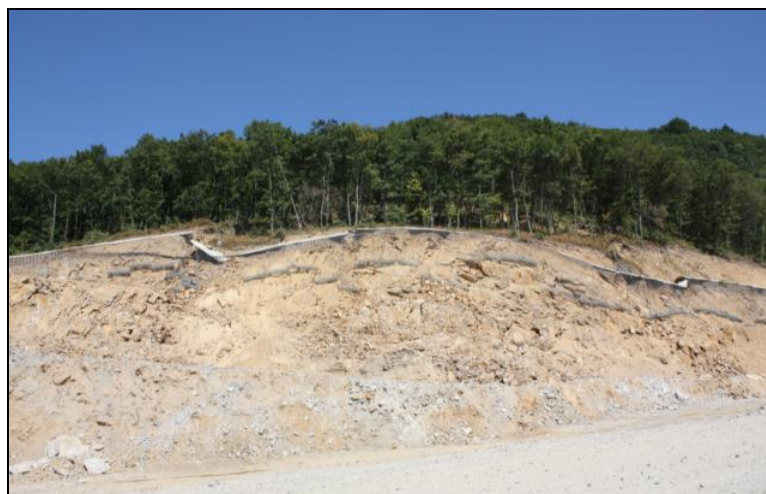
The slope stability problems along the road cut numbered O28 started on summer 2009. The road cut has a height of 30m with 4m wide benches every 10m and consists of schistose gneiss. After the excavation of the second bench, the first cracks on the slope surface were observed and then a greater slide of a significant part of the slope followed (Figure 3). This failure triggered a greater landslide that developed tension cracks in the natural ground, in a distance 70m behind the scarp of the road cut. The shotcrete along the benches failed and a significant part of the slope has been displaced. After that, the excavation works stopped and the slope was backfilled with a temporary buttress. These temporary actions stabilised the slope since no movement had been observed for two wet periods. In order to face these instabilities permanently, slight modification of the road axis with a horizontal offset of about 15m was decided and a new geotechnical design was implemented.

1. Two shear zones have been recognised in cut O28, one sub-vertical and one sub-horizontal. The first was evident after the slide of the slope and the second was recognised in one of additionally drilled investigation boreholes (Γ19A). The mechanical characteristics of these zones are very poor, since they are consisted of foliated particles of clayey-sandy nature with small rock fragments. The shear zones, other geological features and the tensile cracks are highlighted in the Figure 4. These features can be combined geometrically and it can be presumed that the failure occurred along this surface. It is multi-planar but can be conceptualized in significant degree as circular. It is evident that the excavations of the cut, the design of the slope angles and the presence of shear zones created adverse conditions for the stability of the road cut. Although there are no detailed information about the groundwater conditions at the time of the failure, the fact that sliding occurred during the dry season (summer period), led to the conclusion that the shear zones were the crucial elements triggering the slope failure.

Figure 3 - The slide of the road cut O28. Drain trenches and benches have cracked.

In this case study, the sliding occurred along two shear zones, consisting of foliated gneiss that resembles almost to sandy-clayey soil material after its tectonic disturbance. The first shear zone forms the scarp of the slide, and the second - the main sliding surface - is almost parallel to the slope surface. Although the geotechnical parameters of the surrounded gneissic rock mass (type III,  $\gamma = 25$  kN/m<sup>3</sup>,  $\sigma_{ci}=35$  MPa, GSI= 25-35,  $c= 100$  kPa and  $\phi= 30^\circ$ ) were incorporated in the analyses, the critical parameters are the ones of the shear zones. The piezometric surface has been found in a depth of 13m due to the fracturing of the rock mass. The concluded values from the analysis are  $c = 50$  kPa,  $\phi = 23^\circ$ . Similarly to case study 1, the analyses were done for circular and non-circular surfaces. Although the sliding surface fits better (geometry of shear zones, location of surface cracks on the cut and the natural slope, depth of movement) to a non-circular surface, the results were similar (0.999 for the non-circular and 1.015 for the circular surface).

The slide has a length of 150m and a width of 80m. To avoid intensive, costly and time consuming retaining structures the road axis was slightly modified by moving it approx. 15m horizontally away from the side. Due to this the extension and height of the cut slope decreased significantly and it was only necessary to stabilise a small part of the failed rock mass. This was done by cement grouting of the jointed gneiss. Additionally drainage holes were drilled in the rock mass to drain the surface water saturating into the ground and to avoid the development of any water pressure.

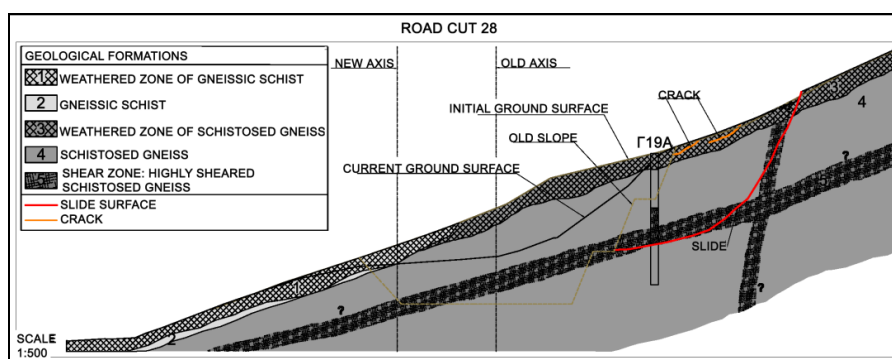
Figure 4 - Geological section along the slide of the road cut O28 (Case Study 2).
