Stability analysis of construction and demolition waste (CDW) deposits in the abandoned quarry of Profitis Ilias, Kozani, Greece.

STABILITY ANALYSIS OF CONSTRUCTION AND DEMOLITION WASTE (CDW) DEPOSITS IN THE ABANDONED QUARRY OF PROFITIS ILIAS, KOZANI, GREECE

The current paper presents the results of the study titled: “Geological – Geotechnical Study at Prophet Elias area for the restoration of the old quarry”, conducted by the Institute of Geology and Mineral Exploration of Greece (IGME) and assigned by Municipality of Kozani.

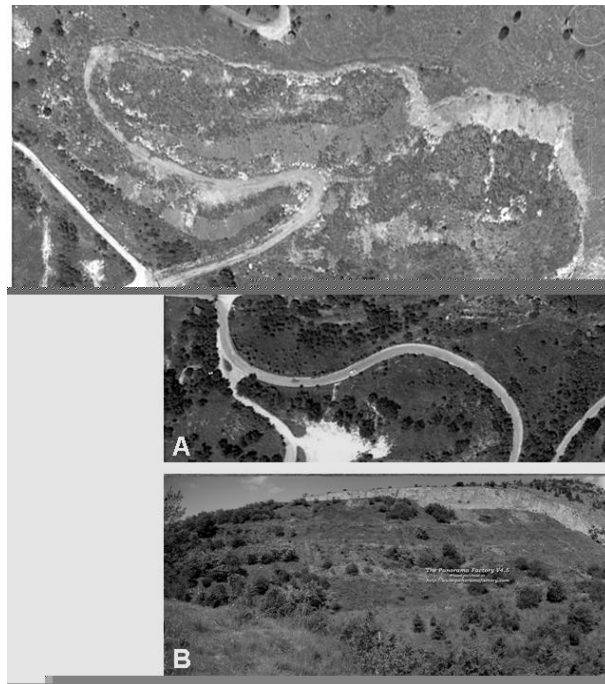
Figure 2 – Plan view (A) and panoramic photo (B) of the CDW deposits.

The CDW materials have been deposited in a stepped arrangement. Slope inclination among terraces is ranging between 33° and 45°. The old pit has been completely filled, except some areas close to the western, northern and north-eastern boundary, where the residual rock quarry faces form slopes from 1 to 30 m high. The waste has been covered by a 50 cm thick top soil layer used for planting. Positive outcomes of this procedure have been the partial recovery of the natural relief and the reduction of the aesthetic distraction of the site, while slope stability conditions and potential pollution are questionable.

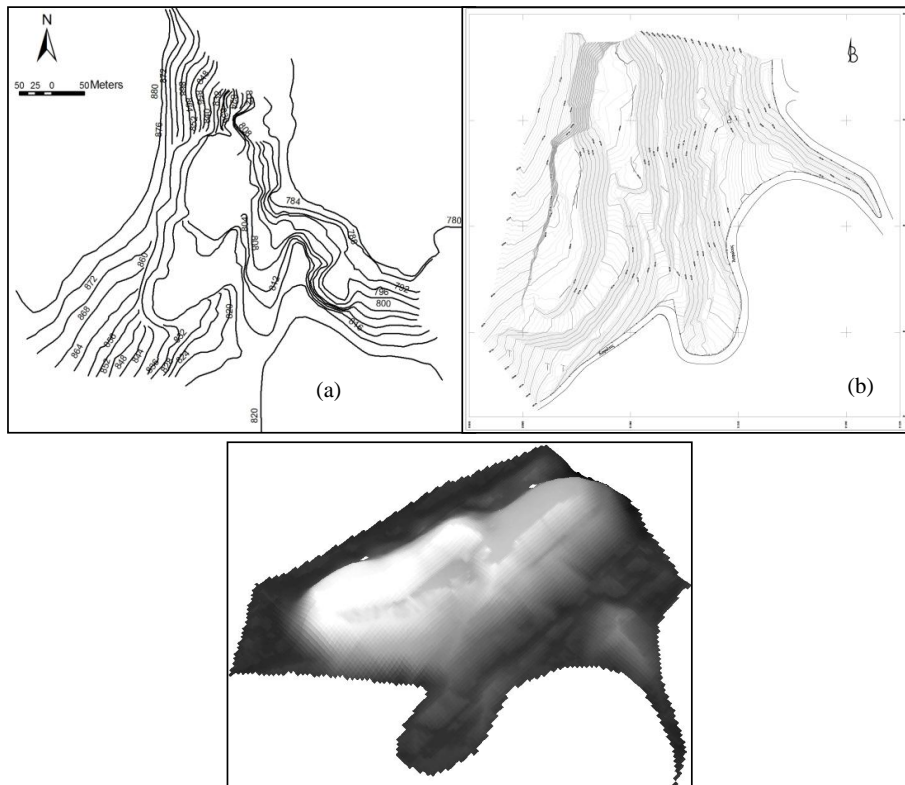
To calculate the thickness and hence the volume of CDW deposits, a detailed topographic map at 1:1.000 scale (Liakos, 2012), showing the current status of the quarry (Figure 3b), was contrasted to the one before the deposition (Figure 3a). The superimposition of the two digital elevation models reveals both the spatial distribution and the overall thickness of the deposits. Thus, the average thickness of CDW is estimated to 25 m, reaching 42 m locally, while the total volume of the deposits is calculated to 772.000 m³ (Figure 3c). Apart from the above considerations, the thickness of the CDW deposits was estimated by a representative sampling borehole located around to the centre of the old quarry and found to be 25 m.

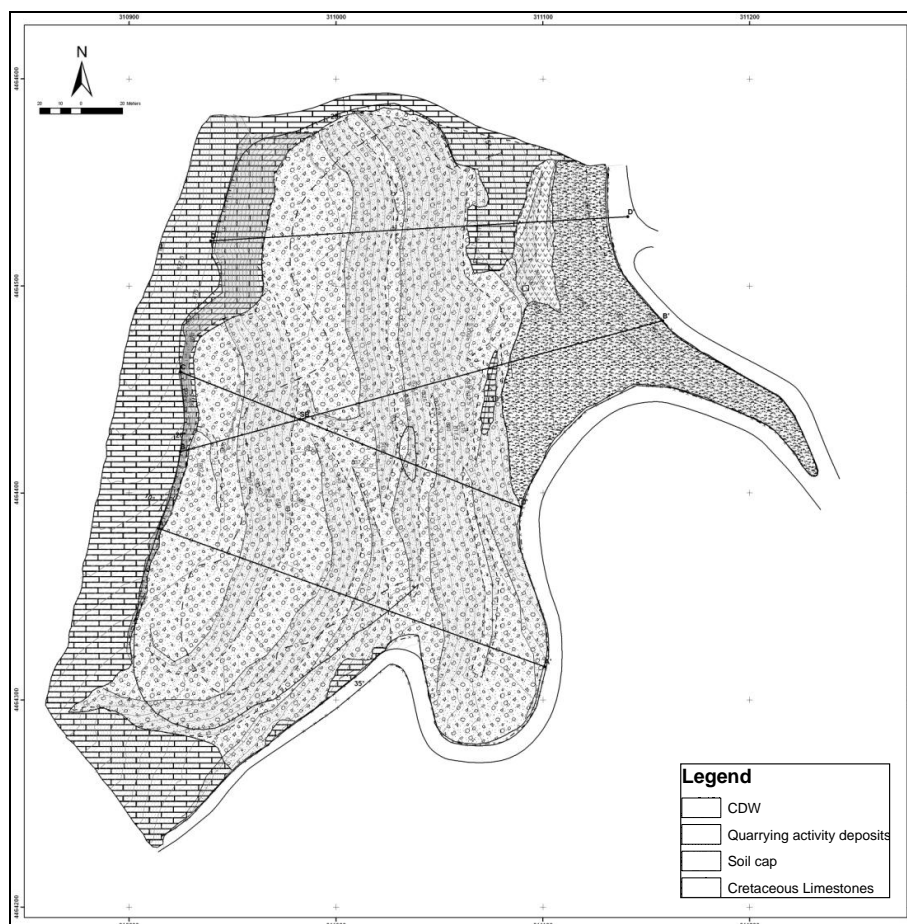
Figure 4 – Engineering geological map of the studied area.

Ground failures are evident on the soil cover of the upper three terraces of the CDW body. The mode of failures includes profound, almost vertical extensional fractures, 10-60 m long and 5-40 cm wide with local expansions. They are wavy in form, usually running parallel and close to the edge of the terraces (Figure 4).

Slope failures on soil cover may be started by ravelling and collapse due to the movement of fines into larger voids or sudden collapse of hollow structures within the buried CDW deposits, which may cause significant settlement. When current tension cracks fill with water, the hydrostatic pressure exerted on their walls can lead to failure. At the same time, tension cracks may facilitate rainwater infiltration increasing seepage forces acting to cause slope movement.

The main reason for the occurrence of top soil tension cracks in the studied area is the settlement of underlying CDW deposits. Mechanisms resulting in settlement may be: a) Physical compression

Apart the settlement mechanism, rain water plays an important role in the evolution of observed cracks. The high permeability of CDW materials reduce the surface flow of rainwater resulted in high rate water infiltration into the waste body. The leachate water increases pore water pressure within the fine grain layers of deposits, decreasing the shear strength of material.

The protection measures aim on reduction of water infiltration, improving the leachate drainage and minimizing the settlements. Vegetation also could improve the stability conditions, as well as the filling of the open cracks.

The above examination of the dynamic evolution of cracks showed that the probability of failure of a large CDW volume is limited. However, to increase slope stability the following measures are proposed herein: 1) Closure of the existing cracks with clay material in order to reduce the water infiltration within the CDW body, 2) Improvement of the runoff system by configuration of the slope for the free removal of surface waters, 3) Vegetation thickening, 4) Installation of a flexible metal ring net barrier at the south-eastern boundary of the old quarry, following the superelevation of the residual rock quarry faces which operates as a natural barrier.

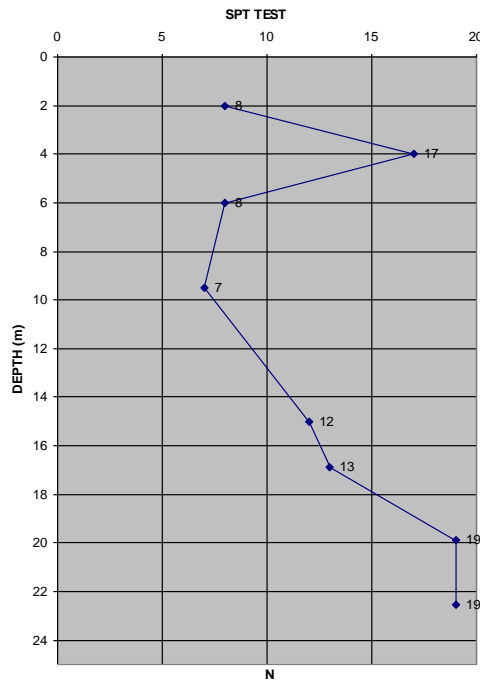
Figure 5 – Standard Penetration Test’s results.

studied quarry can not be classified as soils, SPT N values may be indicative of the relative density (D_r , %) variation with depth (Terzaghi and Peck, 1967). These indicative values corresponding from very loose to medium density materials due to the low compaction and existing voids within CDW body. Additionally, all in situ permeability tests considered very high permeable materials by calculating values for the coefficient k greater than 1×10^{-2} cm/sec.

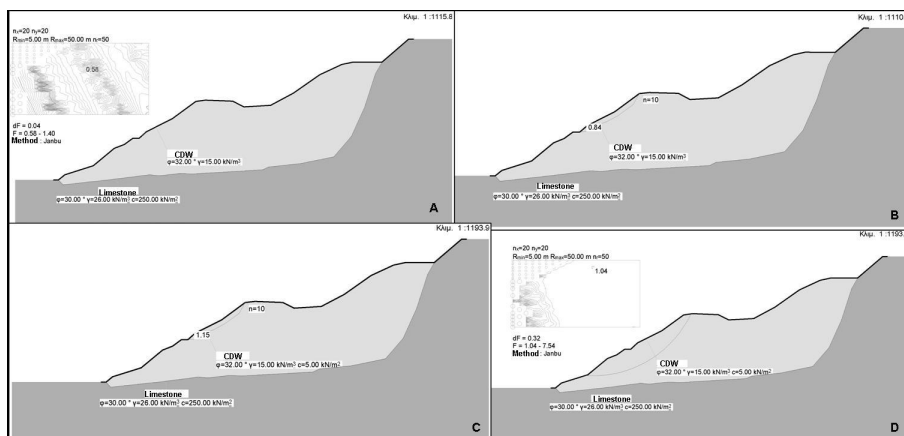
Figure 6 – Slope stability analysis performed in cross section BB (A: Stability analysis without a predefined rupture surface, B: Stability analysis considering existing tension cracks, C: Back analysis considering existing tension cracks, D: back analysis without a predefined rupture surface).

Very low safety factors lower than 1, and slip zones of low thickness and range were computed. For this reason successive back analysis was conducted to the places of mapped cracks, aimed to determinate the mechanical parameters of the slope during the failure. Since it has been assumed that the values of friction angle and bulk density taken by the bibliography feet to the current CDW materials, they were kept unchanged during the back analysis in order to estimate the cohesion (c) value. Despite the fact that the deposits are composed of heterogeneous materials, which have not been condensed, the overall cohesion of the slope is not zero, on account of the "interlocking" of varying size particles of the material. Geotechnical parameters outcome from the back analysis are: $\phi=32^\circ$, $c=5 \text{ kN/m}^2$ and $\gamma=15 \text{ kN/m}^3$. Matching the instability phenomena observed on the slope, safety factor varies close to the limit equilibrium confirming the values of the shear strength parameters chosen for the analysis (Figure 6).
