## Hydrologic Effectiveness and Plant Survivability in the Holmes Lake Rain Garden Pilot Program: Year Three

**Hydrologic Effectiveness and Plant Survivability  
in the Holmes Lake Rain Garden Pilot Program:  
Year Three  
Lincoln, Nebraska**

Masters Horticulture Project  
University of Nebraska–Lincoln  
August 2011

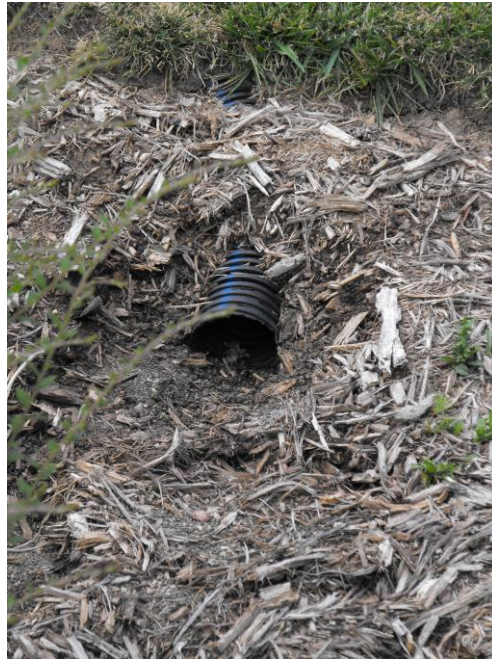
2) **Are any inlet structures clogged?** Inlet structures should be free of debris and other obstructions to allow stormwater runoff to freely enter the rain garden. All the rain gardens had good inlet flow, except garden #8 that had two buried and clogged downspouts. Two other rain gardens had buried downspouts which were free of obstruction; garden #2 showed channelization at the entry, garden #7 was functioning properly (Fig. 5). Most of the rain gardens have roof downspouts that intercept a turf lawn and need to be monitored for grass and leaf litter that cause clogging. Gardens #1, 3, 5, 13, 16, & 17 all had unmown grass causing downspout obstruction. Garden #9 had a slightly crushed downspout. Gardens #4 & 16 need the use of a turf edger on the inflow edge of the rain garden.

(Fig. 5) Buried downspout entering rain garden #2 showing channelization.

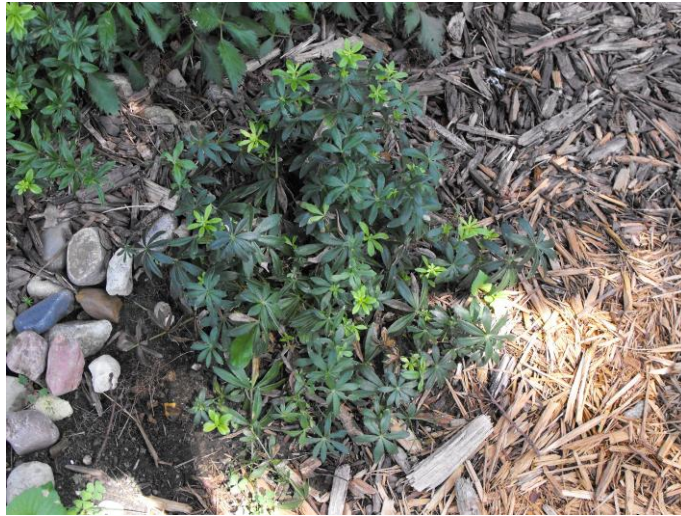
a large storm event. Note that overflow structures were not added to the rain garden program until the second year of the program by the City of Lincoln Watershed Management Office as a result of mulch and sediment overflowing into lawns during year one. It did not appear that every rain garden received overflow structures and the reason is not known. Overflow structures had been used more often due to higher than normal precipitation and showed significant problems, such as mulch washed and extended into turf areas and wider overflow than the structure allowed. Since this year produced higher than average precipitation, next year the overflow structures might be sufficient. Eleven of the eighteen rain gardens had issues with clogging. For example, garden #1 had sediment and plant litter while gardens # 2, 3, 4, 5, 6, 7, 9, 10, 15, 16, 17, 18 & 19 had excess mulch, weeds, or grass that needed to be pushed back or removed (Fig. 7). Gardens #7 & 11 possess buried overflow drains. Gardens #13 & 20 lacked overflow structures.

(Fig. 7) Clogged rock overflow showing encroaching mulch needing redistribution.

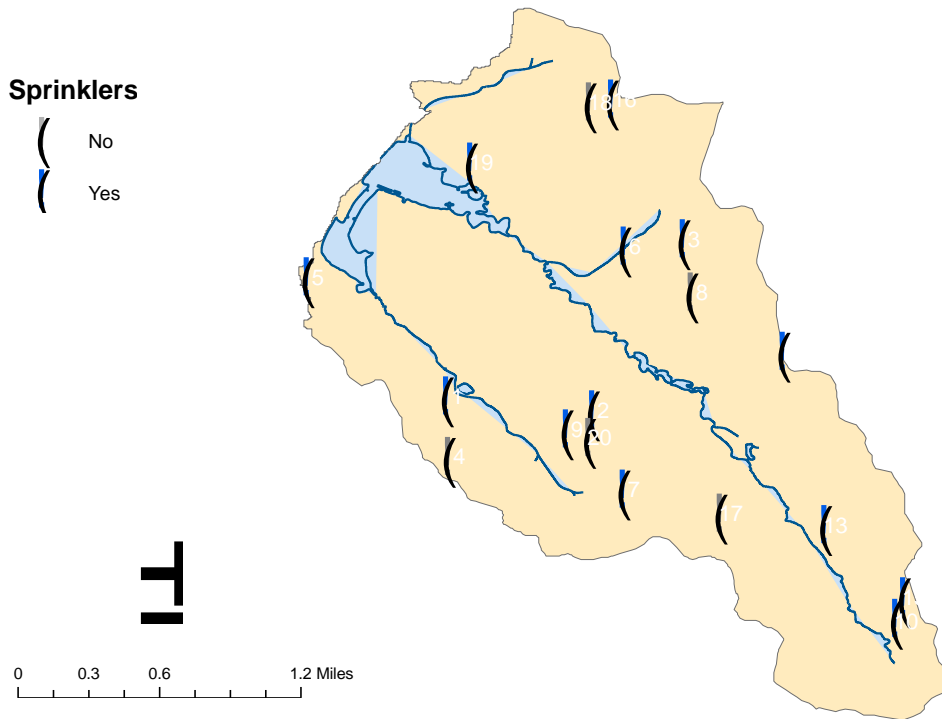
**Site conditions:** The context of the rain garden heavily influences its functional and aesthetic characteristics. Adding rain garden bioretention into private residential properties presents a new issue – conflicts with sprinkler systems. Routine watering of native plant material can cause it to grow inordinately large, fall over, or die (Lamb 2009). Typically, native plant material is rain fed. In the study area, thirteen of the eighteen rain gardens were irrigated by sprinkler systems designed to accommodate supplemental water applications for turf. The five remaining rain gardens relied on natural rainfall; three were residences and two were schools (Fig. 8).

(Fig. 8) Sprinkler systems shown in blue within the pilot rain gardens.

Site conditions indicated sprinkler systems and shading negatively impacted several rain gardens. Thirteen of eighteen rain gardens had sprinkler systems and the best bottom plants grew in those without sprinkler systems, relying only on rain event watering. In the newer residential developments, small existing trees near rain gardens that were not an issue at the time of rain garden installation are now beginning to cast shade on previously sunny rain garden locations. In addition, some participants have recently planted trees without regard to their location and potential shading impact on the rain garden.

Site conditions revealed that sprinkler systems may be adding excess water to the native plant vegetation used in the rain gardens. With such increased moisture, different plant selections will need to be considered, such as incorporating rushes, sedges or other plants with higher moisture tolerance. In some cases, individual changes in watering habits may be all that is needed to correct the problem of over watering native plant vegetation. Simple things such as changing sprinkler patterns or disconnecting sprinkler heads within the basin area could enhance rain garden plant success for gardens that overlap irrigated landscape areas. Using a system less frequently and applying less water per cycle, might also enhance rain garden success, but the water adjustments will need to be balanced with the surrounding landscape areas. Further research needs to be done to see if use of sprinkler systems affects plant survivability, especially in the rain garden bottoms. Another site consideration, tree placement with respect to rain garden location, needs to be considered as this will change the sun/shade dynamic of garden plants and conditions,

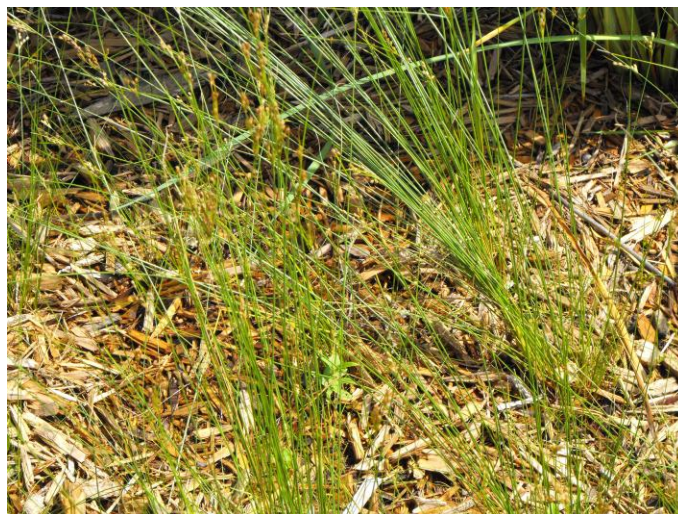
Only rain gardens #3 & 4 had all original plantings survive. Gardens #1, 3, 6, 13, 15, 17, 18, 19 & 20 had invasive/volunteer plant material (Fig. 10). Garden #8, 9 & 13 had original plantings growing out of bounds. Gardens #17, 18, 19, 20 were weedy. #1, 7, 9, 10, 15, 16, 17, 19, 20 have open areas within the rain garden. Gaps in plantings create open space in which weeds and invasive vegetation can establish. Note that higher than normal amount of rainfall may have added to weed and invasive problems.

(Fig. 10) Invasive vegetation in rain garden #1 due to open spaces from plant loss.

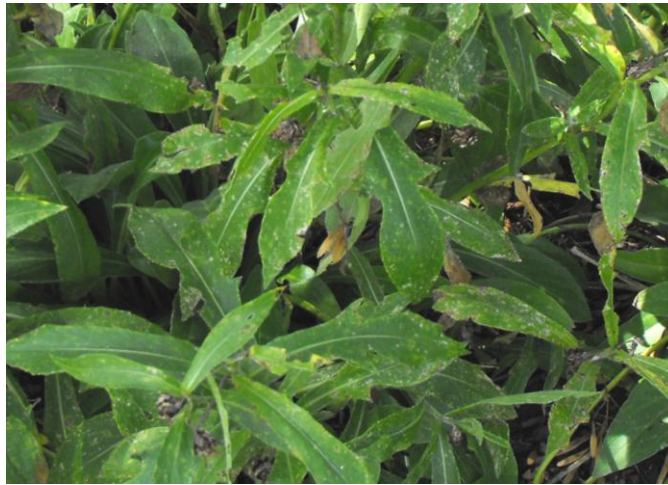
3) **Does vegetation appear healthy?** Plant health indications can include wilted leaves/stems, discoloration of leaves, lack of flowering bud development, stunted growth or a decrease in plant numbers. Overall the vegetation health was very good in most rain gardens with the exception of gardens #2, 3, 4, 7 & 20 with indicated slight problems. Problems with vegetation vigor are often tied to site conditions. Garden #8 had mildew on the shasta daisy plants (Fig. 11). In rain garden #19, the amount of stormwater runoff may have been underestimated by the contractor and the plants are showing signs of being water logged. In addition, the area had invasive wetland vegetation, including cattails, rushes and willow trees. Specific plant issues include rudbeckia showing leaf mottling. Monarda, sweetshire and siberian iris had leaf yellowing.

(Fig. 11) Signs of mildew on shasta daisy plants.

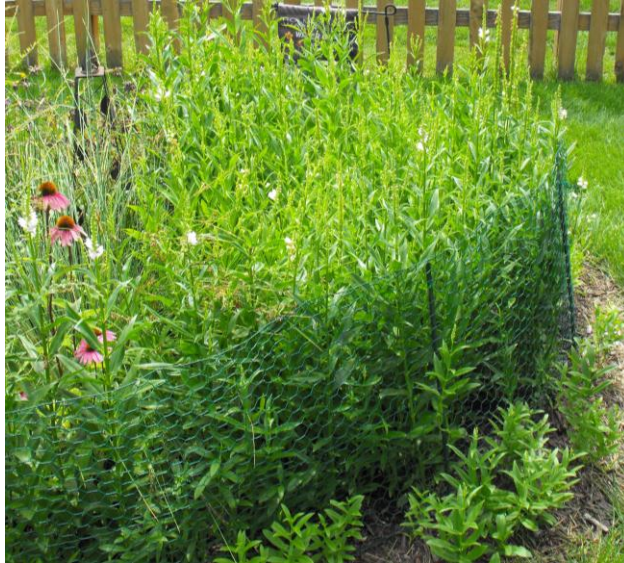
4) **Is vegetation appropriate density/size?** This study was conducted in the third year of plant growth by which time the plants should be at the appropriate density/size for each particular variety. Under development indicates poor health or problems with hydraulic function. Over development can be an indication of extra watering or use of fertilizers. Gardens #1 & 15 reflected appropriate density/size, while the majority of the gardens (#2, 3, 4, 5, 6, 7, 9, 10, 11, 17, 18, 19 & 20) had slight issues. As already described in question 4 above, gardens #8 & 13 had plantings growing out of bounds (Fig. 12). In some gardens plants need dividing. In rain garden #16, the sunlight conditions may not have been estimated properly by the contractor. The plants were grossly undersized as varieties for a sunny site had been selected and this is a dry, shade site. Specific plants with growth issues include rudbeckia, variegated sedge, summersweet, siberian iris, red baron grass and obedient plant in which all were shorter than expected for healthy plants. Siberian iris showed bare centers. Red baron grass and siberian iris were sparse. Penstemons, monarda and spiderworts became leggy and liatris bolted.

(Fig. 12) Obedient plant growing out of bounds and becoming invasive.

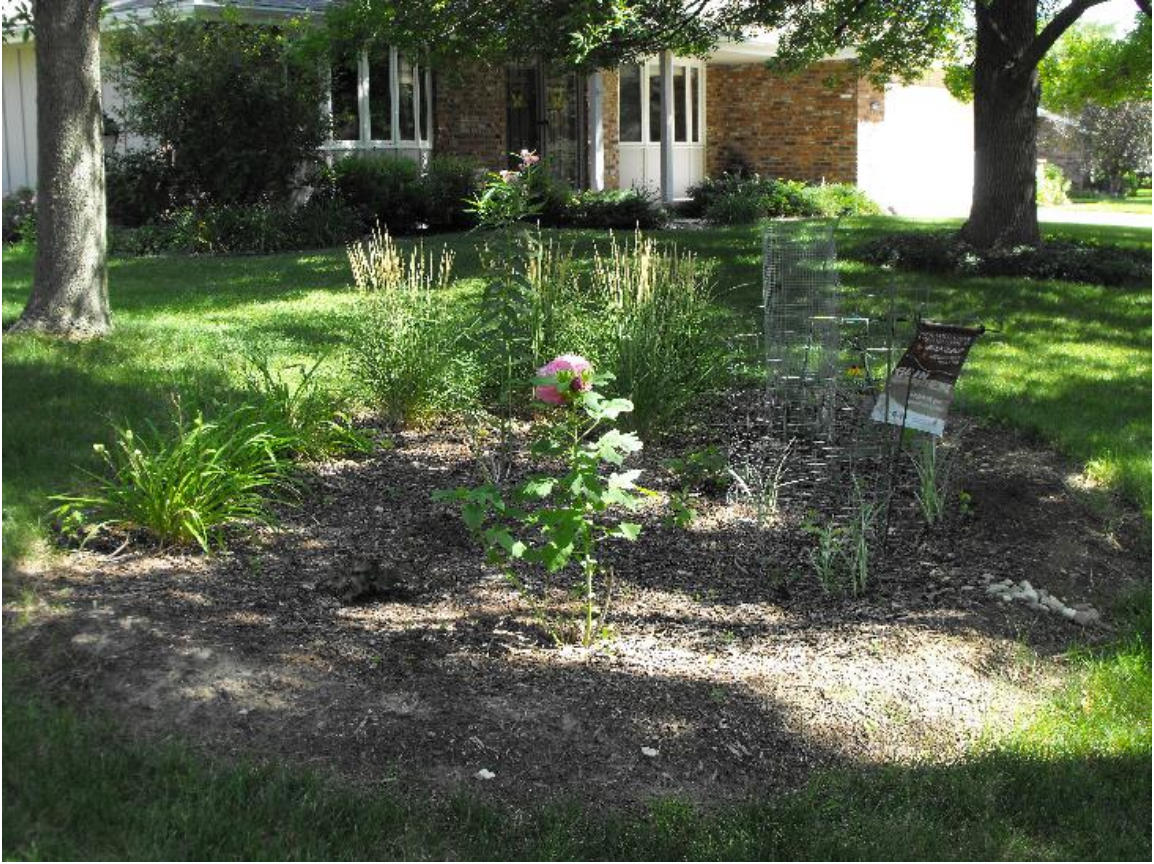
plantings are  
very sparse

Added 2  
Heuchera  
(1 coneflower  
barely hanging  
on)
