# Phase III Development of a Short-Radius Guardrail for Intersecting Roadways

*Midwest States' Regional Pooled Fund Research Program  
Fiscal Year 2001-2002 (Year 12)  
Research Project Number SPR-3 (017)  
NDOR Sponsoring Agency Code RFPF-02-02*

MwRSF Research Report No. TRP-03-183-07

December 6, 2007

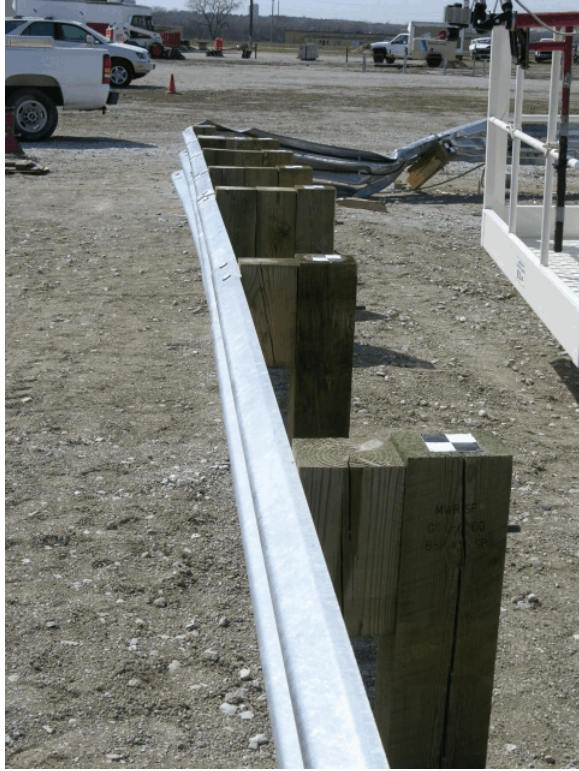
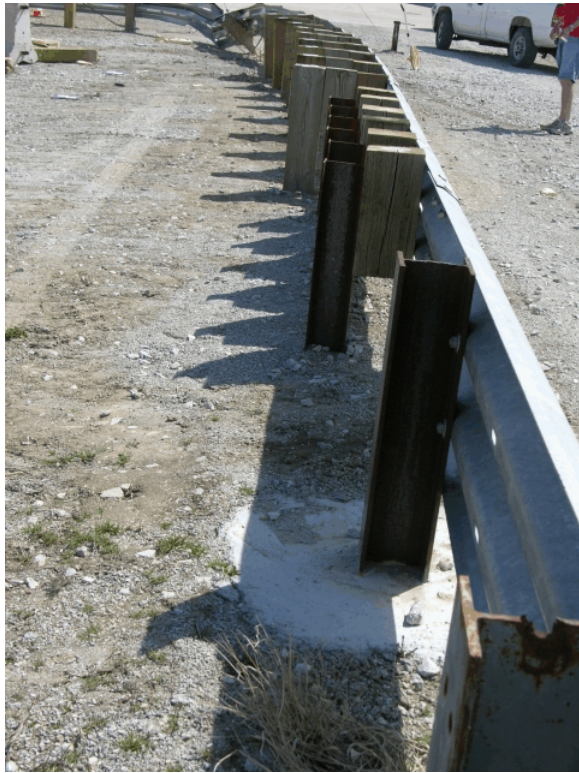
Figure 51. System Damage, Test SR-5

Damage to the short-radius system was moderate, as shown in Figures 51 through 61. Post no. 1P fractured at the foundation tube but remained attached to the rail. Post nos. 2P through 3P fractured at ground level and disengaged from the rest of the system. The tapered blockout at post no. 2P disengaged from the post. Post no. 4P fractured approximately 178 mm (7 in) below the groundline and disengaged from the system. Post no. 5P cracked at the groundline and rotated backwards in the soil. Post no. 6P sustained a 229-mm (9-in.) long crack through the transverse hole and rotated backward in the soil. Post no. 7P also rotated backward in the soil.

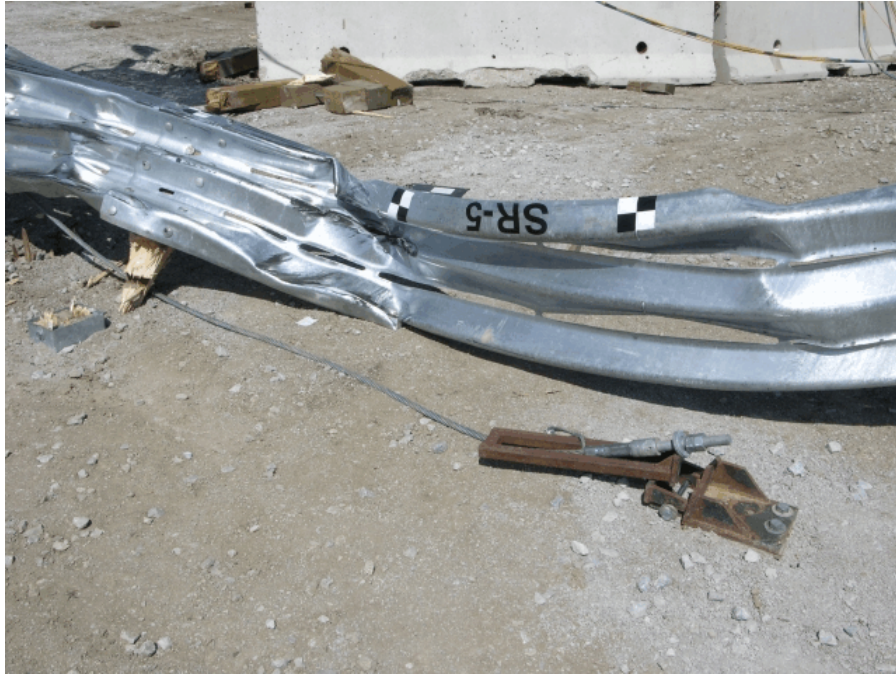
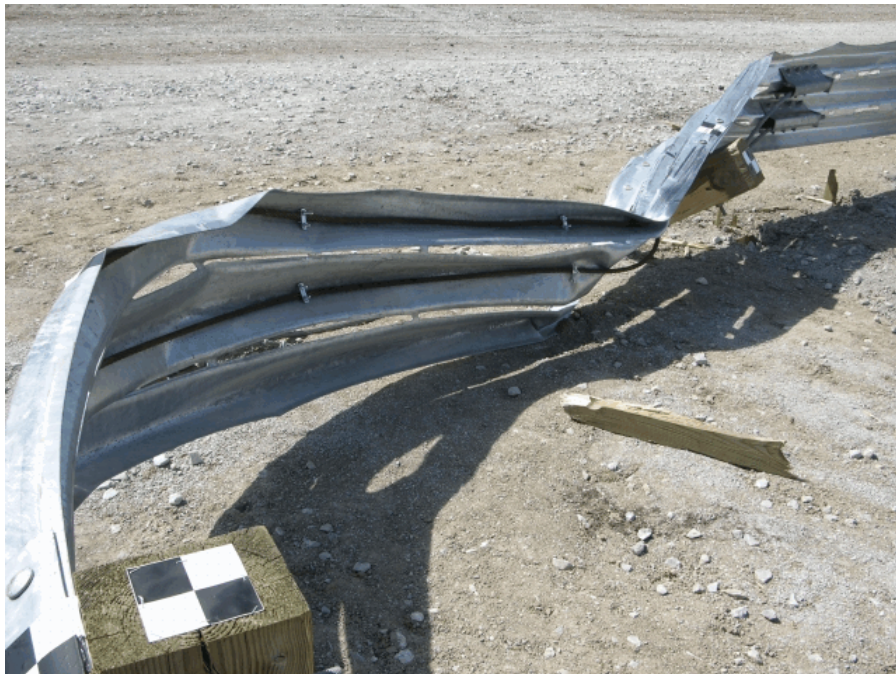
Figure 53. Damage to Nose Section, Test SR-5

Contact marks were found on all three corrugations between the impact location on the rail and post no. 7P. The rail was flattened and deformed between the center of the nose section and post

no. 2P. Rail flattening also was found between post nos. 3P and 5P. Rail bending was observed along curved nose section. Additional rail bending was found at post nos. 3P, 4P, and 6P through 8P. The post bolts released from the rail at post nos. 2P through 4P. Significant post bolt rail deformation was found at post no. 6P. The rail slots between post nos. 3P and 4P were folded and closed by rail flattening and deformation. The rail was deformed backwards and the bottom corrugation deformed upward between post nos. 3P and 7P.

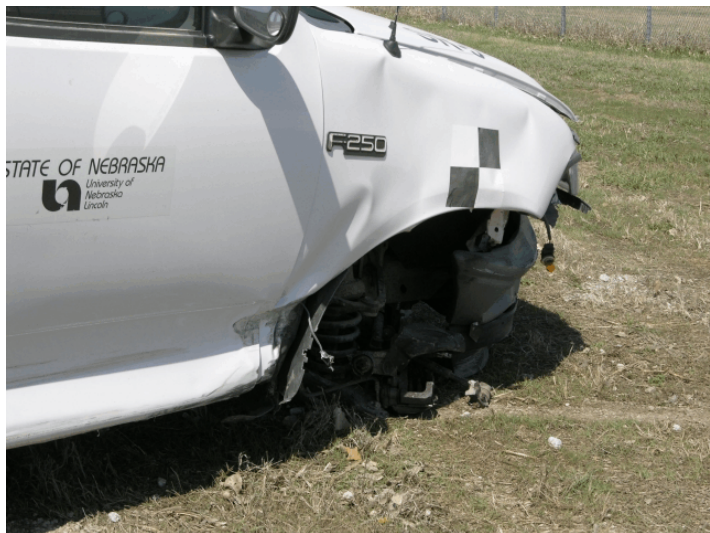
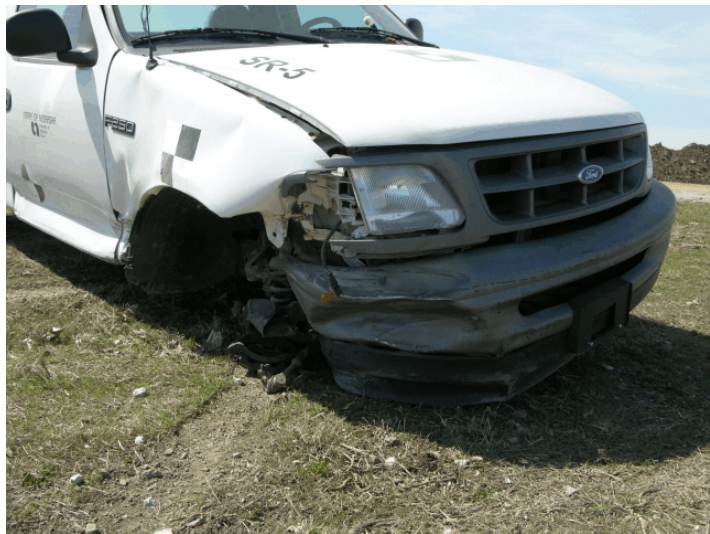
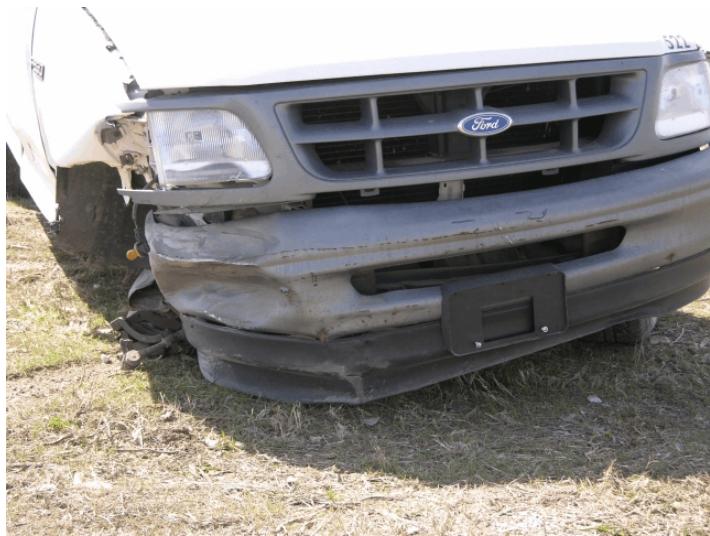
Figure 63. Vehicle Damage, Test SR-5

Exterior vehicle damage was minimal, as shown in Figures 62 through 64. Occupant compartment deformations to the right side and center of the floorboard were judged insufficient to cause serious injury to the vehicle occupants. Maximum longitudinal deflections of 13 mm (0.5 in.) were located near the left side of the right-side floorboard. Maximum lateral deflections of 25 mm (1 in.) were located near the right-front corner of the right-side floor pan. Maximum vertical deflections of 38 mm (1.5 in.) were located near the center of the right-side floorboard. Complete occupant compartment deformations and the corresponding locations are provided in Appendix C.

The right-front bumper corner was deformed inward and encountered significant dents and scratches. The right side of the grill was also deformed inward and fractured around the headlight.

The right-front turn signal cover was fractured and disengaged from the vehicle. The right-front quarter panel was crushed inward and wheel well was severely deformed. The entire right side of the vehicle sustained dents and scratches. The top of the right-side door was jarred open and it could not be opened nor closed. The right-front upper and lower ball joints fractured. The right-side steering arm fractured at the spindle. The right-side lower A-frame control arm was bent. The right-front wheel was separated from the vehicle and encountered significant scratches, dents, deformations, and gouges on both the inside and outside of the rim. The right-rear tire also encountered minor abrasions, but the rim remained undamaged. The spare tire under the vehicle was scratched and torn. The exhaust was fractured, and the gas tank was dented. The left side and rear of the vehicle, the hood, and all window glass remained undamaged.

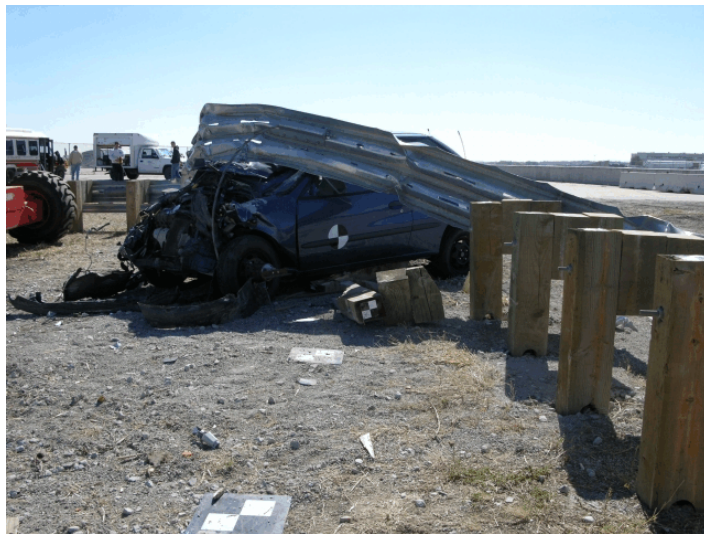
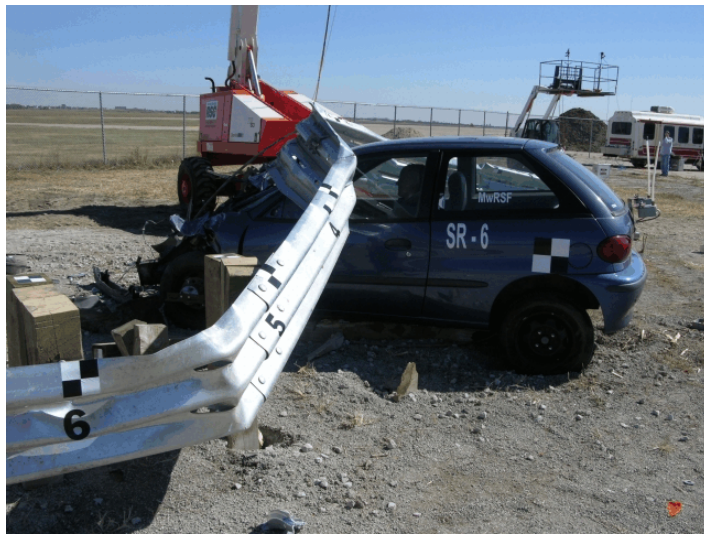
Figure 88. System Damage, Test SR-6

Damage to the short-radius system was moderate, as shown in Figures 88 through 92. Post nos. 1P and 1S fractured at the foundation tube. Post no. 1P disengaged from the rest of the system and post no. 1S remained attached to the rail. Post no. 2P fractured at ground level and disengaged from the rest of the system. Post nos. 3P and 4P also fractured at ground level and disengaged from

the rest of the system. Post no. 5P twisted downstream and encountered a small crack at ground level. The blockout at post no. 5P disengaged from the rail, but remained attached to the post.

Contact marks were found between the center of the nose section and post no. 3P. The rail was flattened and deformed between post nos. 1S and 3P. Rail buckling was found along the curved nose section. Additional rail buckling was found at post nos. 1P through 5P and between post nos. 5P and 8P. The post bolt released from the rail at post nos. 6P through 8P. The lower corrugation encountered a 178-mm (7-in.) long tear 2,134 mm (3 ft) downstream from the impact point. Another 178-mm (7-in) long tear occurred on the middle corrugation of the nose section between the primary-side quarter point and the center of the rail. All rail slots were bent and deformed on the primary side. Minor post bolt slot deformation occurred at post nos. 3P through 7P. The galvanization was removed the nose section.

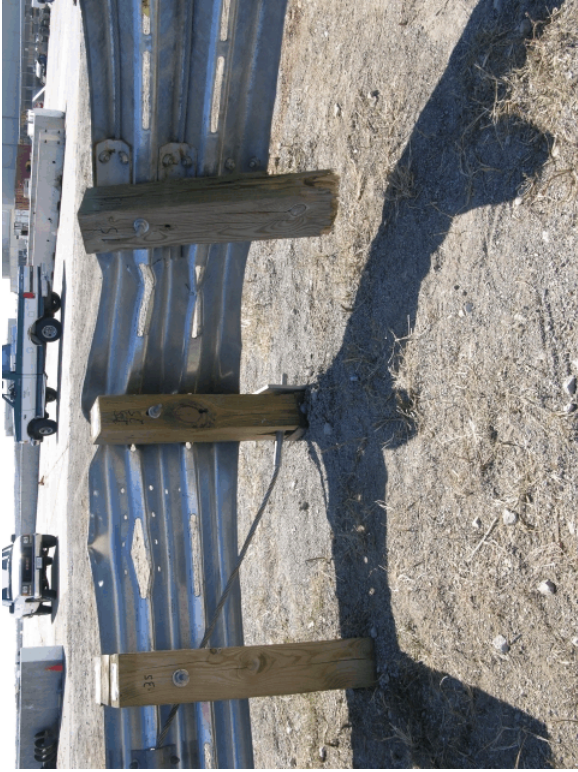
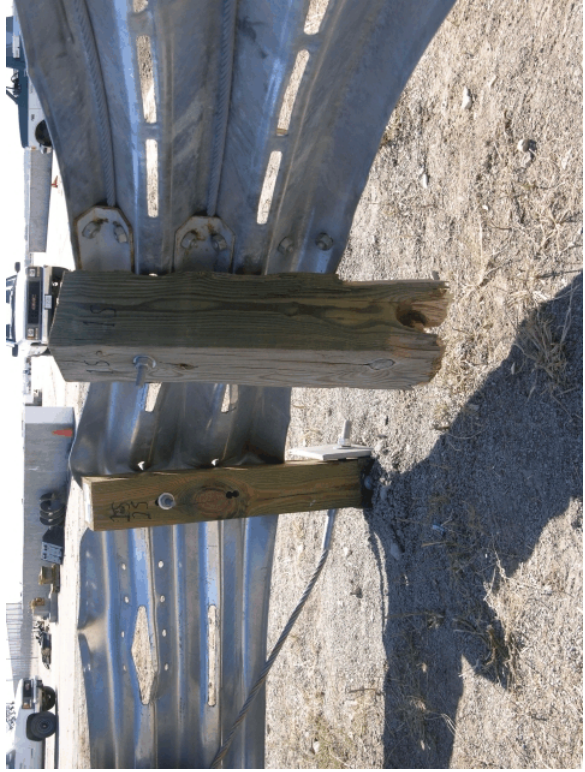
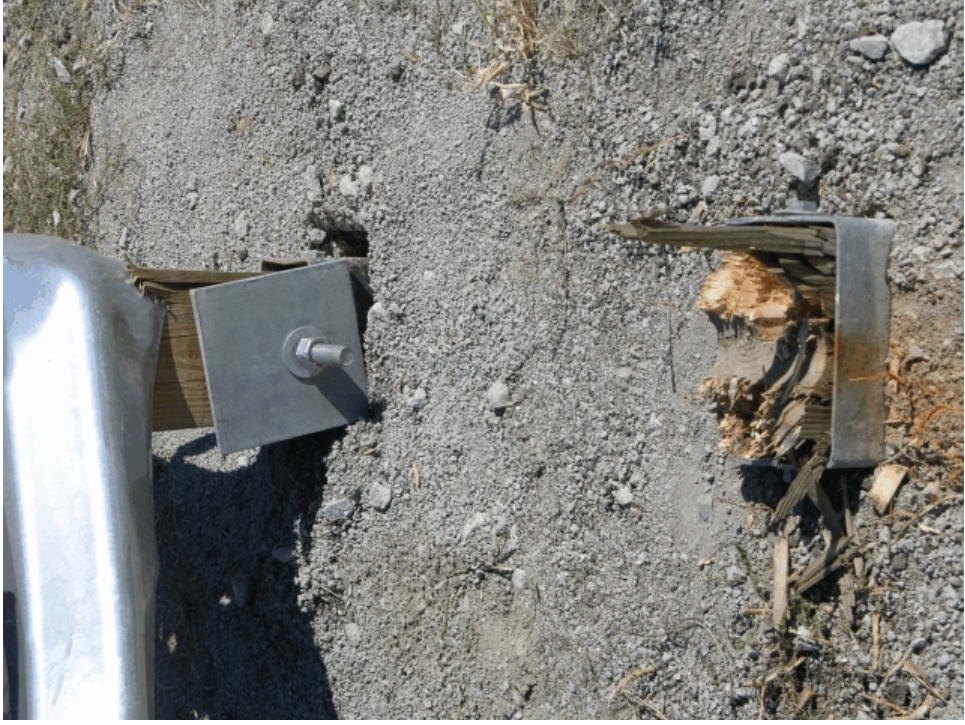
Figure 90. Post Nos. 1S Through 3S Damage, Test SR-6

Damage to the cable anchorage systems was minimal, as shown in Figure 90. The cable bracket at post no. 1P was bent and released the cable. The cable end plates at post nos. 1S and 2S remained attached to the posts. Both nose cables were stretched and the primary side ends disengaged from the rail.

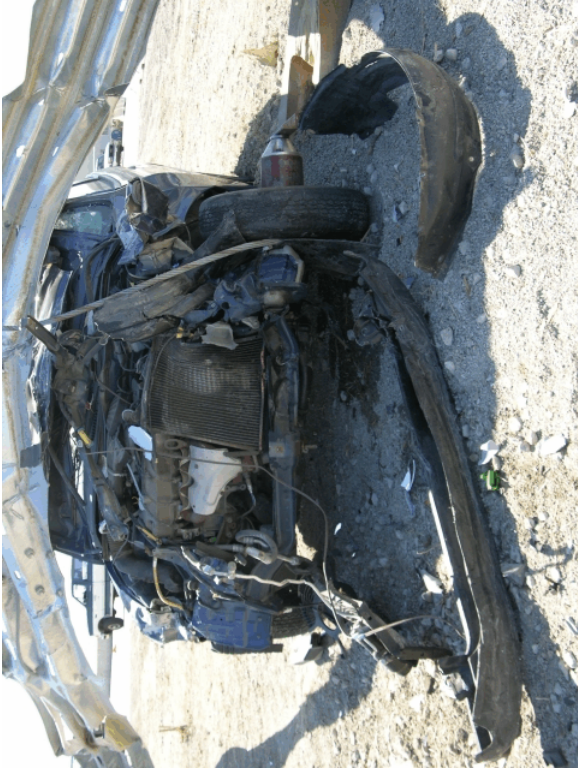
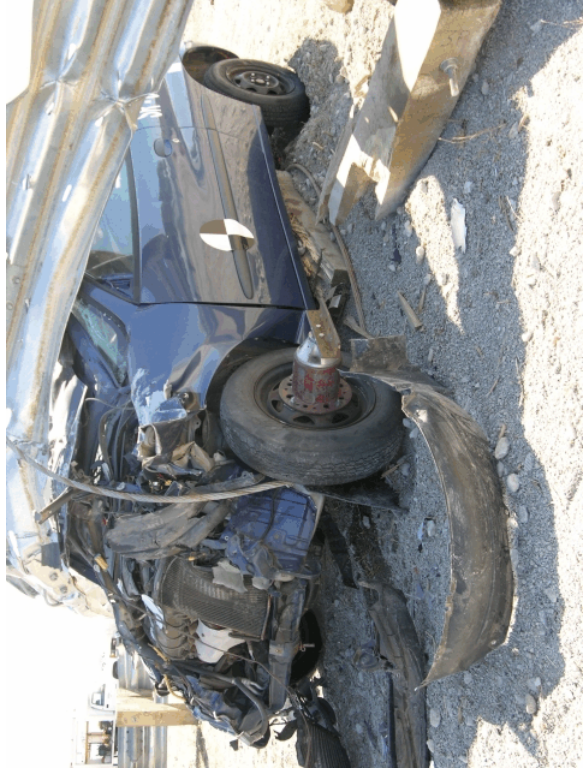
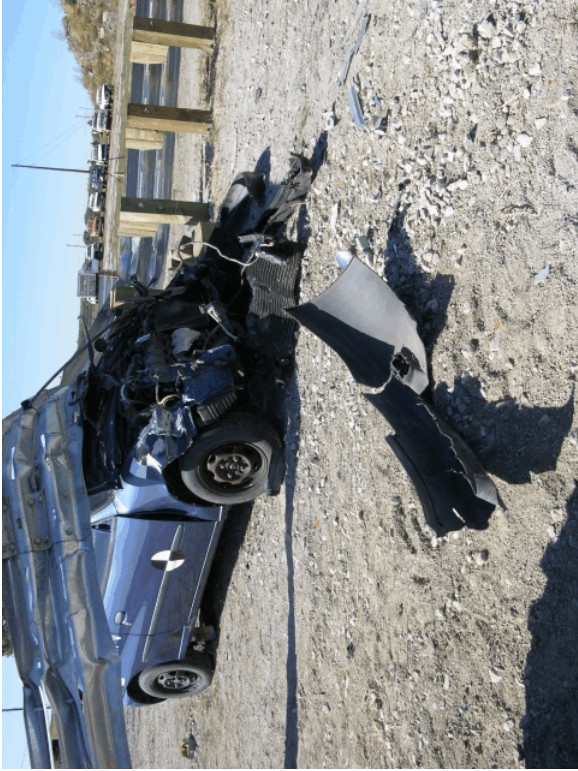
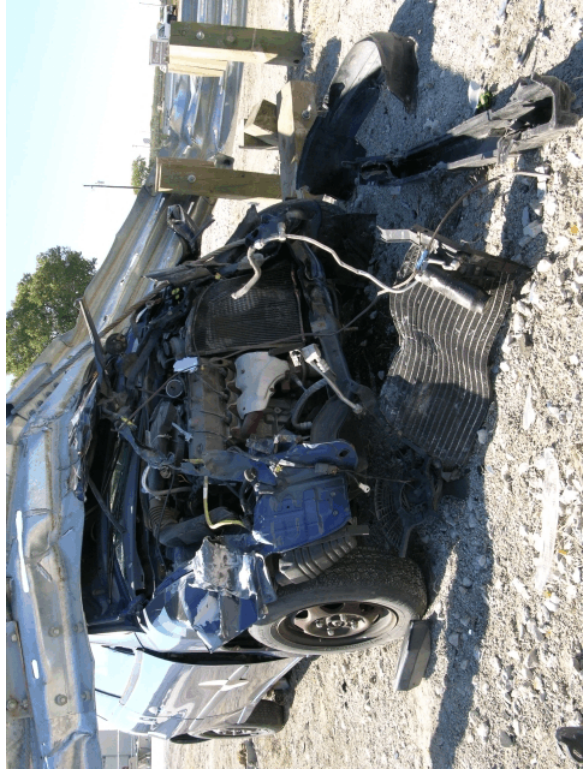
Figure 93. Vehicle Damage, Test SR-6

Exterior vehicle damage was extensive, as shown in Figures 93 through 96. Occupant compartment deformations were negligible, as shown in Figure 96. Complete occupant compartment deformations and the corresponding locations are provided in Appendix G.

The left-front and right-front quarter panels were severely crushed and deformed inward toward the wheel wells and encountered tearing of the sheet metal. The front bumper was also deformed and torn and disengaged from the vehicle due to fractured front bumper mounts. The hood

was folded in half and pushed back into the windshield. Contact marks were found on the right-front wheel rim and hubcap. The front frame was dented and crushed inward. The undercarriage sustained scratches and dents. The radiator and coolant valves and cases were crushed and dented. The radiator fan and belts were disengaged and broken. The engine block was displaced backwards and to the left. The windshield was crushed and sustained extensive “spider-web” cracking throughout. Deformation of the windshield exceeded 76 mm (3 in.) near the center of the glass on the left side. In addition, there were two small holes in the center of the windshield where the hood penetrated the glass. The right-rear and left-rear sides, the rear, and all other window glass remained undamaged.
