Evaluation of Rigid Hazards Placed in the Zone of Intrusion

EVALUATION OF RIGID HAZARDS PLACED IN THE ZONE OF INTRUSION

1. Report No. TRP-03-151-08	2.	3. Recipient's Accession No.	
4. Title and Subtitle Evaluation of Rigid Hazards Placed in the Zone of Intrusion		5. Report Date January 3, 2008

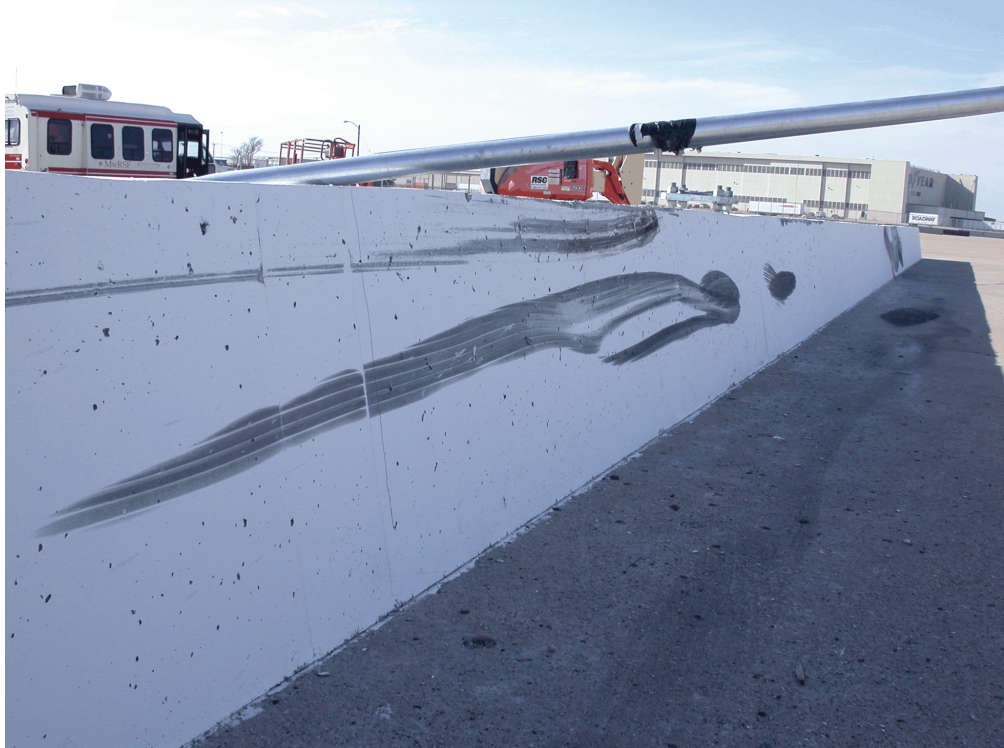
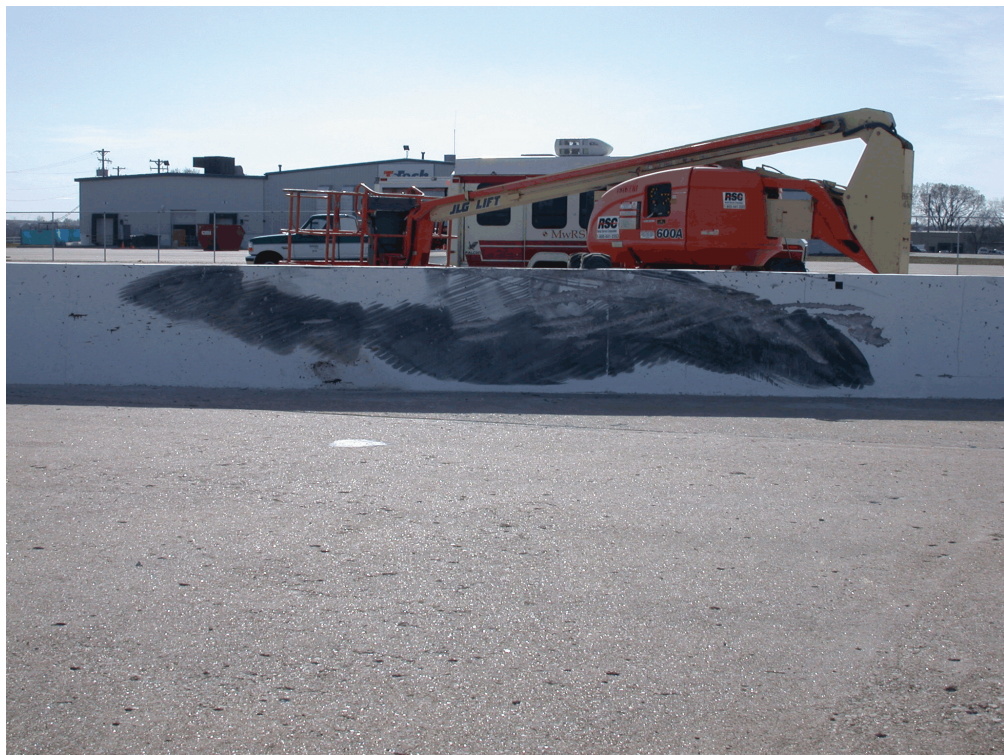
Figure 35. System Damage, Test No. ZOI-1

Damage to the barrier and pole was moderate, as shown in Figures 35 through 37. Barrier damage consisted of gouge marks and tire marks. The length of vehicle contact along the concrete barrier system was approximately 26.26 m (86 ft - 2 in.), which spanned from 17.12 m (56 ft - 2 in.) upstream of the centerline of the pole through the downstream end of the system.

A 25-mm (1-in.) deep wheel gouge began 17.12 m (56 ft - 2 in.) upstream of the centerline of the pole at a height of 256 mm (14 in.) to 559 mm (22 in.) from the ground and continued for a length of 4.88 m (16 ft). A 5.16-m (16-ft 11-in.) long tire mark began 76 mm (3 in.) downstream from the beginning of the first gouge. Tire marks and minor gouges were found on the top and back edges and front face from the barrier upstream of the centerline of the pole. Tire marks and gouges also began 305 mm (12 in.) downstream of the centerline of the pole and continued through the end of the barrier. Hairline cracks and surface chipping was found on the top of the barrier and extended diagonally from three of the bolts.

The pole fractured above the weld line on the impact-side face. Contact marks were found on the upstream edge of the pole plate and on one of the bolts and nuts. The pole buckled 610 mm (2 ft) above the ripped pole surface. The arms of the pole were bent due to contact with the ground and the barrier. One set of the ballest plates disengaged from the pole. After disengaging from the barrier and landing on the ground, the top of the pole was located 3.51 m (11 ft - 6 in.) downstream from its original position and 1.02 m (3 ft - 4 in.) behind the barrier and the bottom of the pole was located

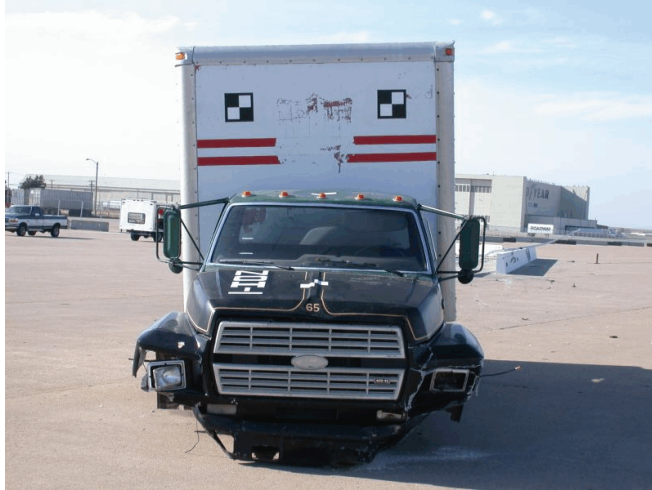
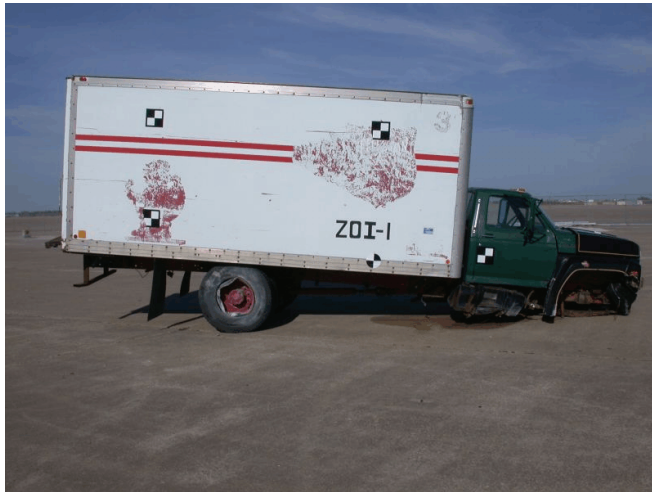
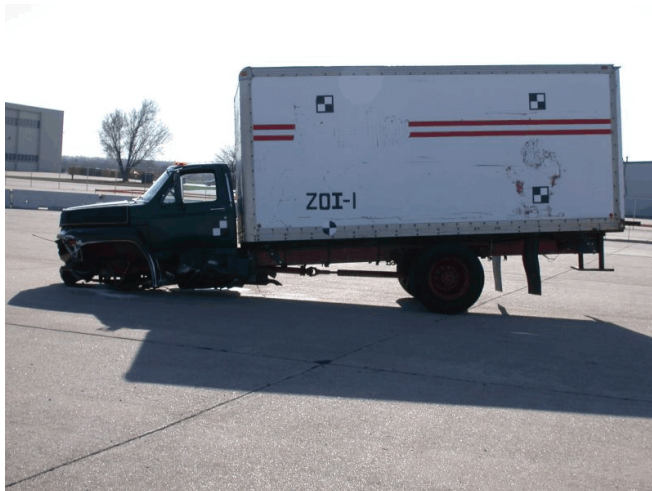
Figure 38. Vehicle Damage, Test No. ZOI-1

Exterior vehicle damage was moderate, as shown in Figures 38 through 40. Occupant compartment deformations did not occur. Damage was concentrated on the front and right sides of the vehicle. The outer rim of the right-rear was severely bent, and the tire deflated. The front face of the right-side fuel tank was deformed and dented. The left-side fuel tank was bent upward and lodged into the bottom of the door causing the door to not open. The front bumper bent backward around the frame support on both sides. Minimal separation was found between the fender, the hood, and the right-side door. The right-front shear plate on both sides was bent. All three U-bolts in front of both the right and left leaf spring attachments were bent, but remained attached. The right leaf spring attachment fractured. The additional U-bolt behind the leaf spring attachment on both sides fractured. The front axle disengaged. All four U-bolts for the front axle fractured. All window glass, the rear, and the box remained undamaged.

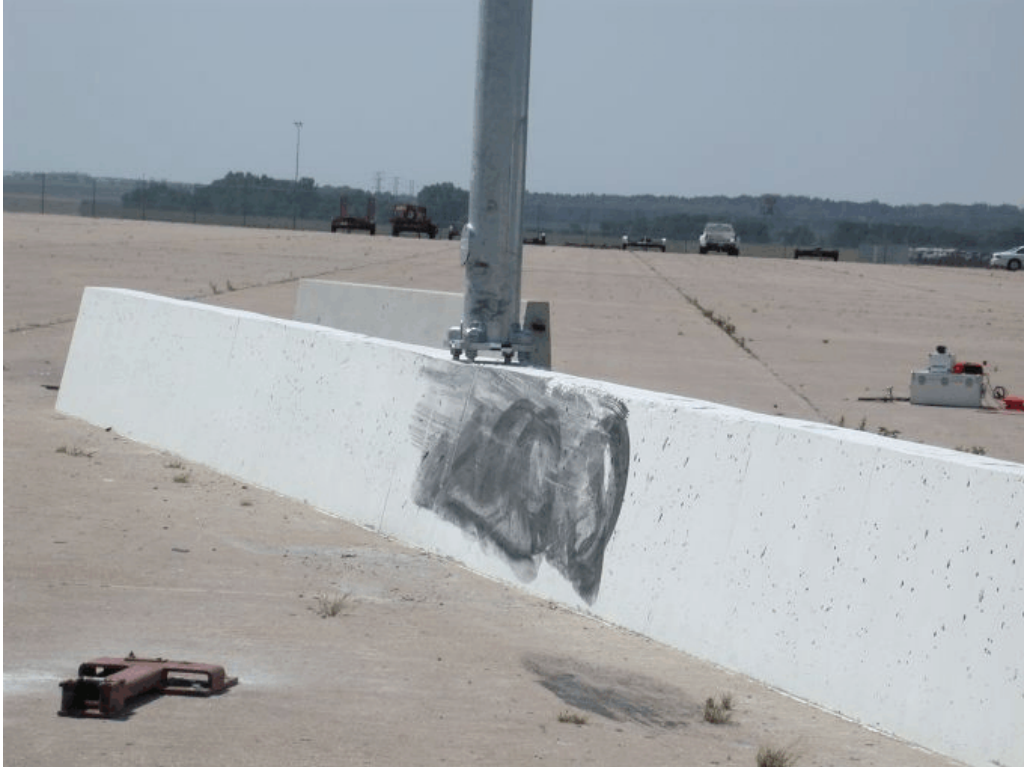
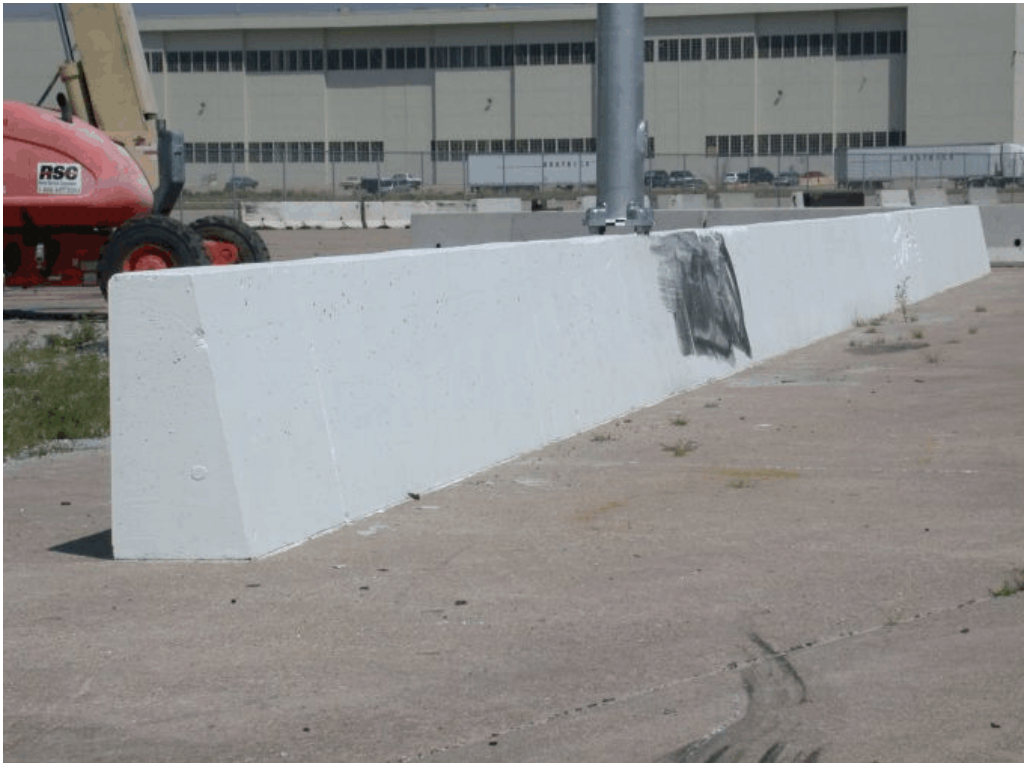
Figure 50. System Damage, Test No. ZOI-2

Damage to the barrier and pole was minimal, as shown in Figures 50 through 51. Barrier damage consisted of gouge marks and tire marks. The length of vehicle contact along the concrete barrier system was approximately 3.33 m (10 ft - 11 in.), which spanned from 2.90 m (114 in.) upstream from the centerline of the pole through 432 mm (17 in.) downstream from the centerline of the pole.

Tire marks on the front face of the barrier began 2.90 m (114 in.) upstream from the centerline of the luminaire pole and continue to 432 mm (17 in.) downstream from the centerline of the pole. Minor concrete gouges occurred at the front edge of the concrete barrier's top face throughout the tire mark region. Major gouges were found on the front-top edge of the barrier between 1,346 mm (53 in.) and 1,600 mm (63 in.) upstream from the centerline of the luminaire pole. A 254-mm (10-in.) long by 76-mm (3-in.) wide wheel gouge began 2,362 mm (93 in.) upstream from the centerline pole and 381 mm (15 in.) above the ground on the front face of the concrete barrier. Another 919-mm (7.5-in.) long by 32-mm (1.25-in.) wide wheel gouge on the front

face of the wall began 1,842 mm (72.5 in.) upstream from the centerline of the pole and 476 mm (18.75 in.) up above the ground. Another major gouge on the front face of the concrete barrier was located 2,654 mm (104.5 in.) upstream from the centerline of the pole and 330 mm (13 in.) up above the ground. Another 114-mm (4.5-in.) long by 121-mm (4.75-in.) wide gouge surrounded the bolt on the upstream-front corner of the pole. Another major gouge occurred on the downstream edge of the bolt on the upstream-back corner of the pole. Paint scratches were found at 2,769 mm (109 in.) upstream from the centerline of the pole and 178 mm (7 in.) above the ground through 622 mm (24.5 in.) above the ground. Another major region of paint scratches occurred from 584 mm (23 in.) through 1,905 mm (75 in.) upstream of the centerline of the pole and was 152 mm (6 in.) to 254 mm (10 in.) above the ground. The luminaire pole connection bolts were slightly bent.

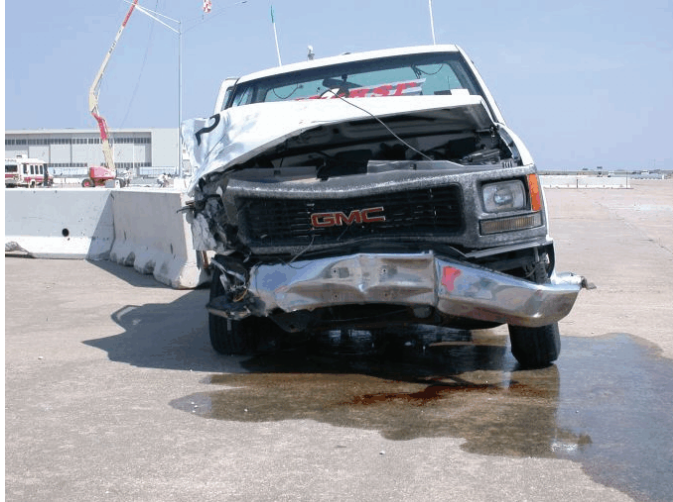
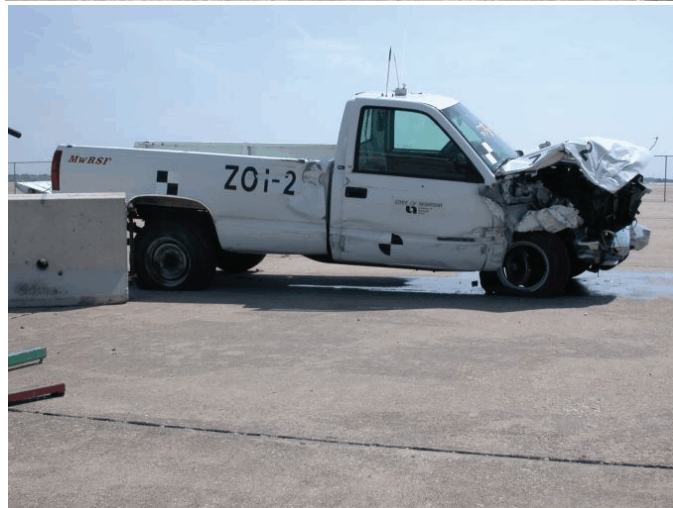
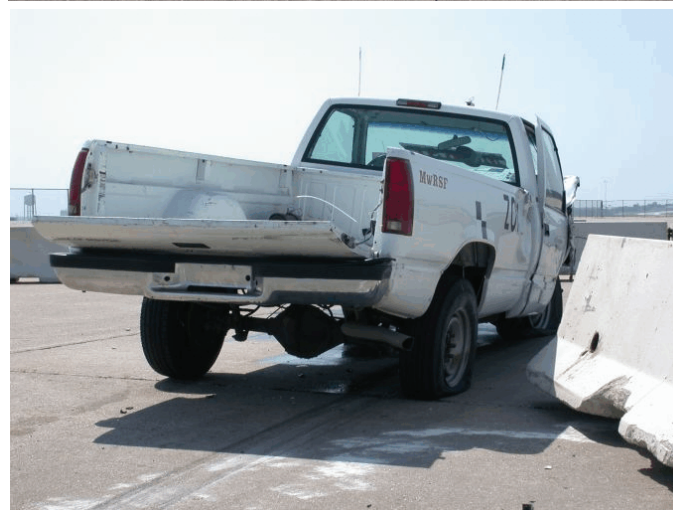
Figure 52. Vehicle Damage, Test No. ZOI-2

Exterior vehicle damage was moderate, as shown in Figures 52 through 54. Occupant compartment deformations to the right-side floorboard were judged insufficient to cause serious injury to the vehicle occupants, as shown in Figure 55. Maximum longitudinal deflections of 60 mm (2.375 in.) were located near the right-front corner of the right-side floorboard. Maximum lateral deflections of 70 mm (2.75 in.) were located near the right-front corner of the right-side floorboard. Maximum vertical deflections of 98 mm (3.875 in.) were located near the right center of the right-side floorboard. Complete occupant compartment deformations and their corresponding locations are provided in Appendix F.

Damage was concentrated on the front and right sides of the vehicle. The right-front quarter-panel, wheel well, and hood were deformed and dented. The bumper and bumper connections were deformed and damaged. The front bumper encountered two major buckle points. The hood buckled.

The right-front top corner of the box was dented. Light scrapes and deformations were found along the entire right side. One heavy contact mark was found on the right side near the rear of the truck. The top of the right-side door was ajar with a 127 mm (5 in.) gap. The drive shaft disengaged between the rear end and the middle joint. The lower right-side A-frame was deformed upward. The right-side frame horn encountered heavy contact marks and was crushed inward. The right-front wheel fractured but remained attached to the truck. The lower-right side of the windshield shattered. The right-side window glass was fractured and removed. The left side, rear end, and all other window glass remained undamaged.

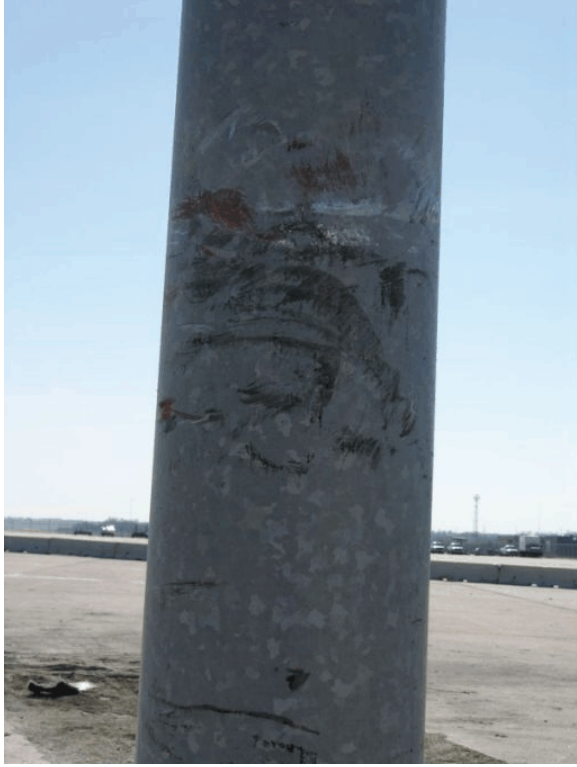
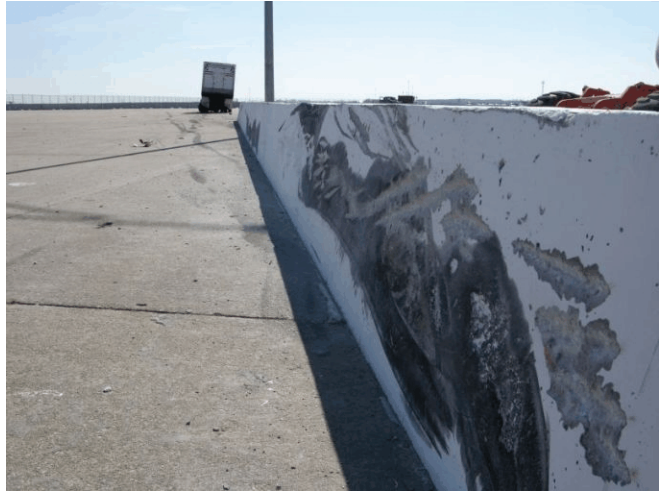
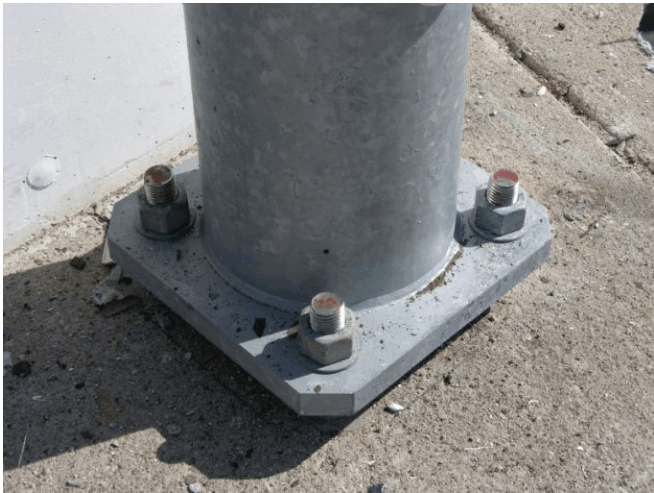
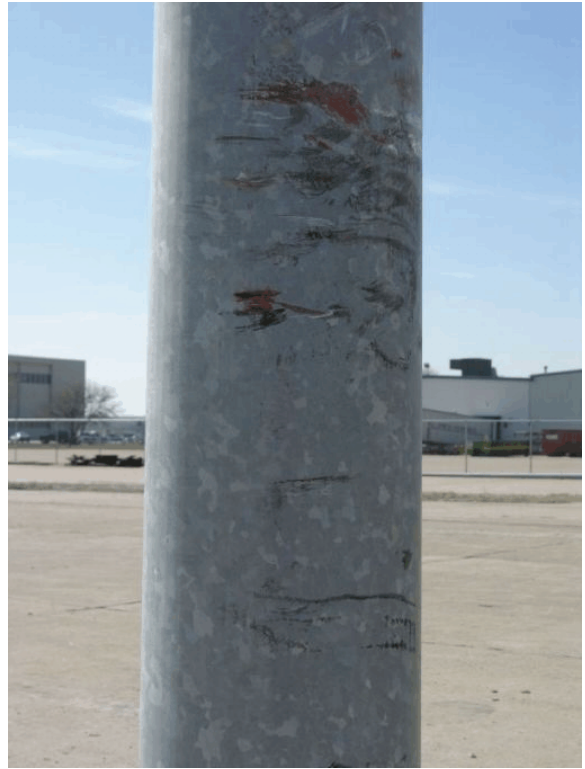
Figure 72. System Damage, Test No. ZOI-3

Damage to the barrier was moderate, as shown in Figure 72. Barrier damage consisted of gouge and tire marks. The length of vehicle contact along the concrete barrier system was approximately 28.78 m (94 ft - 5 in.), which spanned from 16.43 m (53 ft - 11 in.) upstream of the centerline of the pole through the downstream end of the system.

Major concrete gouging was found on the front face of the concrete barrier. One large area of gouging began 83 mm (3.25 in.) above the ground and 16.90 m (55 ft - 5.5 in.) upstream from the centerline of the pole and encompassed the majority of the front face through 11.26 m (36 ft - 11.5 in.) upstream from the centerline of the pole. Another large area of gouging with an average width of 381 mm (15 in.), spanned from 7.77 m (25 ft - 6 in.) upstream from the centerline of the pole and

The pole encountered minor scuff and scrape marks on the upstream face. The pole remained attached to the concrete. No deformations or damage occurred to the attachment mechanism, as shown in Figure 72.

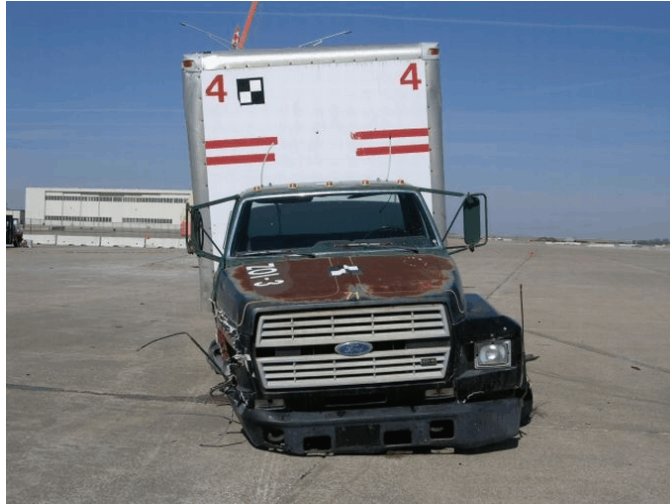
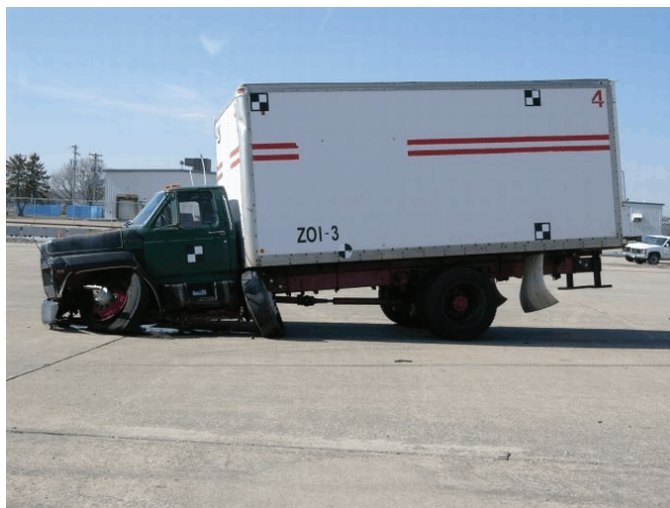
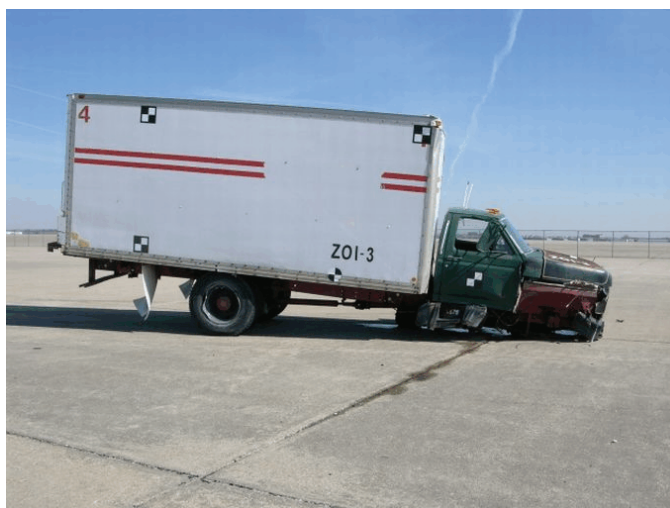
Figure 73. Vehicle Damage, Test No. Z01-3

Exterior vehicle damage was moderate, as shown in Figures 73 through 75. Occupant compartment deformations did not occur. Complete occupant compartment deformations and their corresponding locations are provided in Appendix I.

Damage was concentrated on the right-front corner of the vehicle. The right side of the front bumper deformed inward. The plastic headlight housing fractured on both the left and right sides. The left-side fender was bent and deformed inward. The metal straps for the left-side and right-side fuel tanks fractured. The right-side fuel tank was dented. The box frame on the right side was severely bent above the tire. The wood supports fractured, and the box shifted. The U-bolts deformed. The right-side trim was deformed. The right-side mirror was severely damaged. The right-side suspension springs broke. The right-front fender disengaged. The front axle detached and was

rotated 90 degrees. The left-front tire bead broke, and the tire was deflated. The right-front wheel hub encountered scrapes and dents. The right-front tire was deflated. The right-rear steel rim was damaged, and the outside tire was deflated. The right-side door window shattered. The left side, rear, and all other window glass remained undamaged.
