Design and Evaluation of an Open Combination Traffic/Bicycle Bridge Railing System

DESIGN AND EVALUATION OF AN OPEN COMBINATION TRAFFIC/BICYCLE BRIDGE RAILING SYSTEM

MwRSF Research Report No. TRP-03-162-07

February 9, 2007

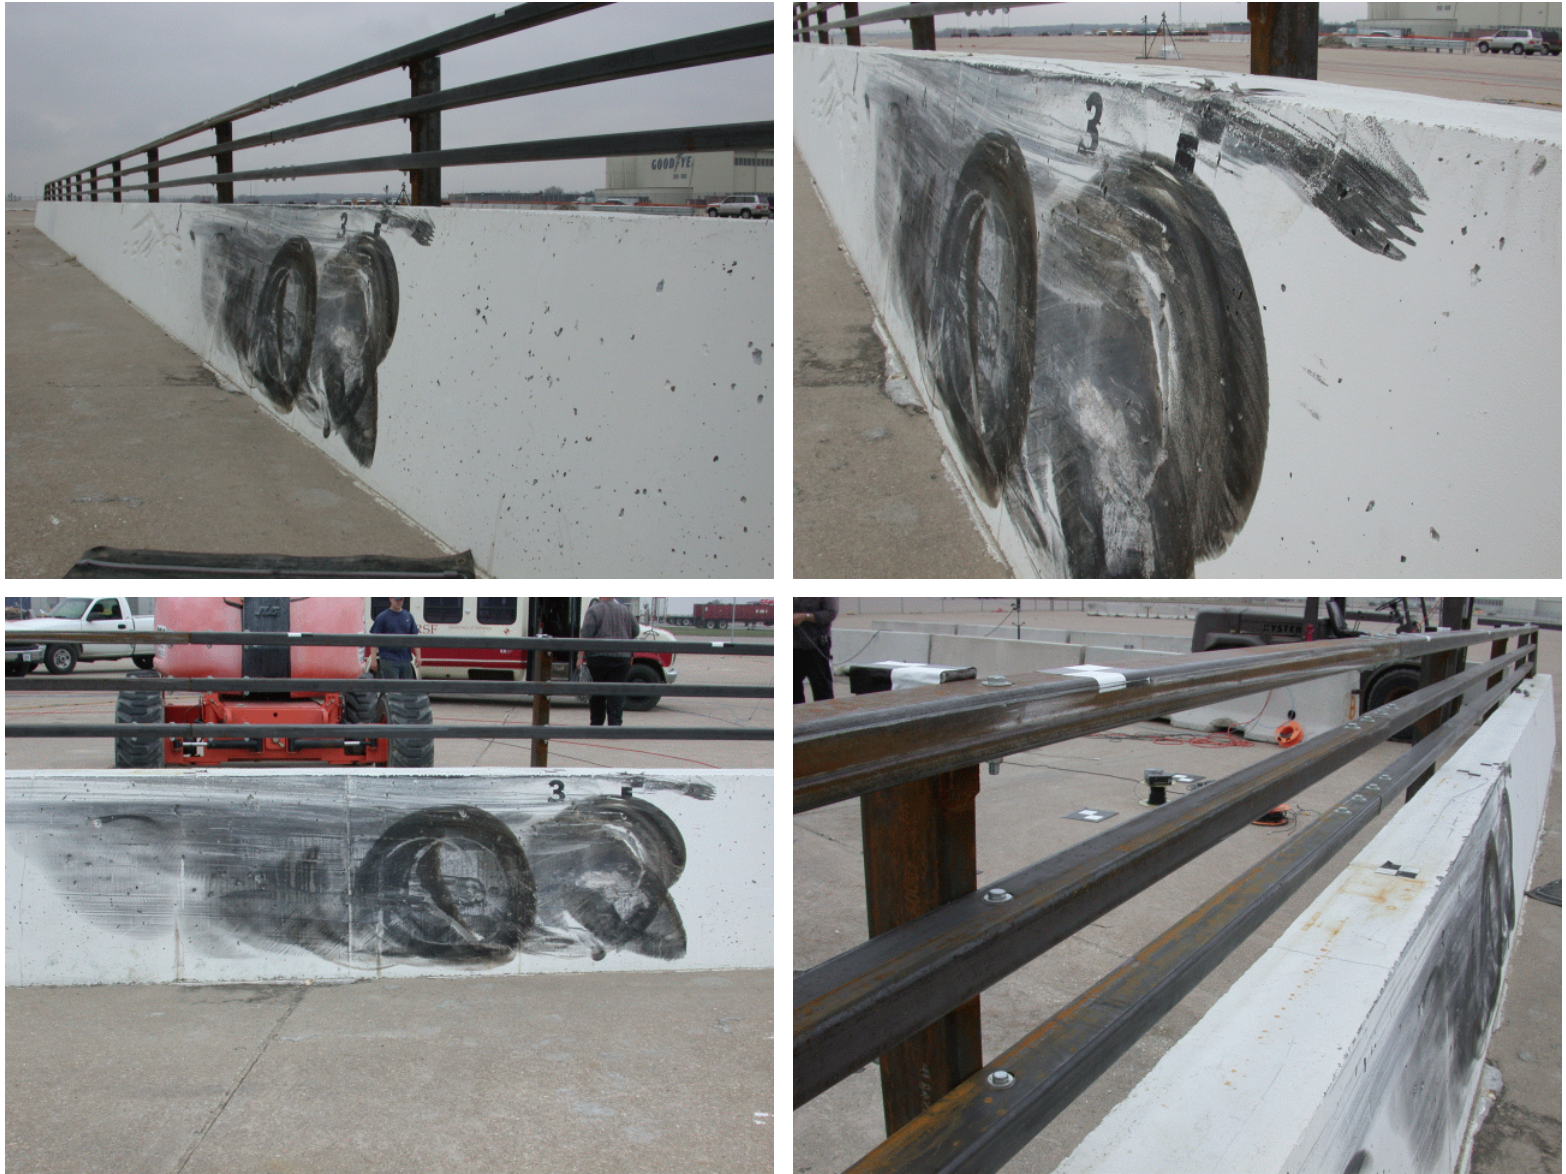
Figure 27. System Damage, Test MOBR-1

Damage to the combination traffic/bicycle bridge rail was minimal, as shown in Figures 27 through 28. Barrier damage consisted of contact and gouge marks on the concrete parapet, contact marks on the bicycle rail, and pull out of attachment bolts. The length of vehicle contact along the combination bridge rail was approximately 3 m (10 ft - 5 in.), which spanned from 533 mm (21 in.) upstream from post no. 3 through 460 mm (16 in.) upstream from the centerline of post no. 4.

Heavy scrapes from the wheel or bumper were located at 356 mm (14 in.) upstream from the centerline of post no. 3. A heavily-defined circular wheel mark was found on the front face of the concrete barrier at 610 mm (24 in.) downstream from the centerline of post no. 3. A 152-mm (6-in.) long gouge in the front face of the concrete barrier was found 152 mm (6 in.) upstream from post no. 3.

Contact marks were found on the upper rail of the bicycle rail beginning at the splice between post nos. 3 and 4 and ending 1,270 mm (50 in.) upstream from post no. 5. Contact marks were found on the front face of the lower and middle rails, starting at the splice between post nos. 3 and 4 to 914 mm (36 in.) downstream from the splice. Light contact marks were found on the bottom and top faces of all three rails. The top two bolts attaching post nos. 2 and 3 to the concrete barrier pulled 6 mm to 13 mm (1/4 in. to 1/2 in.) out of the concrete.

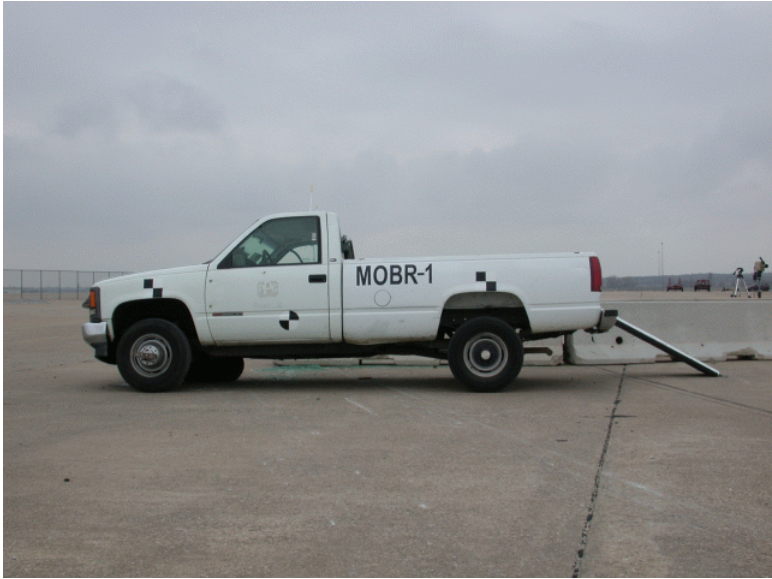
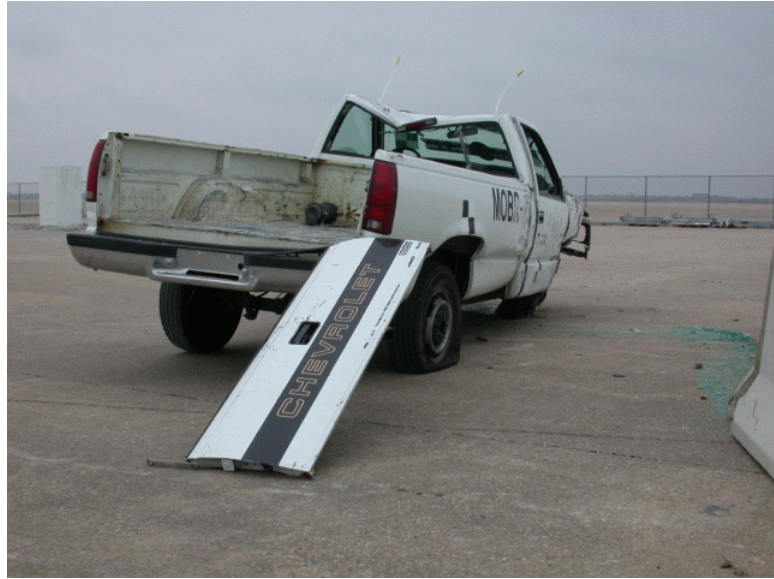
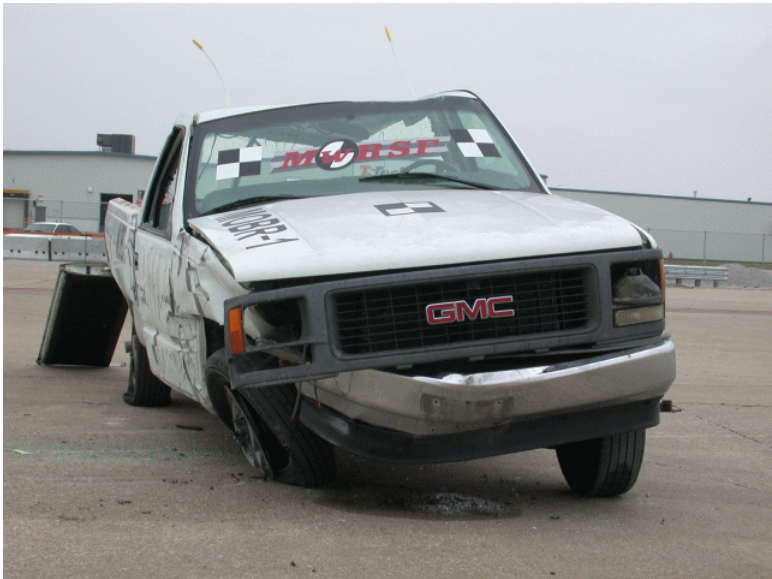
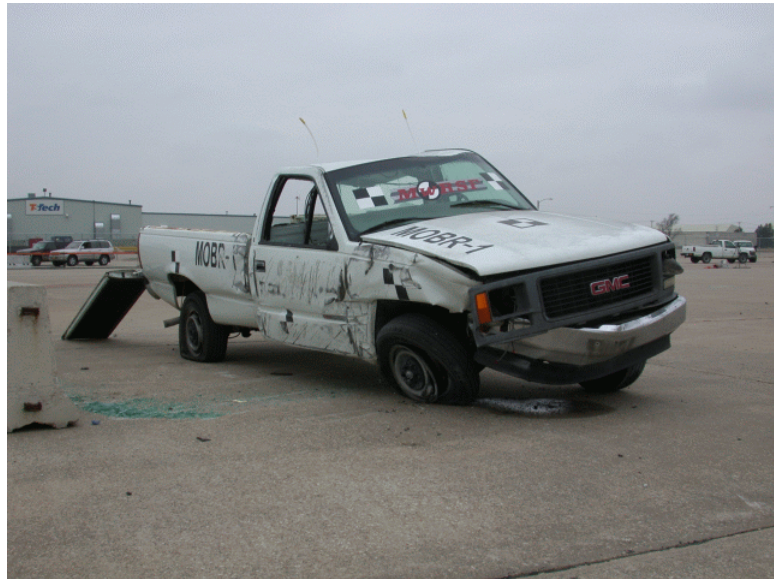
Figure 29. Vehicle Damage, Test MOBR-1

Exterior vehicle damage was extensive, as shown in Figures 29 through 33. Extensive occupant compartment deformations occurred due to vehicle rollover. Moderate deformations occurred near the center of the right-side floor pan. The majority of the vehicle damage was concentrated on the passenger side and front of the vehicle. The front bumper buckled at the centerline. The headlight assemblies were detached. The right side of the grill encountered significant damage and deformation. The right side of the front bumper was deformed and encountered white paint marks from the barrier. The right-front quarter panel was crushed inward and downward. The right-side wheel assembly was deformed severely backward into the frame. The right-side upper A-frame disengaged. The transmission housing and the starter housing were fractured. The frame encountered heavy tire marks due to rubbing from the deformed right-front wheel assembly. Heavy scraping and contact marks were found on the right-side door, front-right quarter panel, box, and right-front steel rim. The right-front wheel hub was ground down due to heavy scraping on the barrier. The seal between the right-front tire and rim was broken, and the tire was deflated. The left side of the roof was crushed extensively with the maximum crush occurring near the outside of the left side of the roof. The tailgate was disengaged from the vehicle. The right-side and rear windows were shattered. The windshield was heavily cracked on the left side.

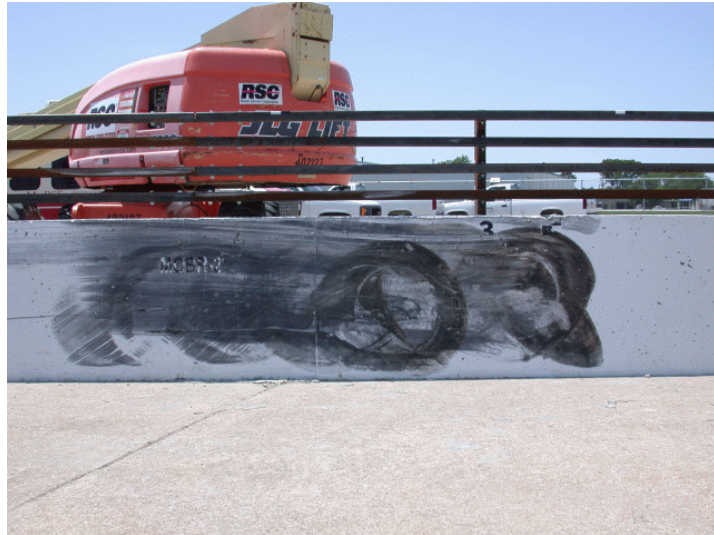
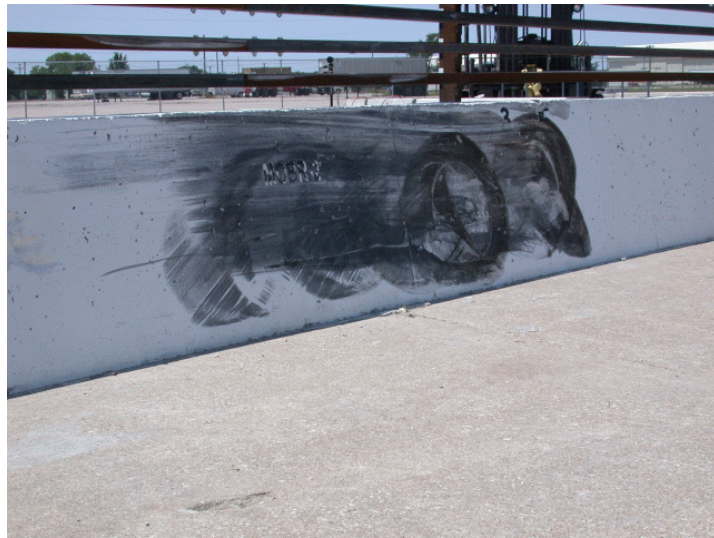
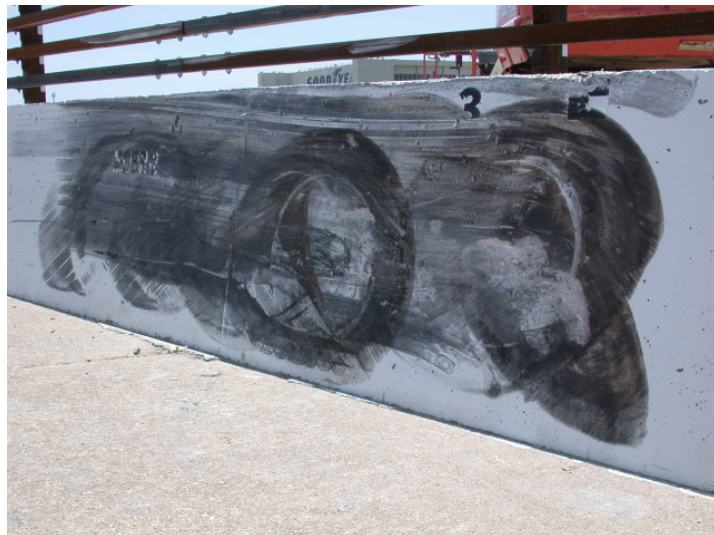
Figure 53. System Damage, Test MOBR-2

Damage to the combination traffic/bicycle bridge rail was minimal, as shown in Figures 53 and 54. Damage to the combination traffic/bicycle bridge rail consisted of contact marks and gouges on the concrete parapet and contact marks on the bicycle rail. Vehicle contact along the combination bridge rail was approximately 5.4 m (17 ft - 10 in.), which spanned 864 mm (34 in.) upstream from the centerline of post no. 3 through 1,524 mm (60 in.) downstream from the centerline of post no. 4. Tire marks began 559 mm (22 in.) upstream from the centerline of post no. 3, with a maximum

White paint marks were found on the front face of the bottom rail between 356 mm (14 in.) and 660 mm (26 in.) downstream from the centerline of post no. 3. Black rubber or plastic marks were also found on the bottom rail between 1,537 mm (60.5 in.) and 2,642 mm (104 in.) downstream from the centerline of post no. 3. Two distinct white paint marks were found on the front, bottom, and top faces of the lower-middle rail. The first mark began 330 mm (13 in.) downstream from the centerline of post no. 3 and continued for 2,007 mm (79 in.). A 6.4-mm (1/4-in.) wide by 1,384-mm (54.5-in.) long mark on the bottom face of the lower-middle rail, began 1,524 mm (60 in.) downstream from the centerline of post no. 3. The upper-middle rail encountered the most markings, with white paint on the front and bottom faces. The contact marks began 102 mm (4 in.) downstream from the centerline of post no. 3 and ended 3,327 mm (131 in.) downstream from the centerline of post no. 3. The width of these marks ranged from 6.4 mm (1/4 in.) to 51 mm (2 in.). The top rail also contained white paint and black tire marks on its front face. Six distinct marks, ranging in width from 6.4 mm (1/4 in.) to 38 mm (1 ½ in.), began 114 mm (4.5 in.) downstream from the centerline

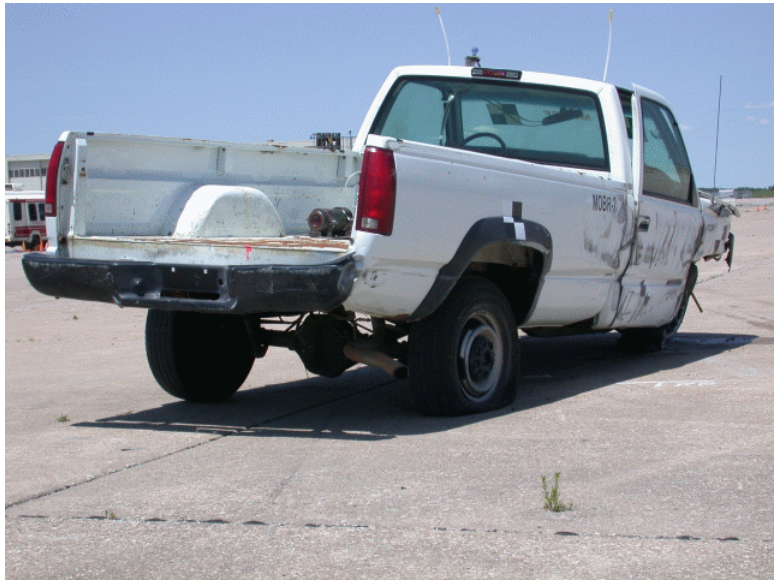
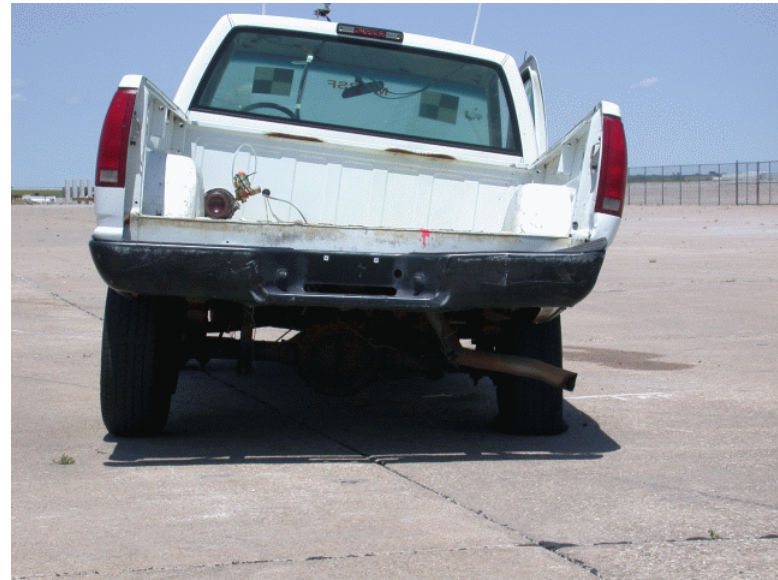
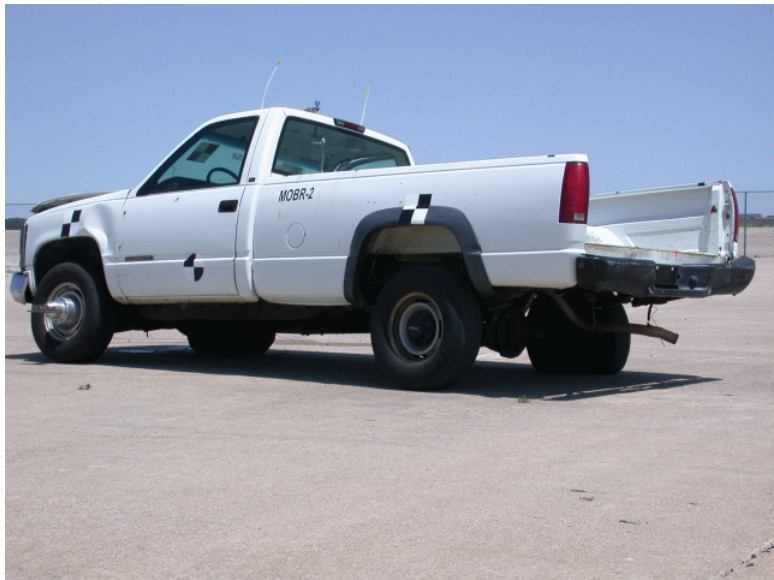
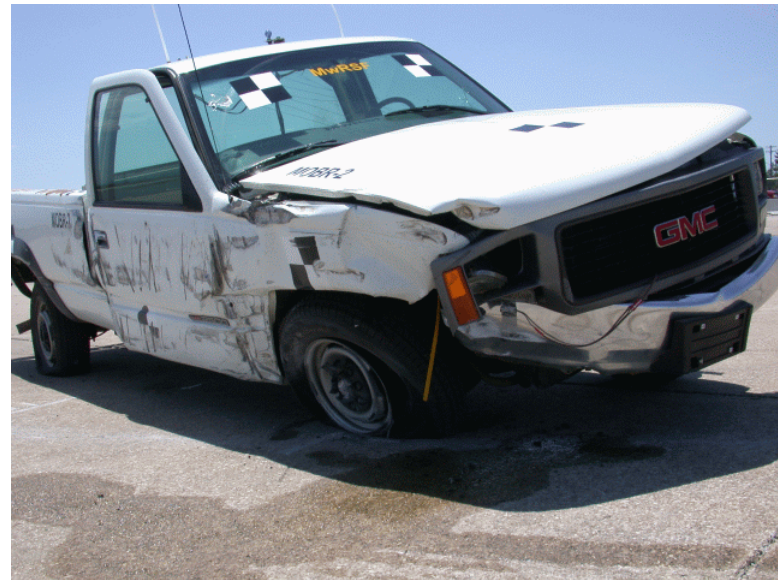
Figure 55. Vehicle Damage, Test MOBR-2

Exterior vehicle damage was moderate, as shown in Figures 55 through 59. Moderate deformation occurred near the center of the right-side floorboard, and the right side was shifted backward and inward. The majority of the vehicle damage was concentrated on the right side and the front of the vehicle. The front-right tire was pushed backward into the wheel well. The front-quarter panel was severely scratched at random locations, with concentrated scratches at the door hinge and hood joint. The right-front quarter panel was dented and buckled. The headlight housing was cracked, and the lights were pushed backward and downward into the wheel well. The front bumper was dented, scratched, and pushed back into the vehicle on the right side, and encountered a buckle point near the center.

The left side encountered only minor damage including a dent in the front quarter panel. The rear bumper was severely scratched and dented on the right side. The tailgate was detached from the vehicle. The roof suffered no damage.

The hood was latched but deformed upward on the left side and bent downward and backward on the right-front corner. The hood's hinges were severely deformed, but the hood could still be opened. The plastic grill and light housing assembly were cracked and pushed back into the wheel well. The air filter housing was cracked in half. The right-side door encountered random scratches with a high concentration at the handle height near the rear of the cab. The top of the right-side door was ajar, and the door could not be opened. The A-pillar had random scratches throughout its length and a severe dent at the bottom end. The box of the vehicle was severely scratched and dented, with minor scratches on the wheel well trim. The right-rear tire was scratched along the steel rim, and the hub cap was broken and collapsed. The right-rear tire was deflated, but the attachment and position of the wheel remained normal. The windshield showed cracks radiating outward from the bottom-center. All other glass remained undamaged.

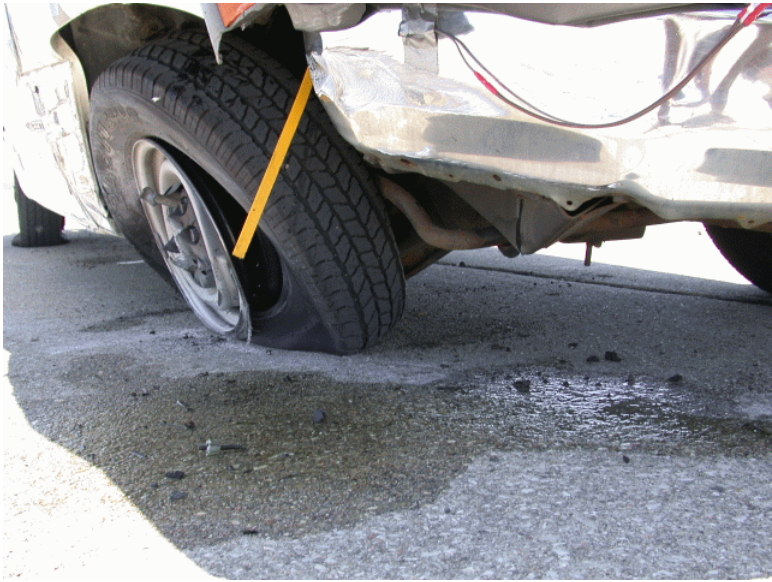
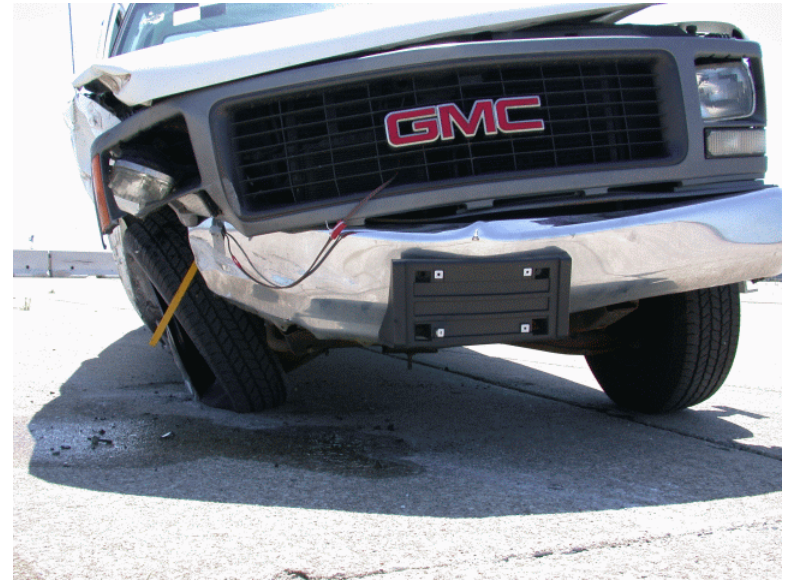
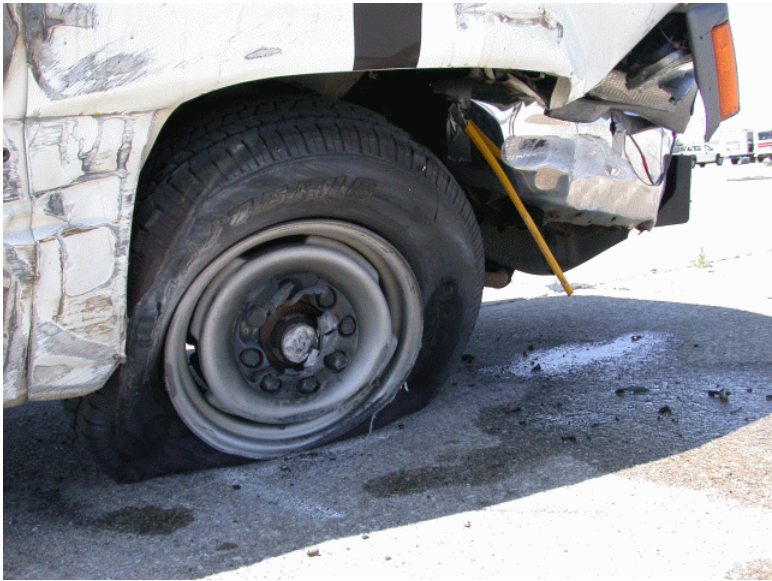
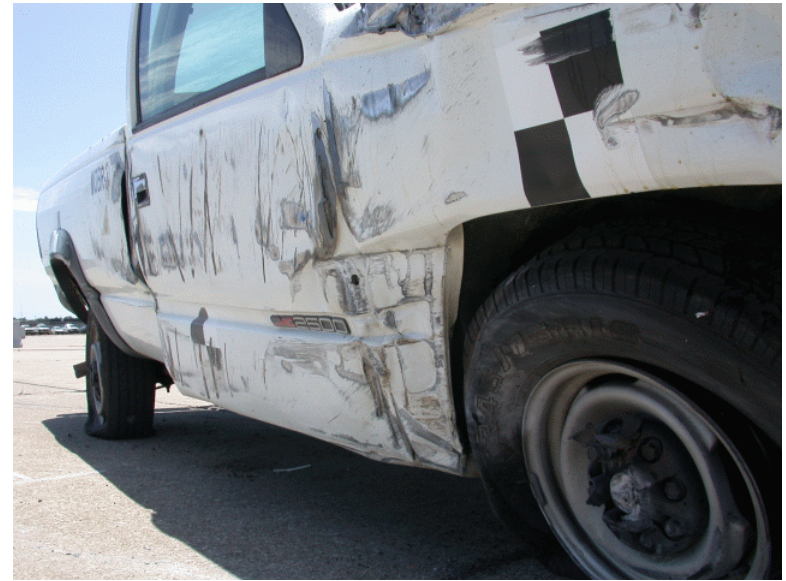
Figure 56. Vehicle Damage, Test MOBR-2

The outside steel rim of the right-front wheel was scratched, and the hub cap in the center was torn apart. The right-front tire's seal was broken, and the tire was deflated. The wheel bearing was severely scratched.

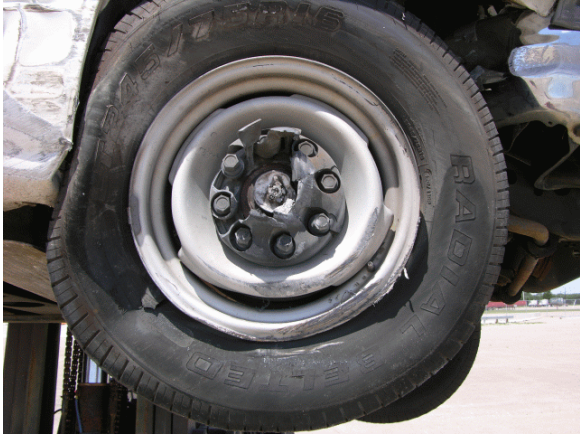
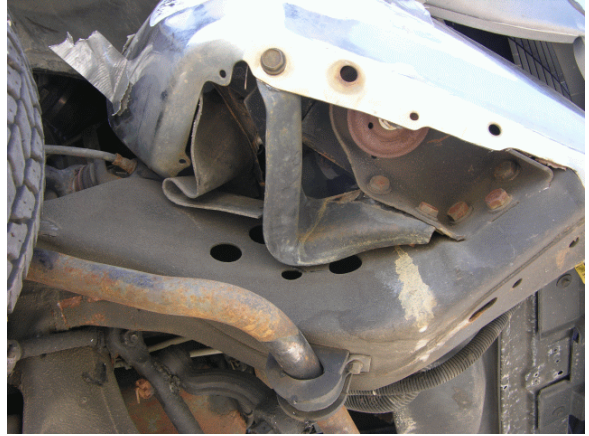
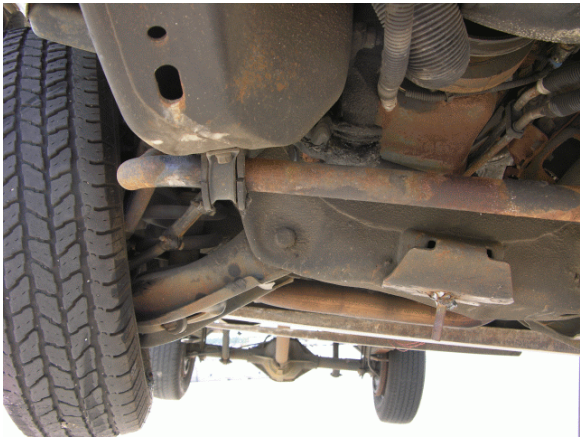
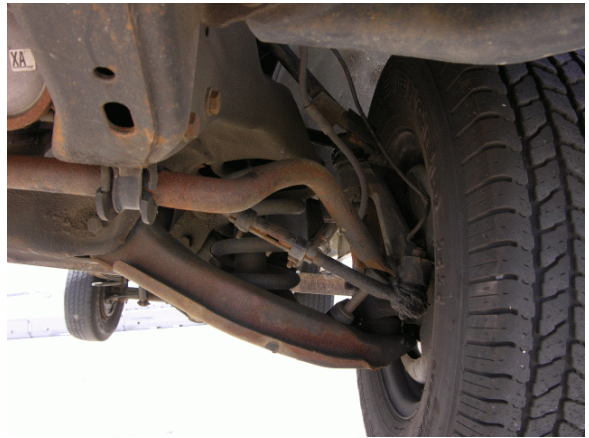
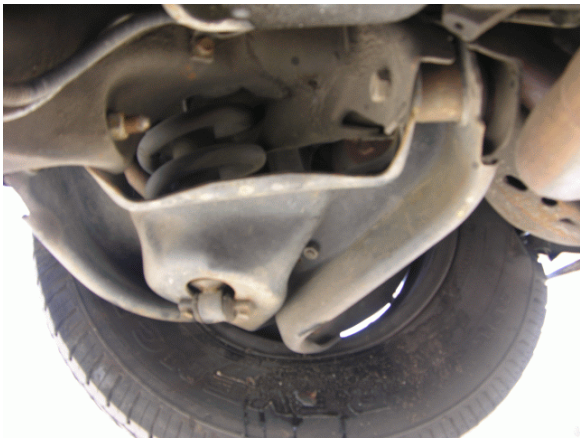
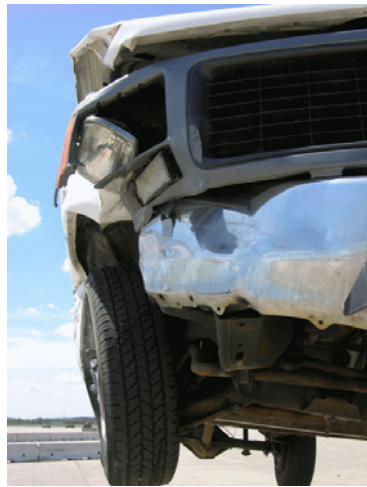
Figure 58. Vehicle Undercarriage Damage, Test MOBR-2

The right-side lower and upper A-arms were bent and buckled, with the lower arm more severely damaged than the upper. The right-side sway bar and tie rod were bent. The right-front end of the frame buckled at the front of the transmission mount and the cross frame buckled between the two front wheels. The right-side steering arm frame pivot was bent backward. The right-side bumper
