# SAFETY PERFORMANCE EVALUATION ON THE NEBRASKA TURNED-DOWN APPROACH TERMINAL SECTION

Project RES 1 (0099) P464  
TRANSPORTATION RESEARCH REPORT TRP-03-32-92

October 1992

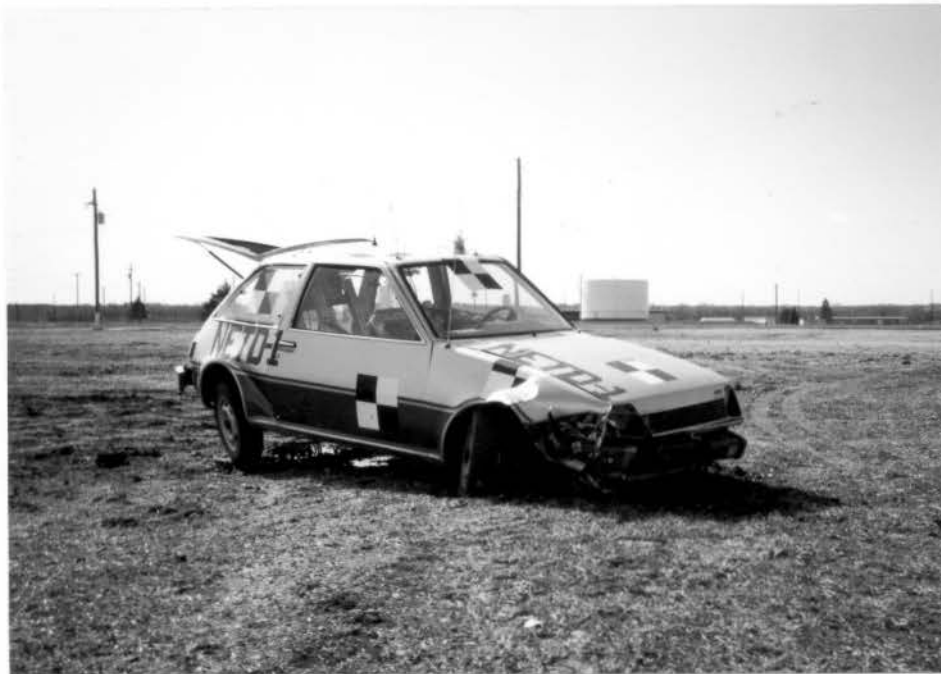
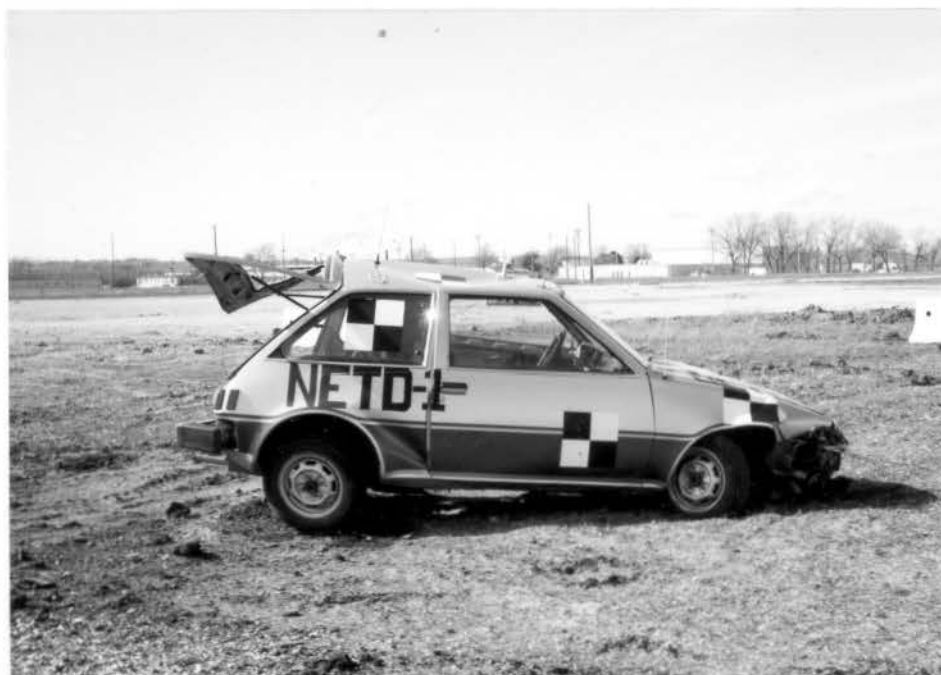
FIGURE 17. Vehicle Damage, Test NETD-1

Exterior vehicle damage is shown in Figures 17 and 18, while the interior vehicle deformations are shown in Figure 19. The majority of the vehicle damage occurred at three body

panel locations, the right-front quarter, the left-rear quarter, and the rear end. The right-front quarter damage occurred primarily to the fender, axle, and bumper. The left-rear quarter damage occurred primarily to fender (18-in. crush depth), undercarriage, axle, bumper, and hatchback. In addition, excessive interior deformations occurred at the left-side rear seat position as a result of the excessive, exterior left-rear quarter damage (Figure 19).

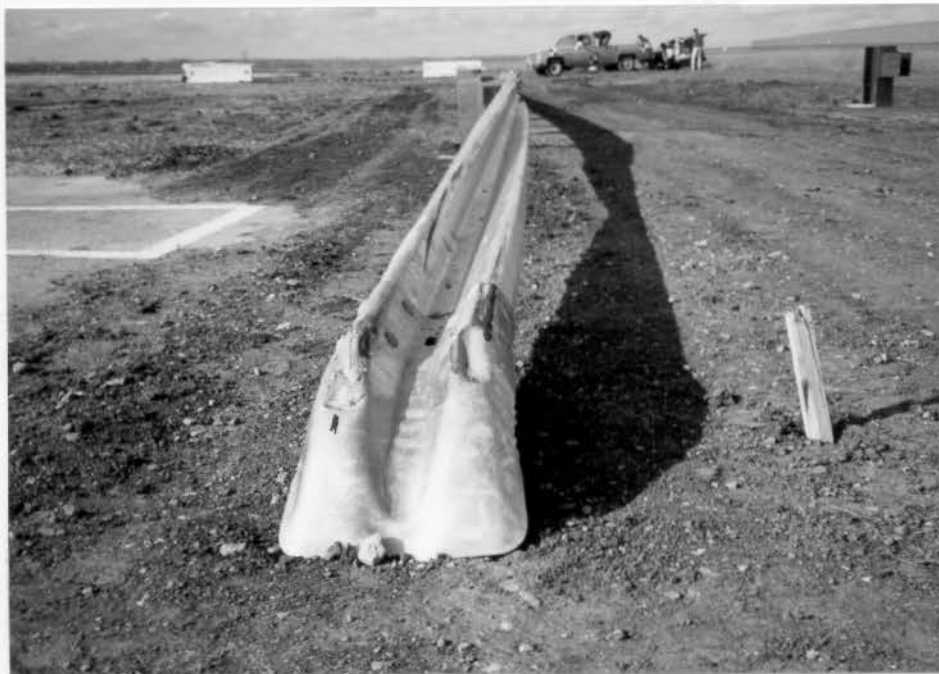
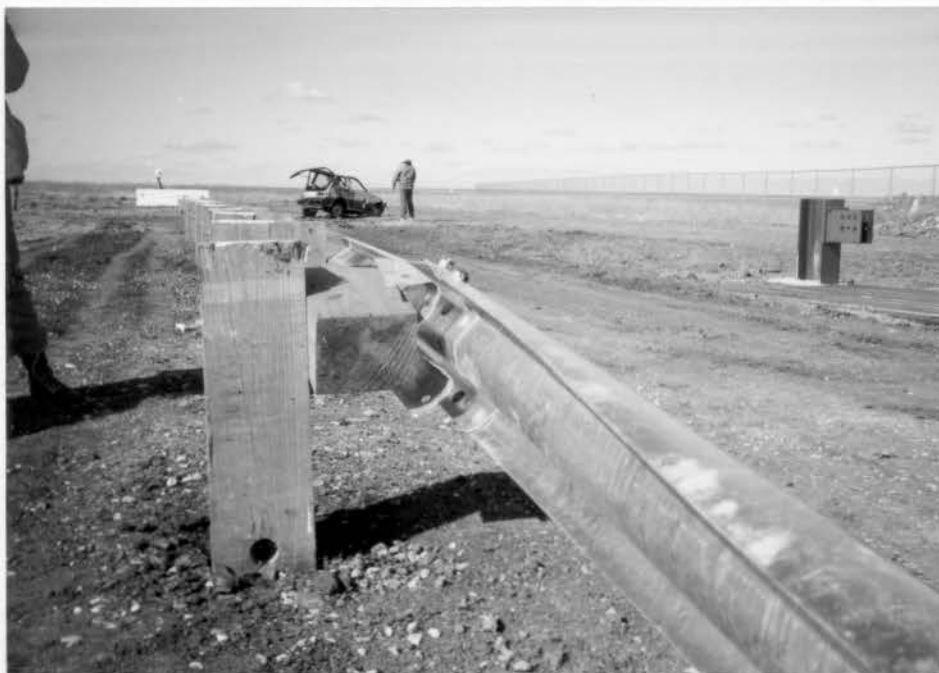
**FIGURE 20.** Turned-Down Terminal Section Damage, Test NETD-1

Guardrail damage is shown in Figures 20 through 22. The Michigan end shoe received dents, scrapes, and tire marks (Figure 20). Additional tire marks were evident on the surface of the twisted, 25-ft terminal section. Minor gouging was evident on the top of Post No. 1 and the attached spacer block (Figure 21). In addition, the spacer block was rotated approximately 85 deg clockwise in the direction of traffic (Figures 20 and 21). The back-up plate at Post No. 1 was also deformed. The shear bolts at Post Nos. 1 and 3 had also failed (Figures 21 and 22).

First, the steel anchor post and attached Michigan end shoe projected above the ground in excess of 9-in. This structural component provided the initial ramping or launching effect on the vehicle which contributed to the vehicle rollover. In addition, the launched vehicle could not provide sufficient downward force on the rail to cause the rail to drop to the ground. Initial vehicle performance could be improved with the embedment of the anchor post, this has been successfully incorporated in similar designs.

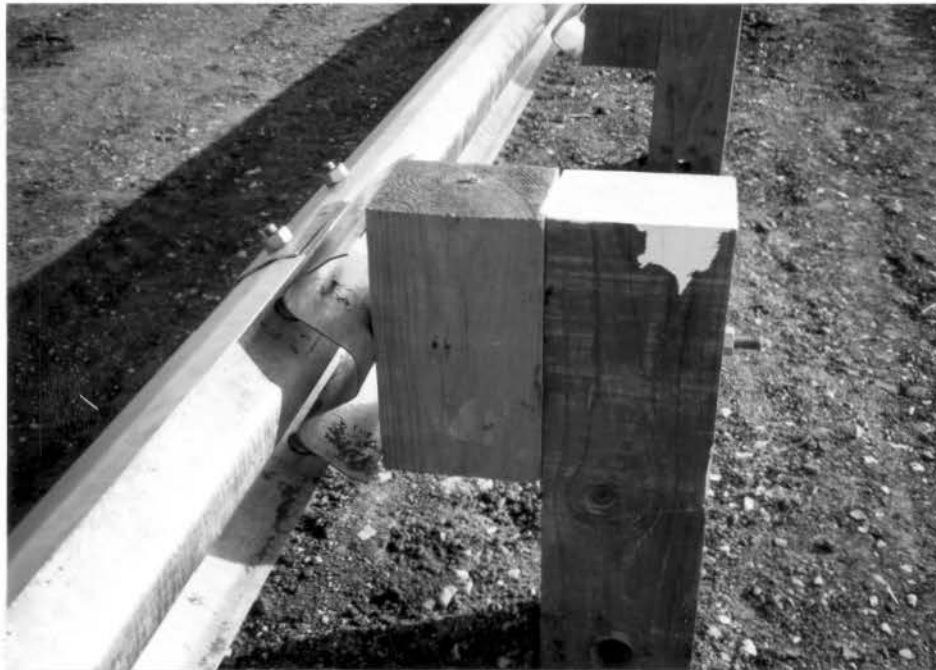
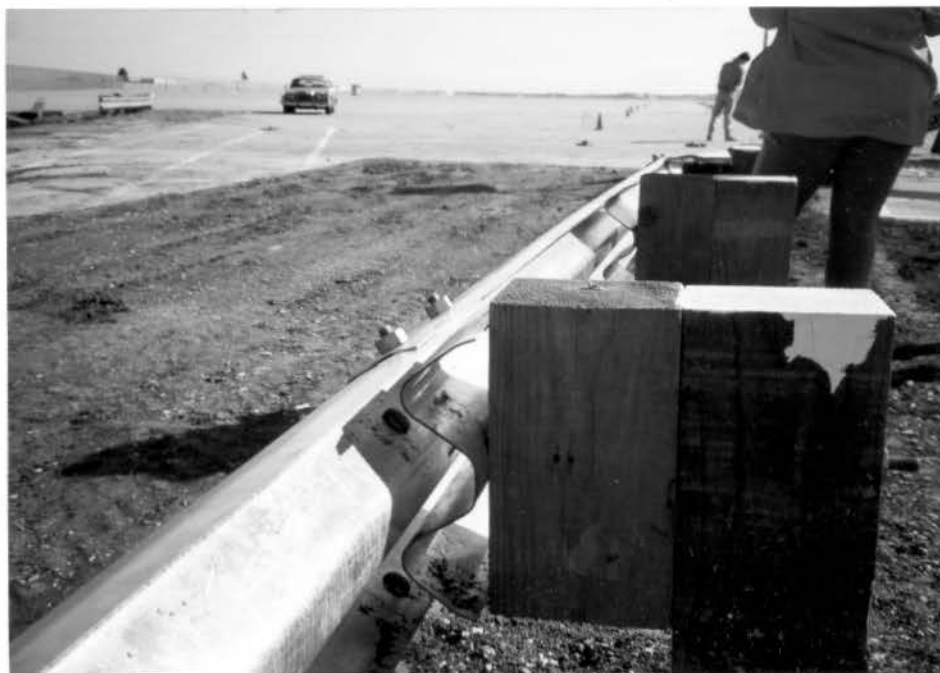
**FIGURE 22.** Shear Bolt Failure at Post No. 3, Test NETD-1

Third, the release mechanism did not activate properly. This may have been due to the insufficient length over which the W-beam was allowed to release from its mounted position. The CRT design incorporated a guardrail release mechanism which extended over the length of twelve posts spaced at 6-ft 3-in. (8,9). This distance was found to be necessary for preventing vehicle uplift when impacted with an 1,800-lb vehicle. To further maintain vehicle stability, drilled holes should be provided in at least the first ten posts with diameters of approximately 3 1/2-in.
