SAFETY PERFORMANCE EVALUATION OF THE STEEL-BACKED LOG RAIL

Midwest Roadside Safety Facility
Civil Engineering Department
University of Nebraska-Lincoln
1901 "Y" St.
P.O. Box 880601
Lincoln, Nebraska 68588-0601
(402) 472-6864

Federal Highway Administration Eastern Federal Lands Highway Division 21400 Ridgetop Circle Sterling, Virginia 22170

Transportation Research Report No. TRP-03-35-92

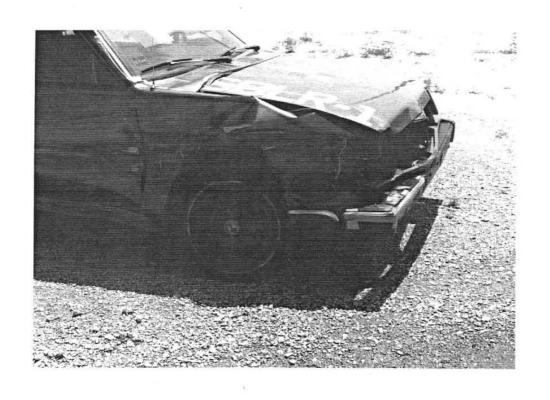
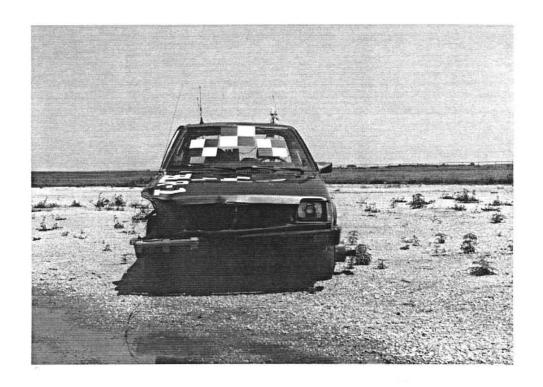
FIGURE 16. Vehicle Damage, Test SBLR-1

Test vehicle damage was relatively minor and was largely limited to the right-front quarter panel and passenger door, as shown in Figure 16. There was no intrusion or deformation of the occupant compartment. Vehicle crush measurements are shown in Figure 17.

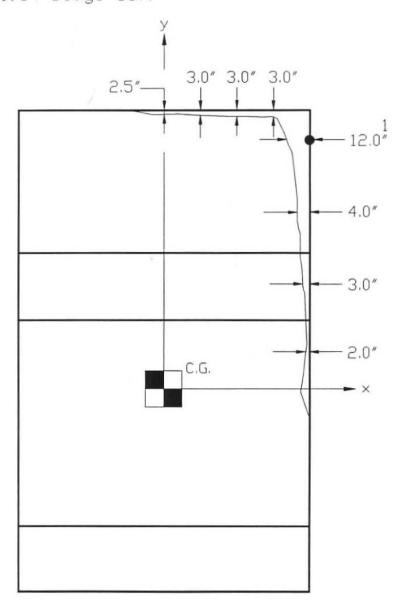
FIGURE 17. Vehicle Crush Measurements, Test SBLR-1

$^{^1-\}mbox{Maximum}$ static crush distance of 12" occurred at (24",54") marked by the point.

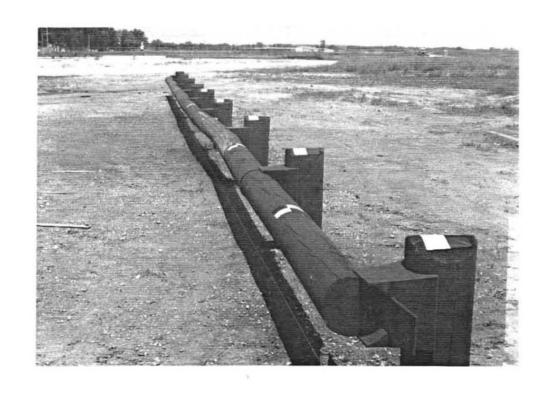
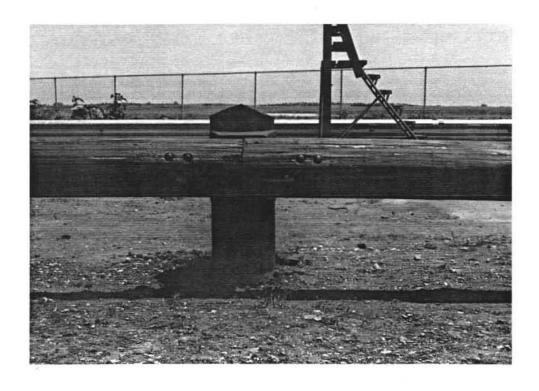
FIGURE 18. Log Rail Damage, Test SBLR-1

Damage to the Log Rail consisted of minor scrapes on the surface of the rail and a maximum permanent deflection of 2 15/16 in. at the first post after impact. This damage can be seen in Figure 18. The effective coefficient of friction was found to be 1.02 and would be classified as "marginal" according to the AASHTO Guide Specifications for Bridge Railings (5).

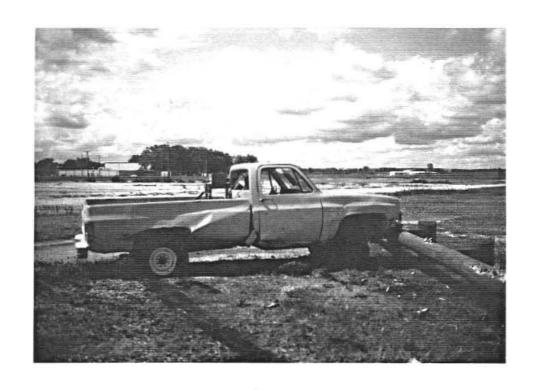
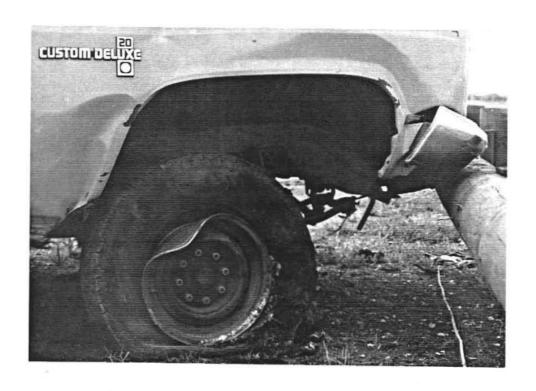
FIGURE 24. Vehicle Damage, Test SBLR-2

Test vehicle damage, shown in Figure 24, was limited to the undercarriage on the rightfront corner and along the right side. Vehicle crush measurements are shown in Figure 25. The vehicle remained upright both during and after the test, and there was no intrusion of the occupant compartment.

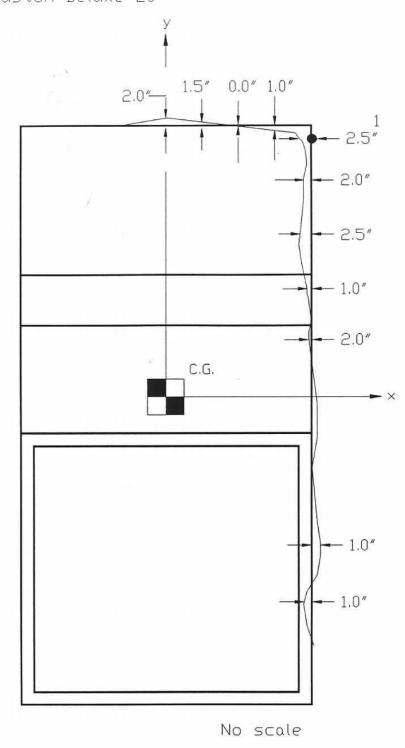
FIGURE 25. Vehicle Crush Measurements, Test SBLR-2

$^{1}\mathrm{-Maximum}$ static crush distance of 2.5" occurred at (36",96") marked by the point.

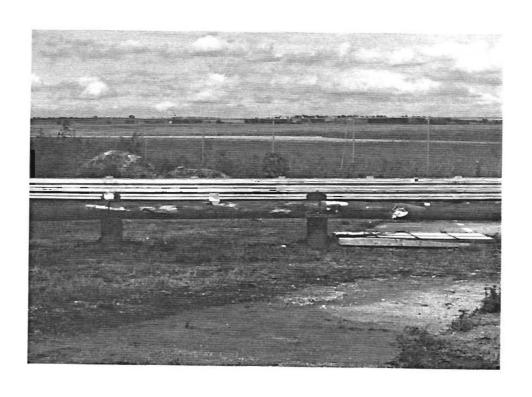
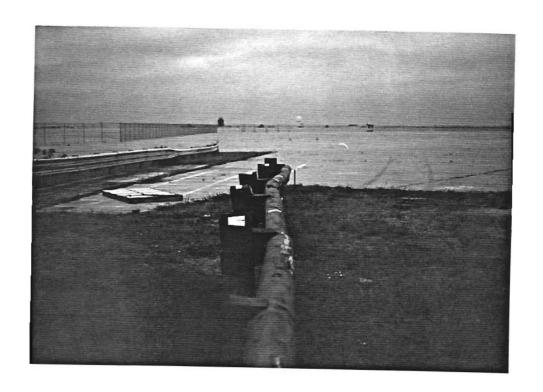
FIGURE 26. Log Rail Damage, Test SBLR-2

Damage to the log rail consisted of scrapes and gouges along the traffic face and at some of the posts. A maximum permanent deflection of 9 ½ in. was measured at Post No. 3. The damaged barrier is shown in Figure 26.
