# Safety Performance Evaluation of the George Washington Memorial Parkway Bridge Rail

Transportation Research Report TRP-03-45-94

**FHWA Contract No. DTFH71-90-C-00035**

June, 1995

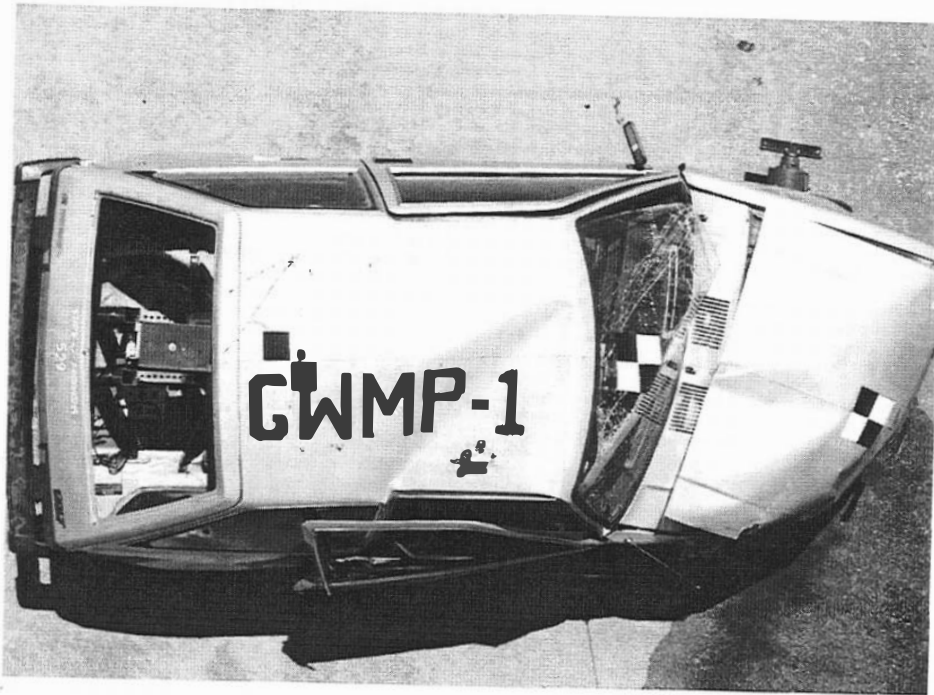
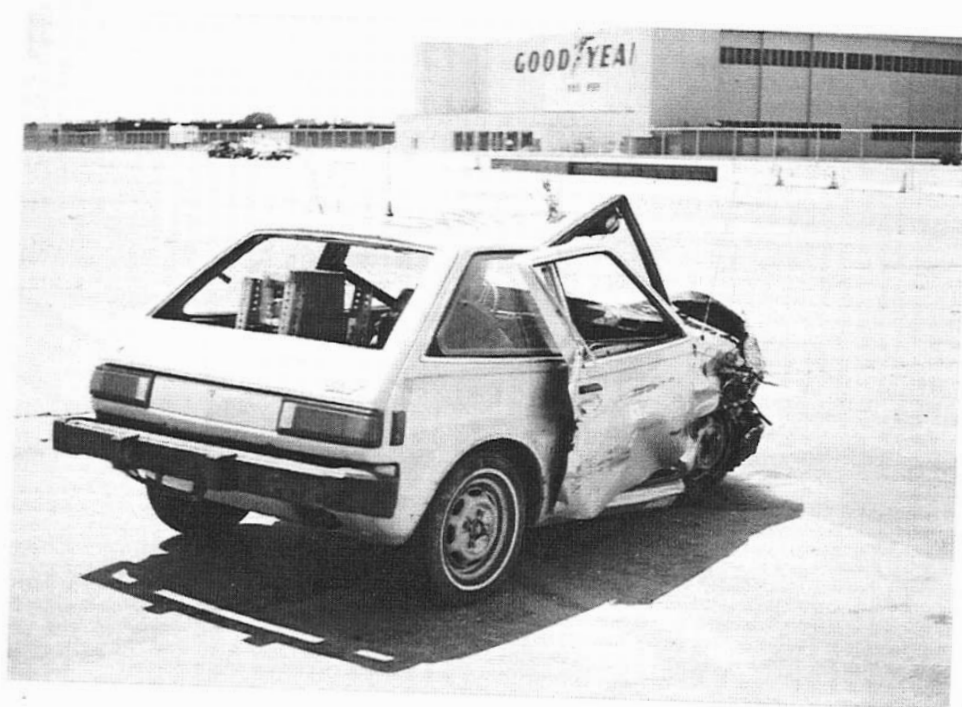
Figure 17. Vehicle Damage, Test GWMP-1.

The vehicle damage, shown in Figures 17 and 18, included the crushing of the right front corner of the vehicle, twisting of the car to the right of its longitudinal centerline, buckling of the hood, roof, windshield frame, firewall, passenger compartment floor and the passenger side door. The front right tire was deflated and the rim was deformed. The maximum crush deformation of 21

As is evident in the vehicle damage shown in Figures 17 and 18, there was significant occupant compartment damage in the test vehicle. This damage was caused by the snagging of the vehicle on the system posts and, along with the excessive lateral ridedown decelerations, caused the system to fail this compliance test. In order to alleviate this snagging problem, the rail size was increased from 4.5 in. O.D. to 5.0 in. O.D. (114 mm to 127 mm), and it was moved further out from the post. The details of this change can be seen in Figures 3 and 4.

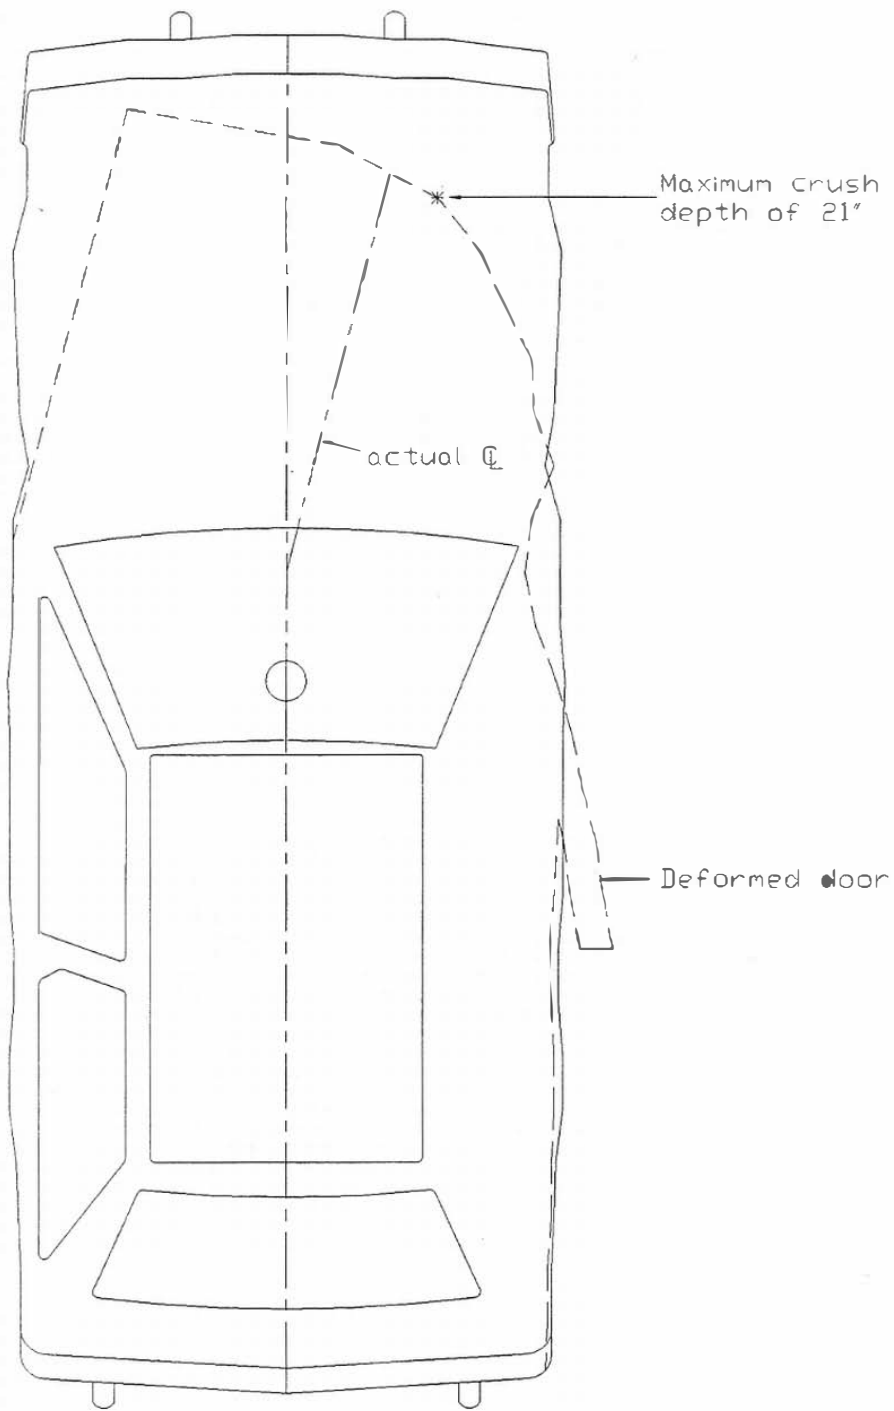
Figure 19. Vehicle Crush Measurements, Test GWMP-1.

in. (53.3 cm) is shown in Figure 19.

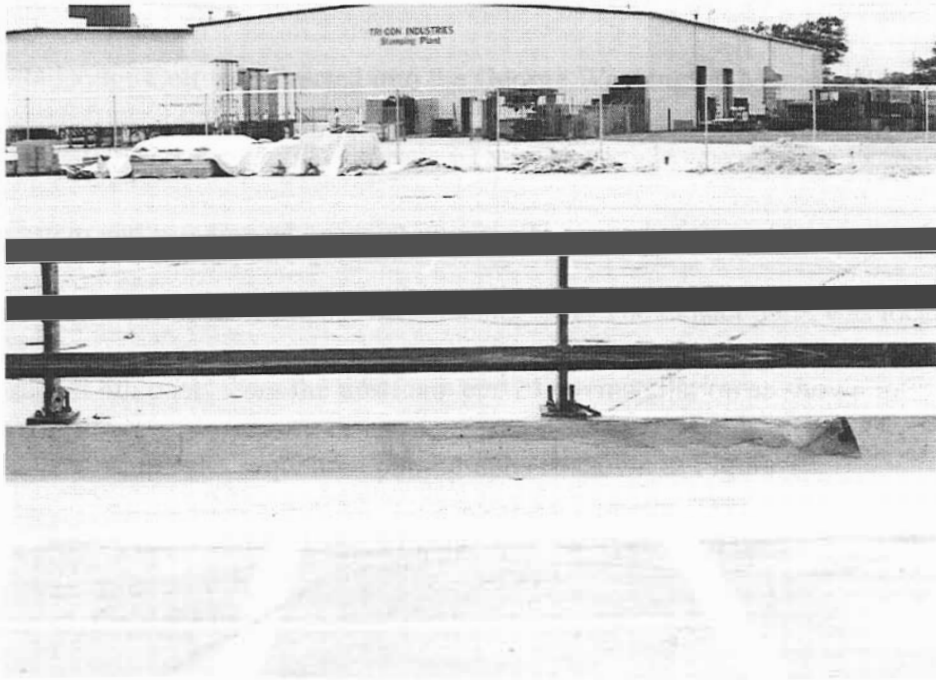
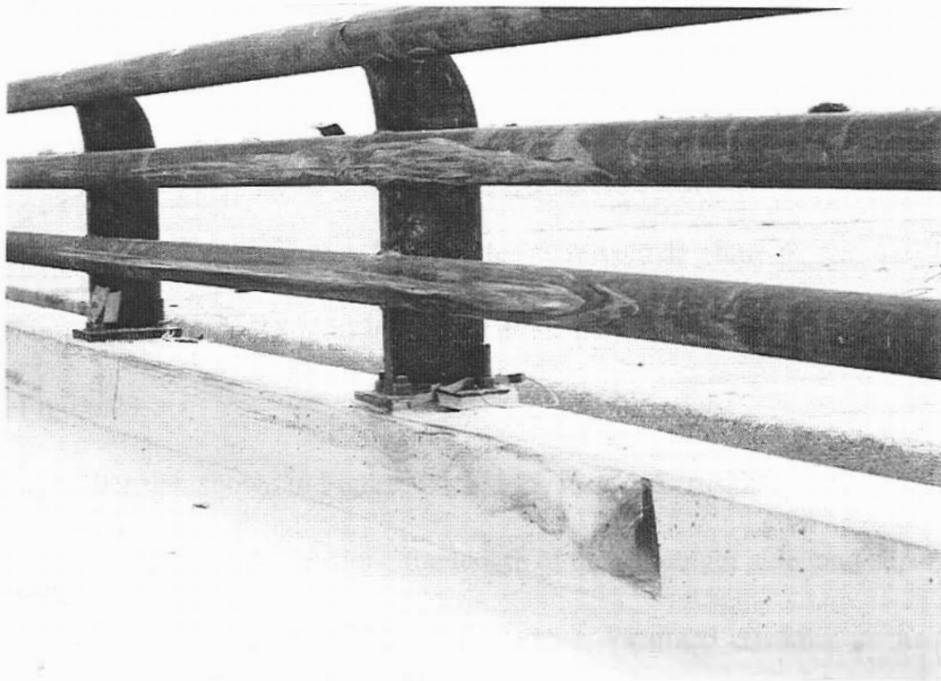
Figure 20. Bridge Rail Damage, Test GWMP-1.

The damage to the bridge rail was minor, with superficial scrapes on the curb, rail and posts as shown in Figure 20. There was no permanent set deflection in the bridge rail. The contact marks on the curb started at impact, 4 ft. - 5 in. (1.35 m) before post 4, and continued for 11 ft. - 8 in. (3.56 m). Contact with the lower rail began 4 ft. - 0 in. (1.2 m) before post 4 and continued for 19 ft. - 6 in. (5.94 m), and contact with the middle rail began 3 ft. - 8 in. (1.12 m) before post 4 and continued for 17 ft. - 0 in. (5.18 m).

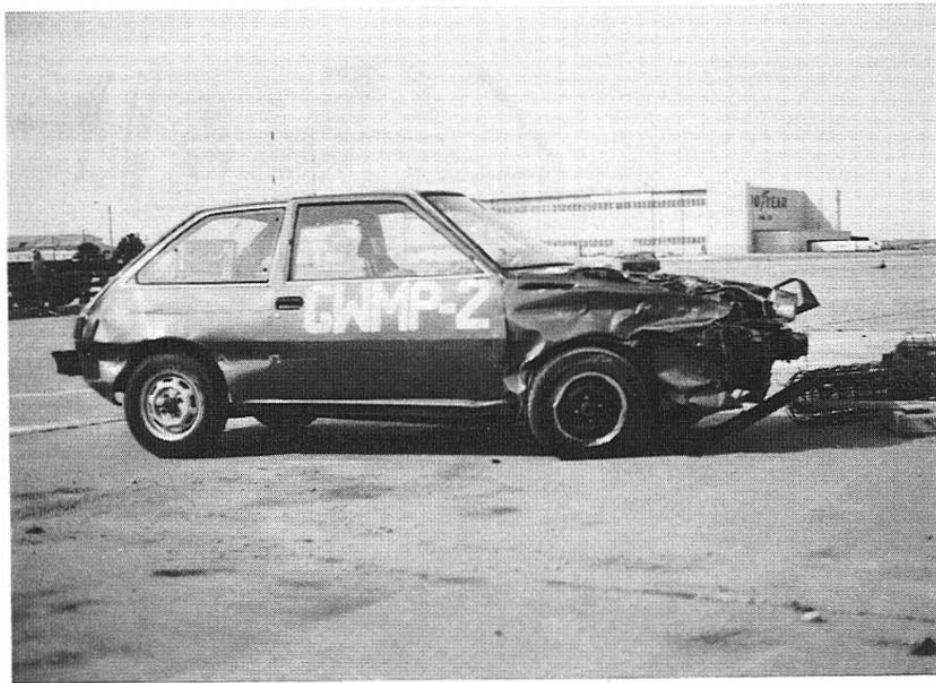
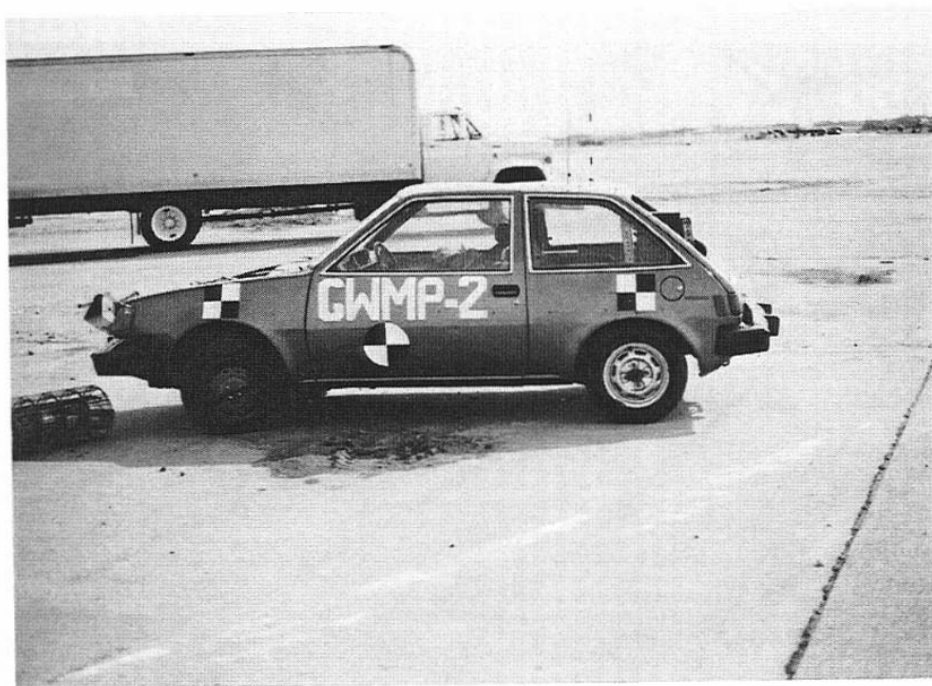
Figure 24. Vehicle Damage, Test GWMP-2.

The vehicle damage, shown in Figures 24 and 25, included crushing of the front right corner of the vehicle, minor scrapes and dents along the length of the passenger side, and separation of the hood. The windshield was not penetrated but did sustain localized cracking in the lower right corner. The front right tire was blown out and the rim was bent outward at the top. The occupant compartment floor sustained minor buckling in the front passenger side floor area. The maximum

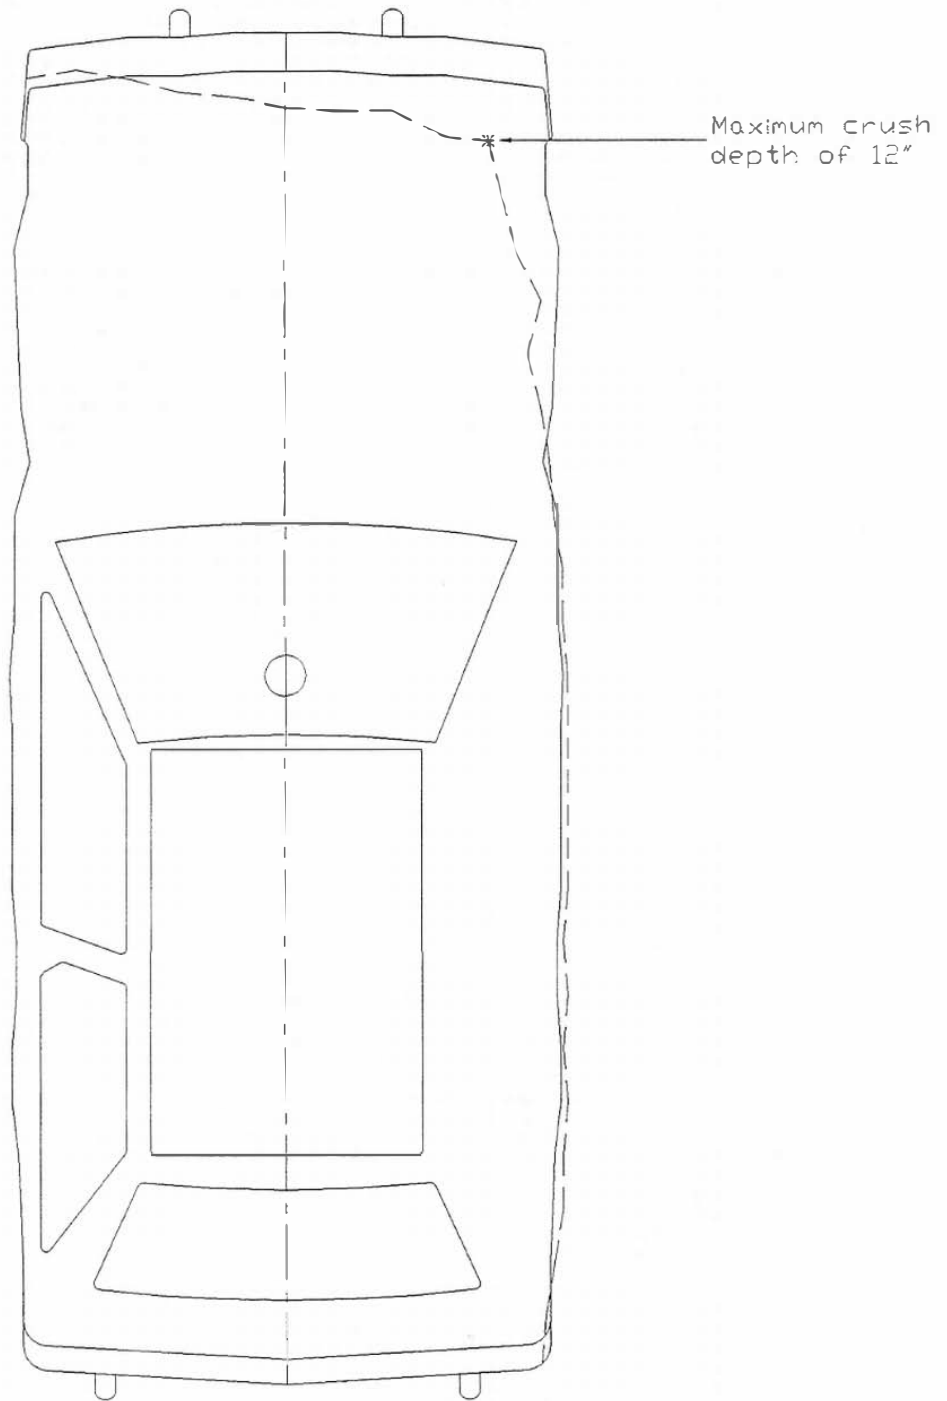
**Figure 26.** Vehicle Crush Measurements, Test GWMP-2.

crush deformation of 12 in. (30.5 cm) is shown in Figure 26.

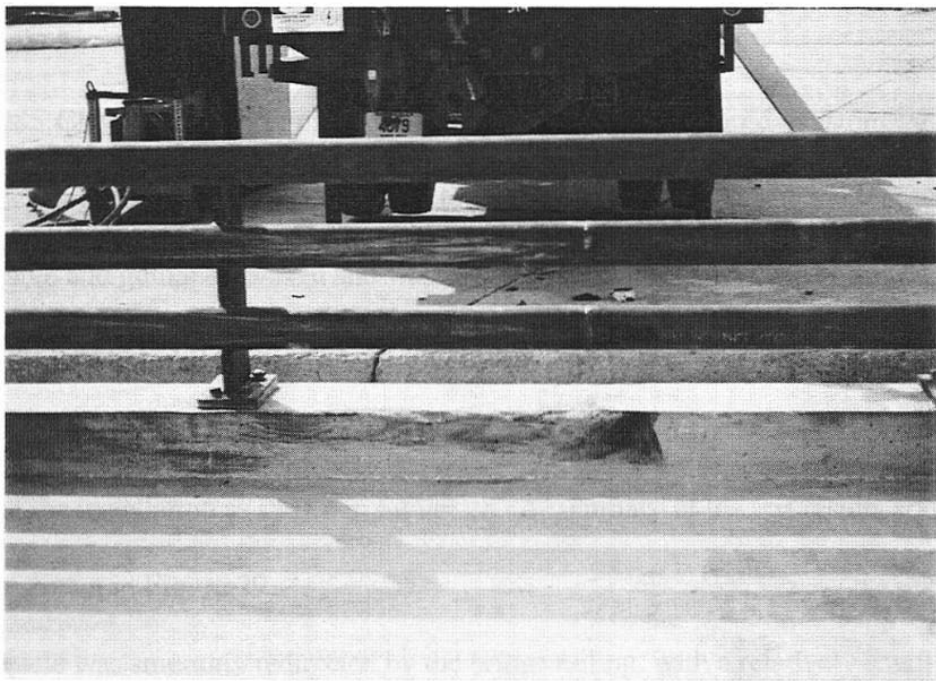
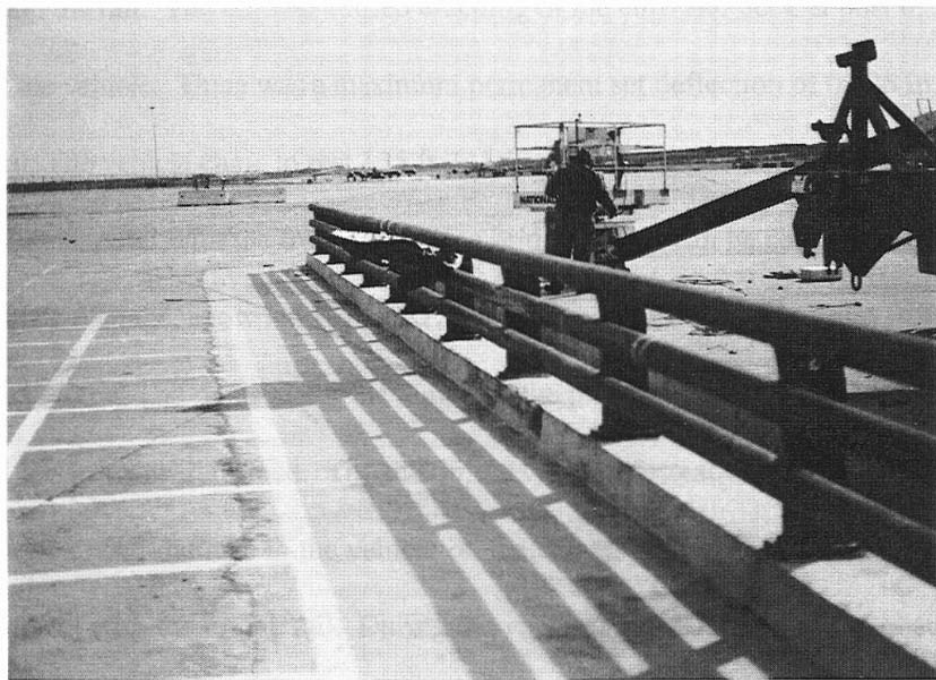
**Figure 27.** Bridge Rail Damage, Test GWMP-2.

As shown in Figure 27, the bridge rail and curb sustained minor scrapes in the area which the impact occurred. Contact with the middle and lower rail began at the midspan between posts 4 and 5, and continued to the midspan between posts 3 and 4.

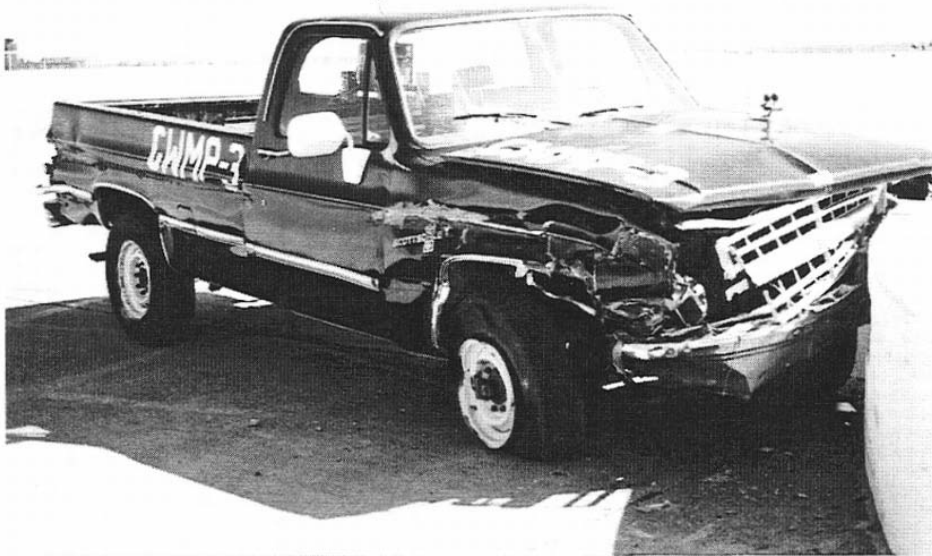
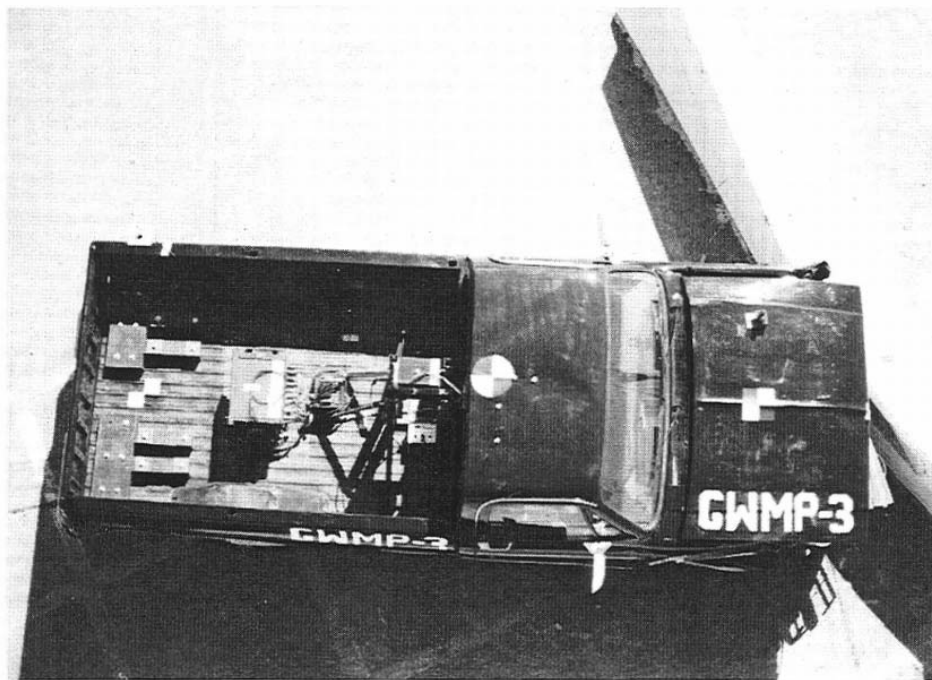
Figure 31. Vehicle Damage, Test GWMP-3..

The vehicle damage, shown in Figure 31, included the crushing of the right front corner of the vehicle, and scrapes and dents along the length of the passenger side. The right front tire was blown out and the rim was deformed. The maximum crush deformation of 9.75 in. (24.8 cm) is shown in Figure 32. All damage to the vehicle on the drivers side of the longitudinal centerline occurred after impact with the bridge rail. During the vehicle's run out, it struck an obstacle on the testing grounds, which resulted in damage to the left front corner of the vehicle..

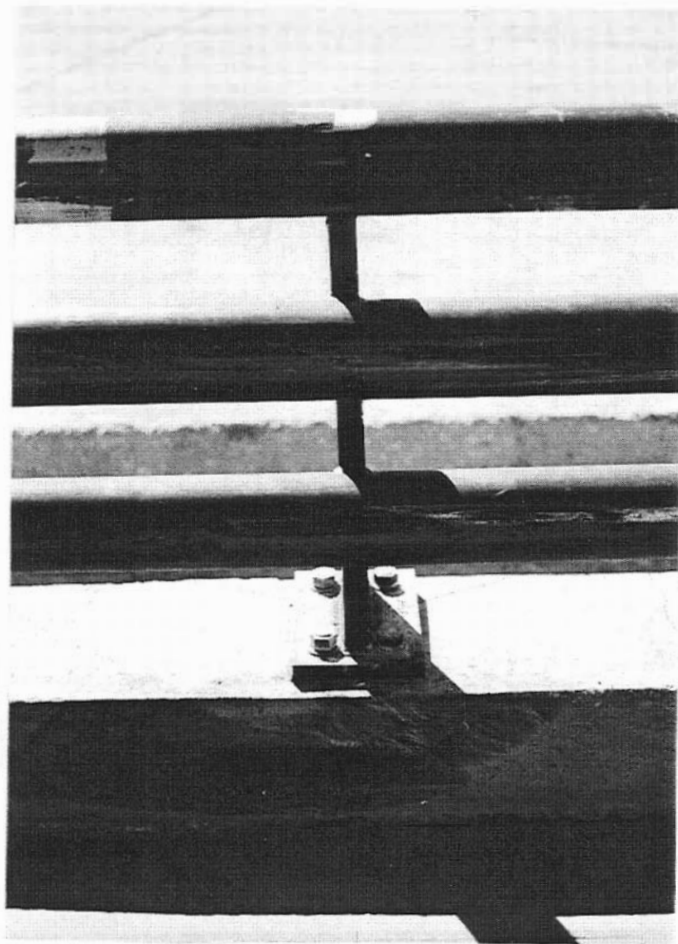
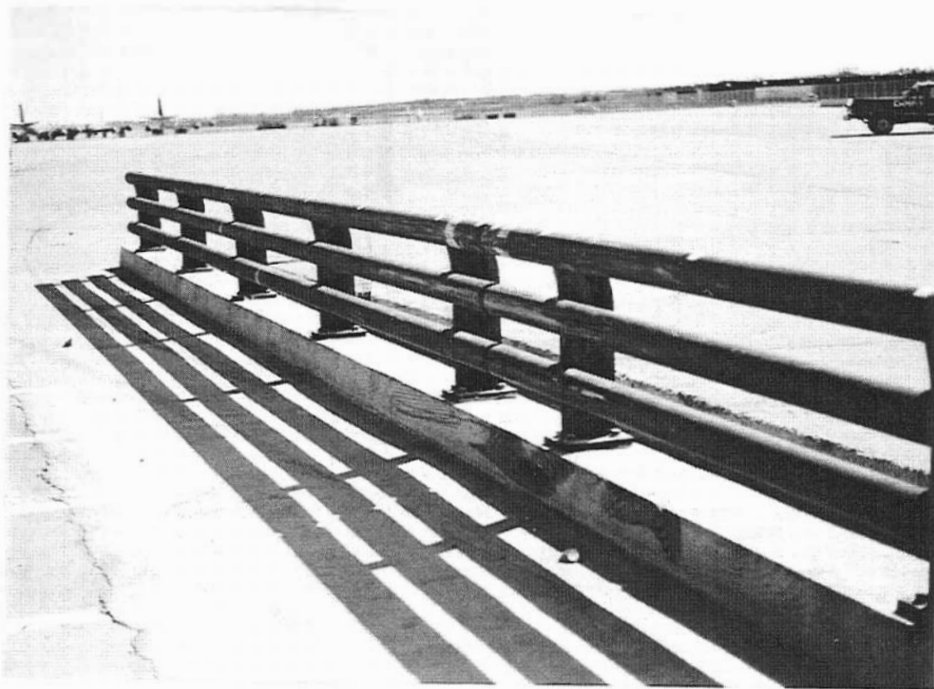
Figure 33. Bridge Rail Damage. Test GWMP-3.

The bridge rail sustained only minor cosmetic damage on each of the three rails as shown in Figure 33. Contact with each of the rails began 3 ft. - 5 in. (1.04 m) upstream of the expansion joint.

The vehicle remained in contact with the rail for 8 ft. - 0 in. (2.44 m) on the bottom rail, 8 ft. - 6 in. (2.59 m) on the middle rail, and 8 ft. - 2 in. (2.49 m) on the top rail.

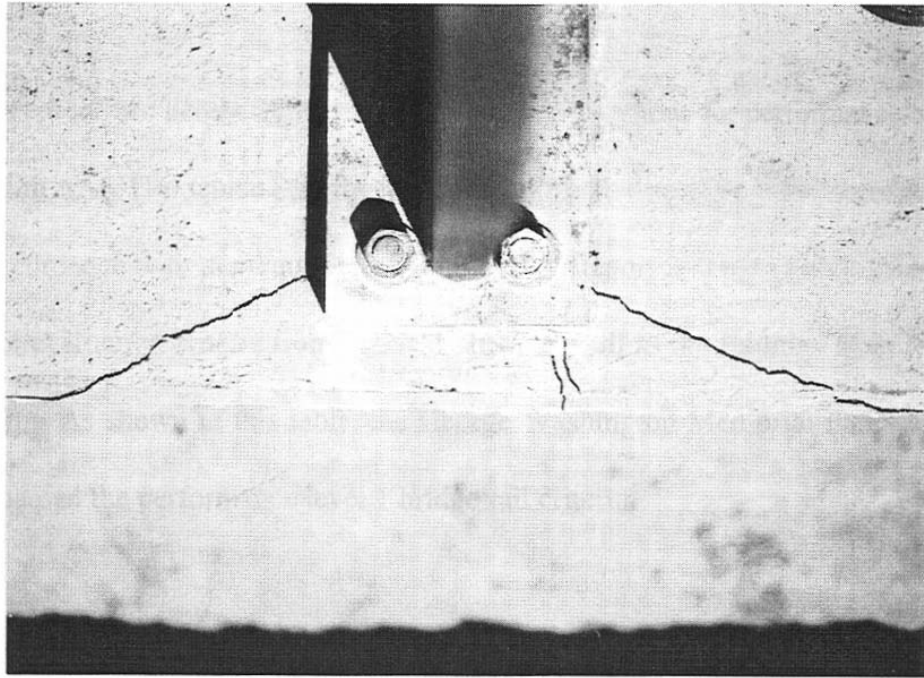
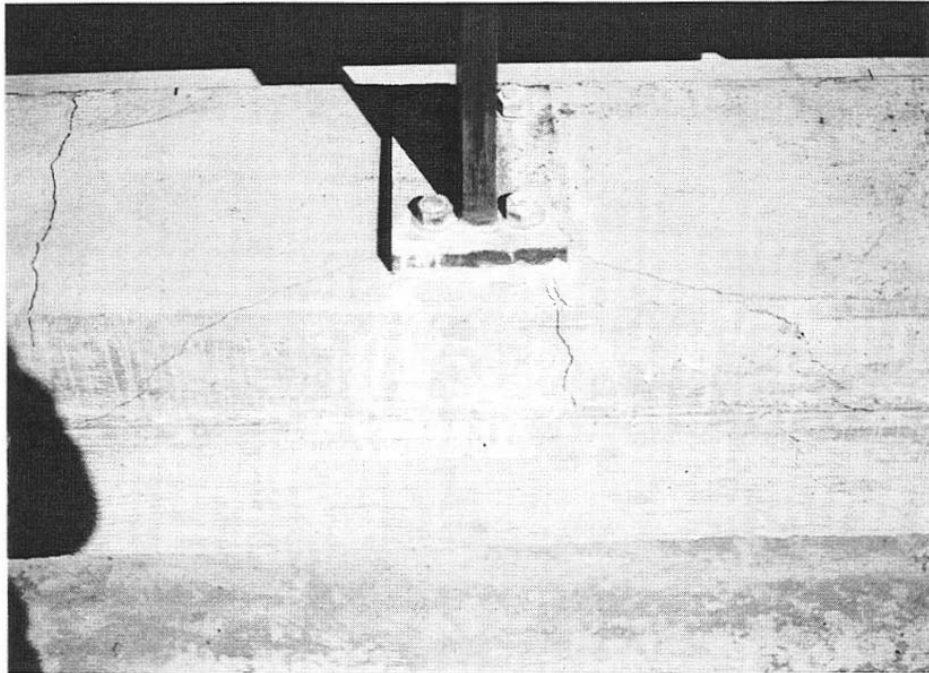
**Figure 34.** Curb Damage, Test GWMP-3.

Cracking occurred in the curb and bridge deck at post number 6. On top of the curb, two cracks propagated outward from each of the rear post bolts, as shown in Figure 34. The length of cracks upstream and downstream of post 6 were 10 in. (25.4 cm) and 11 in. (27.9 cm) respectively.
