Determination of the Maximum MGS Mounting Height -- Phase I Crash Testing

*Midwest States Regional Pooled Fund Research Program
Fiscal Year 2009-2010 (Year 20)
Research Project Number TPF-5(193)
NDOR Sponsoring Agency Code RFPF-10-MGS*

DETERMINATION OF THE MAXIMUM MGS MOUNTING HEIGHT – PHASE I CRASH TESTING

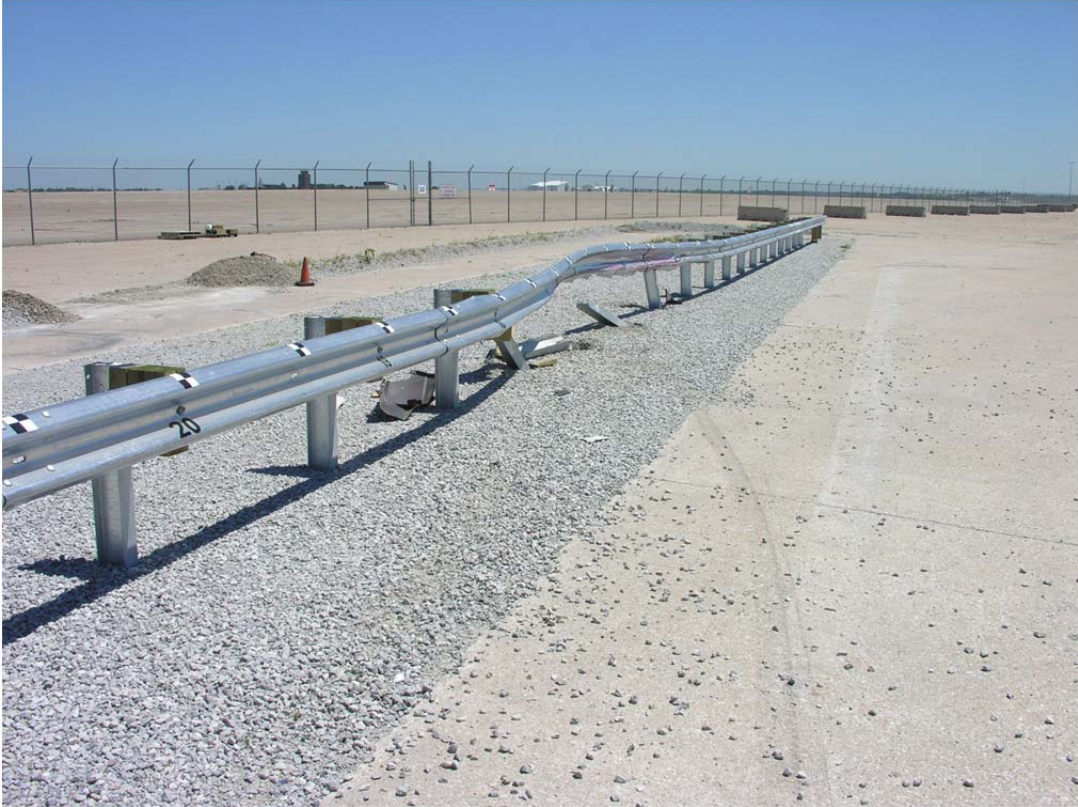
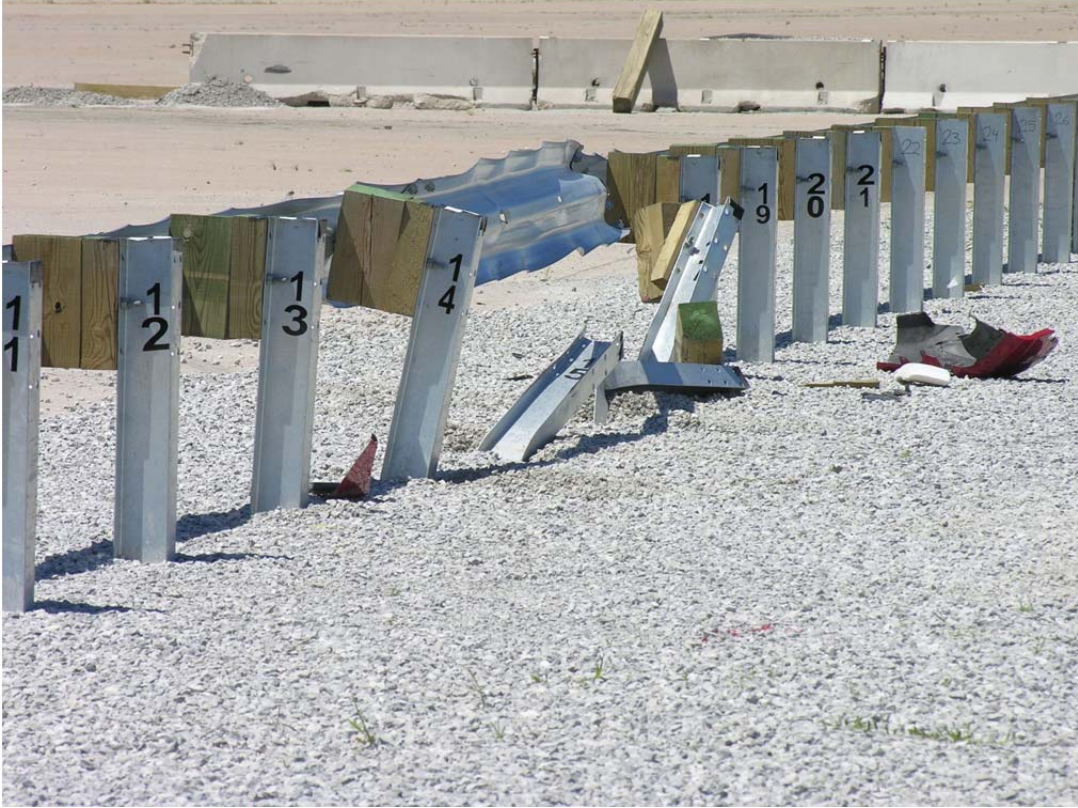
Figure 35. Vehicle Final Position and Trajectory Marks, Test No. MGSMRH-1

Initial vehicle impact was to occur 10 ft (3.0 m) upstream of the centerline of post no. 15, as shown in Figure 34, which was selected using the critical impact point (CIP) plots found in Section 2.3 of MASH. The actual point of impact was 10 ft – 1 in. (3.1 m) upstream from the centerline of post no. 15. A sequential description of the impact events is contained in Table 6. The vehicle came to rest facing downstream, located 190 ft – 5 in. (58.0 m) downstream from impact and 5 ft – 11¼ in. (1.8 m) laterally behind the front face of the guardrail. The vehicle trajectory and final position are shown in Figures 29 and 35.

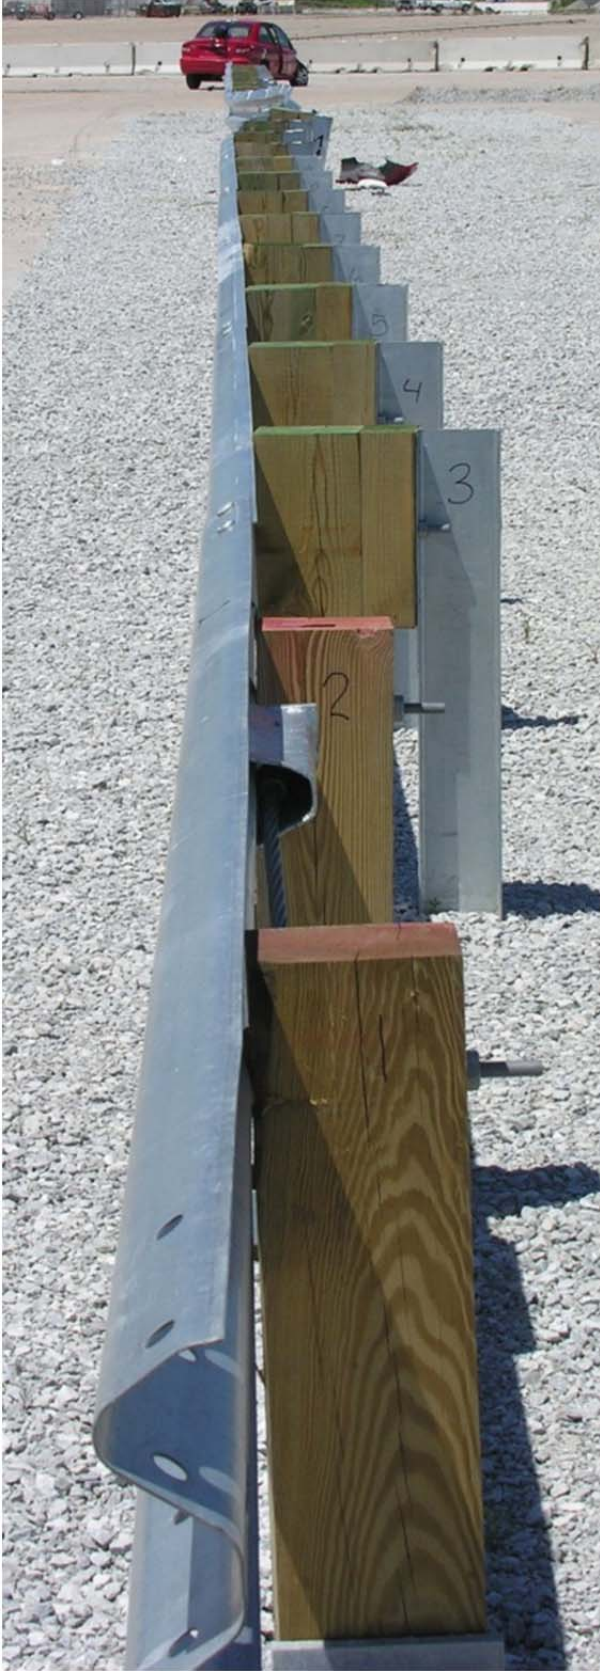
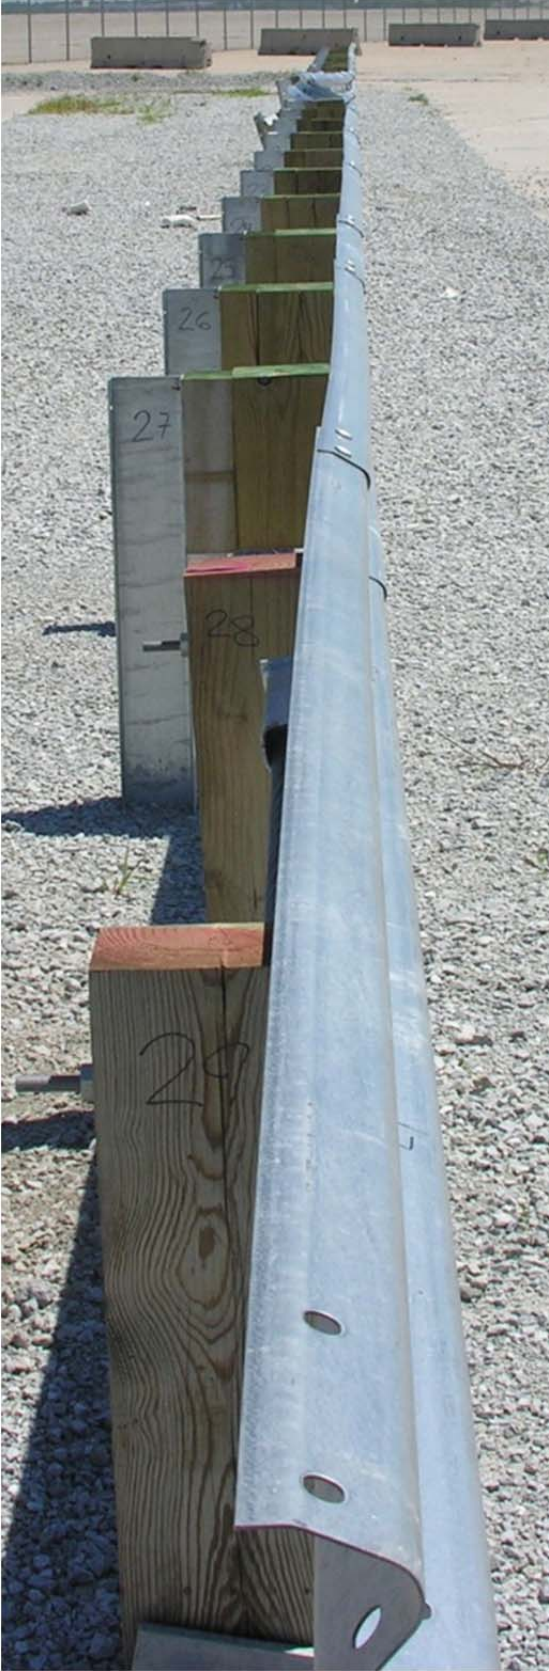
Figure 36. System Damage, Test No. MGSMRH-1

Damage to the barrier was moderate, as shown in Figures 36 through 45. Barrier damage consisted of deformed guardrail posts, disengaged wooden blockouts, contact marks on posts and guardrail, and deformed W-beam rail. The length of vehicle contact along the barrier was approximately 25 ft – 10½ in. (7.9 m) which spanned from 10 ft – 1 in. (3.1 m) upstream of the centerline of post no. 15 to 35½ in. (902 mm) upstream of post no. 18.

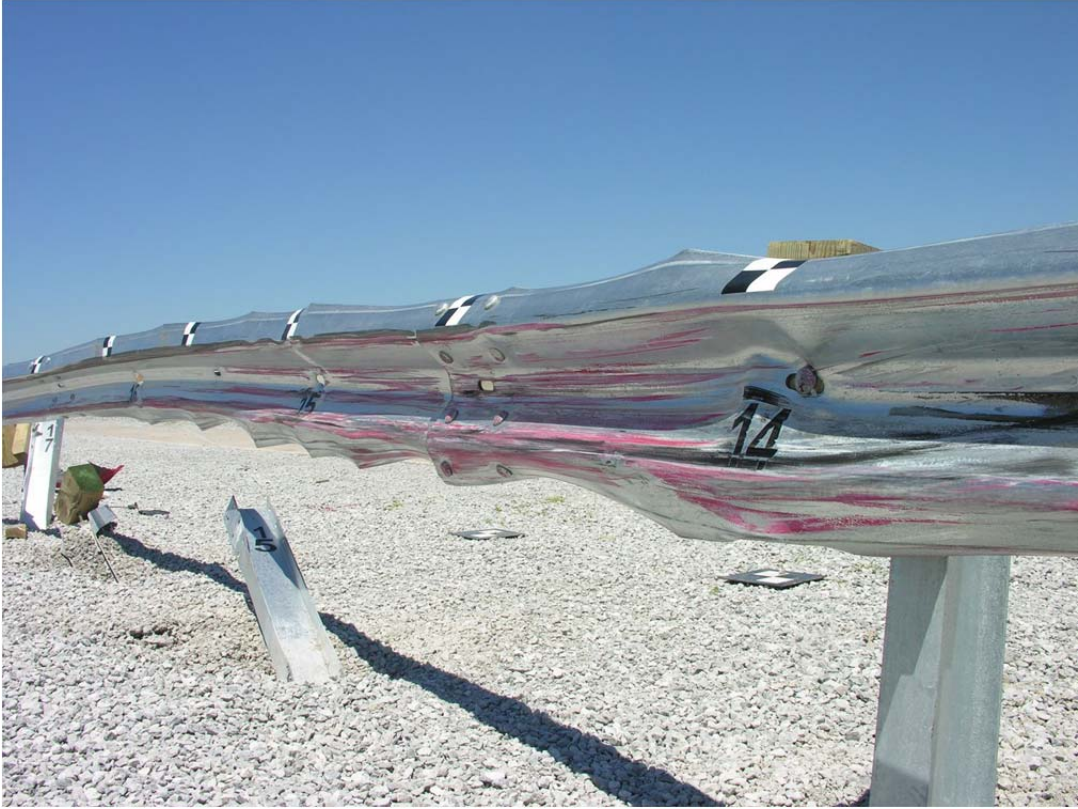
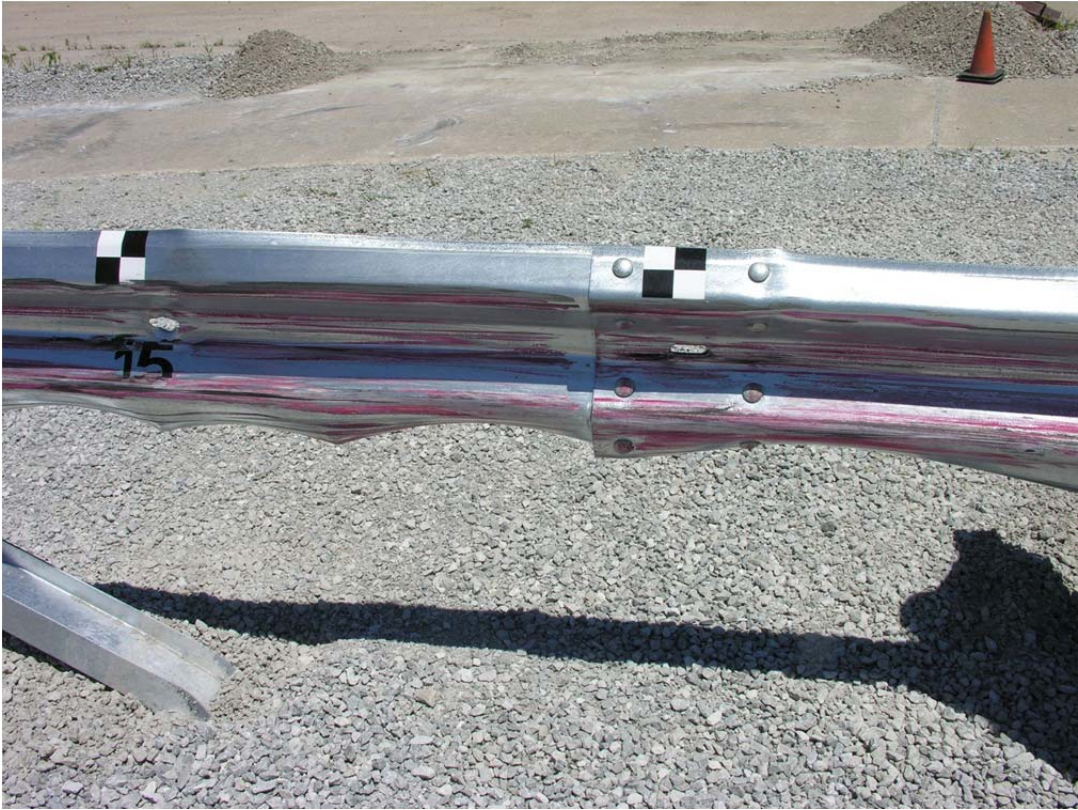
Figure 38. System Damage, Test No. MGSMRH-1

Red paint transfer was found on the rail between the impact location and post no. 18. Minor kinks in the top and bottom corrugations of the rail were found between post nos. 12 and 19, as shown in Figure 38. Flattening and deformation of the rail occurred between post nos. 13 and 18. The bottom corrugation was flattened between post nos. 14 and 16. The bottom edge of the rail was folded upward at post no. 14.

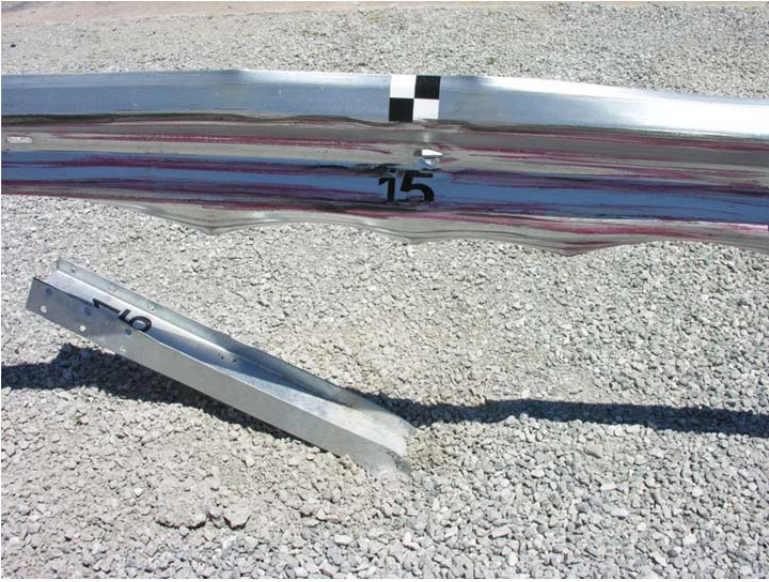
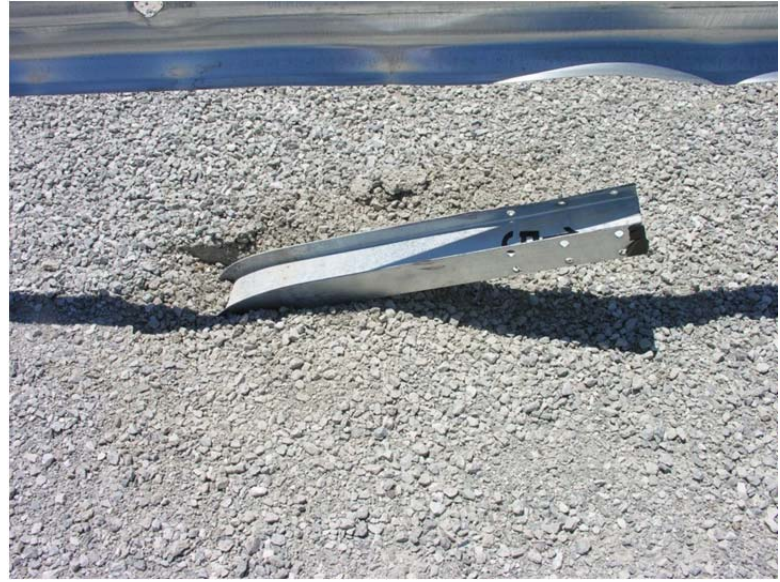
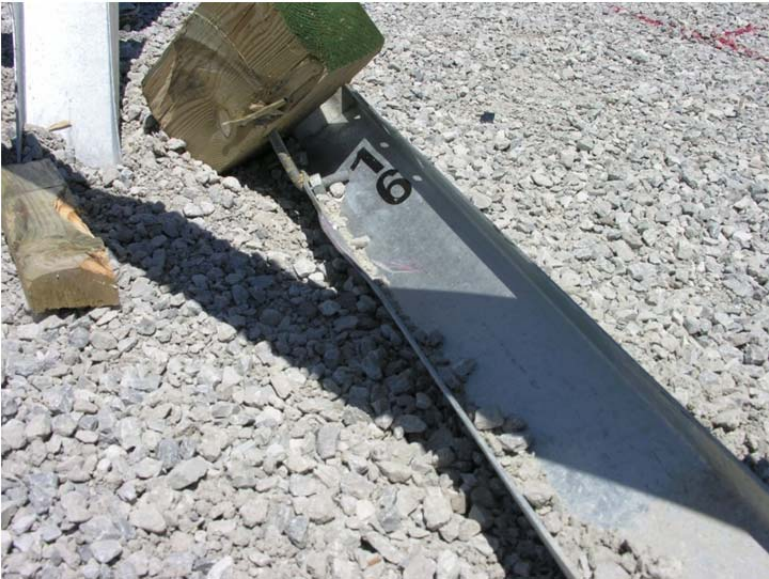
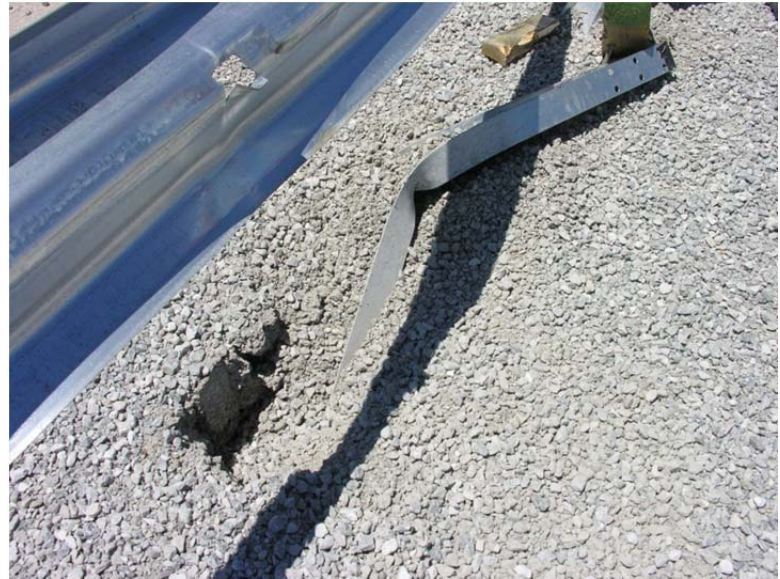
Figure 43. Post Nos. 13 and 14 Damage, Test No. MGSMRH-1

Contact marks were found on the front flange of post no. 14, on the upstream edge of the front flange and on the face of the back flange of post no. 15, on the front flange and the upstream side of the web of post no. 16 as well as on the corresponding blockout, and on both the upstream edge of the front flange on post no. 17 and the corresponding blockout.

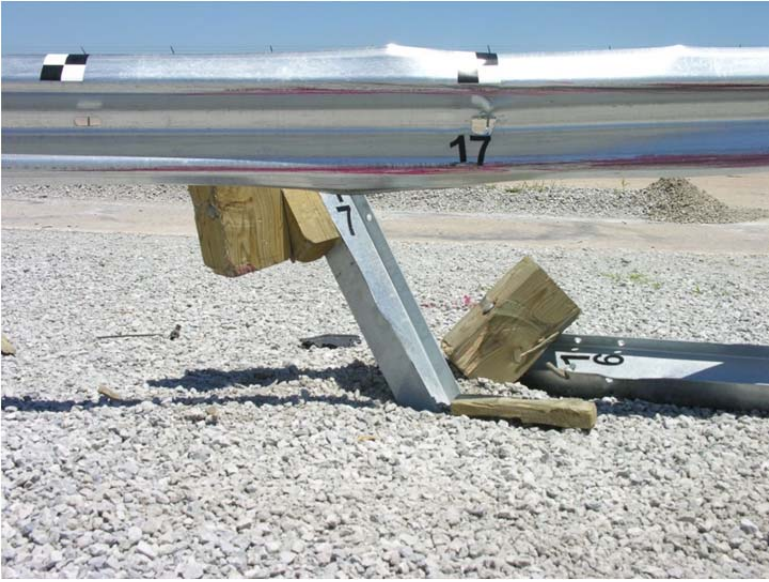
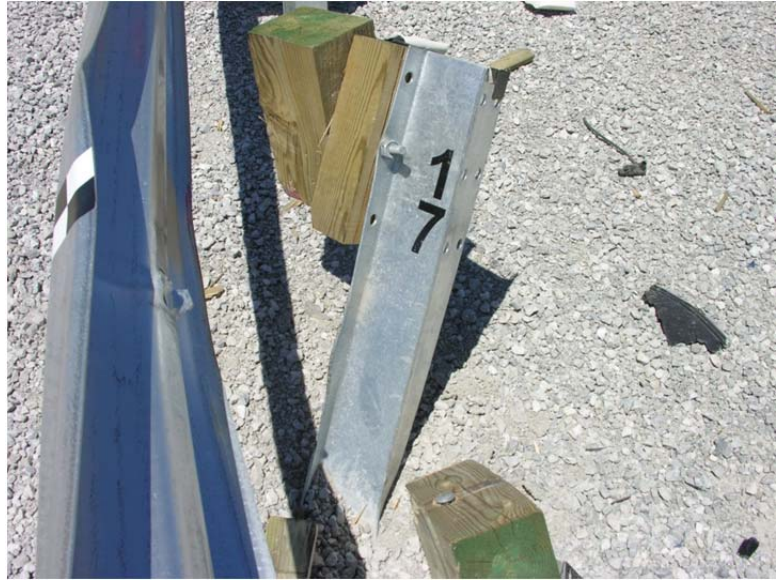
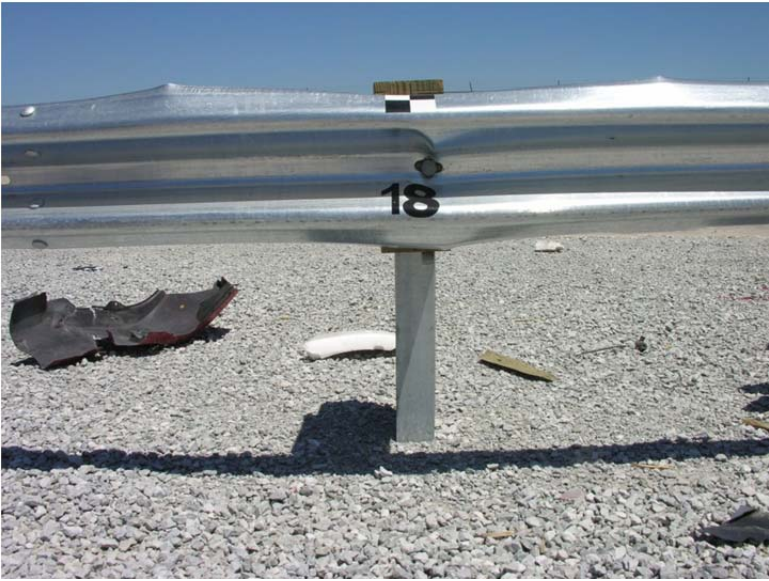
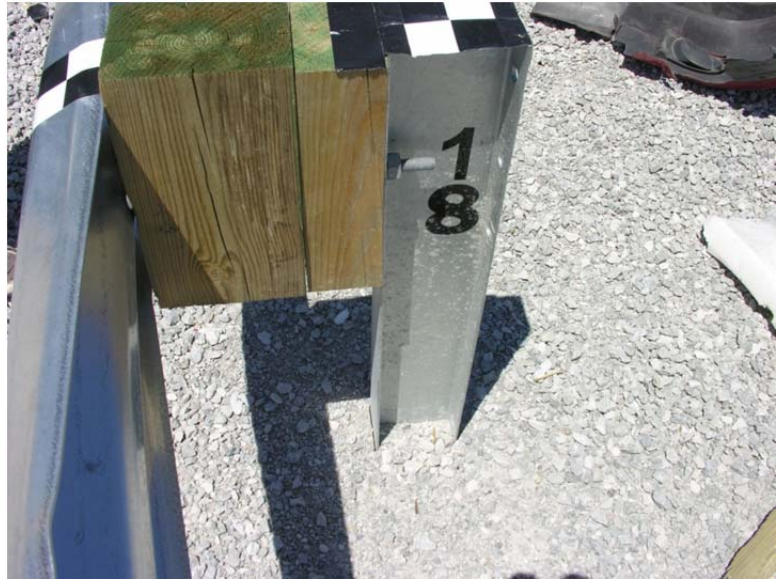
Figure 44. Post Nos. 15 and 16 Damage, Test No. MGSMRH-1

The maximum permanent set rail and post deflections of the barrier system were 18¼ in. (464 mm) at the midspan between post nos. 15 and 16 and 17 in. (432 in.) at post no. 16, respectively, as measured in the field. The maximum lateral dynamic rail and post deflections were 29.0 in. (737 mm) at the midspan between post nos. 15 and 16 and 20.2 in. (513 mm) at post no. 16, respectively, as determined from high-speed video analysis. The working width of the system was found to be 49.4 in. (1,255 mm), also determined from high-speed digital video analysis.

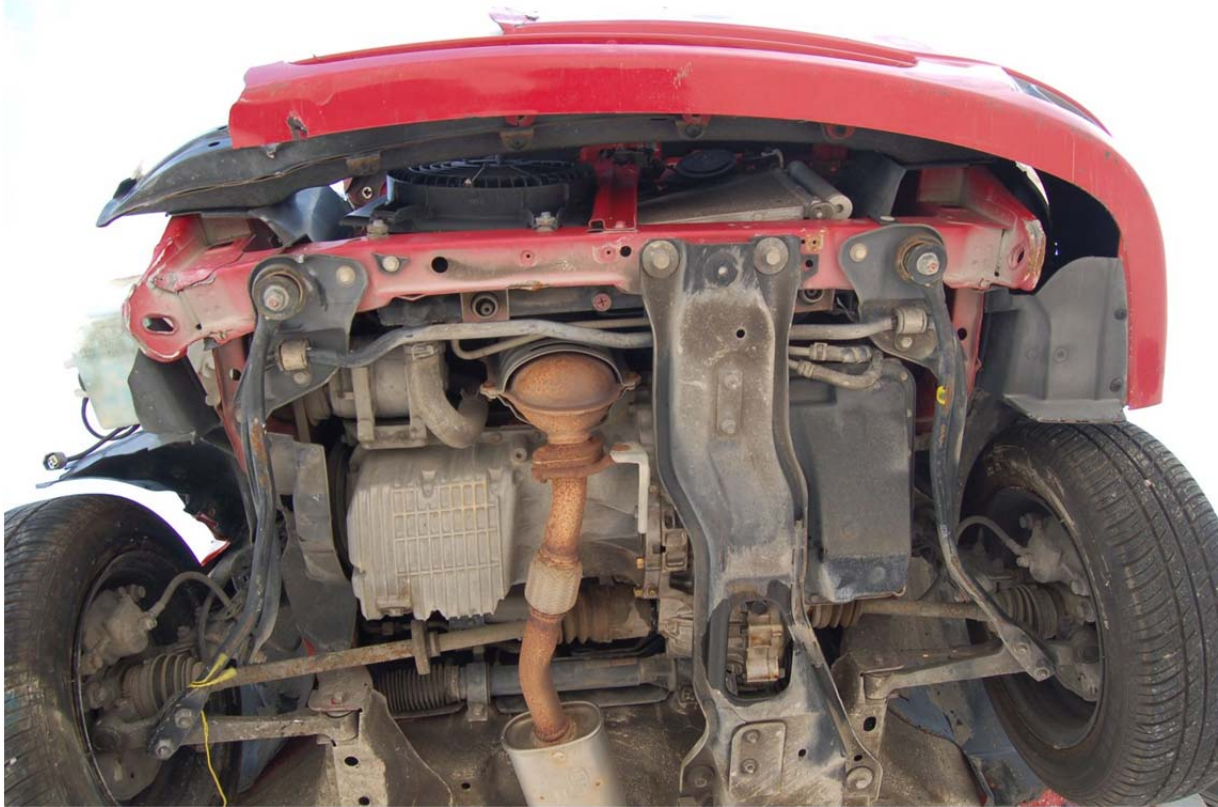
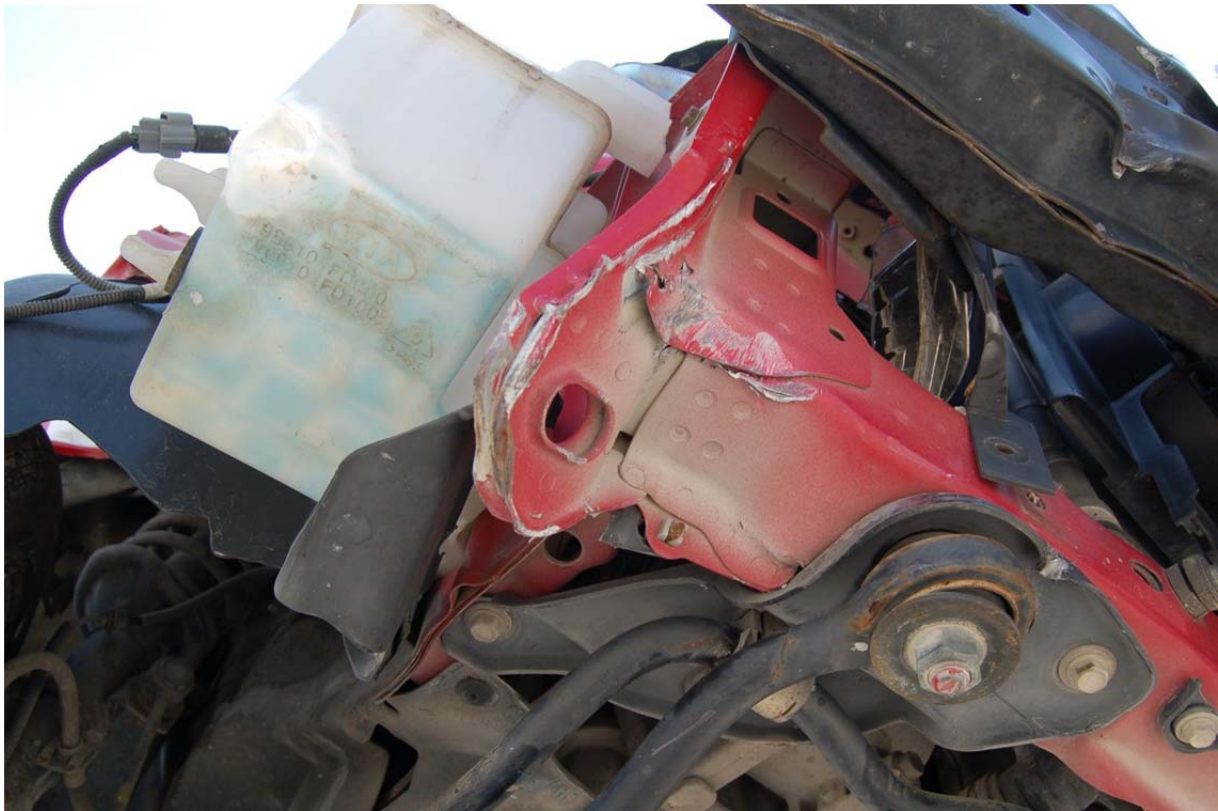
Figure 48. Occupant Compartment Damage, Test No. MGSMRH-1

The damage to the vehicle was moderate, as shown in Figures 46 through 49. The maximum occupant compartment deformations are listed in Table 7 alongside the deformation limits established in MASH for various areas of the occupant compartment. It should be noted that none of the MASH established deformation limits were violated. Complete occupant compartment and vehicle deformations and the corresponding locations are provided in Appendix D.
