Development and Evaluation of Weak-Post W-Beam Guardrail in Mow Strips

Report # MATC-UNL: 206

Final Report
WBS:25-1121-0003-206

16. Abstract <p>The objective of this study was to adapt and evaluate a weak-post, W-beam guardrail system for use within mow strips and other pavements. The weak-post guardrail system was originally designed as the MGS bridge rail and has also been adapted for use on culverts. It was envisioned that the weak-post design would absorb the impact forces and prevent damage to the mow strips, thereby minimizing maintenance and repair costs.</p> <p>Evaluation of the weak posts in mow strips began with three rounds of dynamic bogie testing. Round 1 of bogie testing showed that 4-in. (102-mm) thick concrete would sustain only minor spalling from impacts to the posts. However, the posts would push through 4-in. and 6-in. (102-mm and 152-mm) thick asphalt mow strips. During Round 2, 24-in. (610-mm) long, 4-in. x 4-in. (102-mm x 102-mm) sockets with 10-in. x 9-in (254-mm x 229-mm) shear plates were utilized to better distribute the impact load to the asphalt pavement and prevent damage. However, Round 3 of bogie testing consisted of dual-post impacts, and the asp

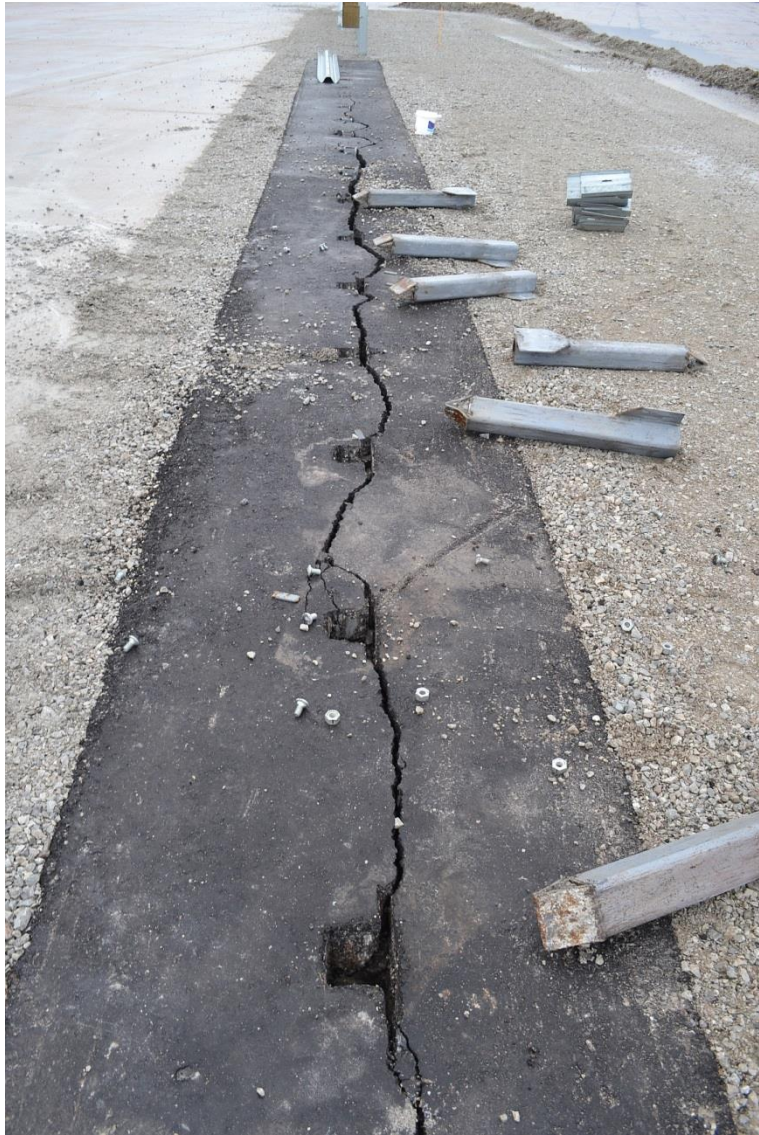
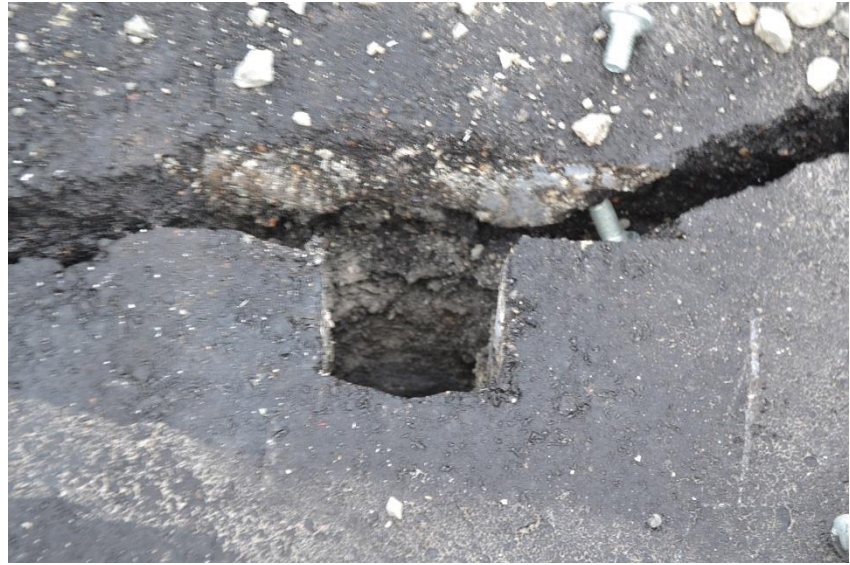
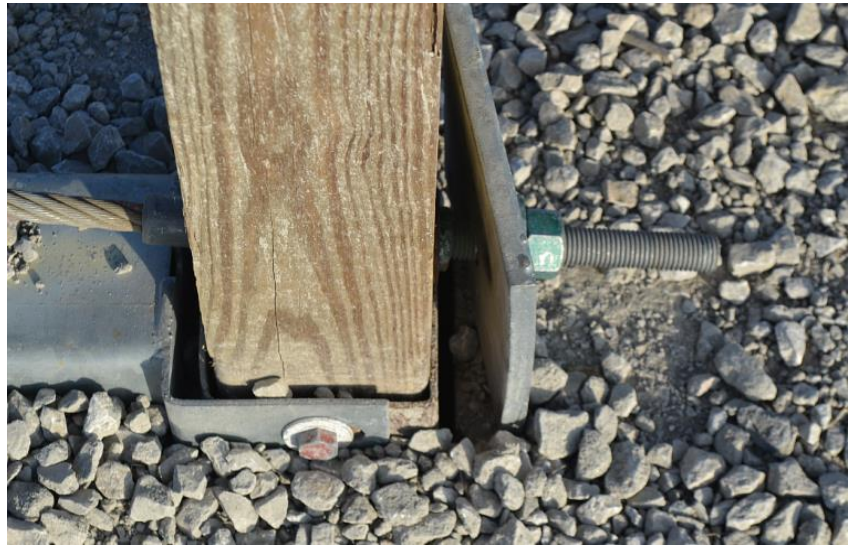
Figure 87. System Damage – Asphalt Fracture and Anchor Movement, Test No. MGSMS-1

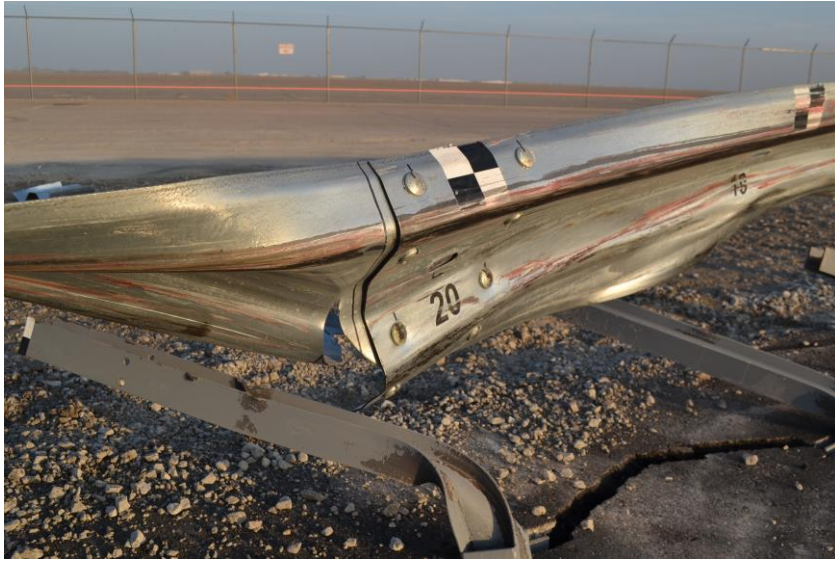
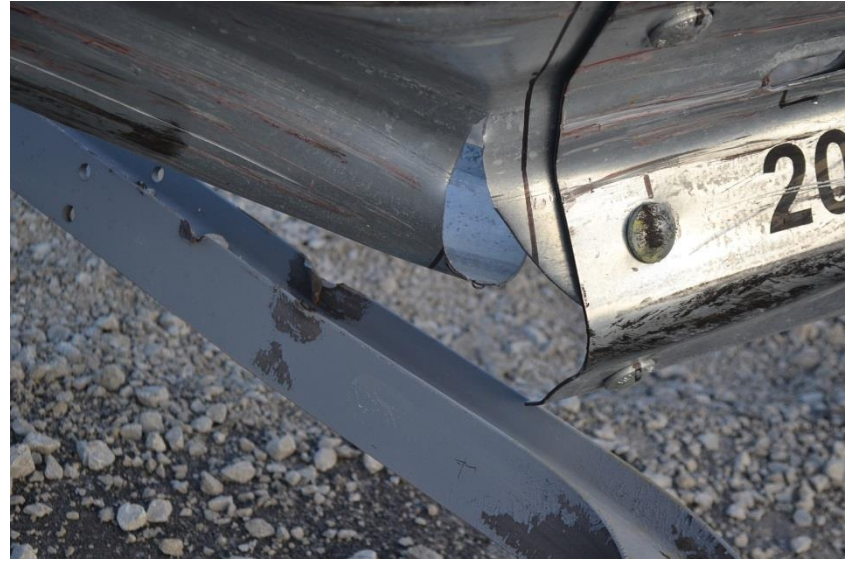
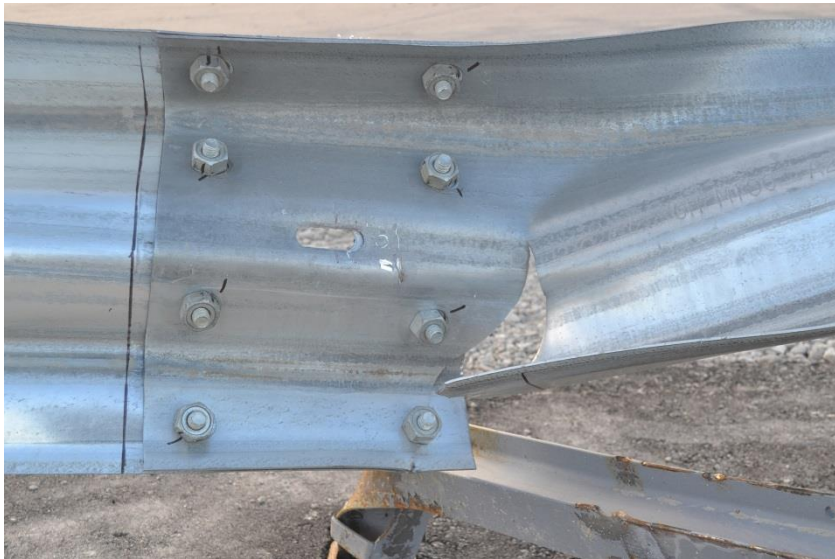
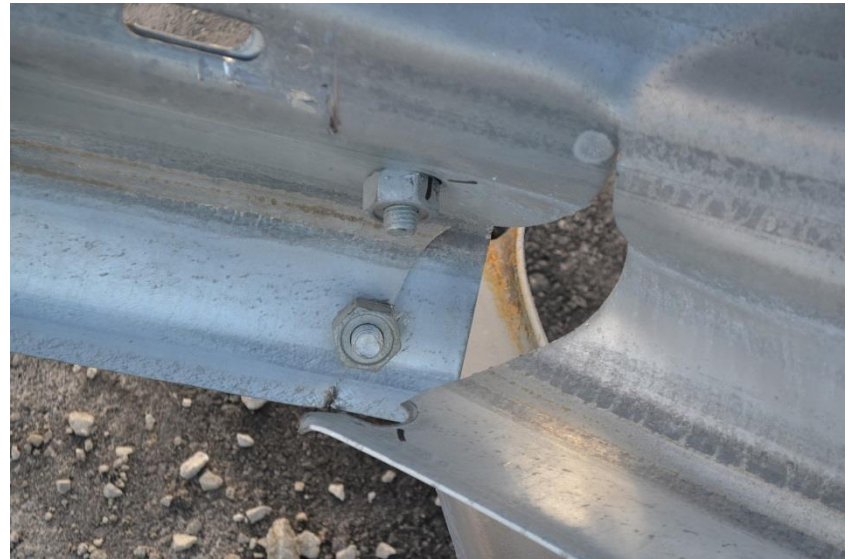
Figure 88. System Damage – Rail Tearing, Test No. MGSMS-1

Since 12-in. (305-mm) long backup plates are unable to be installed at guardrail splices, holes or slots need to be cut into the backup plate to allow the guardrail bolts to pass through the plate. The backup plates could utilize the same splice bolt slot pattern that is currently punched into the ends of every guardrail segment. Utilizing this design, the backup plate could be attached to the guardrail and assembled as a part of the splice. Alternatively, a backup plate could be configured to fit over the back of assembled guardrail splices at the time of mounting the rail to a post. Under these conditions, the slots would need to be enlarged to fit around the splice bolts and nuts. Both of these design options are shown in Figure 92 and should be equally effective in reducing the risk of rail tearing.
