Pavement Quality Indicators Study

Five Year Report

**Construction Management Department
University of Nebraska
Lincoln, NE 68588-0500**

**Researcher: Cody Kluver
Advisor: Wayne Jensen**

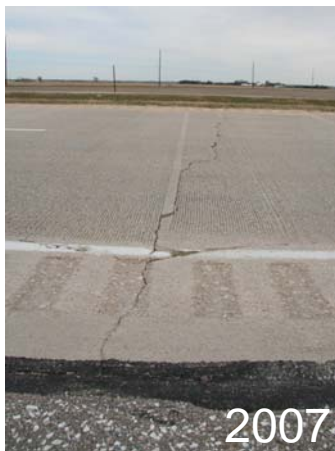
Location: MM 158

- High structural cracking with visible displacement, caused by undermining of pavement for utilities.

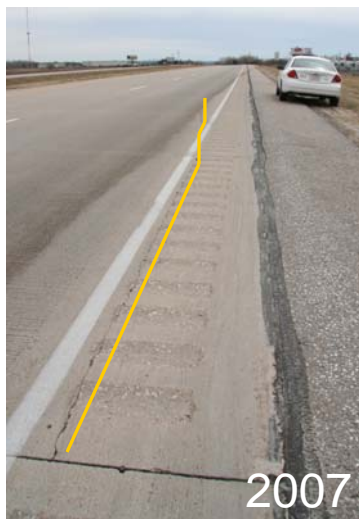
Location: MM 165.5

- Longitudinal crack starting along edge of rumble strips.
- Crack extends four pavement panels in length.
- Located along a gentle curve.

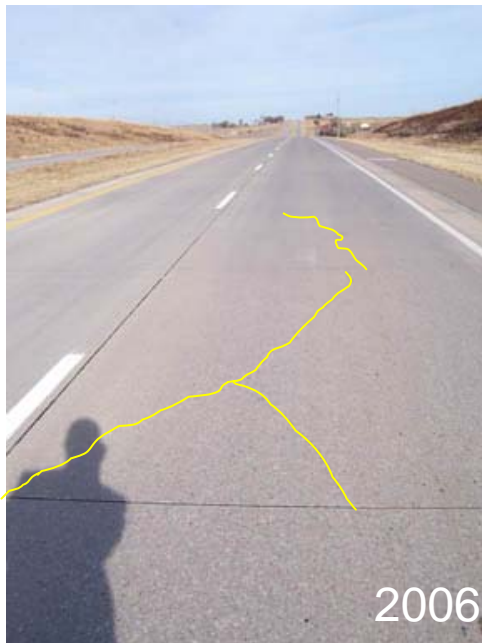
Locations: MM 44.9

- Perpendicular edge cracking along centerline.
- 2"– 8" transverse cracks approximately every four feet along centerline.
- High placement of tie bars across longitudinal joint caused surface cracking shown at left.

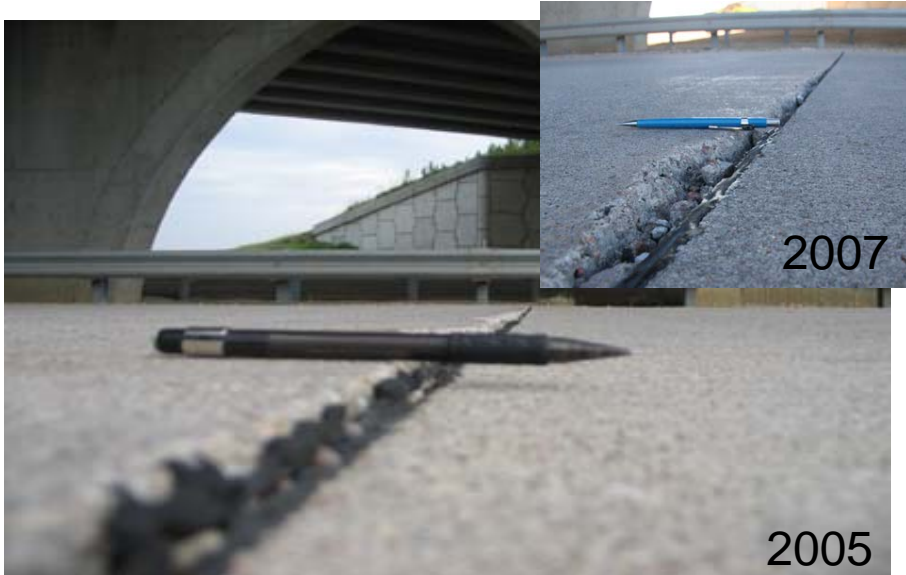
Location: MM 58.01

Faulting 6mm or greater.
Severity of faulting varies with changes in temperature and soil moisture content.
Image from 2005 shows more severe level of faulting.

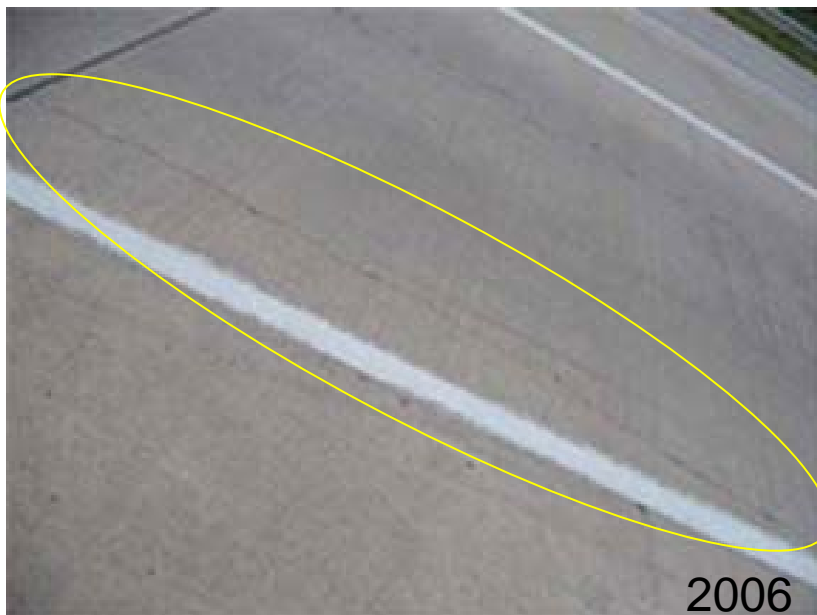
Location: MM 59

Distresses Shown: Longitudinal crack shown is about 10 feet long .

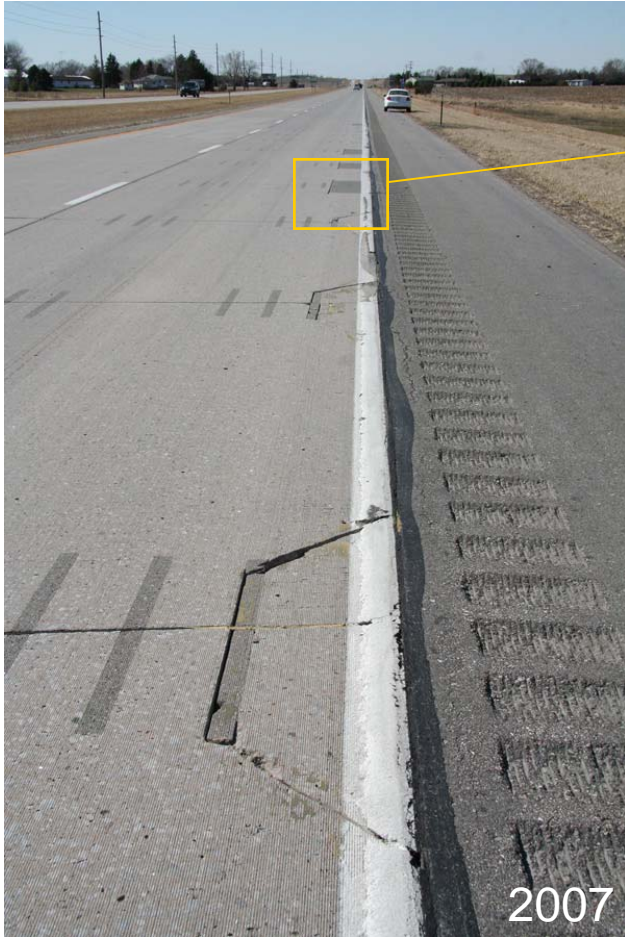
Location: MM 115.9

- Cracking along shoulder where dowel bars were retrofitted is common throughout the study section.
- Euroteck foam was used to prevent additional settling and to raise cracked panels.
- Retrofitted dowel bars placed too close to edge of pavement caused the cracking.
- Retrofitted dowel bars are now placed 6” closer to the centerline to prevent cracking of this type.

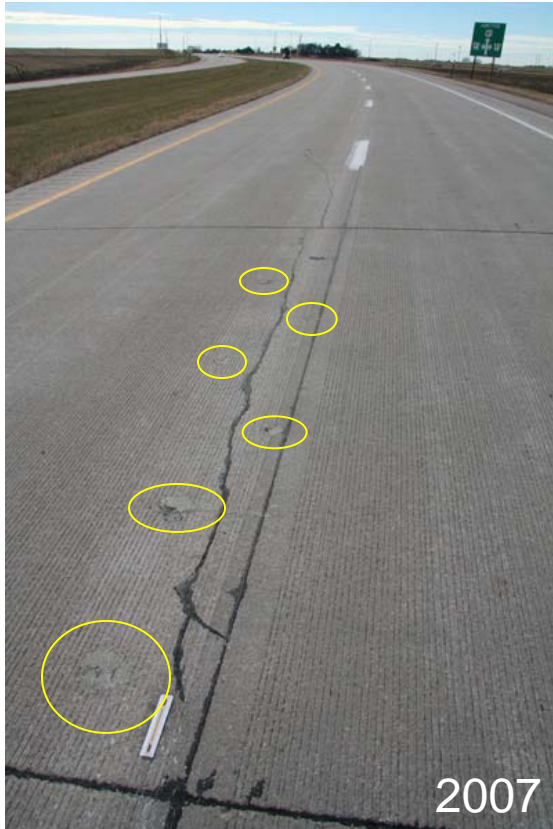
Location: MM 40

- Longitudinal cracking.
- Stitching with deformed bar to prevent further expansion of the cracks.

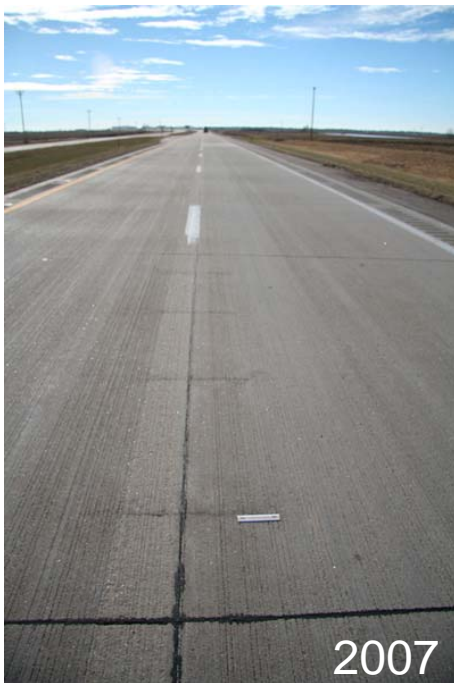
Location: MM 40.8

- Surface cracking extending through 11 to 12 panels along longitudinal joint.
- 2'8" cracks above tie bars across longitudinal joints.

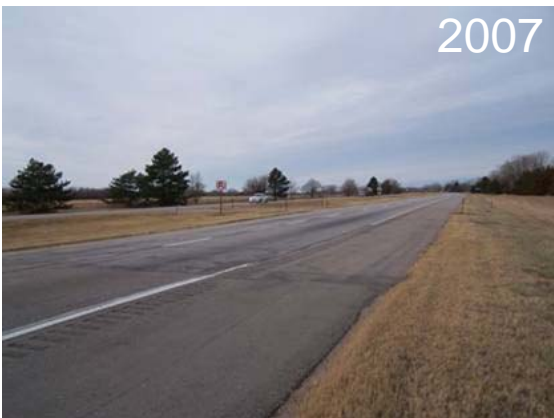
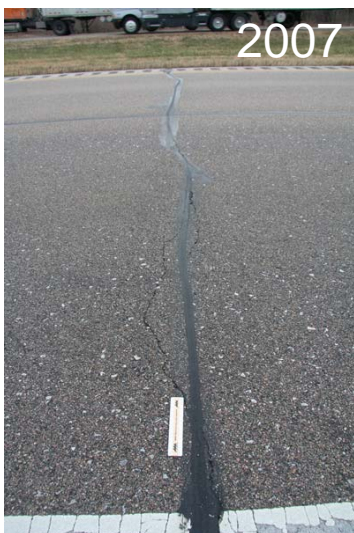
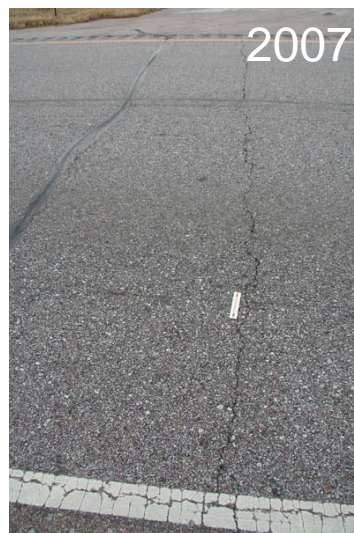
Location: MM 290.94

- Transverse cracking is common throughout the study section.

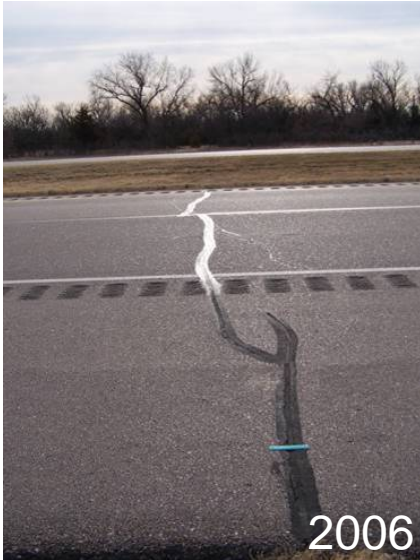
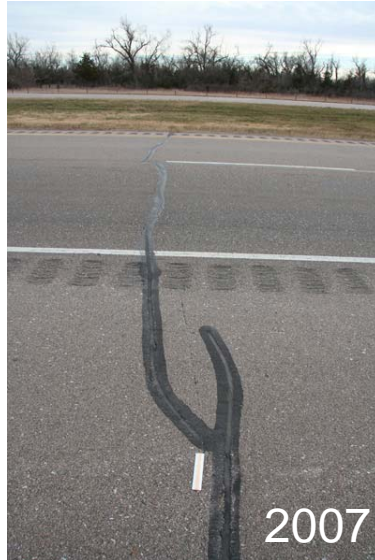
Location: MM 279.5

- High severity transverse cracking.
- Cracking beginning outside of areas where cracks have been sealed.

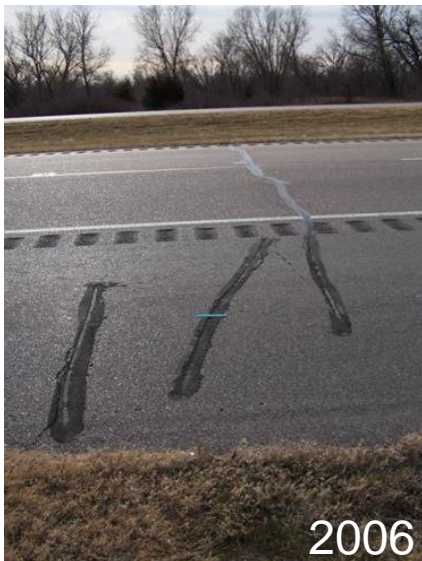
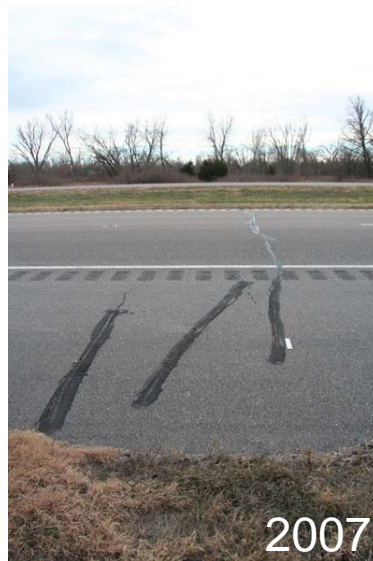
Location: MM 282

- High severity transverse cracking.
- High severity centerline cracking.

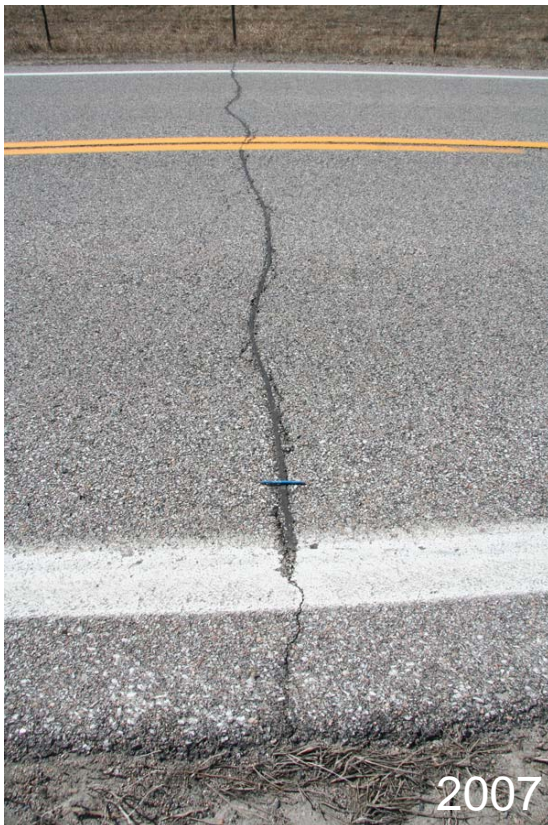
Location: MM 172.6

- Transverse cracking across both lanes and shoulder.

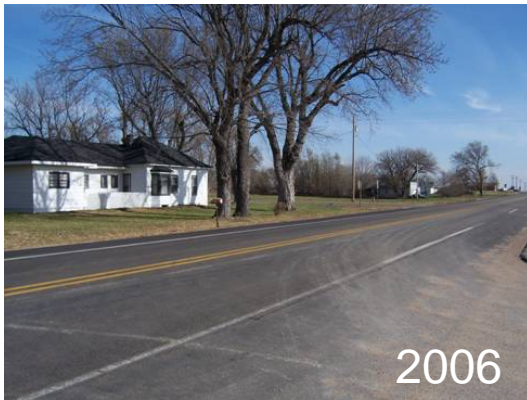
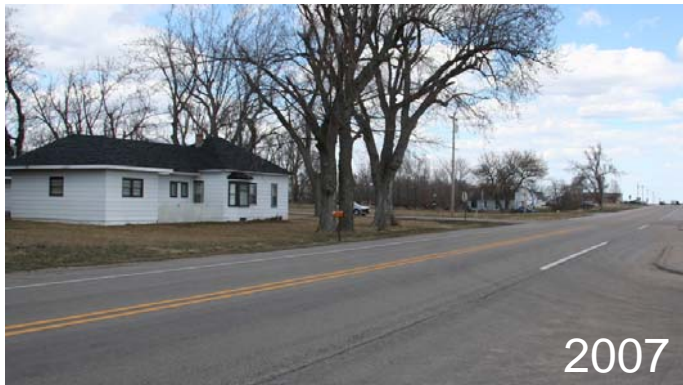
Location: MM 337.58

- New wearing course in 2006.
- Minor surface distortion; some appearance of wear in 2007.

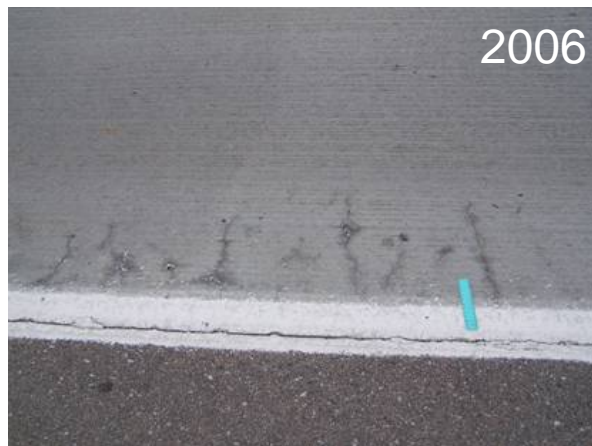
Location: MM 299.2

- Edge cracking adjacent to shoulder.

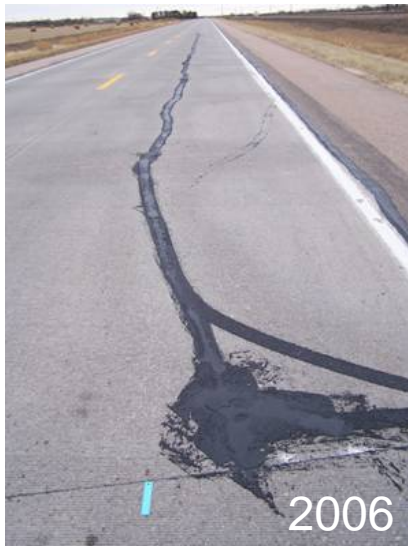
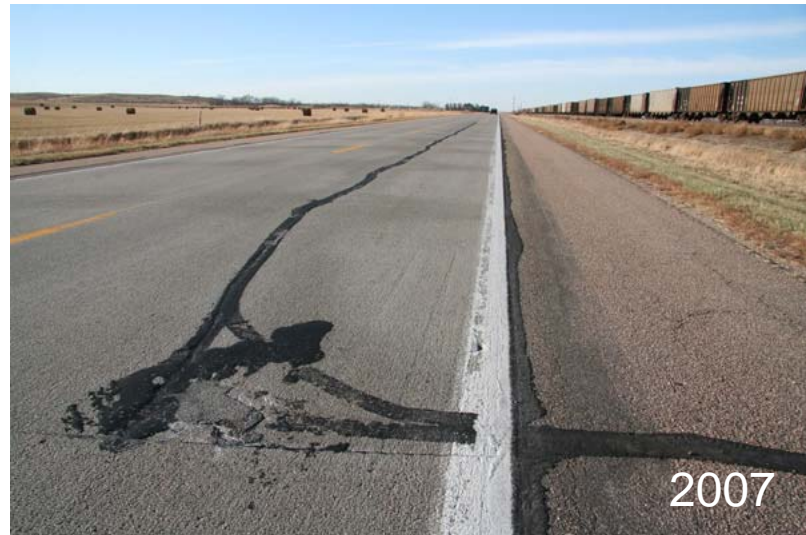
Location: MM 298.6

- High severity longitudinal cracking.
- Low pavement wear in wheel paths.
- ASR cracking at joints and cracks was less visible in 2007 than in 2006.

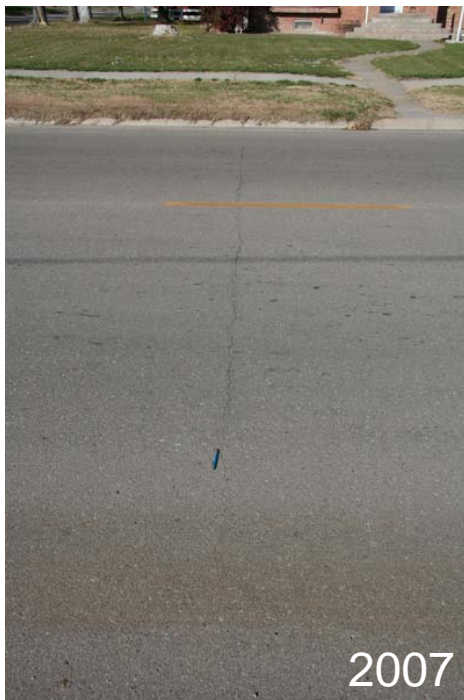
- Only visible crack was in Republican City near end of the study section.

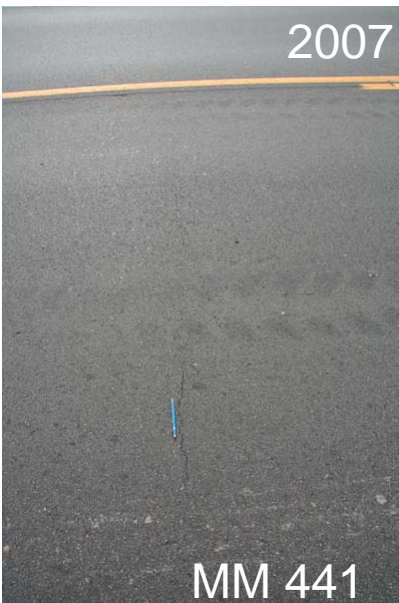
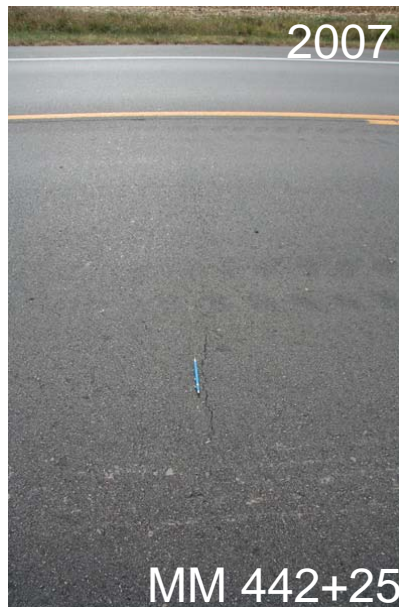
Location: MM 441 and 442+25

- Thin and short transverse cracking.
